## Phase I-Environmental Site Assessment

3432 Greenbank Road  
Ottawa, Ontario

Minto Communities

Report: PE4940-1

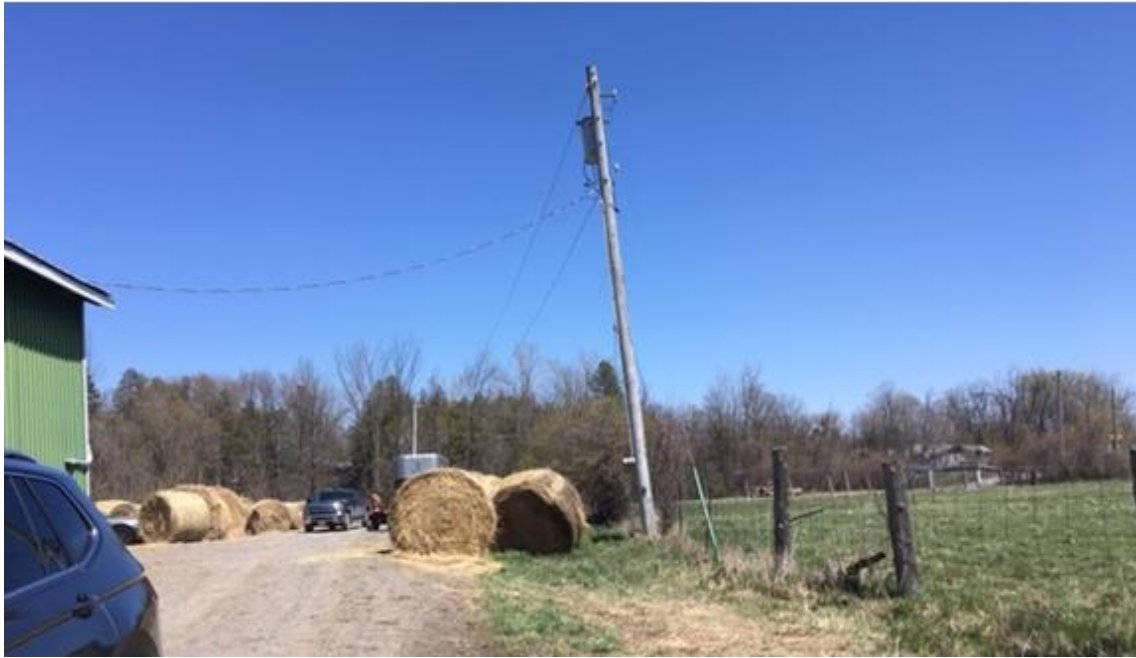
Photograph 1: View of the eastern portion of the Phase I Property, taken from the southcentral side of the Phase I Property, looking towards Greenbank Road.

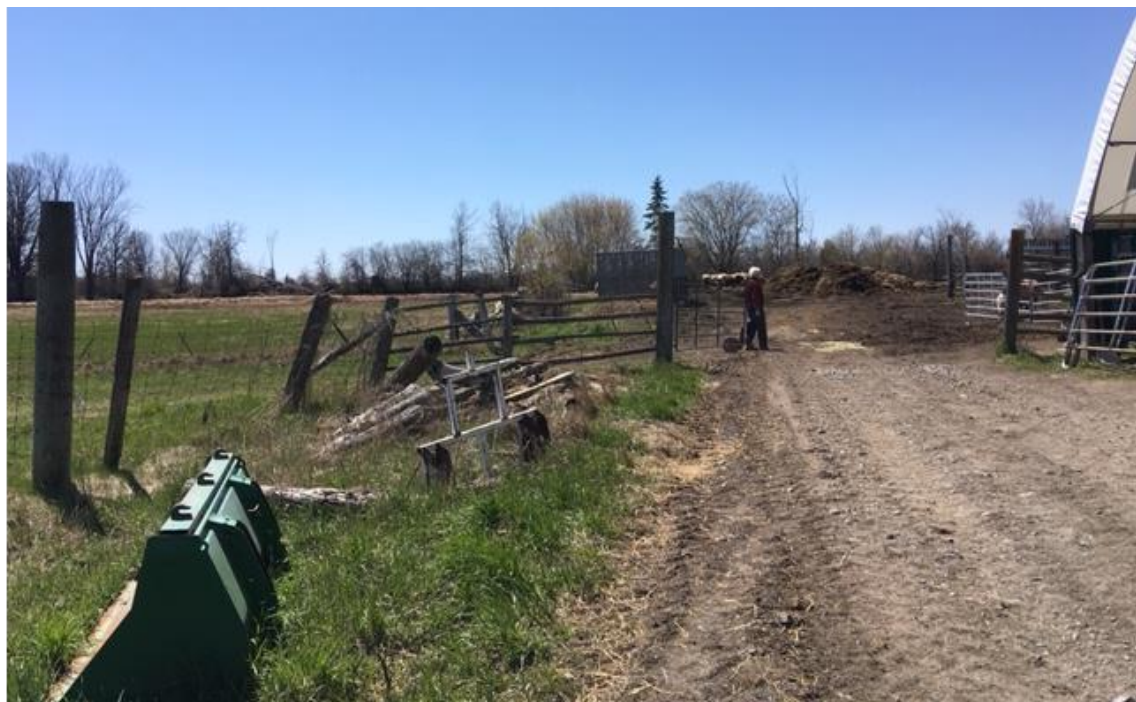
Photograph 2: View of the southern west side of the Phase I Property, looking west.

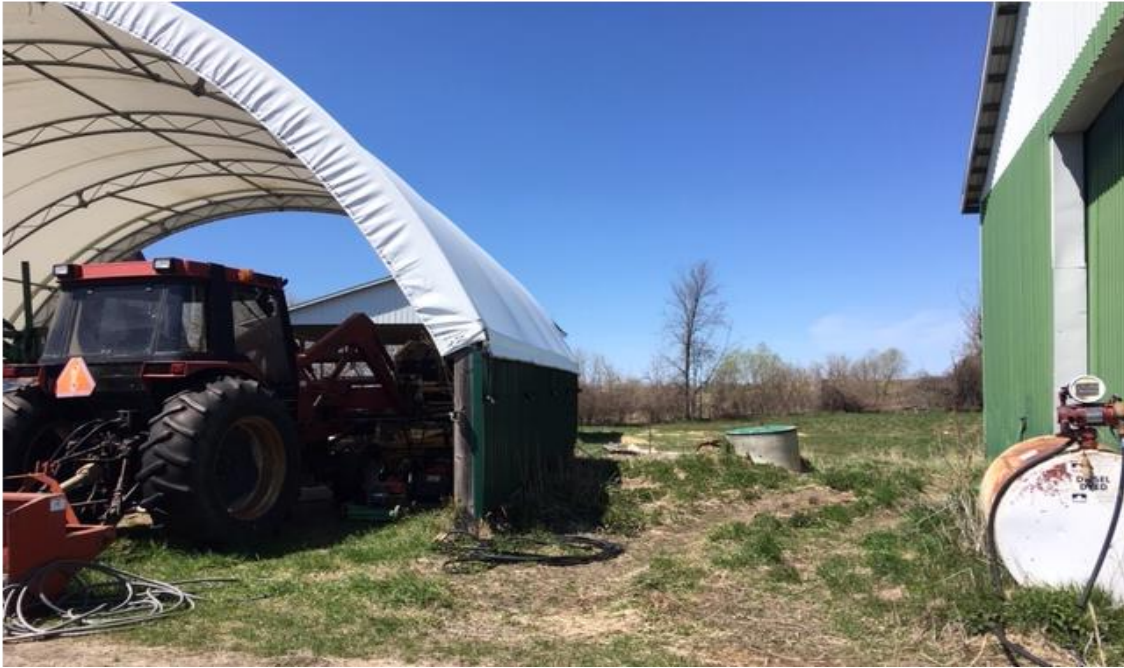
One domestic groundwater well was observed on the western side of the eastern-most building. The well was used for livestock purposes.

A pole mounted transformer was noted on the southeastern property boundary. No signs of staining or stressed vegetation was observed in the immediate area. An exterior 200 Gal (or 760 -L) above ground storage tank (AST) containing diesel fuel was observed on the west wall of the eastern-most building. The AST is presently leased from Petro Canada and is used for refuelling on-site farm equipment. No odour, signs of stained or stressed vegetation were noted at the time of the visit. No hazardous materials, chemicals or waste were noted on-site.

Photograph 2: View of the outbuildings (eastern and northern buildings), exterior diesel AST, domestic well and farm equipment, looking north.

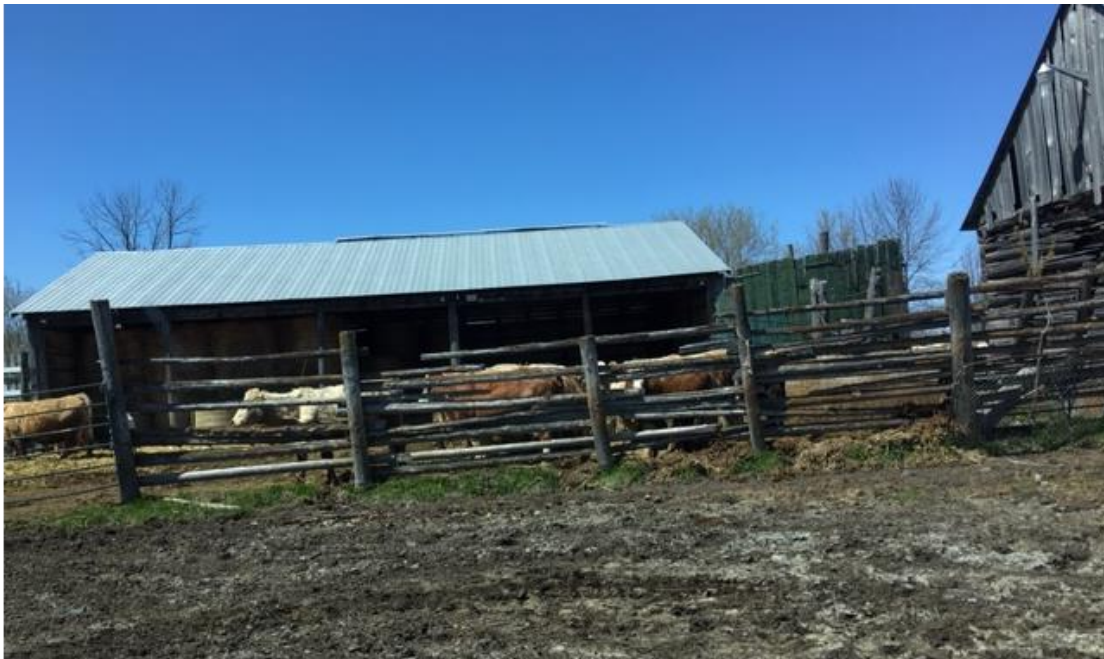
Two (2) barns and three (3) out-buildings occupy the site. Cattle are housed in the farthest buildings to the west, while the remaining three (3) buildings are used to store farm equipment and bales of hay. The out-buildings are constructed with either a rock floor foundation or poured concrete. The barns are finished in wood, while the out-buildings are finished in metal cladding. No other buildings are present on the Phase I Property.

Photograph 3: View of the two (2) barns (western buildings) on the Phase I Property, looking north.
