Phase II – Environmental Site Assessment

2006, 2020, & 2026 Scott Street and
314 & 318 Athlone Avenue
Ottawa, Ontario

Morley Hoppner Group

Report: PE5303-2R

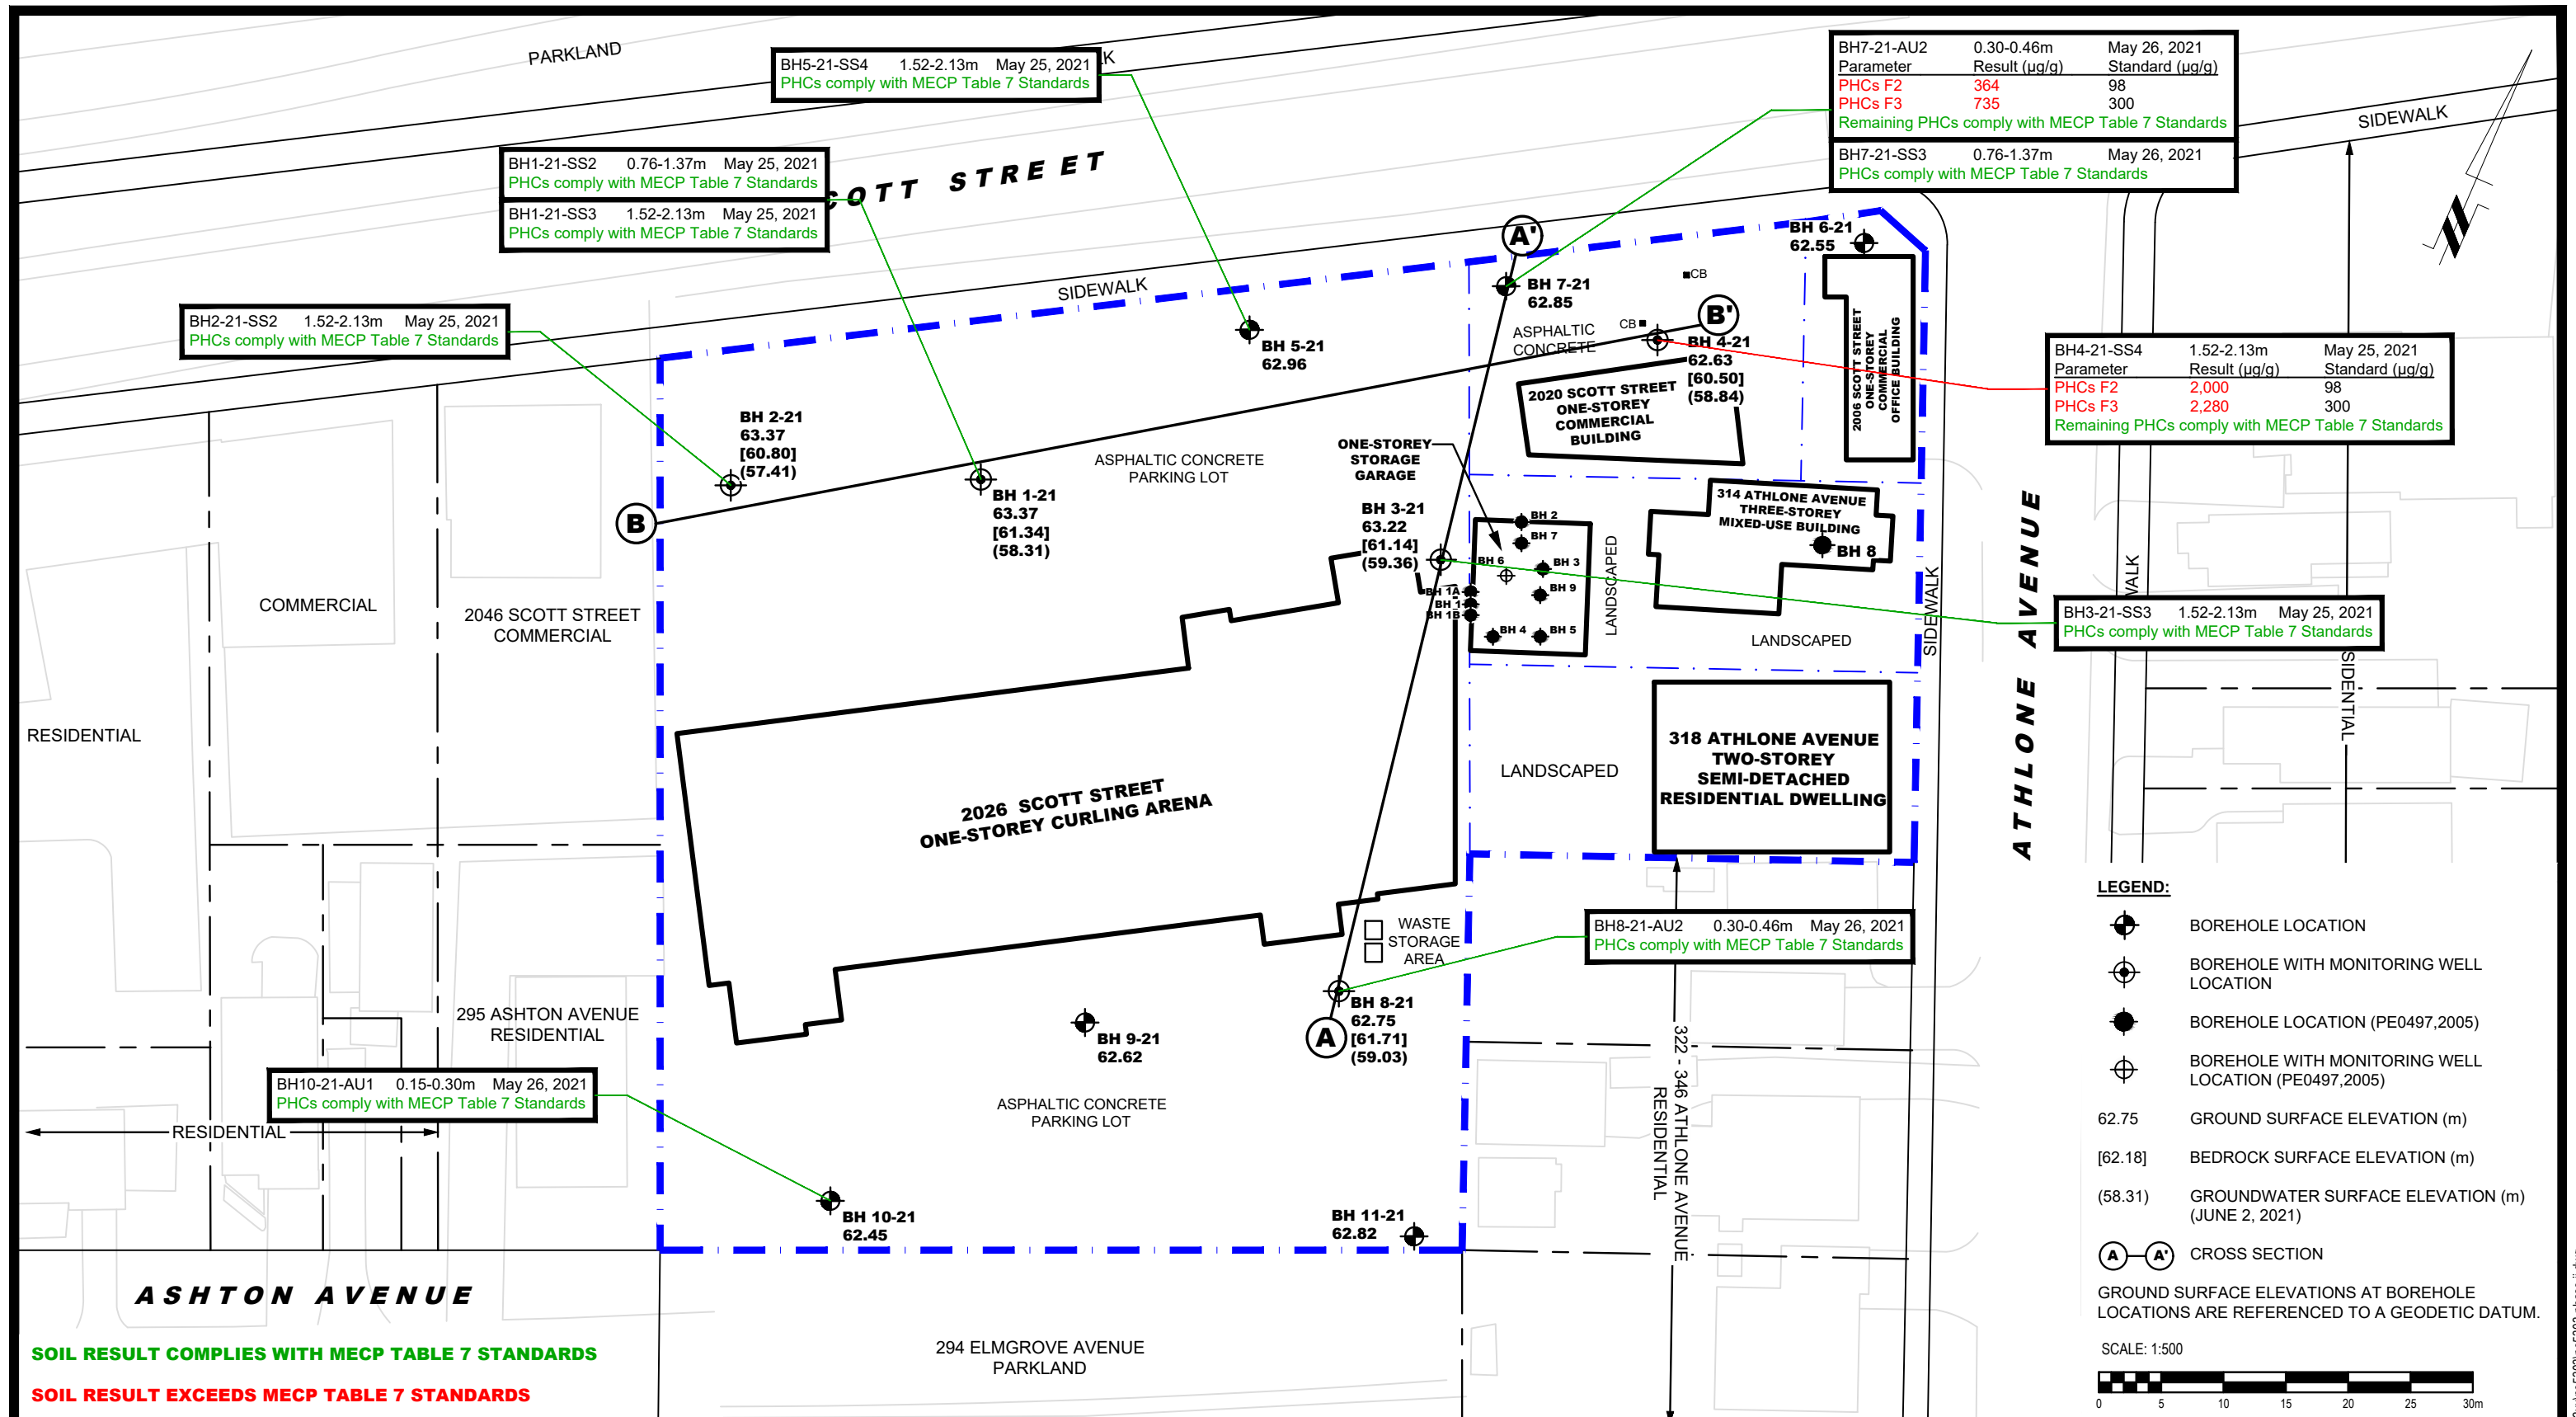
Scale:	1:500	Date:	07/2021
Drawn by:	JM	Report No.:	PE5303-2
Checked by:	NS	Dwg No.:	PE5303-4
Approved by:	MSD	Revision No.:

As previously noted, PHC impacted soil/fill was identified within the eastern and northeastern portions of the subject site (BH4-21 and BH7-21). Based on the low concentration of PHCs detected in the groundwater, this contamination is anticipated to be limited to the soil/fill in this location.

It is our recommendation that an environmental site remediation program be completed in conjunction with site redevelopment activities. This will require the segregation of clean soil from impacted soils, the latter of which will require disposal at an approved waste disposal facility.

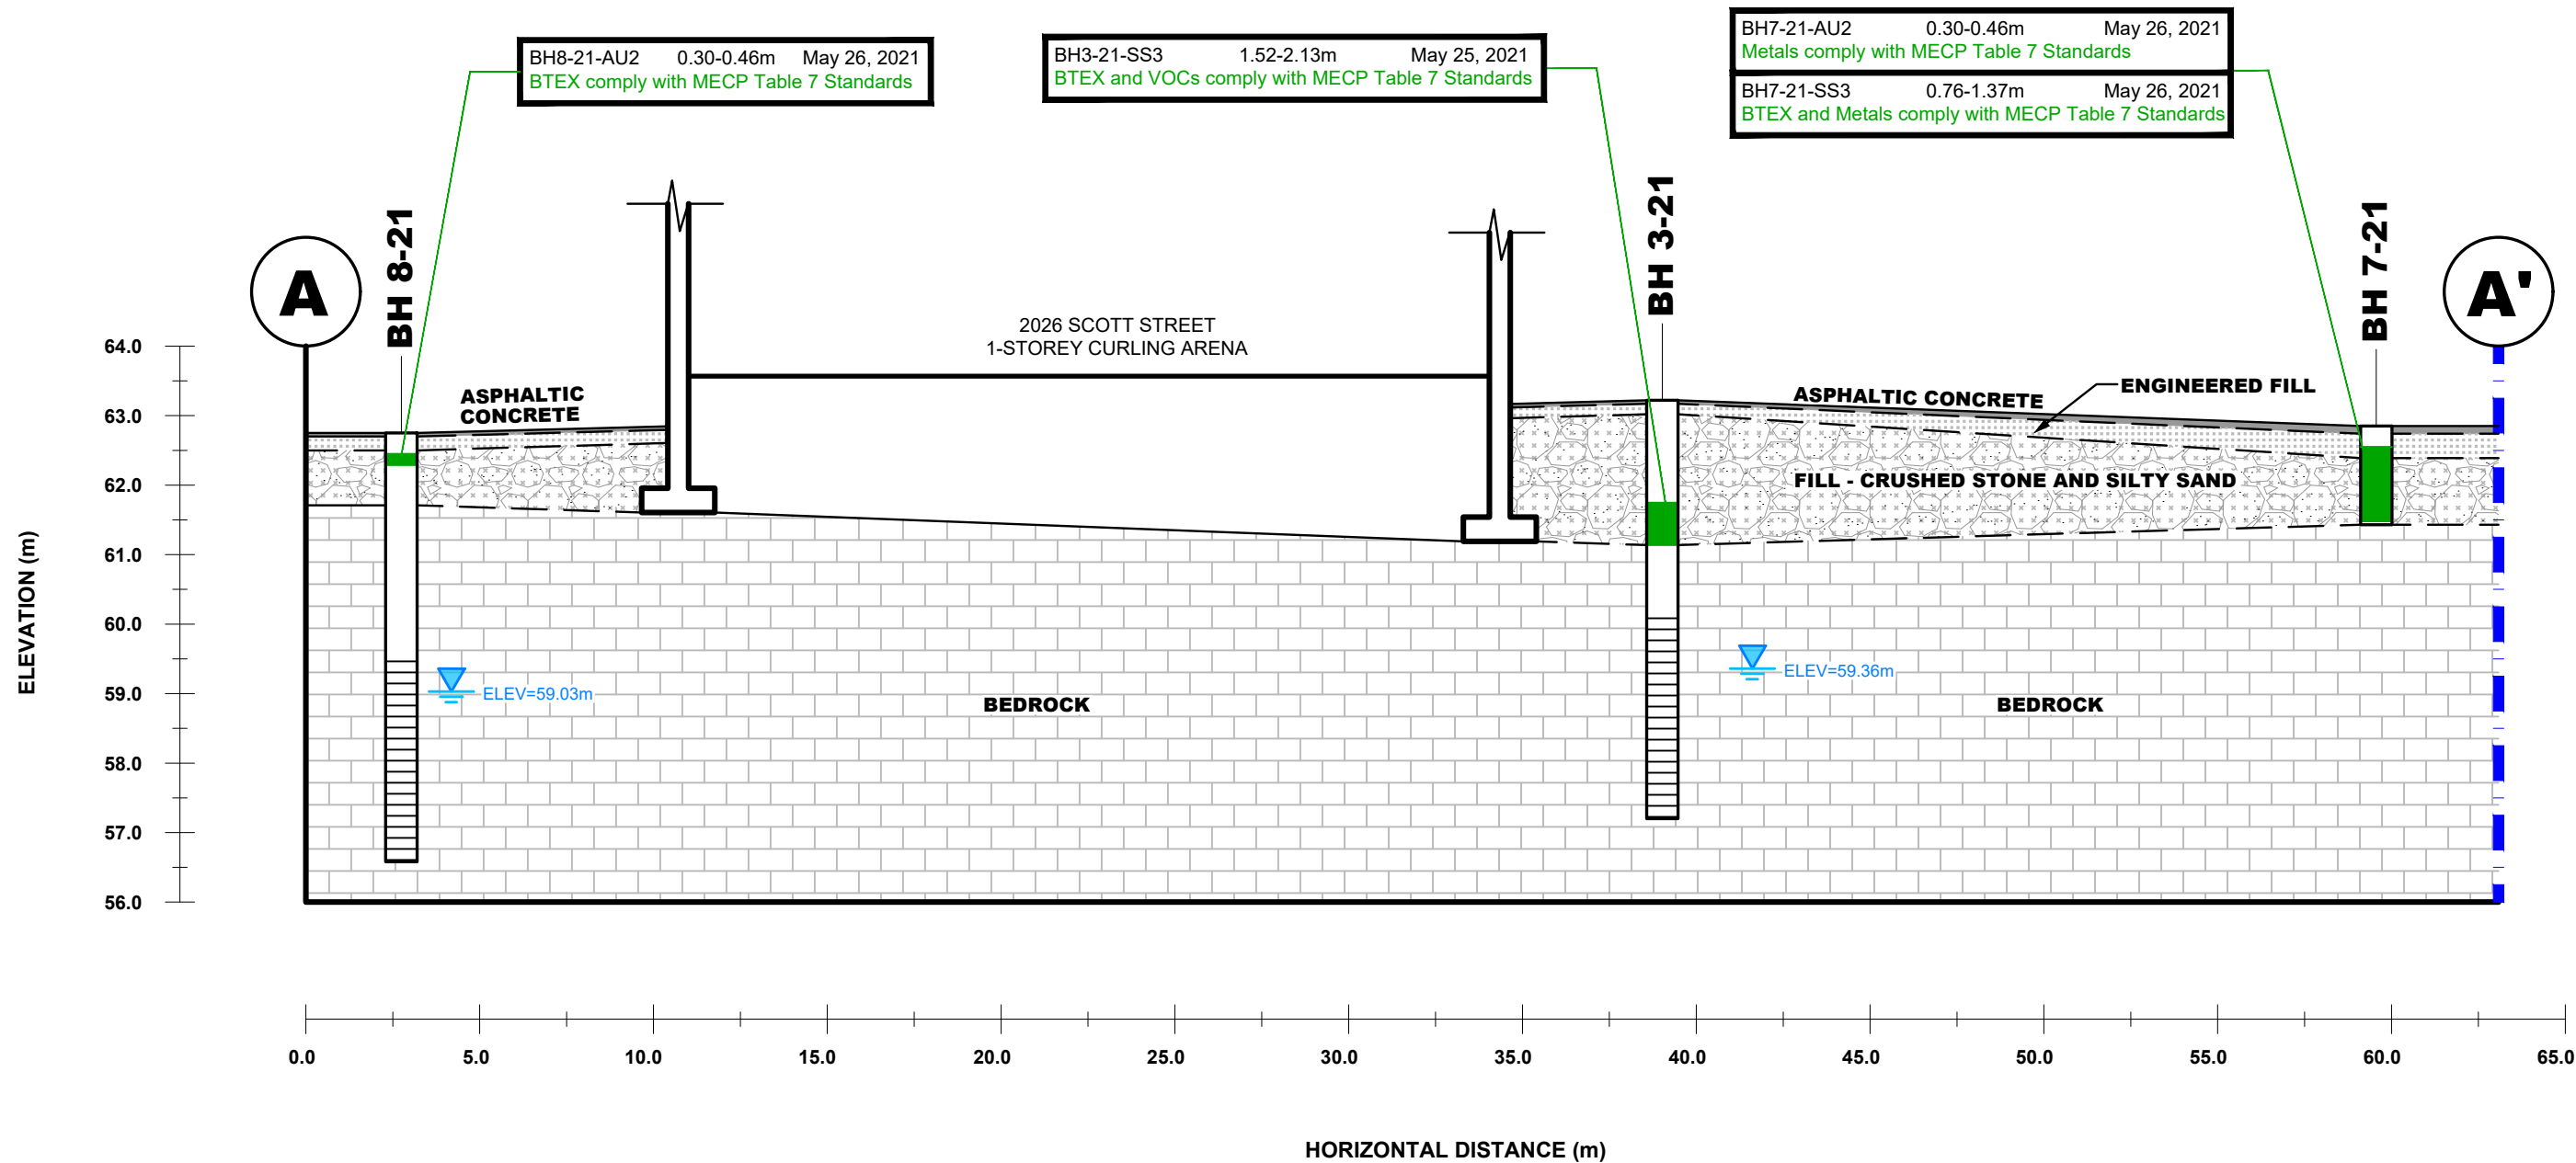
Scale:	AS SHOWN	Date:	07/2021
Drawn by:	YA	Report No.:	PE5303-2
Checked by:	NS	Dwg No.:	PE5303-5A
Approved by:	MSD	Revision No.:

Title:
CROSS SECTION A-A' - SOIL (BTEX, VOCs, METALS)

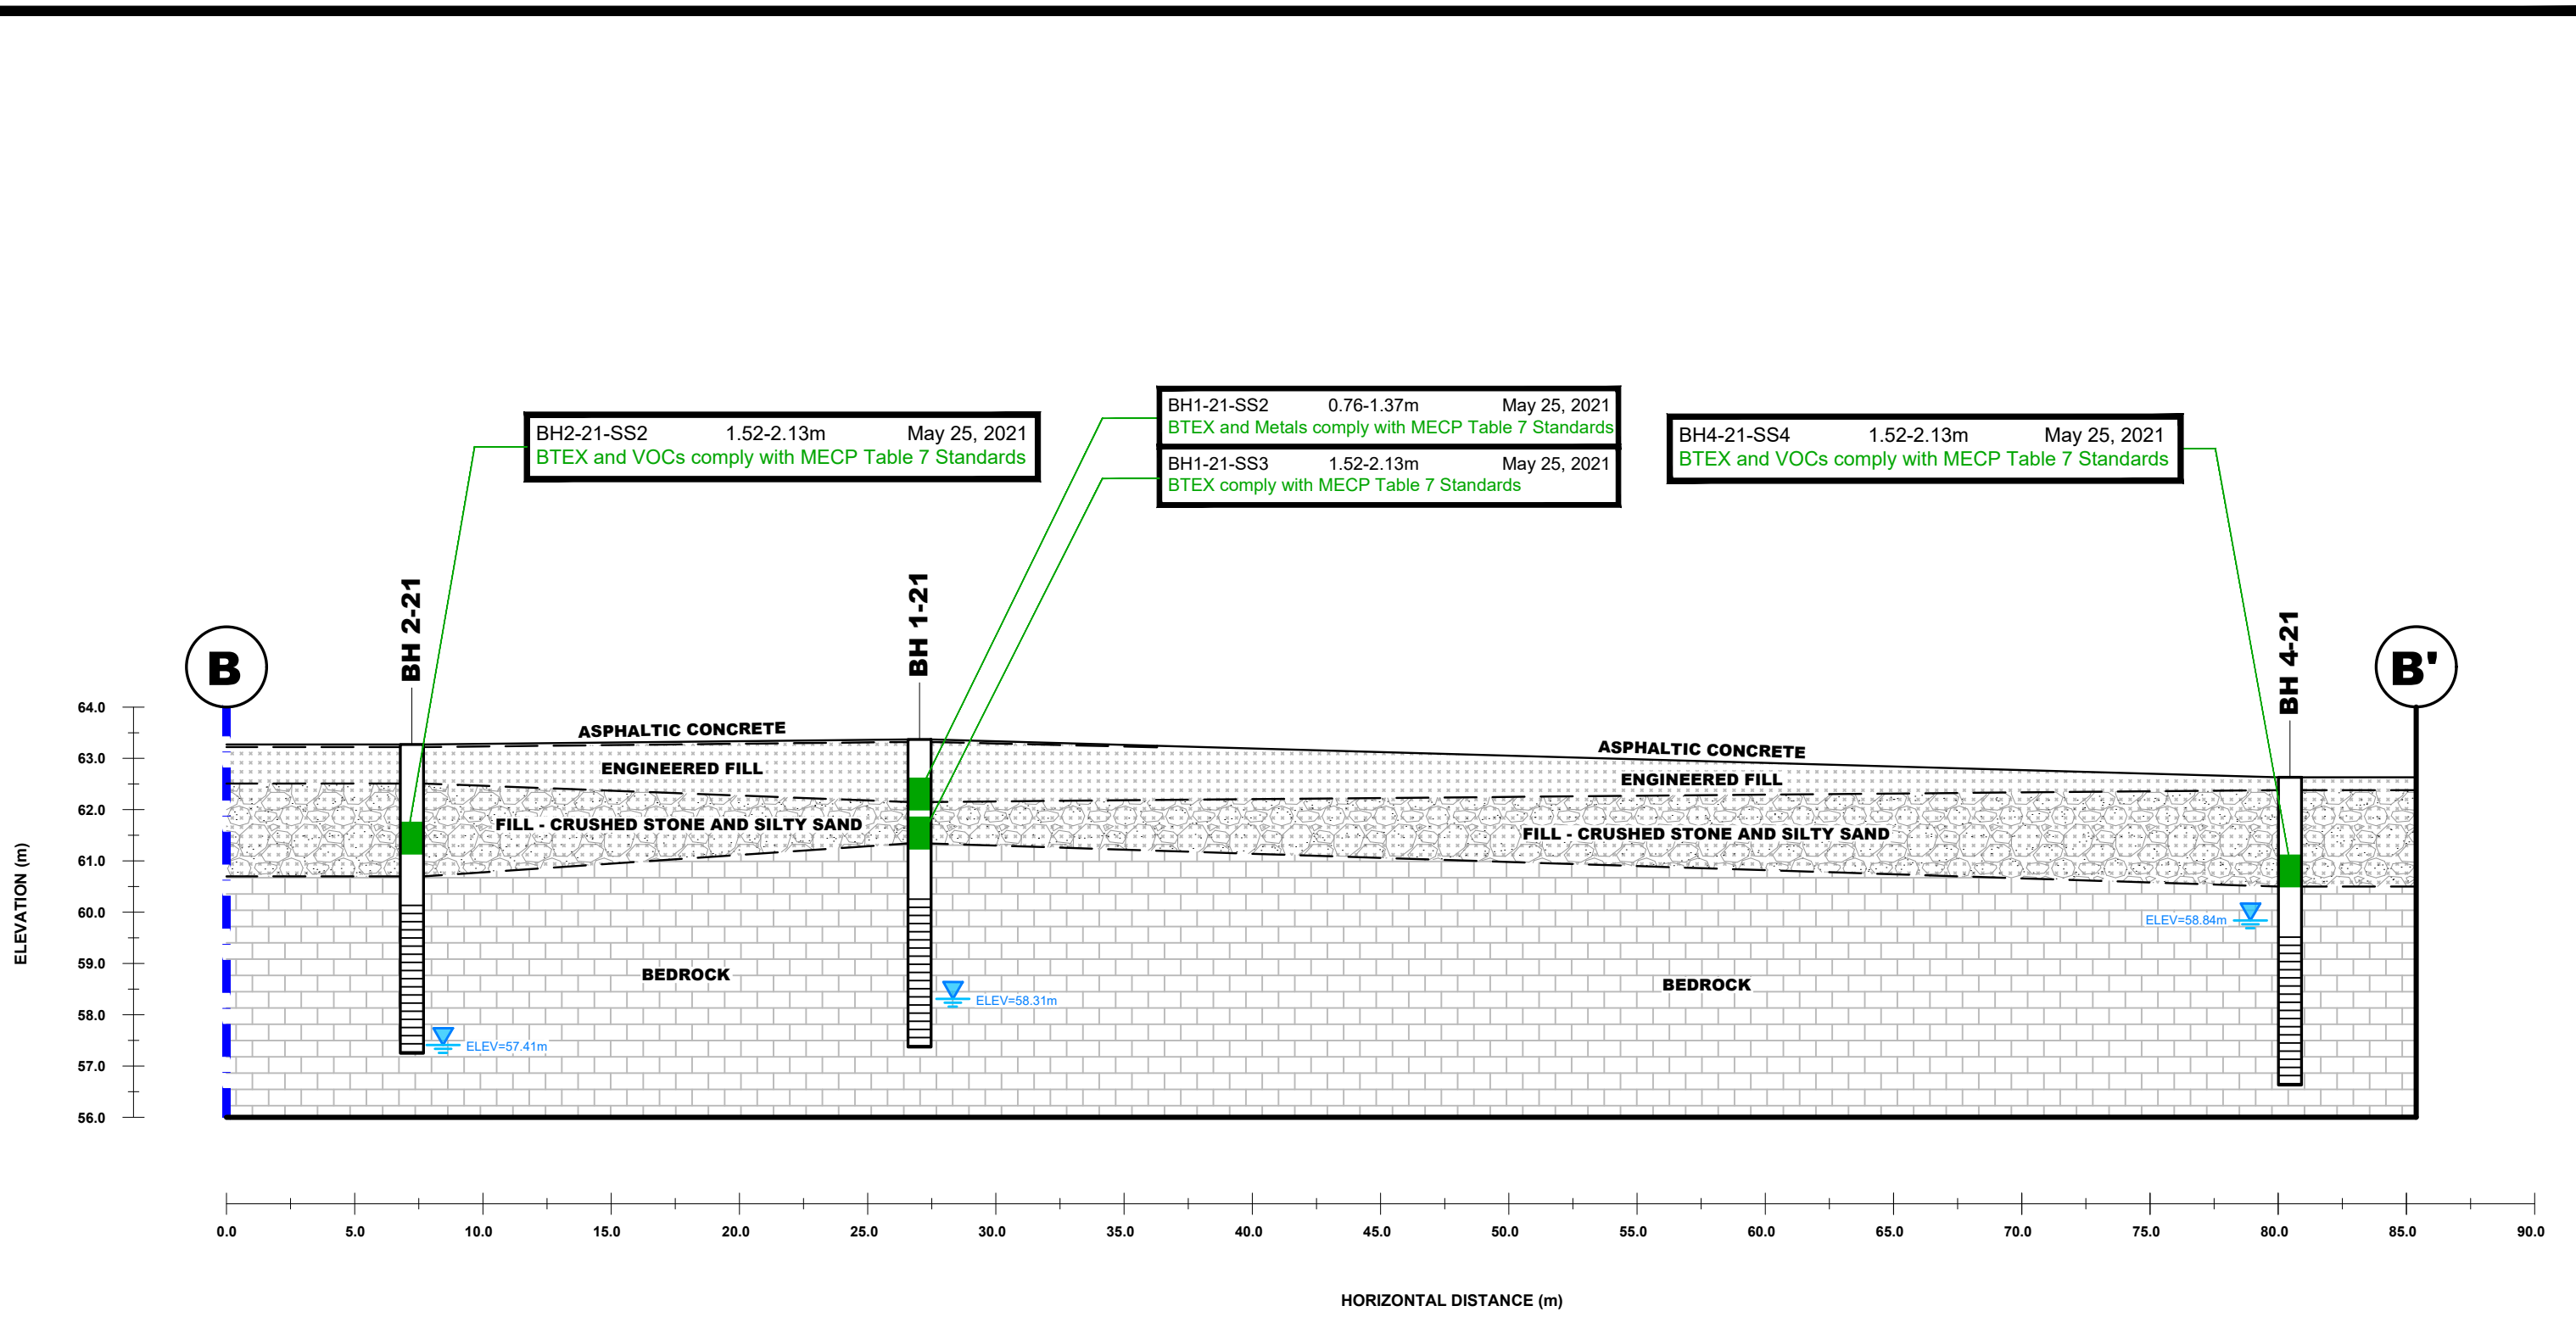
Scale:	AS SHOWN	Date:	07/2021
Drawn by:	YA	Report No.:	PE5303-2
Checked by:	NS	Dwg No.:	PE5303-5B
Approved by:	MSD	Revision No.:

MORLEY HOPNER GROUP
PHASE II - ENVIRONMENTAL SITE ASSESSMENT
 2006, 2020 & 2026 SCOTT STREET
 314 & 318 ATHLONE AVENUE
 OTTAWA, ONTARIO
CROSS SECTION B-B' - SOIL (BTEX, VOCs, METALS)

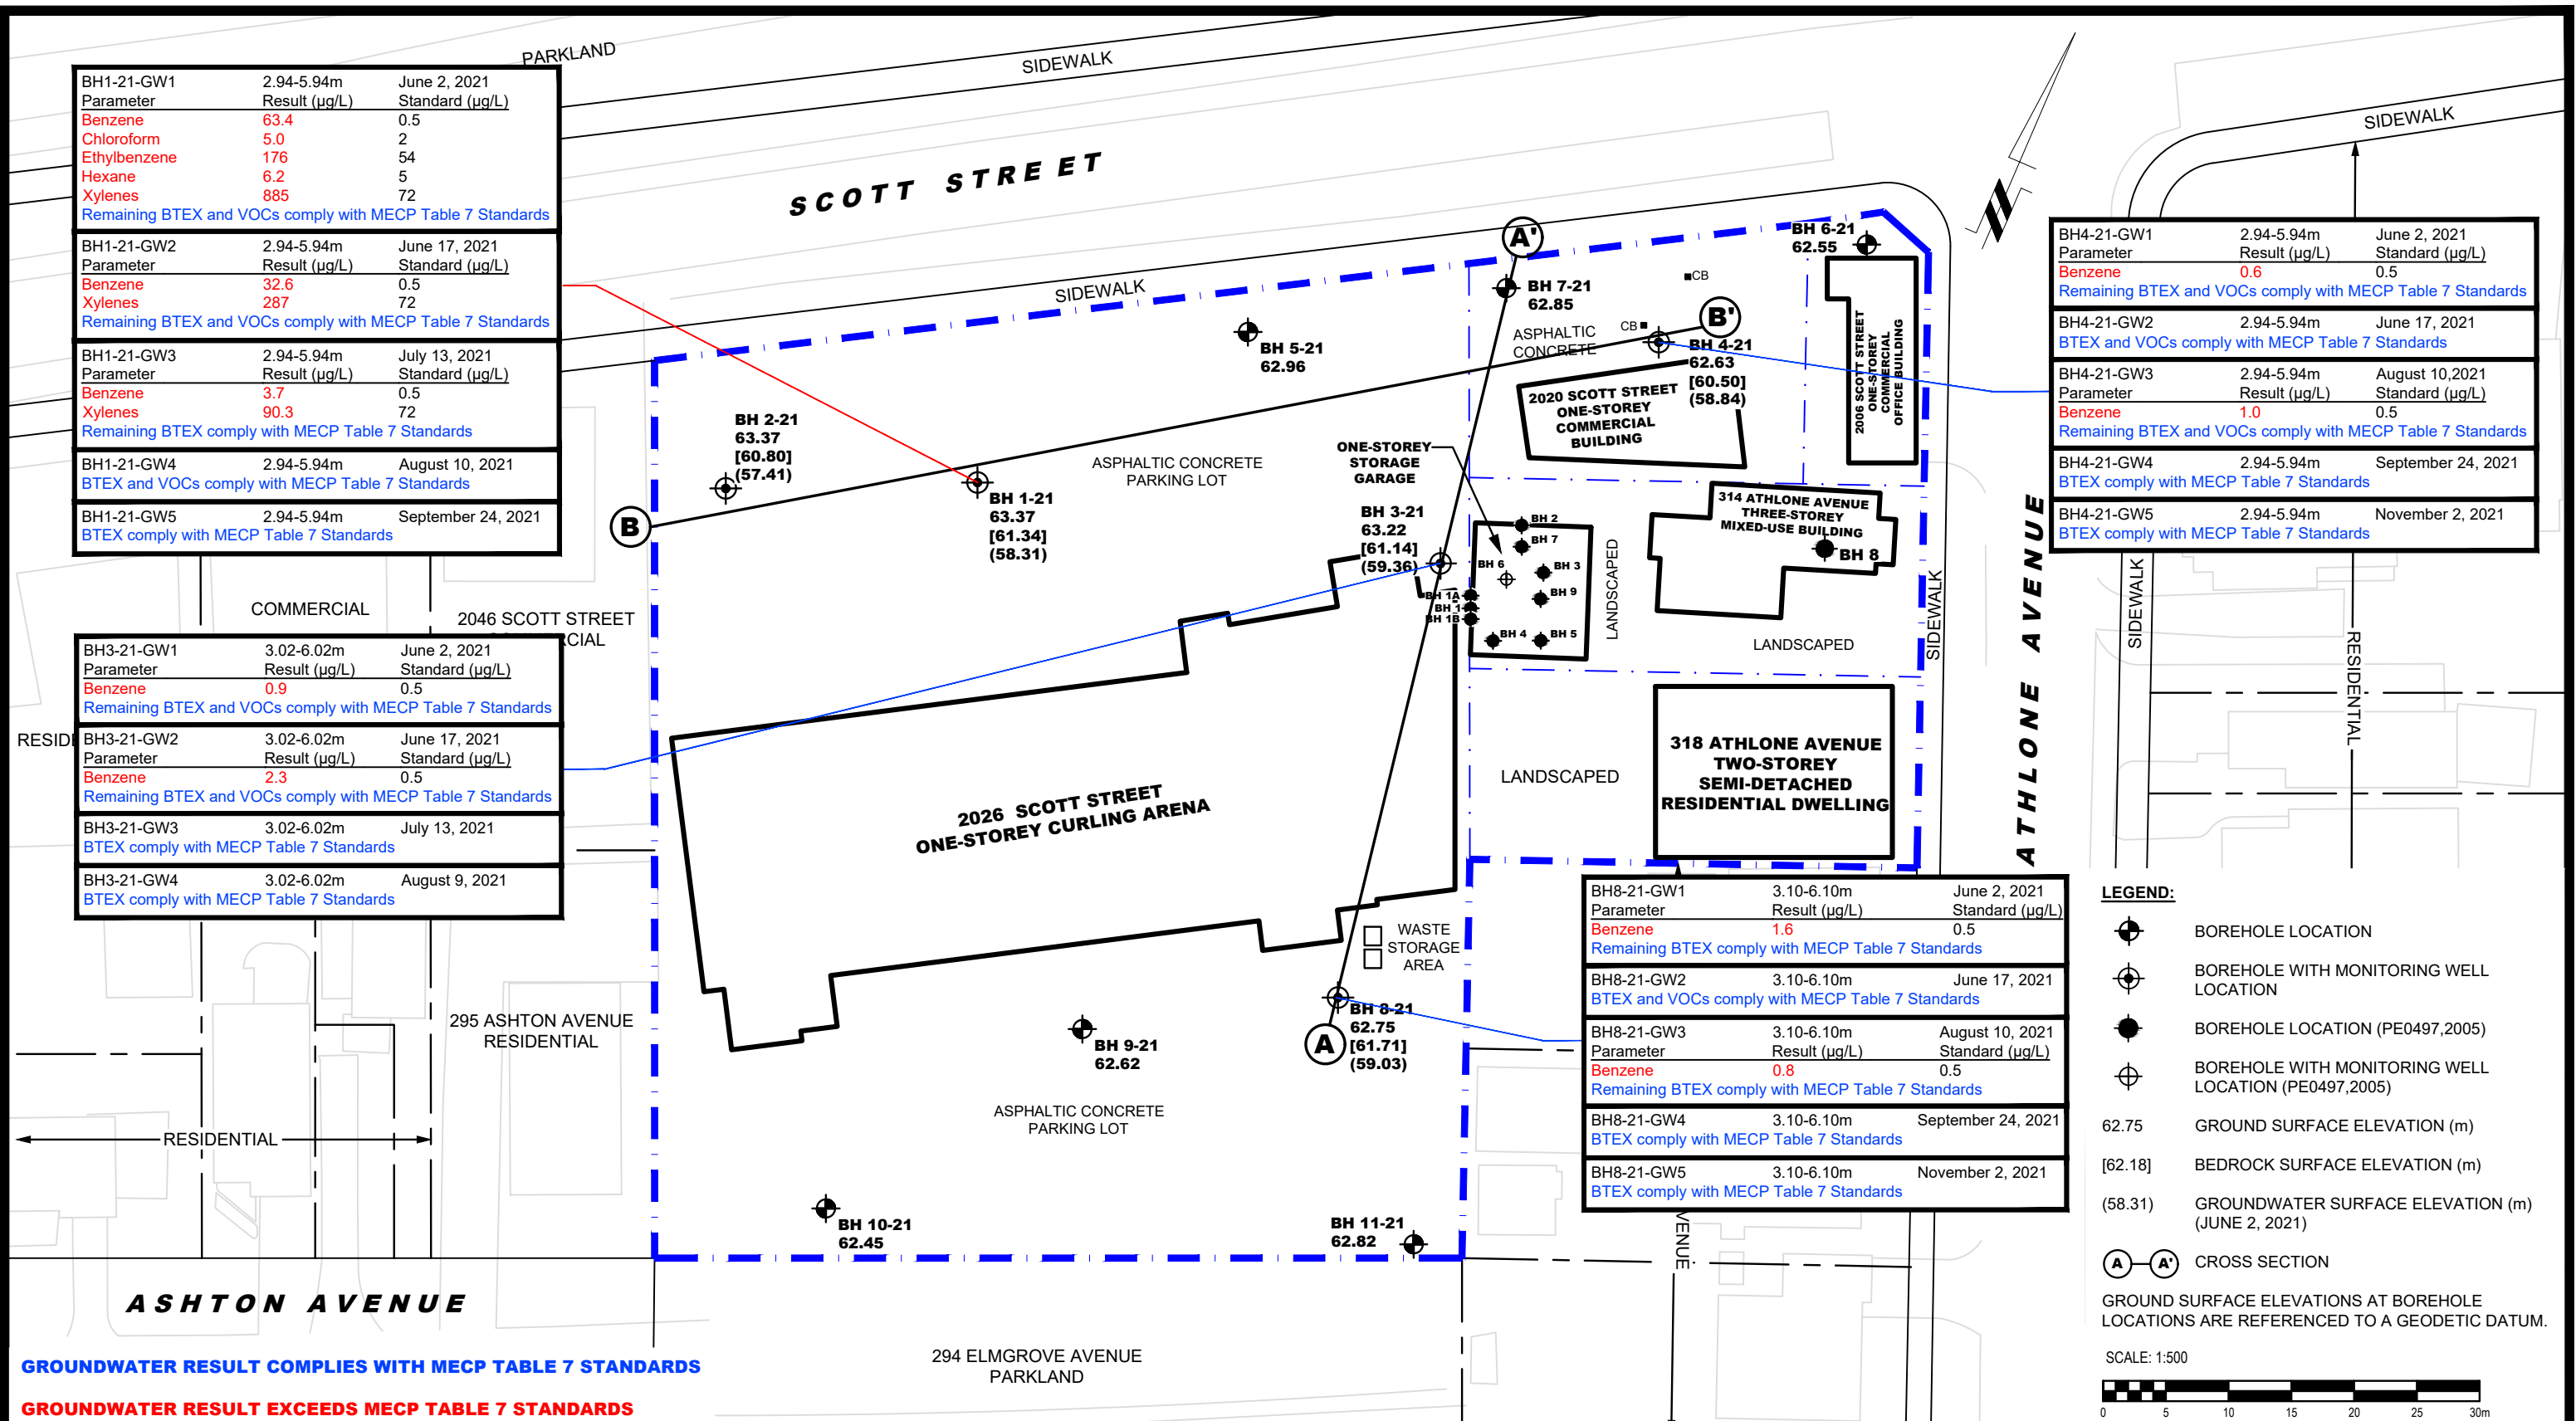
BH1-21-GW1	2.94-5.94m	June 2, 2021
Parameter	Result (µg/L)	Standard (µg/L)
Benzene	63.4	0.5
Chloroform	5.0	2
Ethylbenzene	176	54
Hexane	6.2	5
Xylenes	885	72
Remaining BTEX and VOCs comply with MECP Table 7 Standards		
BH1-21-GW2	2.94-5.94m	June 17, 2021
Parameter	Result (µg/L)	Standard (µg/L)
Benzene	32.6	0.5
Xylenes	287	72
Remaining BTEX and VOCs comply with MECP Table 7 Standards		
BH1-21-GW3	2.94-5.94m	July 13, 2021
Parameter	Result (µg/L)	Standard (µg/L)
Benzene	3.7	0.5
Xylenes	90.3	72
Remaining BTEX comply with MECP Table 7 Standards		
BH1-21-GW4	2.94-5.94m	August 10, 2021
BTEX and VOCs comply with MECP Table 7 Standards		
BH1-21-GW5	2.94-5.94m	September 24, 2021
BTEX comply with MECP Table 7 Standards

BH3-21-GW1	3.02-6.02m	June 2, 2021
Parameter	Result (µg/L)	Standard (µg/L)
Benzene	0.9	0.5
Remaining BTEX and VOCs comply with MECP Table 7 Standards		
BH3-21-GW2	3.02-6.02m	June 17, 2021
Parameter	Result (µg/L)	Standard (µg/L)
Benzene	2.3	0.5
Remaining BTEX and VOCs comply with MECP Table 7 Standards		
BH3-21-GW3	3.02-6.02m	July 13, 2021
BTEX comply with MECP Table 7 Standards		
BH3-21-GW4	3.02-6.02m	August 9, 2021
BTEX comply with MECP Table 7 Standards

Although several groundwater retesting events have already been completed, it is recommended that the groundwater quality be retested and verified a final time prior to any future redevelopment activities.

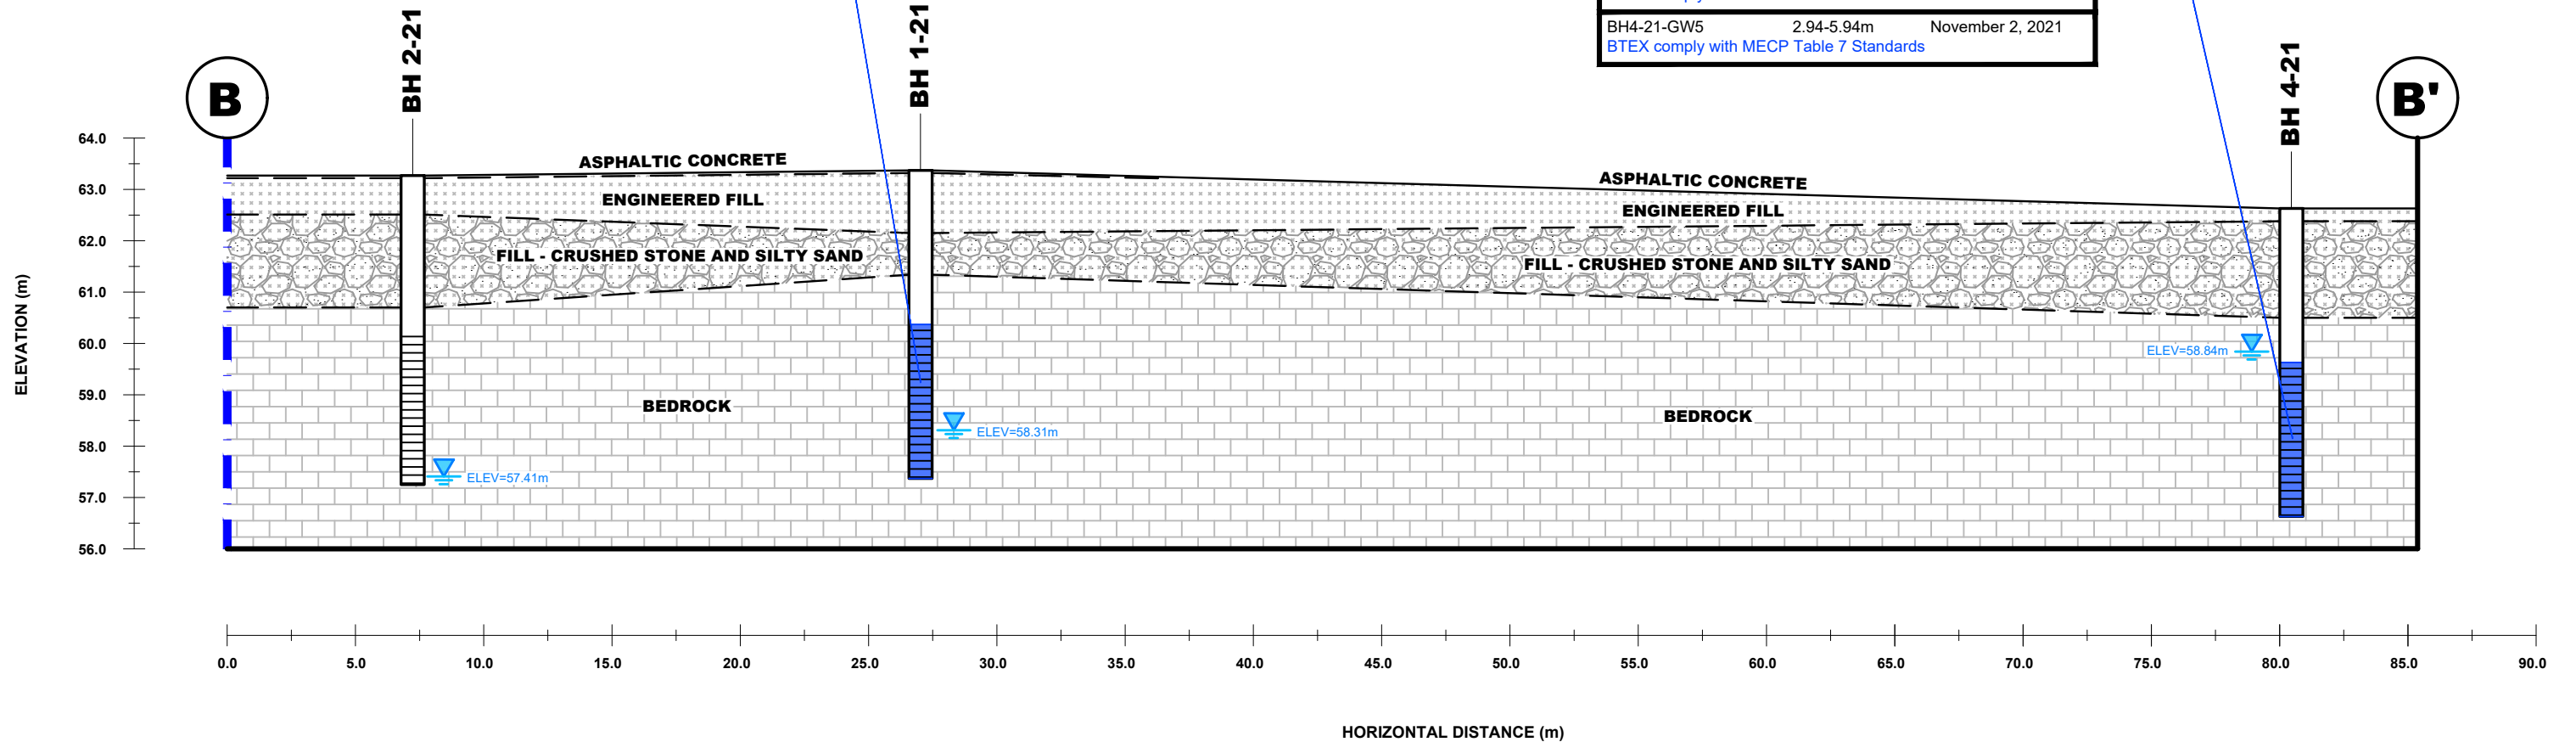
Scale:	AS SHOWN	Date:	07/2021
Drawn by:	YA	Report No.:	PE5303-2
Checked by:	NS	Dwg No.:	PE5303-6B
Approved by:	MSD	Revision No.:

Title:
CROSS SECTION B-B' - GROUNDWATER (BTEX, VOCs)

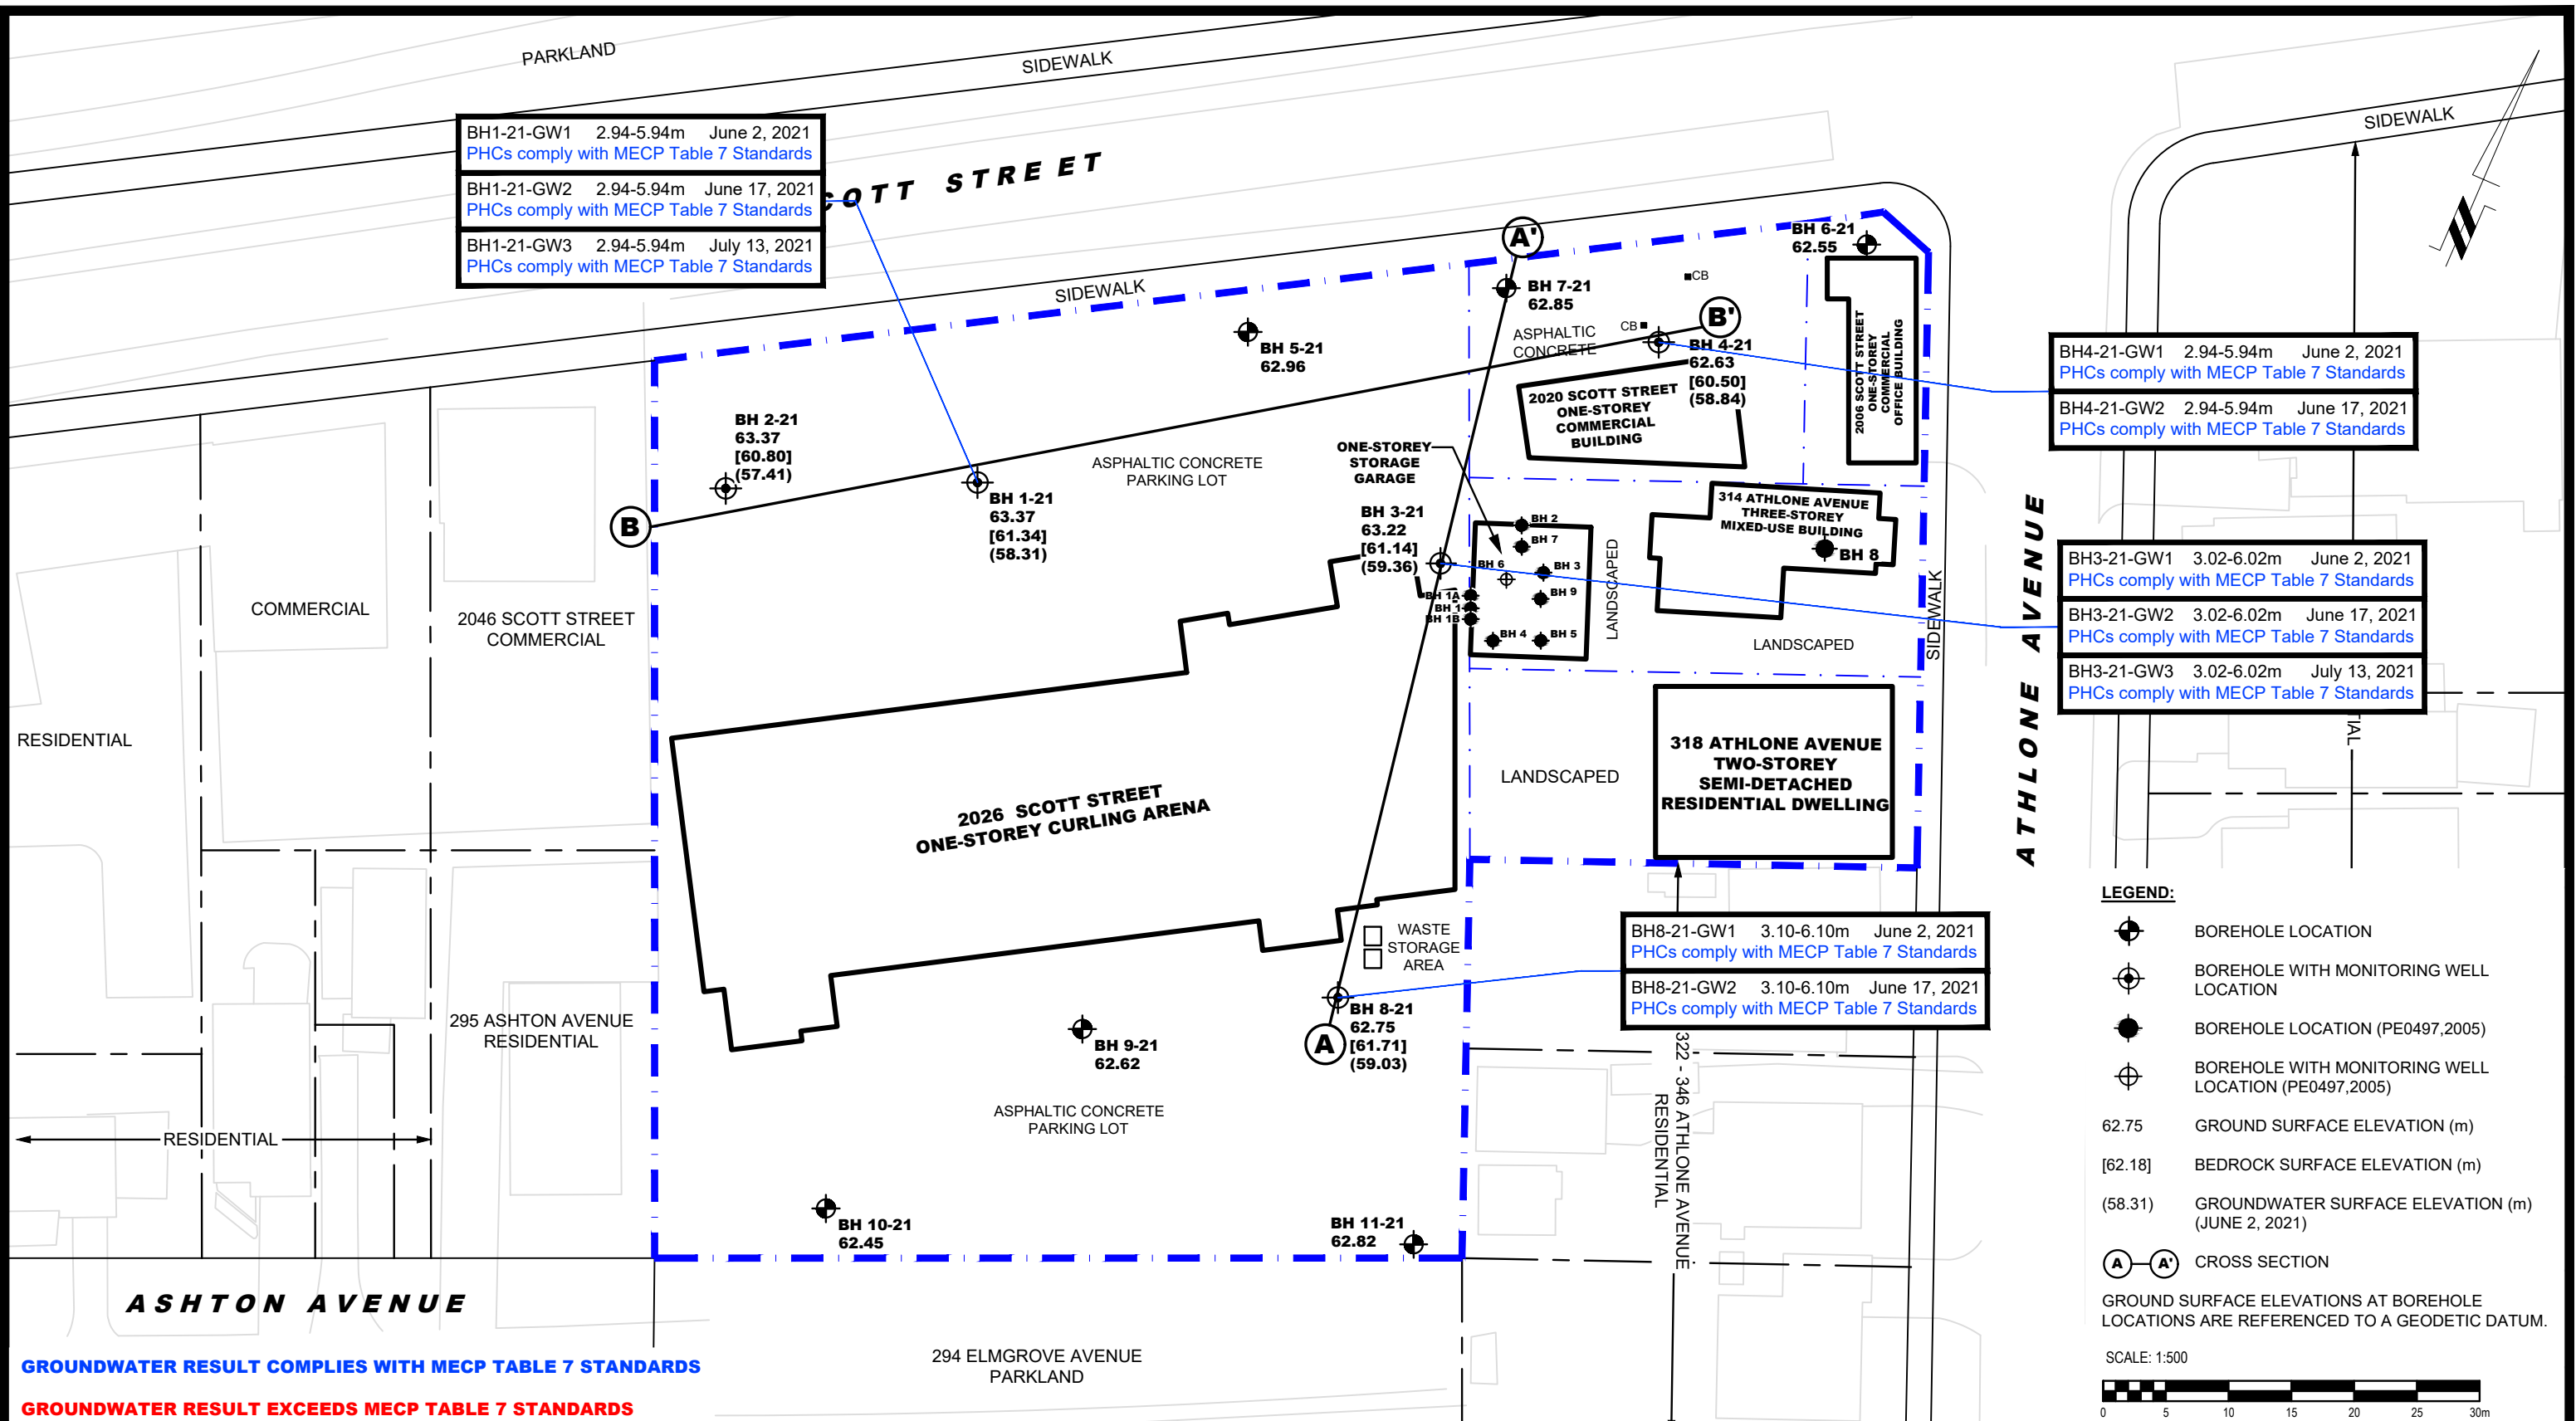
BH1-21-GW1 2.94-5.94m June 2, 2021
 PHCs comply with MECP Table 7 Standards

BH1-21-GW2 2.94-5.94m June 17, 2021
 PHCs comply with MECP Table 7 Standards

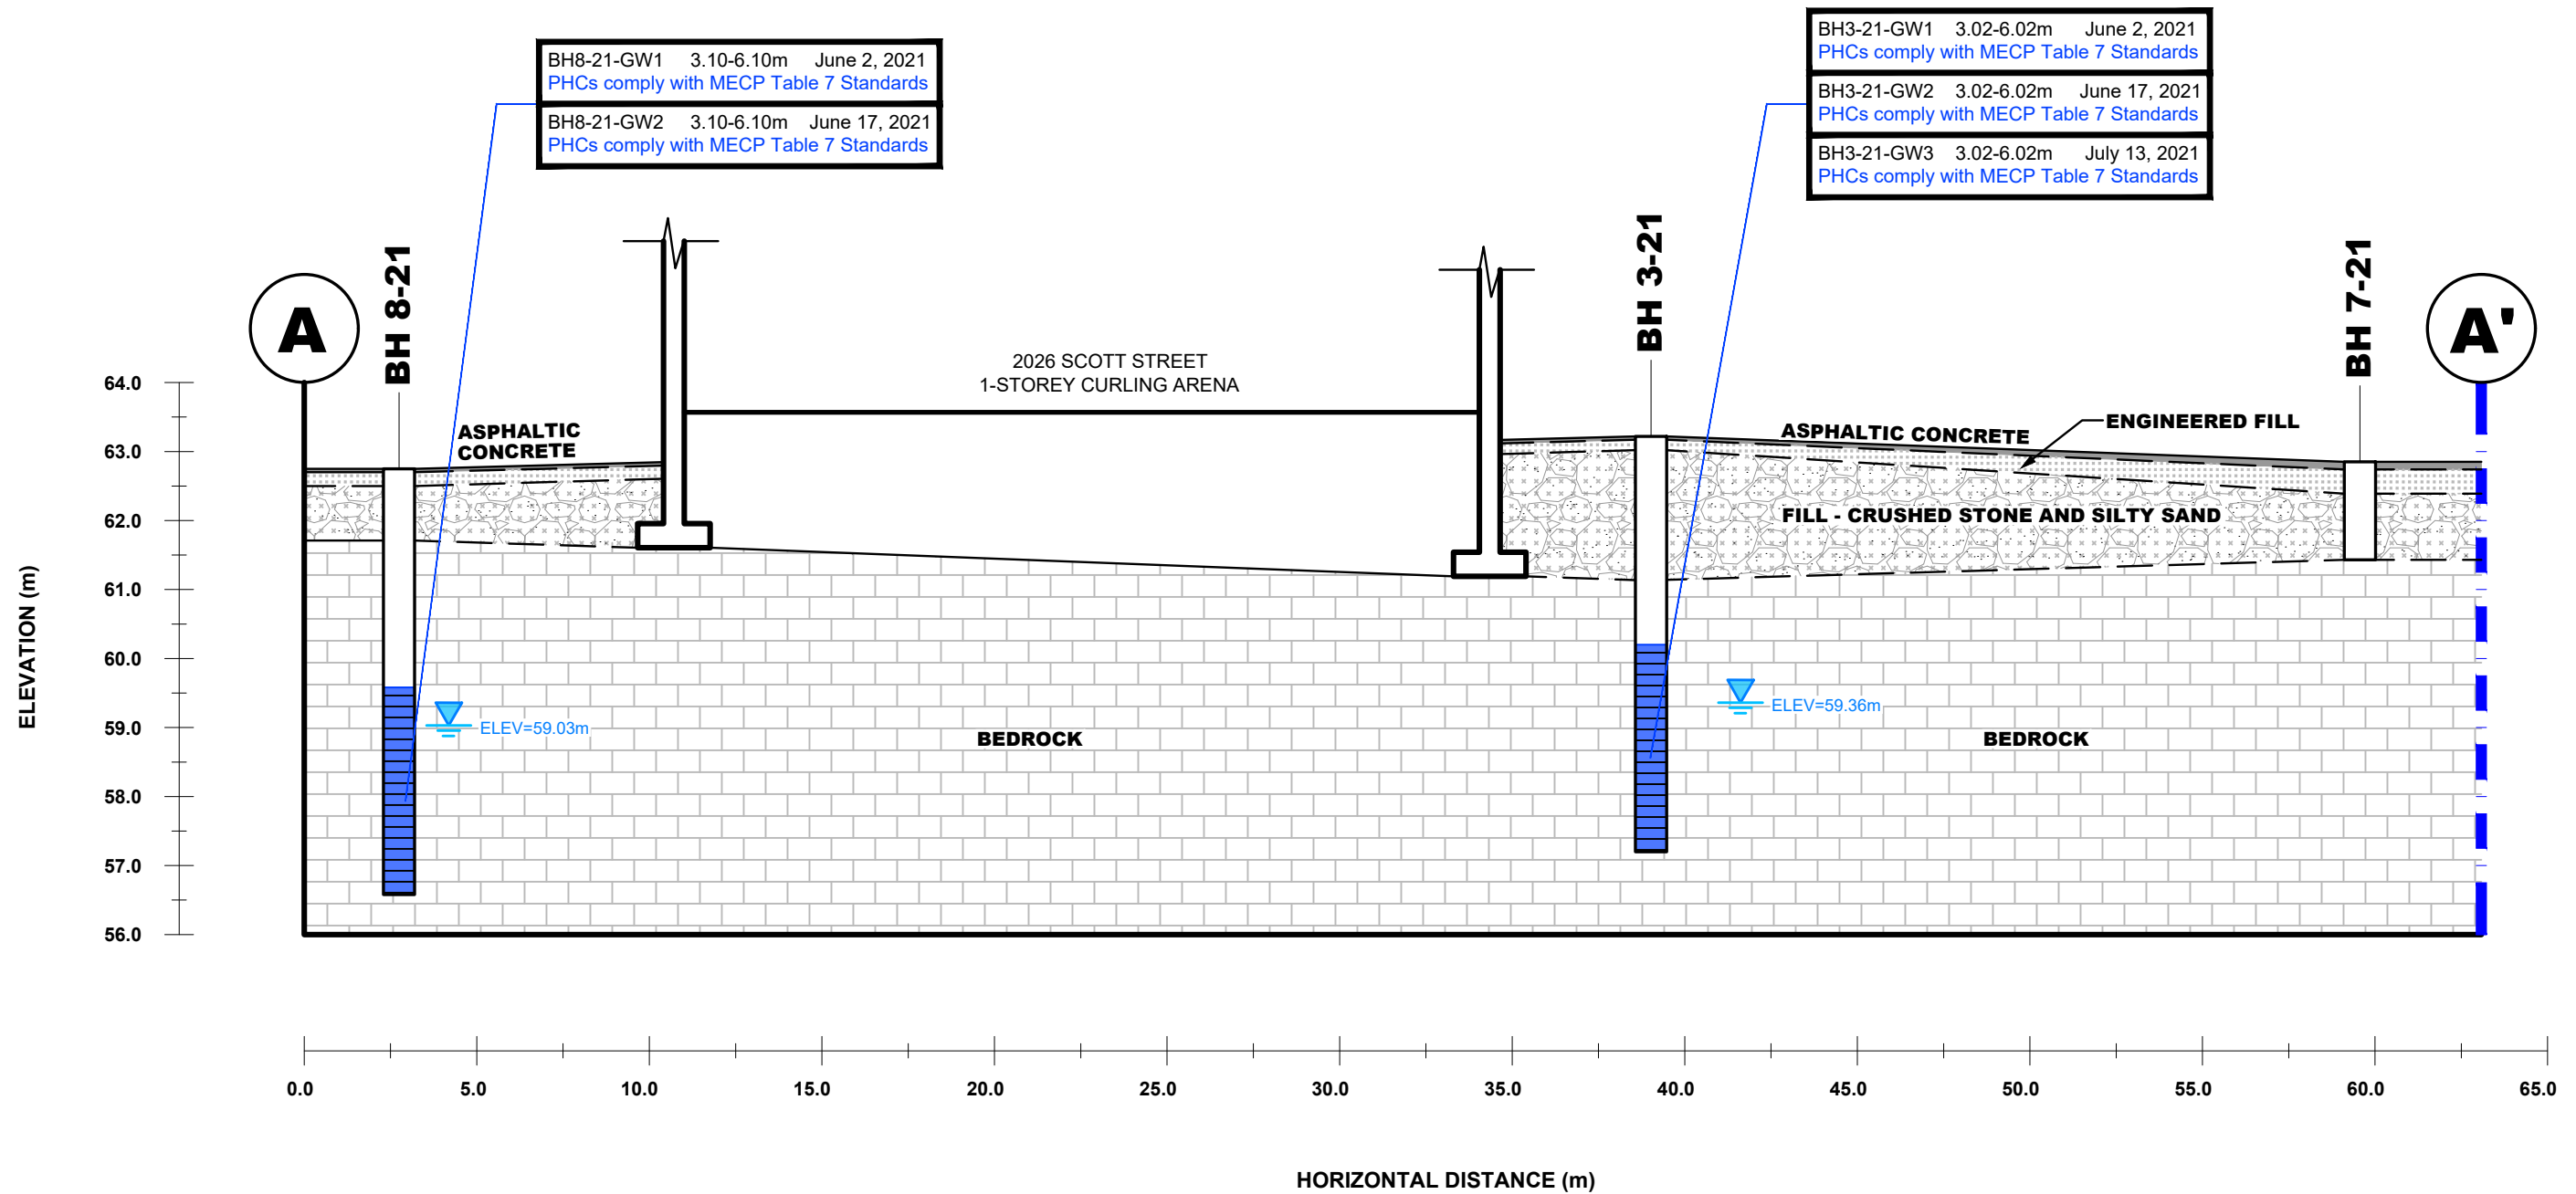
Scale:	AS SHOWN	Date:	07/2021
Drawn by:	YA	Report No.:	PE5303-2
Checked by:	NS	Dwg No.:	PE5303-7A
Approved by:	MSD	Revision No.:

Title: **CROSS SECTION A-A' - GROUNDWATER (PHCs)**
