Phase II – Environmental Site Assessment

2006, 2020, & 2026 Scott Street and
314 & 318 Athlone Avenue
Ottawa, Ontario

Morley Hoppner Group

Report: PE5303-2R

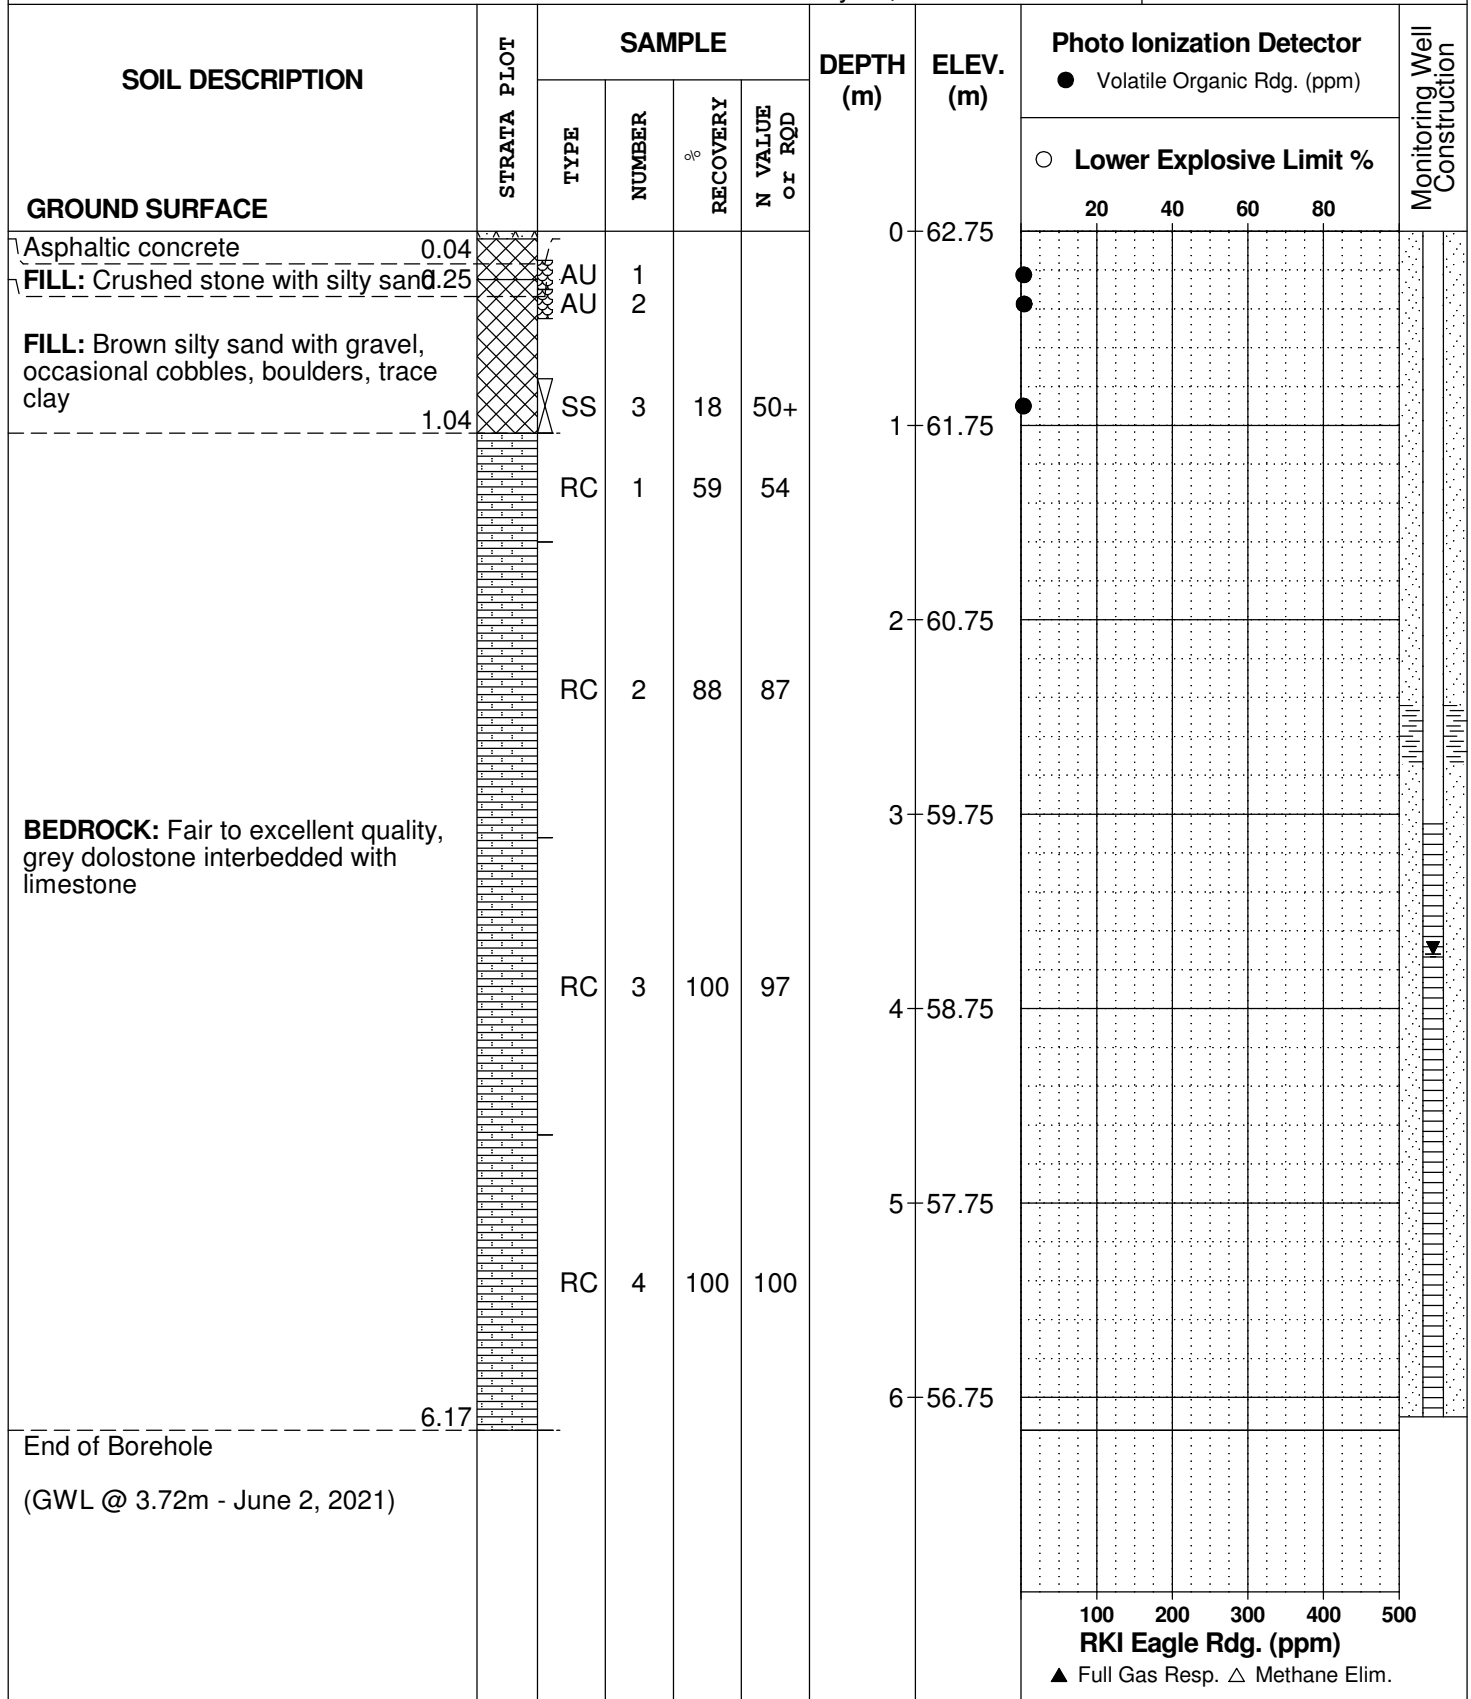
HOLE NO. **BH 8-21**

SOIL PROFILE AND TEST DATA
