Phase I Environmental Site Assessment

1185 Beaverwood Road
Manotick, Ontario

Prepared for ARK Construction Ltd.

Report: PE5615-1R
January 9, 2023

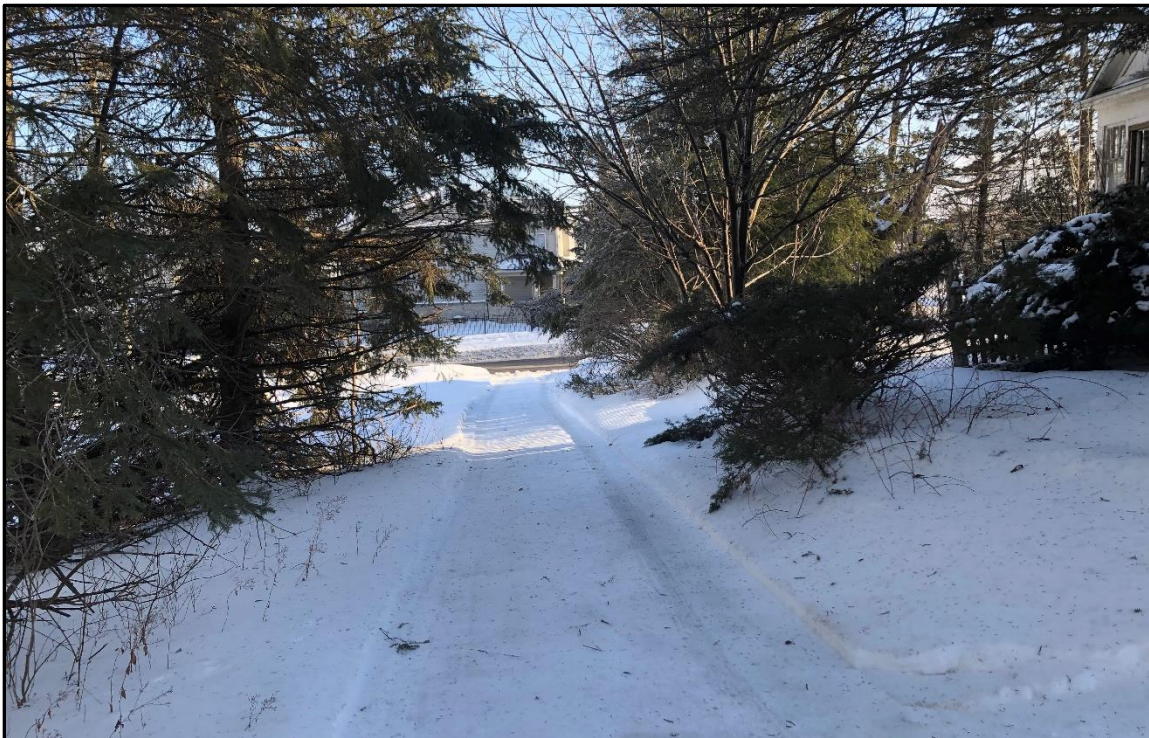
Photo 2: East of the residential dwelling, on the eastern portion of the gravel driveway, facing southeast towards Beaverwood Road.

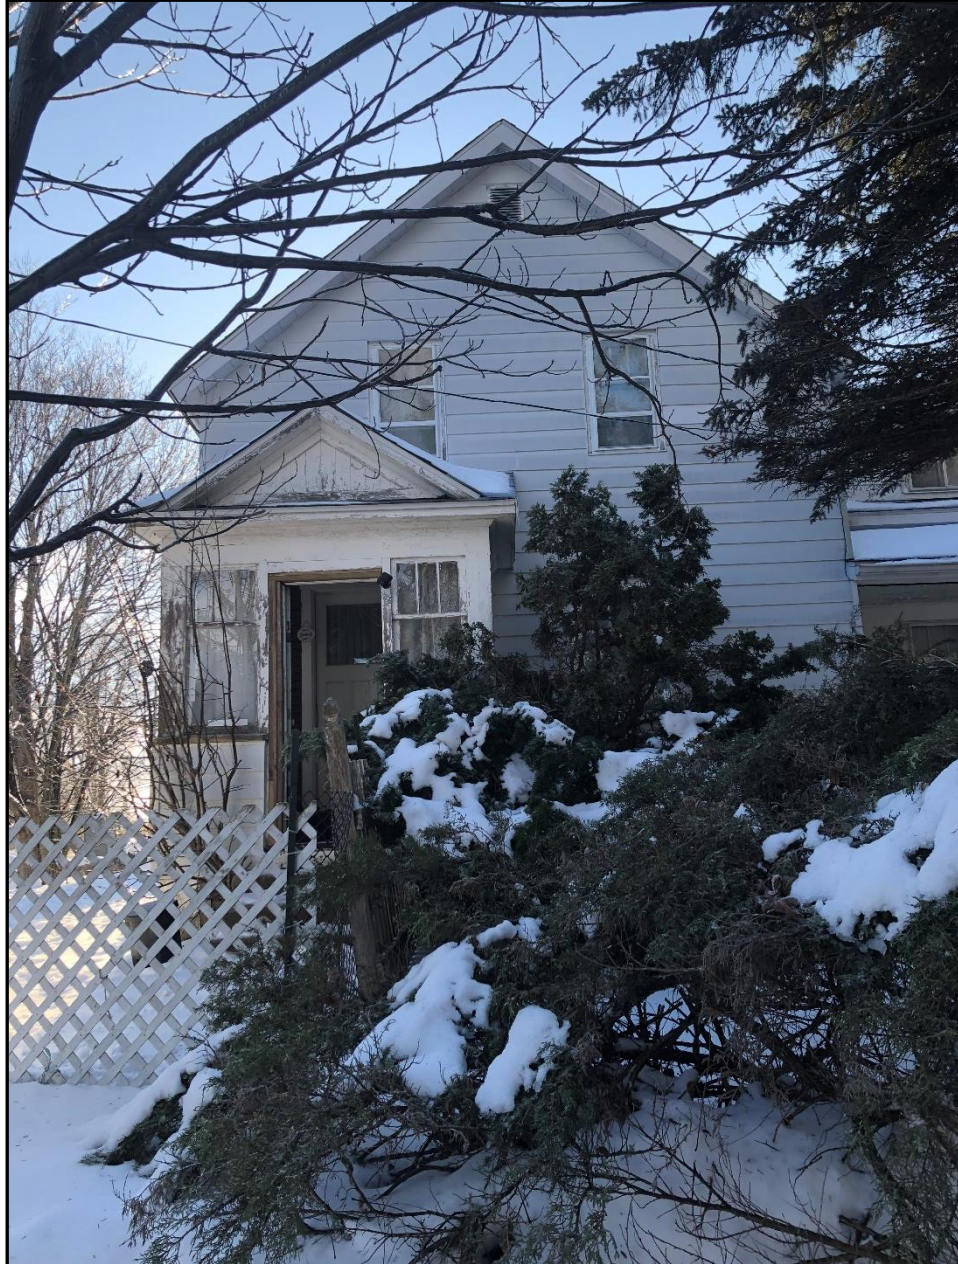
Photo 3: East of the residential dwelling, facing towards the west building face.

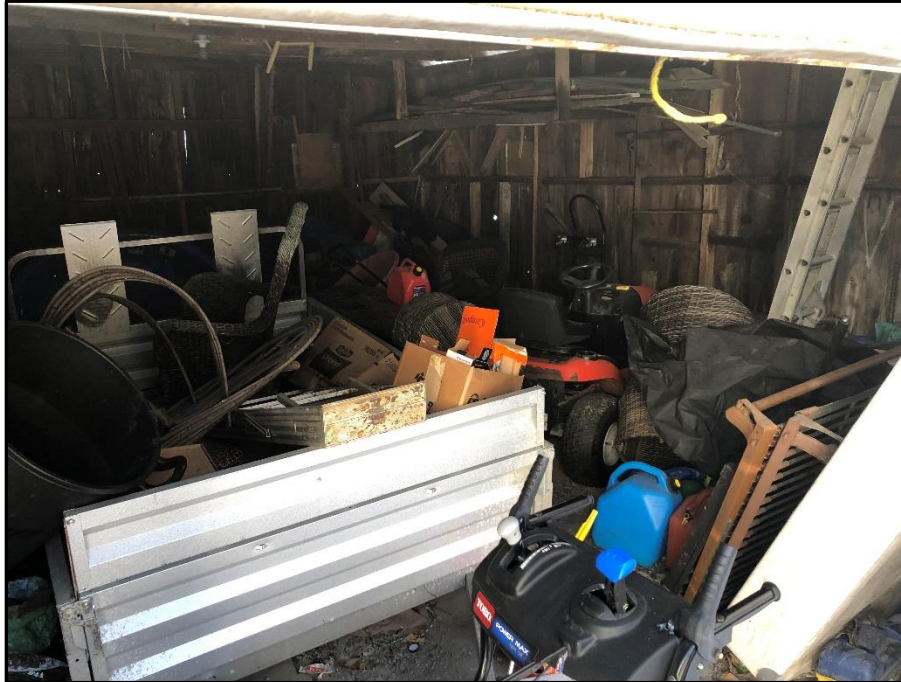
Photo 4: Inside of the detached garage, used for general storage.
