DRAFT REPORT

**Geotechnical Assessment**  
**Proposed Residential Development**  
*3930 and 3960 Riverside Drive, Ottawa, Ontario*

21482114-3000

December 22, 2022

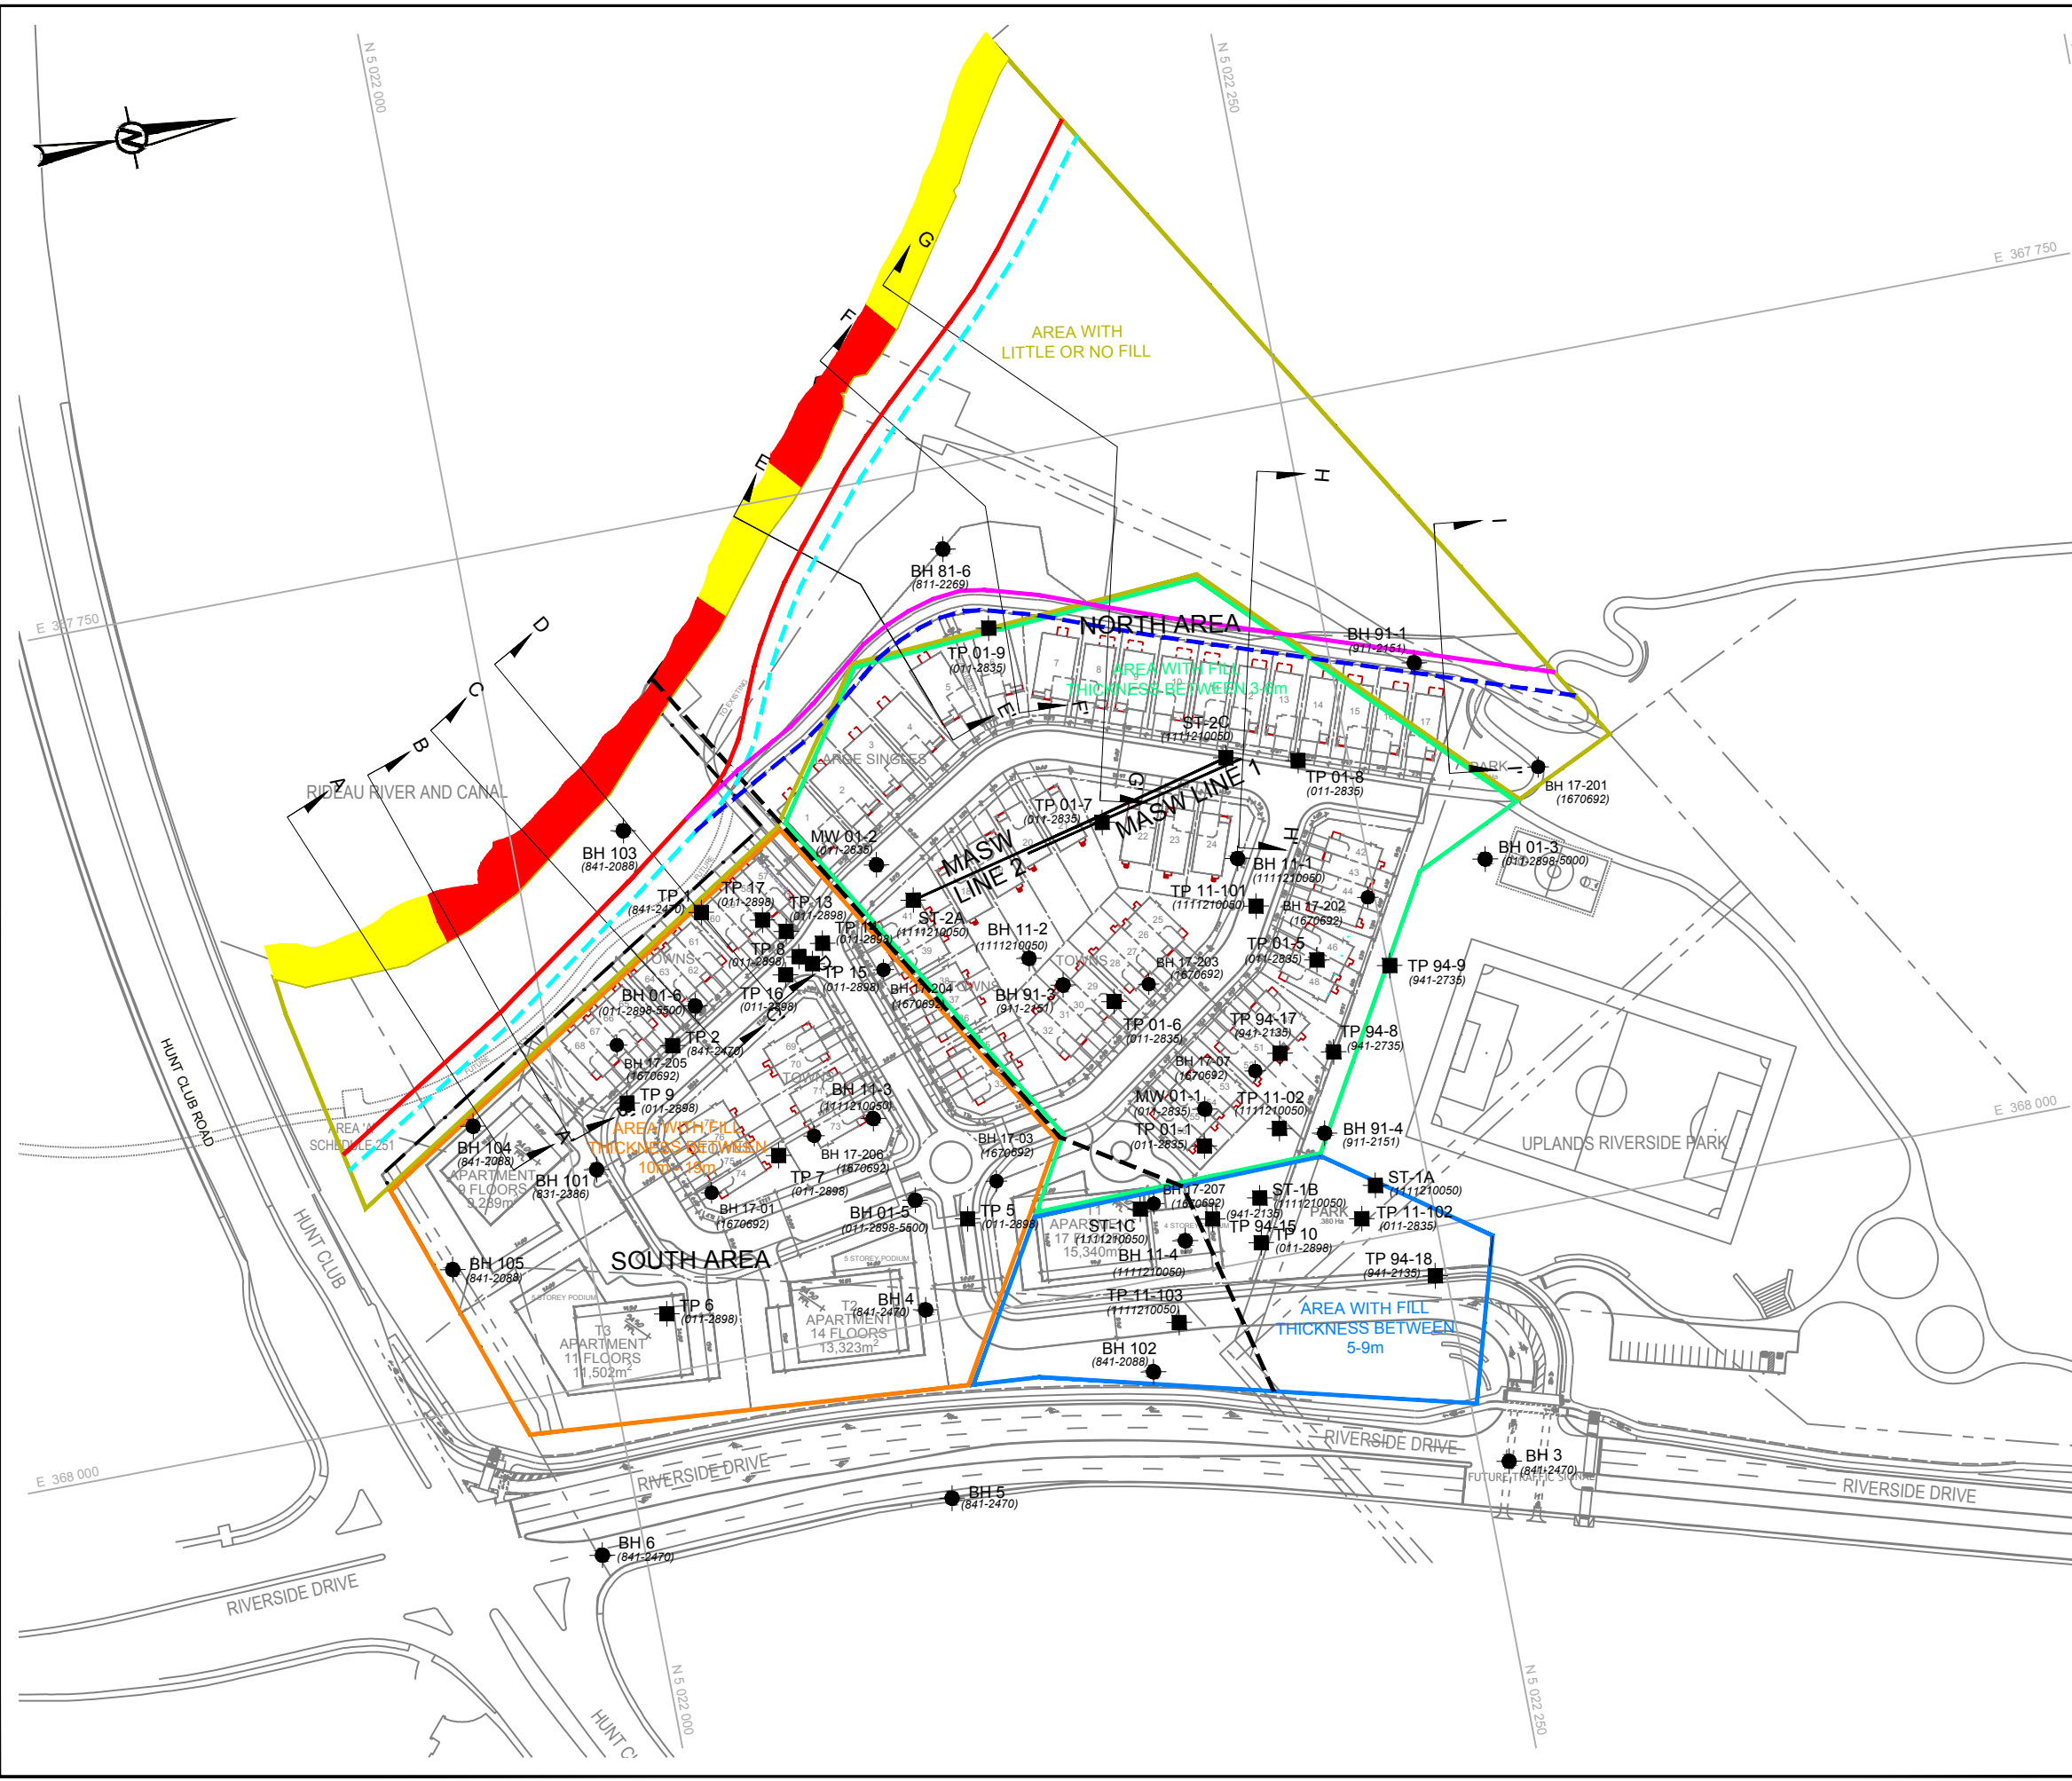
In addition to reviewing the borehole information, the thickness of fill material placed across the site has been assessed using available site topographic maps from the previous investigation reports. In particular, the topographic data given in the 1983 and 1984 investigation reports show the approximate site conditions prior to the placement of significant fill (only relatively minor filling had been carried out by that time). The borehole data was then compared with collected topographic data in about 2007 and again in 2017 for the site, and the resulting assessment of the fill thicknesses across the site is shown on Figure 1.

The site has been divided into two areas based on topographical characteristics at the site. These two areas, hereafter called the North Area and South Area, are shown on Figure 1. The two areas have then been subdivided into a total of six sub-areas based on the estimated amount of filling present at the site, as shown on Figure 1. It is noted that the boundary lines are approximate only and may not be representative of the actual fill thicknesses throughout the entire development site.

Observations were also made on the state of erosion at the slope toe/riverbank in July 2009 and June 2018. Locations of minor to moderate to severe erosion observed at that time are also shown on Figures 1, 1A, and 1B.

No erosion protection is present along the Rideau Riverbank bordering the site. Areas of active erosion were noted at several locations along the Rideau Riverbank, which have resulted in over-steepened slope toes along the Riverbank. The results of the erosion mapping (from the 2009 and 2018 slope reconnaissance) along the Rideau Riverbank are provided on the Site Plan, Figures 1, 1A, and 1B. Above the zone of active erosion at the

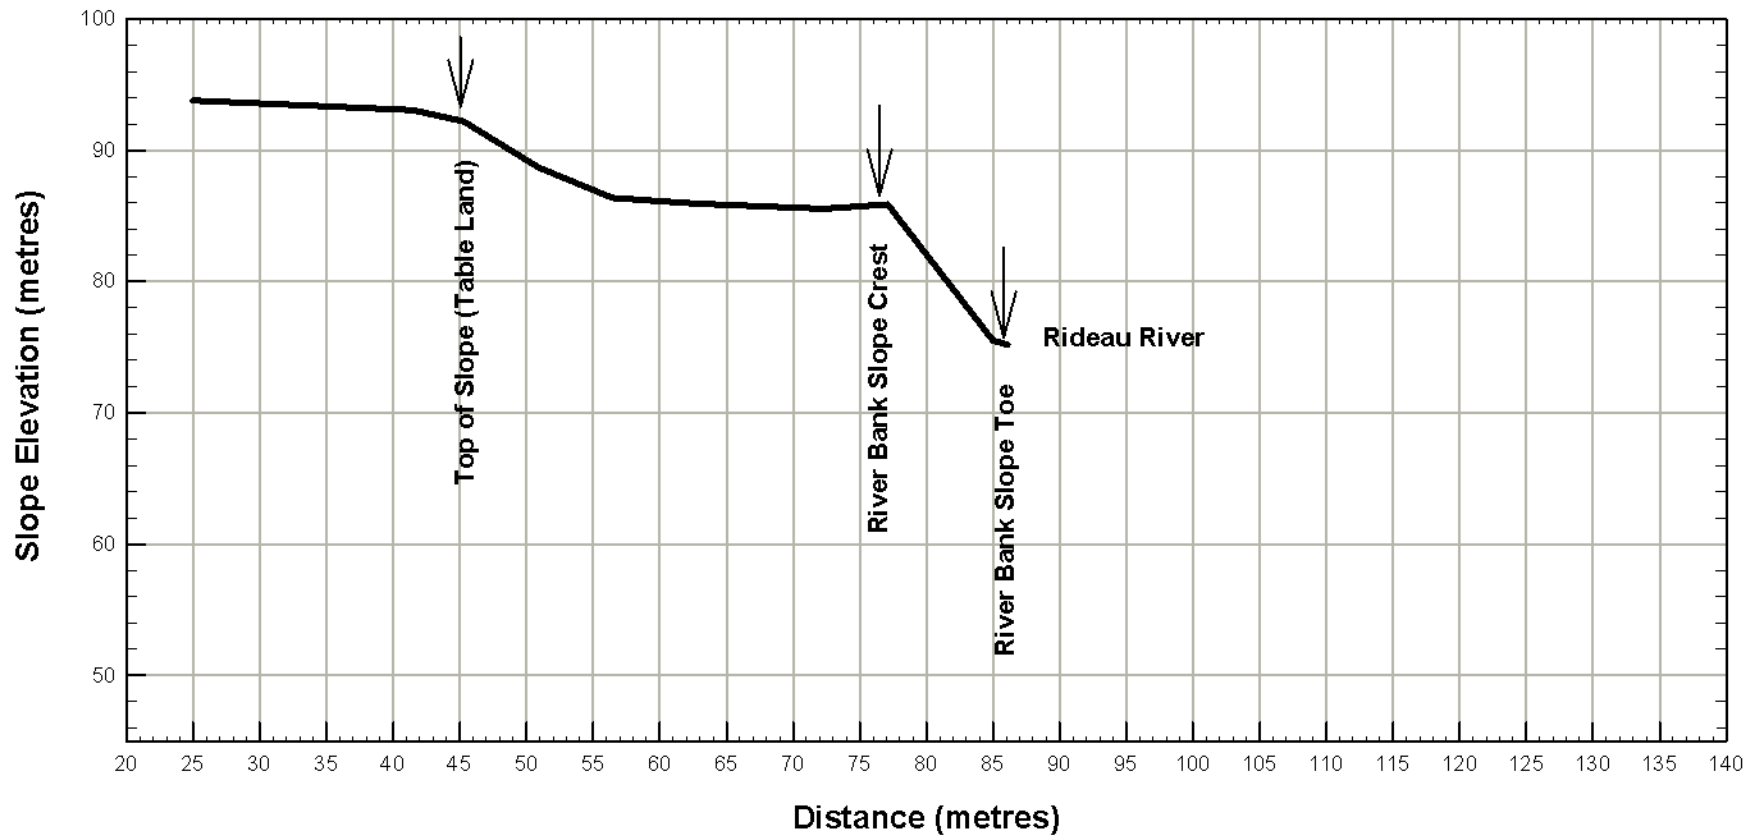
**FIGURE 2**

# Cross Section B-B'

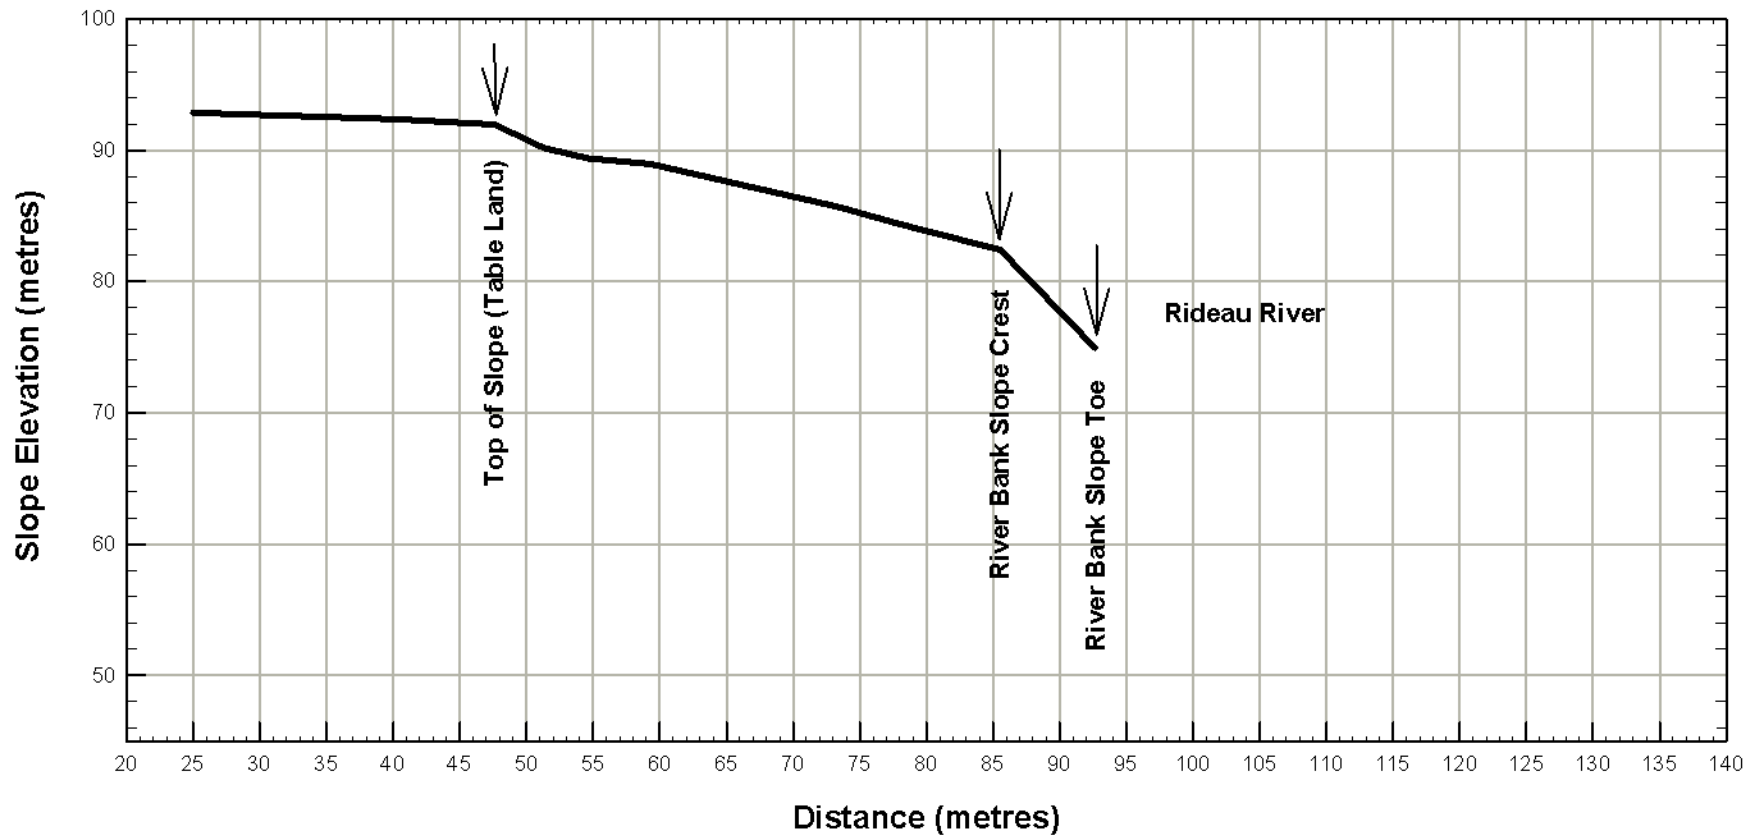
**FIGURE 3**

# Cross Section C-C'

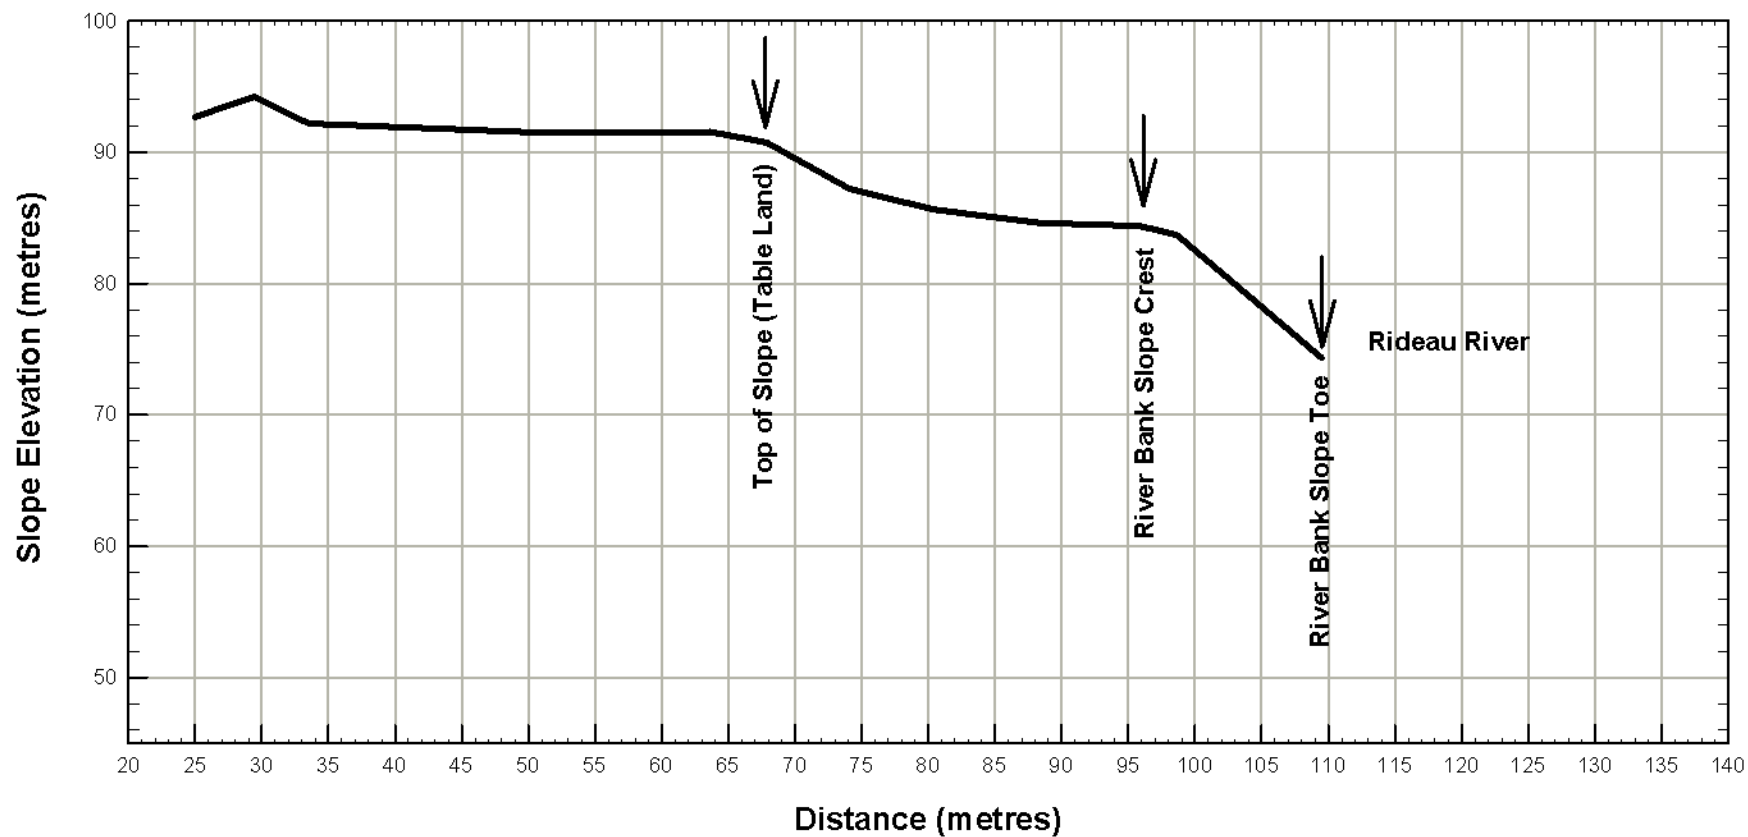
**FIGURE 4**

## Cross Section D-D'

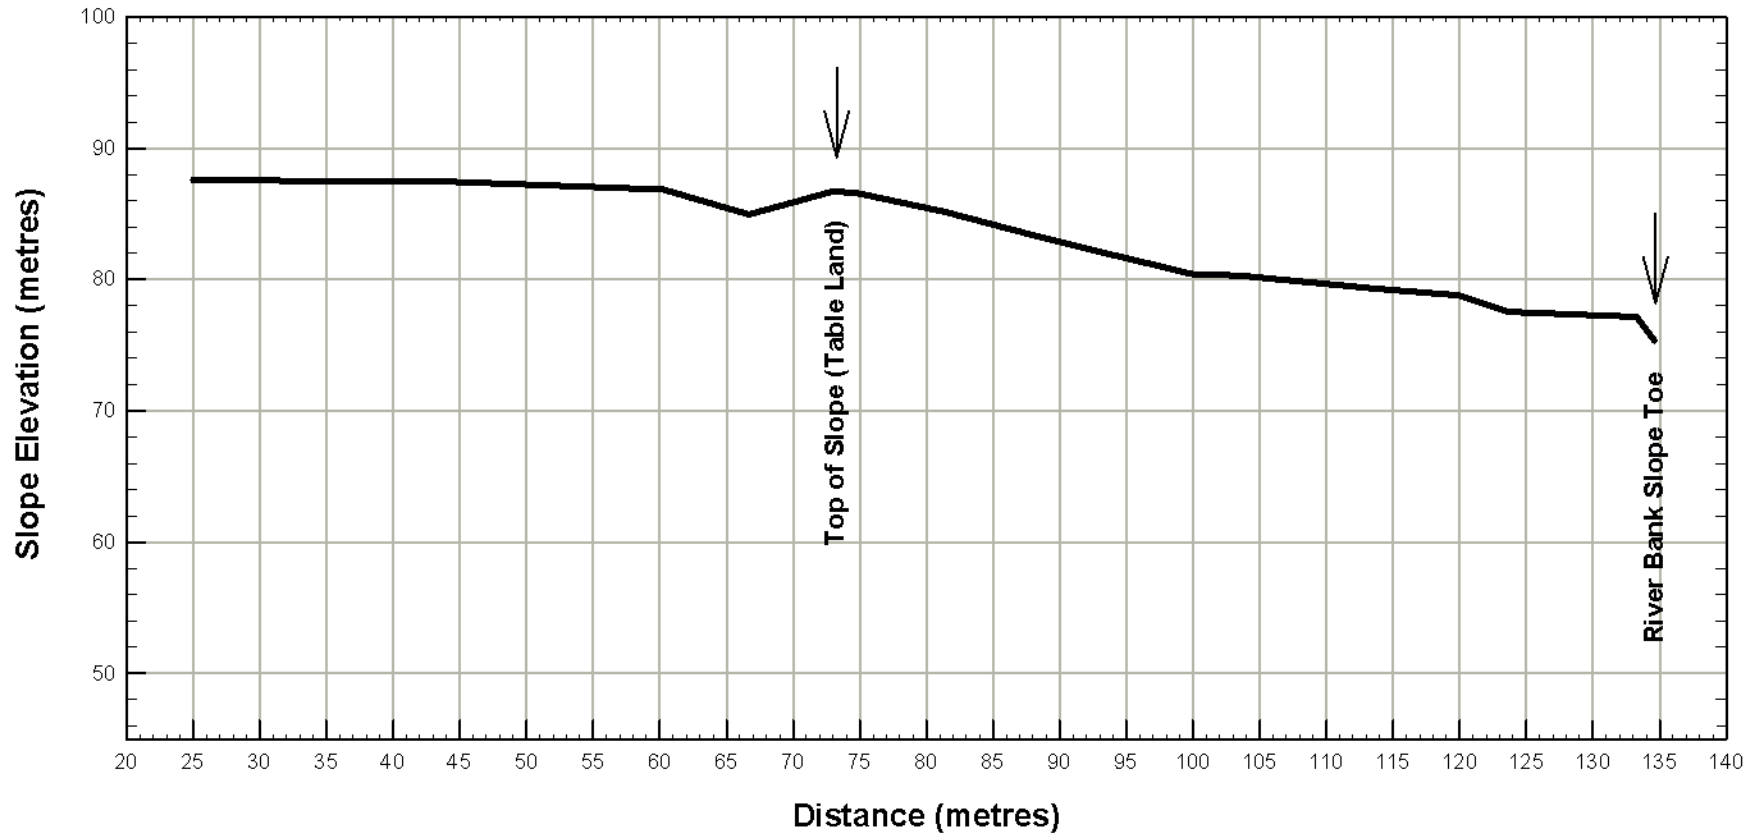
Some moderate to severe active erosion of the Rideau Riverbank (over its 1 to 2 m height) was observed at the locations of cross sections EE' and FF'. Several small drainage gullies also exist which discharge into the Rideau River (i.e., cut into the bank). It appears that large trees and shrubs present along the Rideau Riverbank are responsible for maintaining the stability of the bank. No erosion was observed at the toe of the tableland slopes.

# Cross Section E-E'

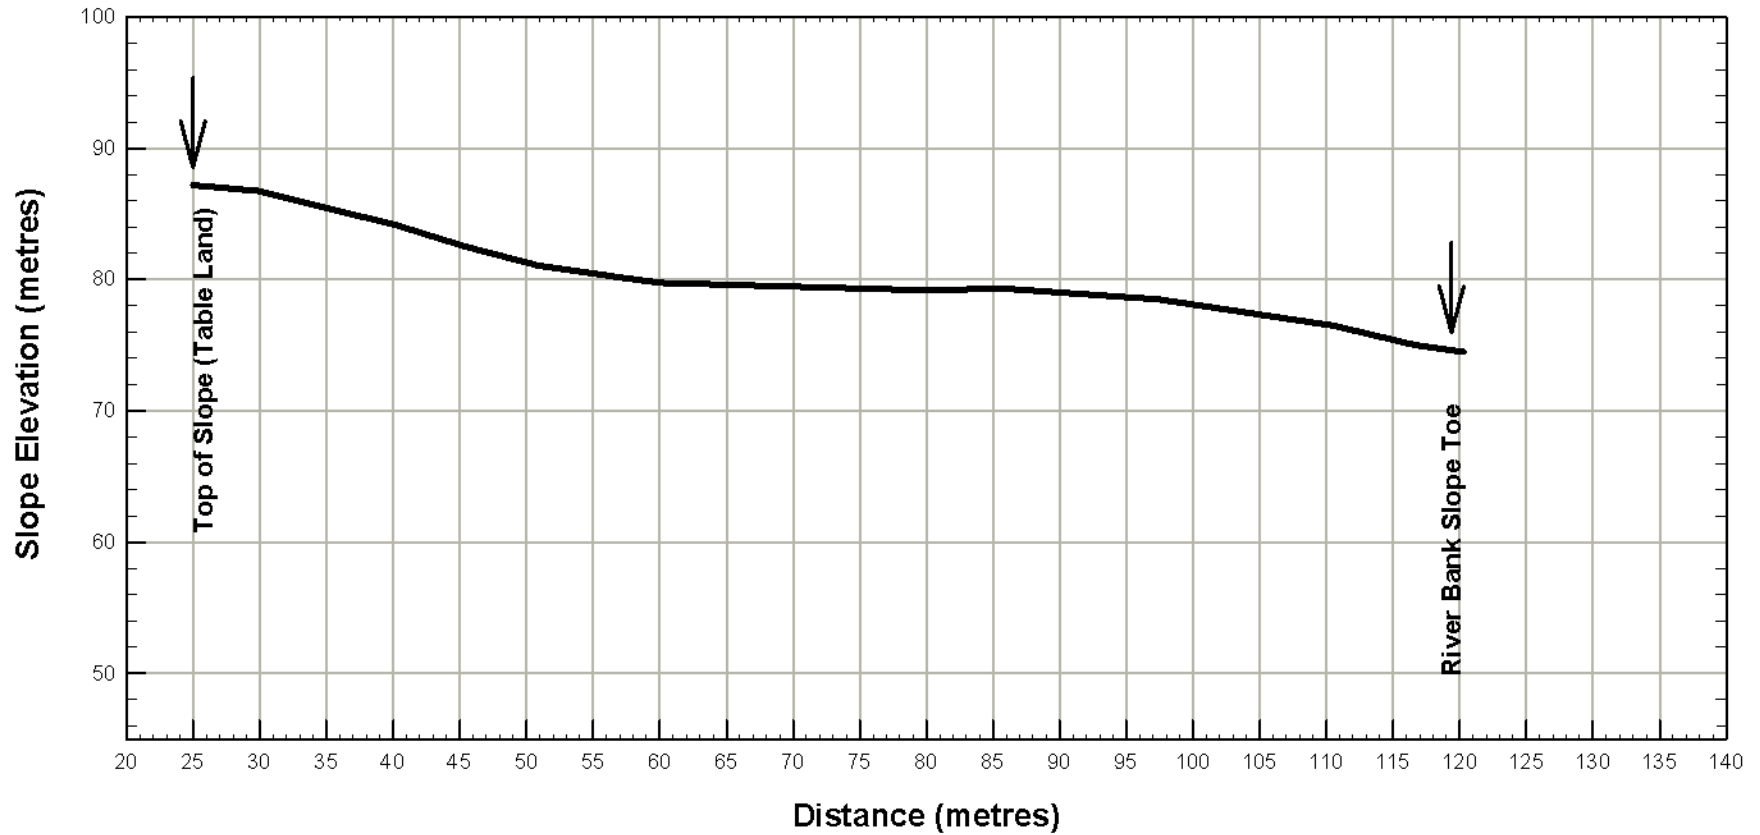
**FIGURE 6**

# Cross Section F-F'

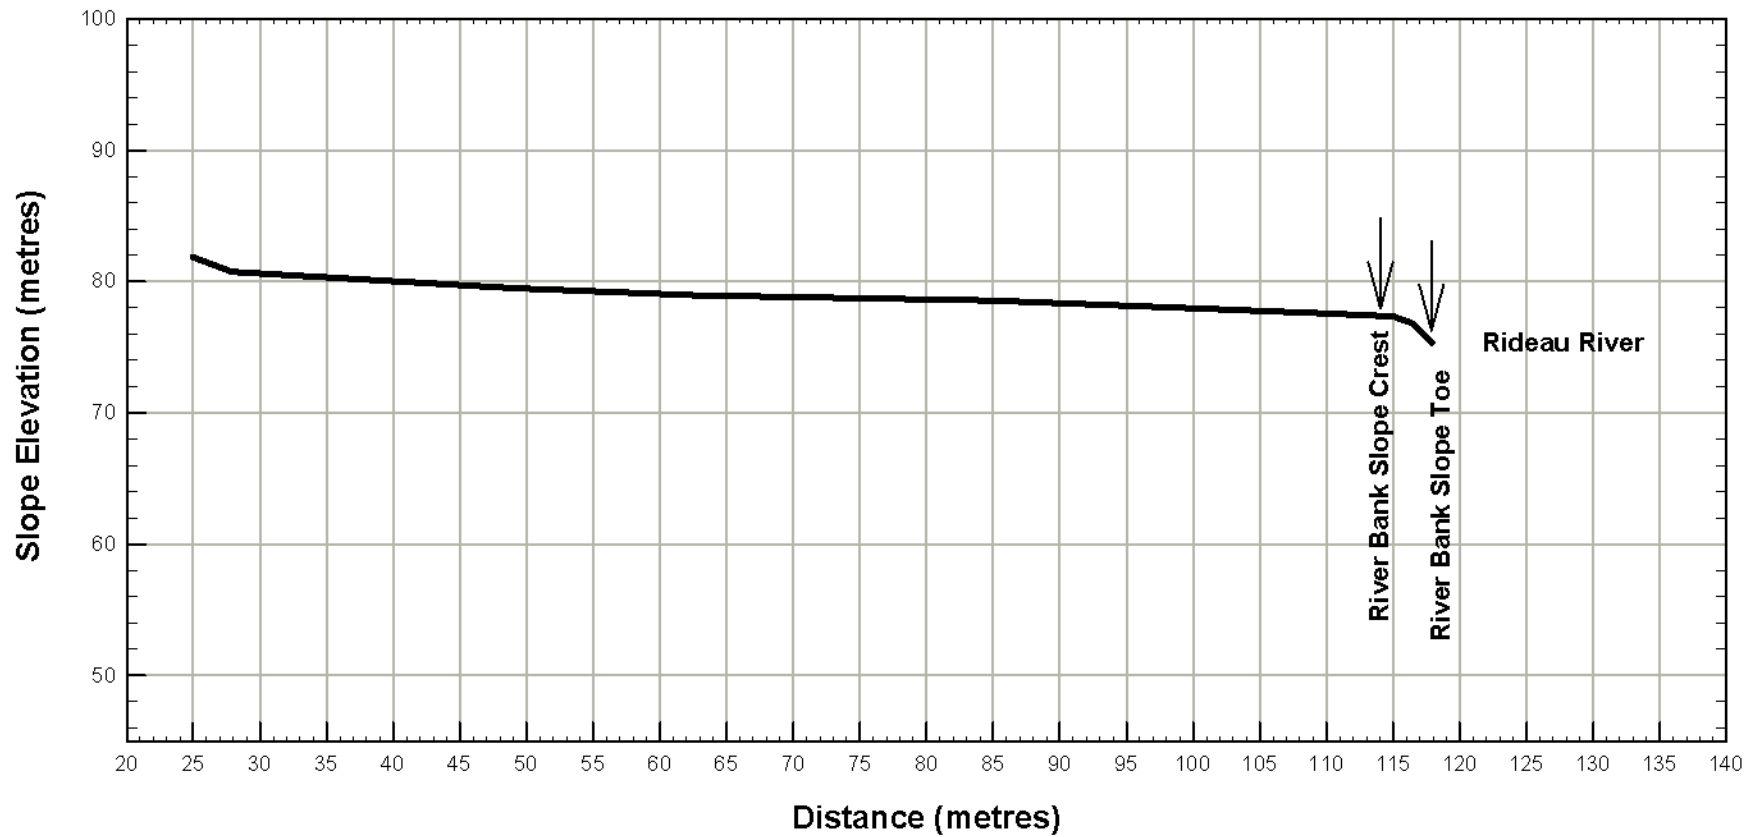
**FIGURE 7**

# Cross Section G-G'

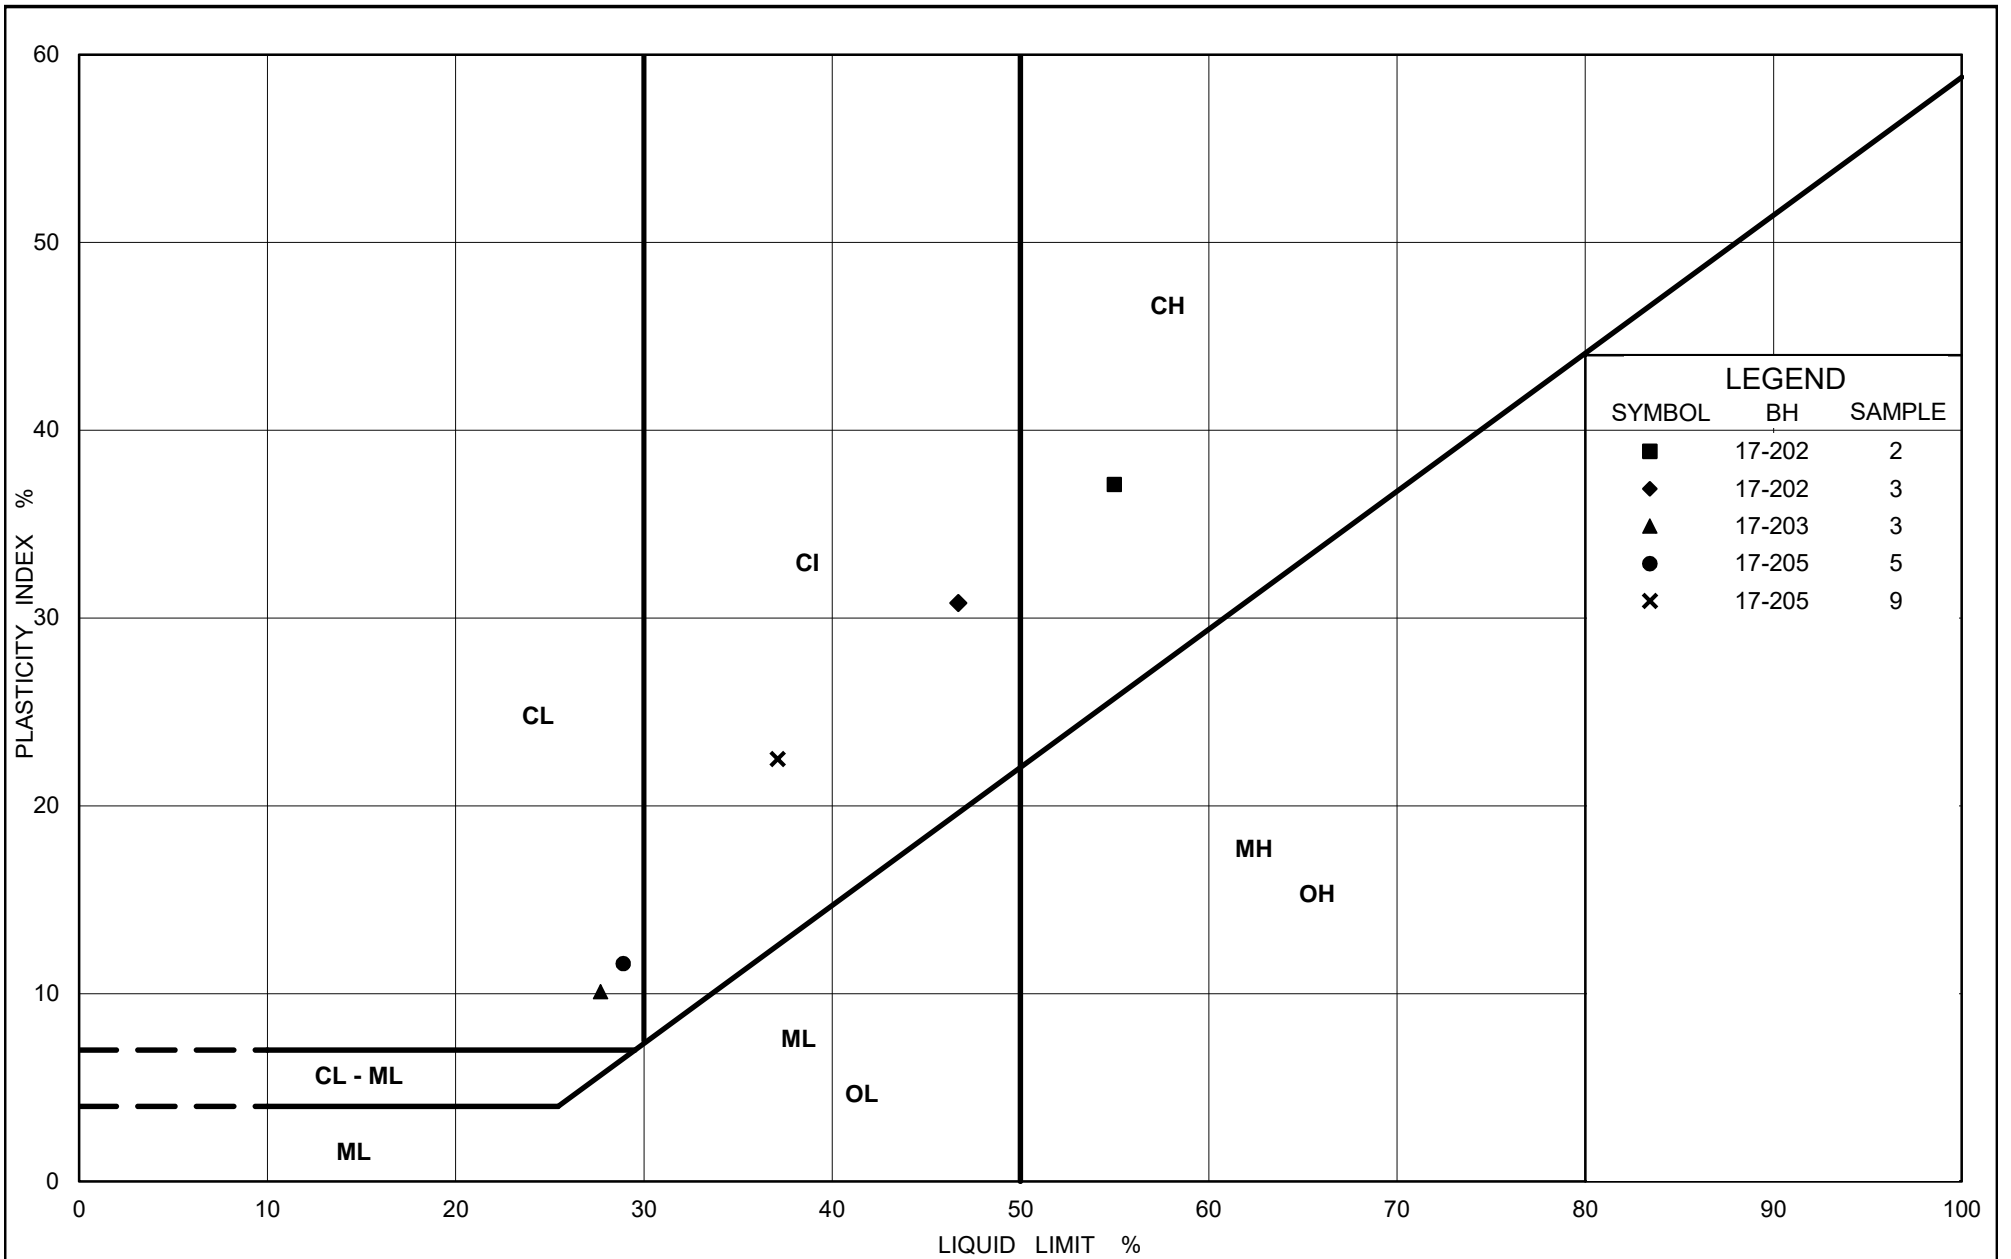
Figure : B1

PLASTICITY CHART  
FILL

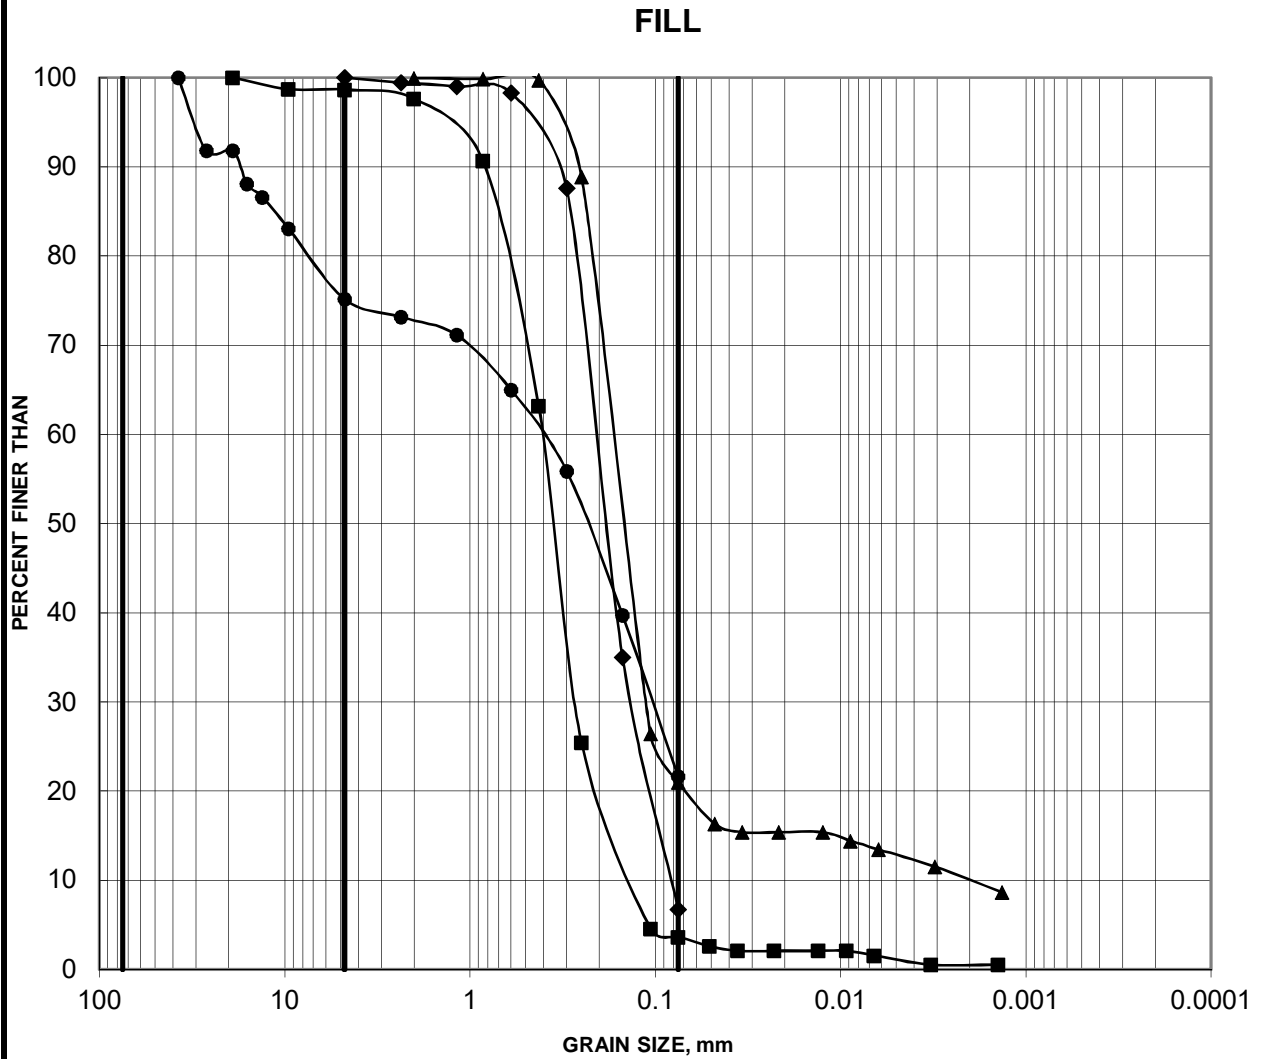
FIGURE B2

# GRAIN SIZE DISTRIBUTION

Borehole	Sample	Depth (m)
—■—	17-201 3	3.05-3.66
—◆—	17-201 5	6.10-6.71
—▲—	17-204 2	1.52-2.13
—●—	17-205 2	1.52-2.13

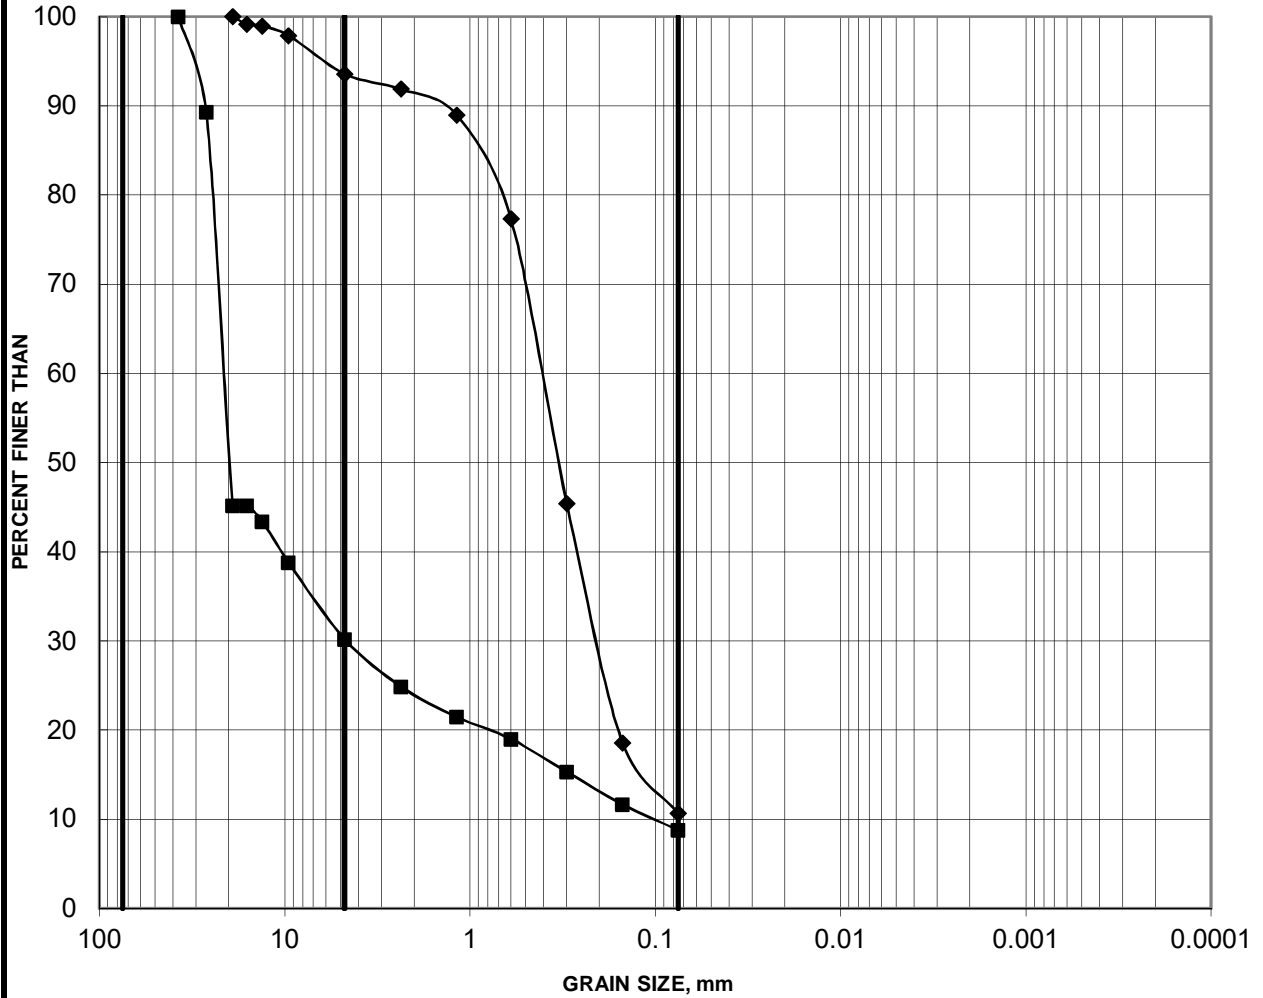
FIGURE B3

## FILL

Borehole	Sample	Depth (m)
—■— 17-206	2	1.52-2.13
—◆— 17-207	4	4.57-5.18

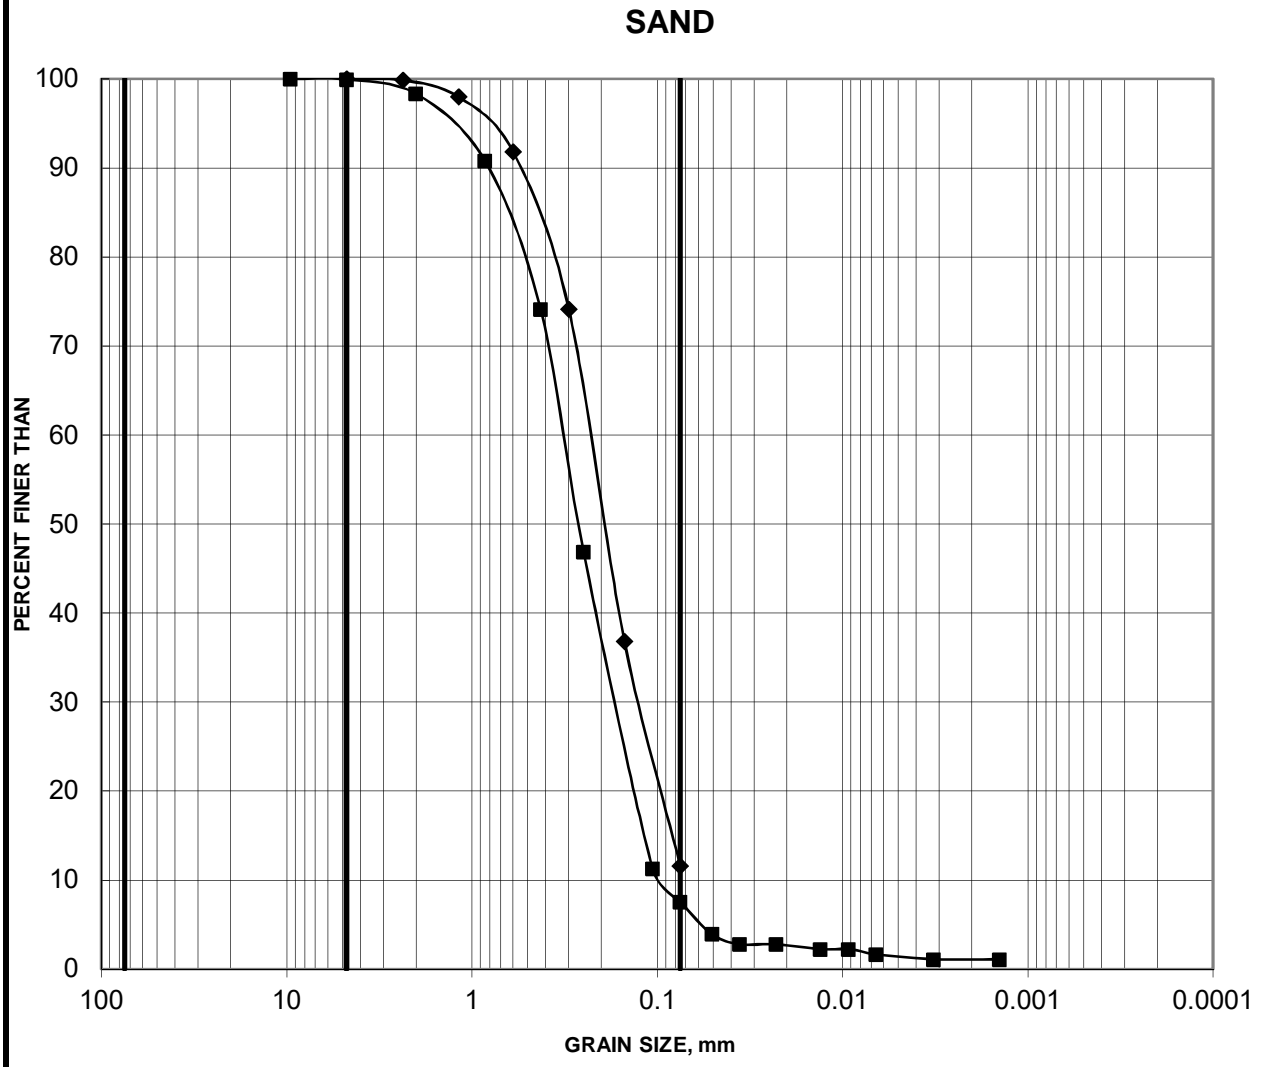
FIGURE B4

# GRAIN SIZE DISTRIBUTION

Borehole	Sample	Depth (m)
—■— 17-203	5	6.10-6.71
—◆— 17-204	5	5.18-5.79

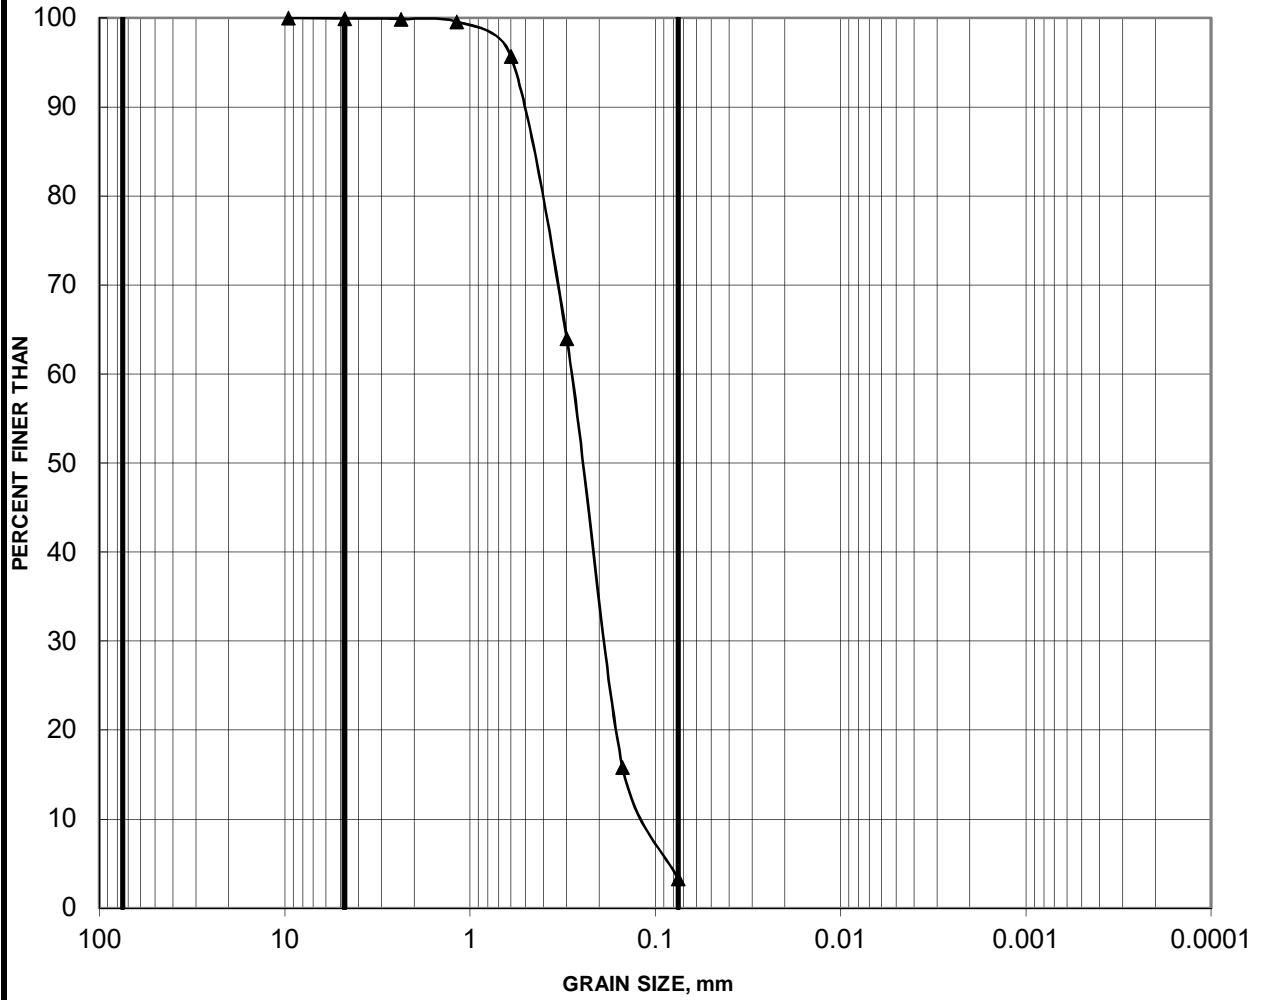
FIGURE B5

SAND

Borehole	Sample	Depth (m)
▲ 17-206	15	16.00-16.61
