DRAFT REPORT

**Geotechnical Assessment**  
**Proposed Residential Development**  
*3930 and 3960 Riverside Drive, Ottawa, Ontario*

21482114-3000

December 22, 2022

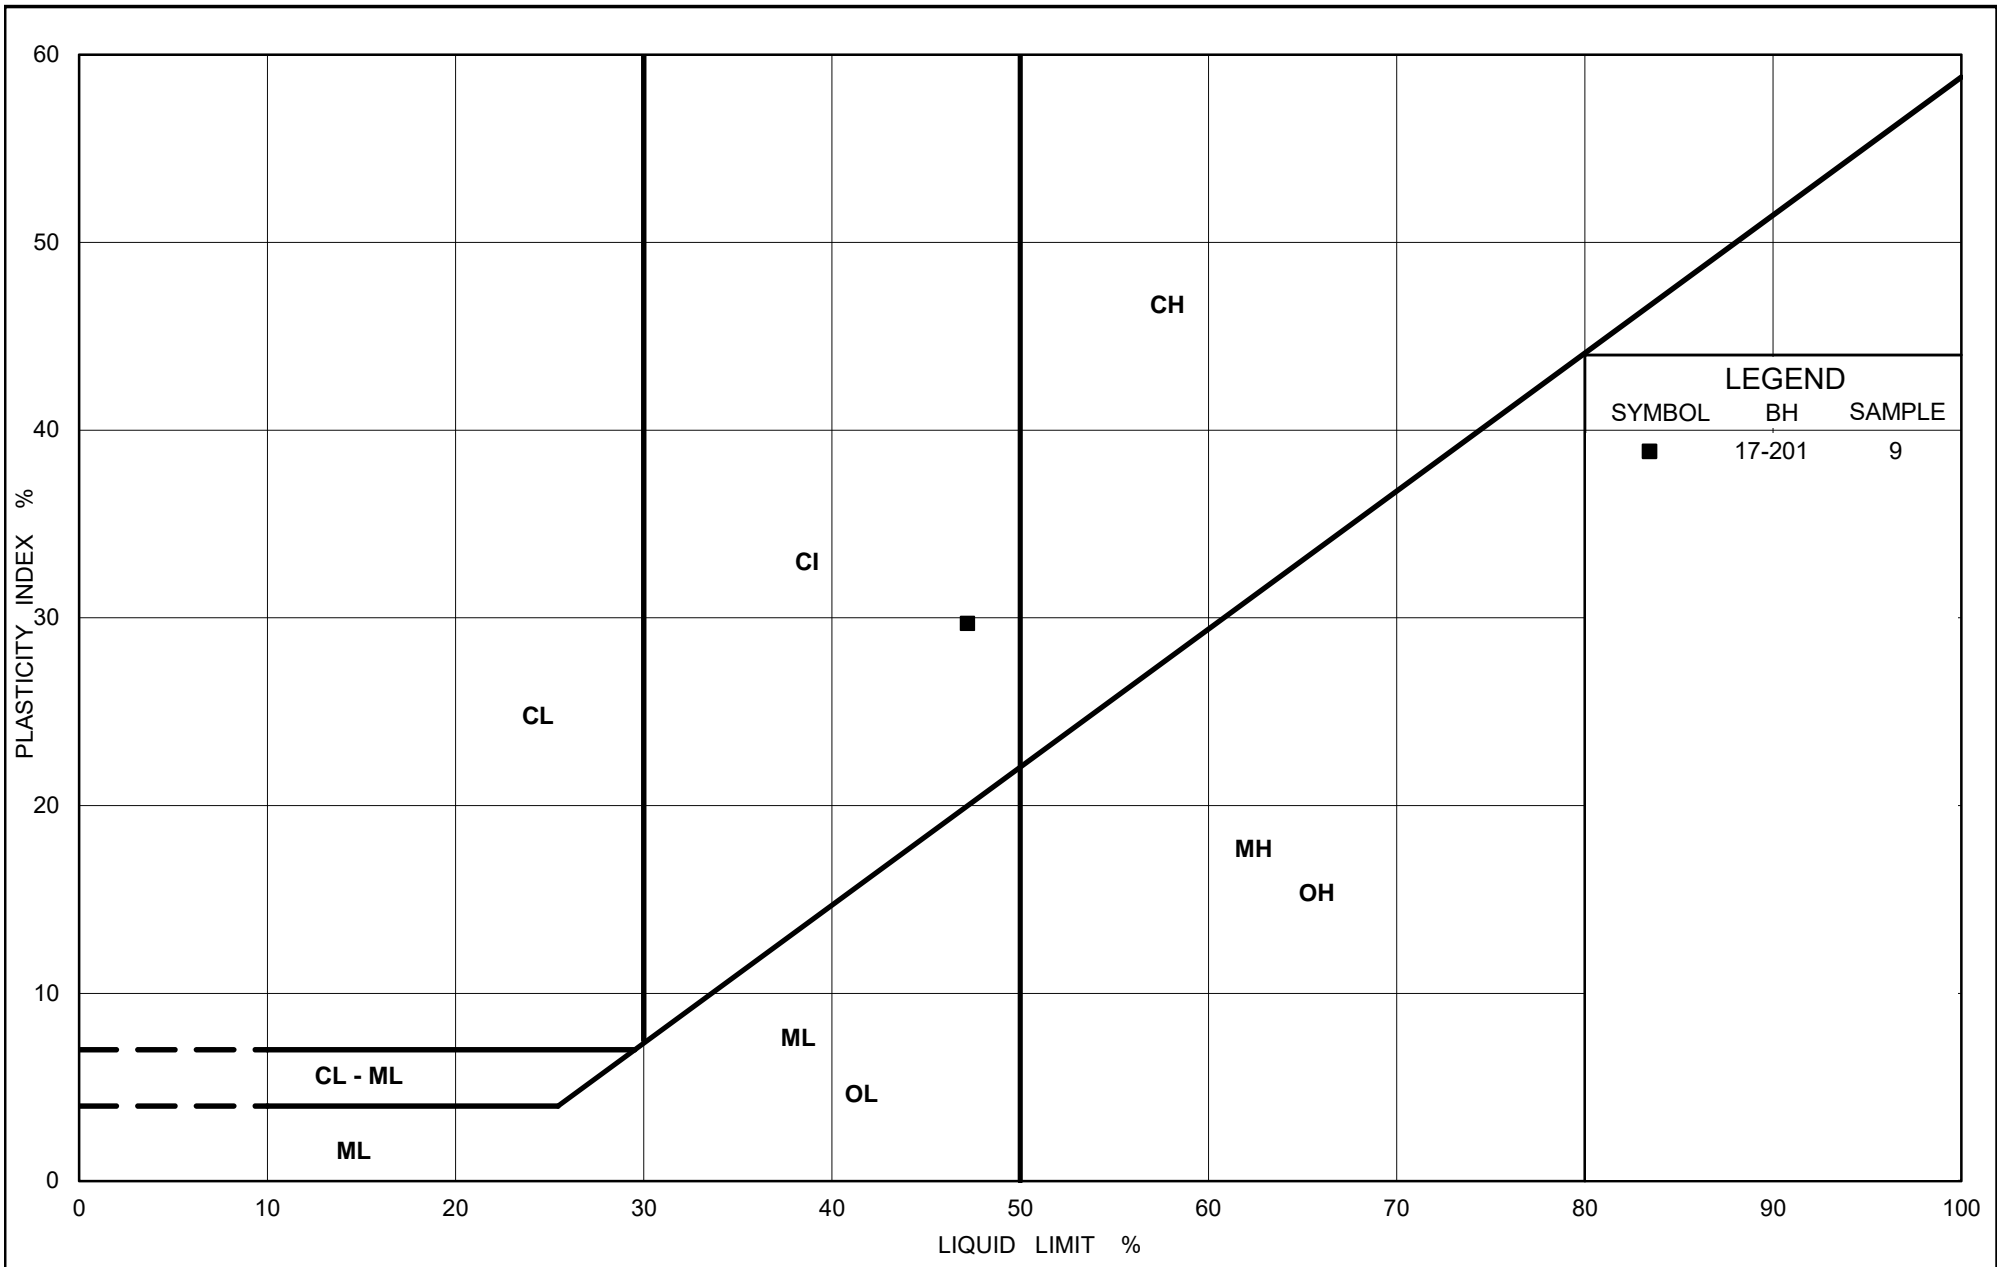
Figure : B6

PLASTICITY CHART  
Sandy SILTY CLAY

As noted previously, relatively thin layers of very stiff cohesive soils exist within the thicker sand deposit at some locations. Atterberg Limits testing carried out on two samples from these layers gave liquid limit values of about 47 % and 23 % and plasticity index values of about 30 % and 12%, respectively, indicating a silty clay of low plasticity. The measured natural water content of these two samples was about 50% and 30 %, respectively. The results of the Atterberg limit testing are summarized on Figures B6 and B7.

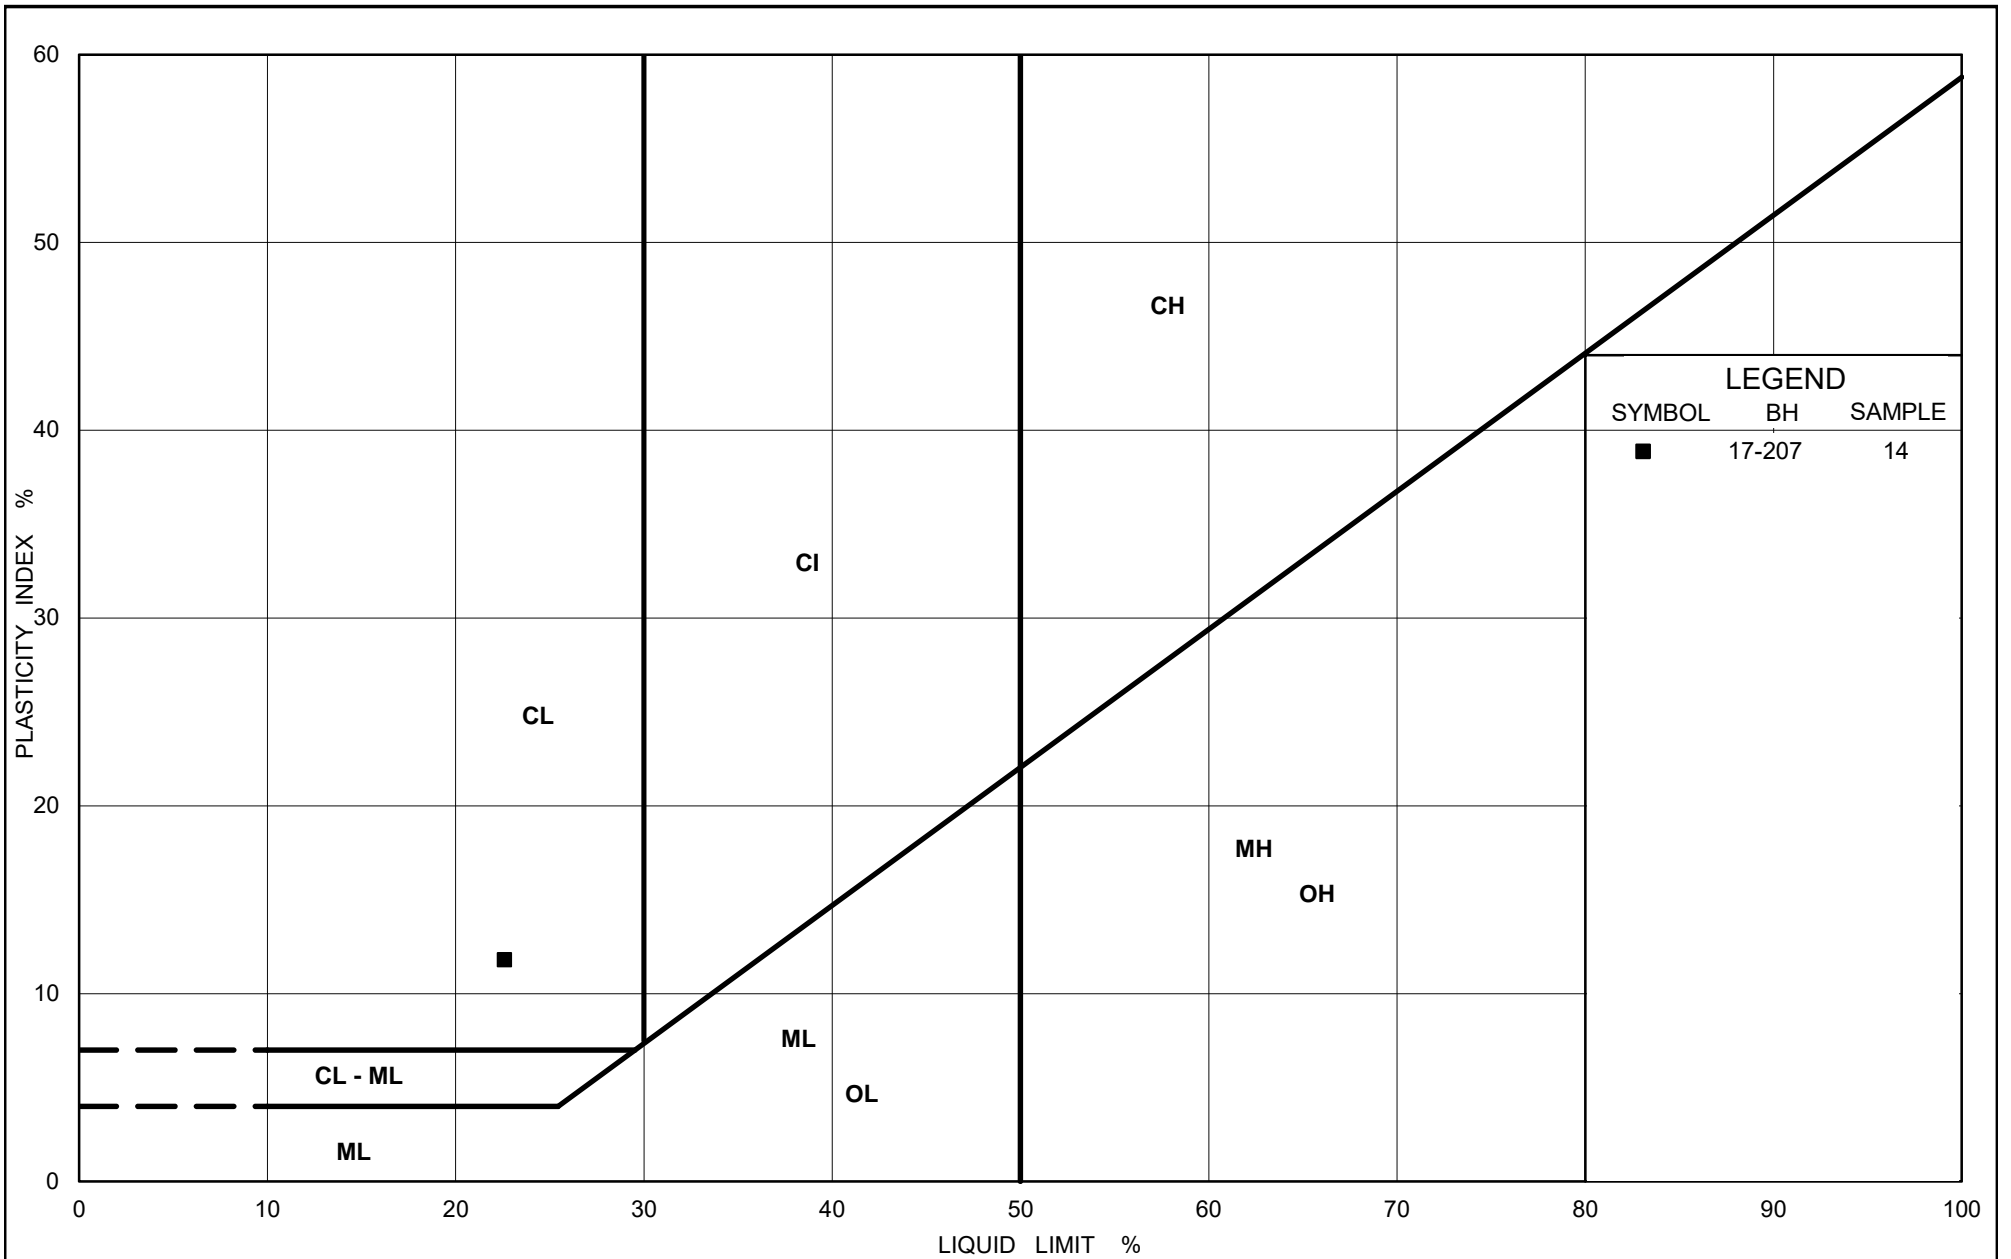
Figure : B7

**PLASTICITY CHART**  
**CLAYEY SILT and SILTY CLAY**

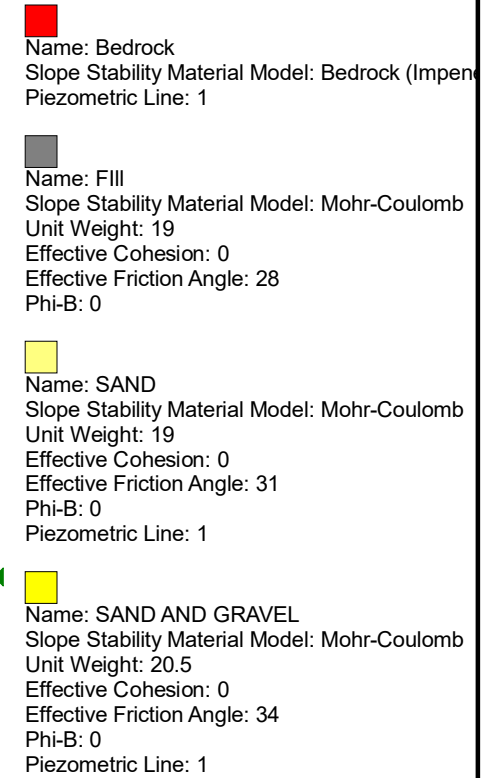
Title: Cross Section A-A  
 File Name: 21482114\_Section A-A\_1m higher\_MG.gsz  
 Name: Static Drained  
 Method: Morgenstern-Price  
 Horz Seismic Coef.: 0

Static Drained	
21482114_Section A-A_1m higher_MG.gsz	
03/11/2022	1:710

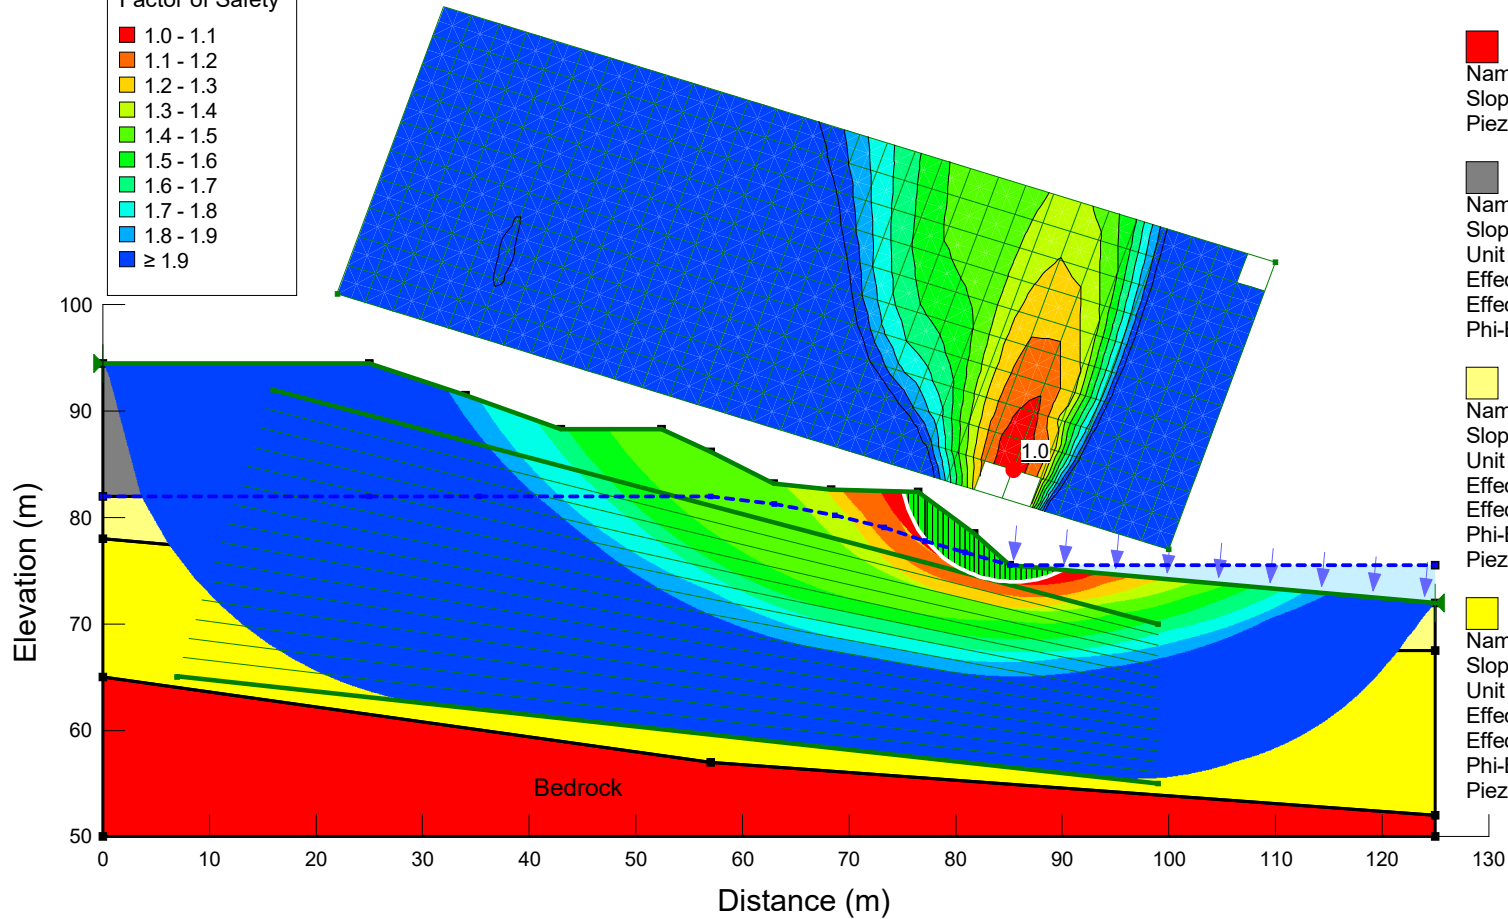
Static Undrained	
21482114_Section A-A_1m higher_MG.gsz	
03/11/2022	1:710

Title: Cross Section A-A  
 File Name: 21482114\_Section A-A\_1m higher\_MG.gsz  
 Name: Static Undrained  
 Method: Morgenstern-Price  
 Horz Seismic Coef.: 0

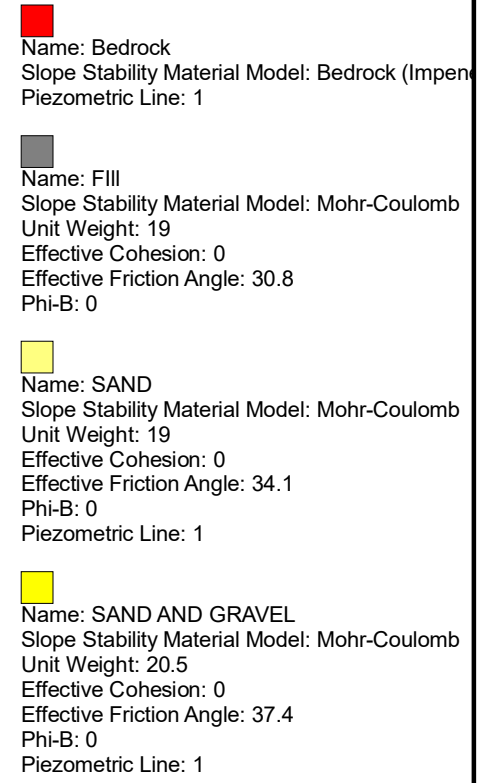
Title: Cross Section A-A  
 File Name: 21482114\_Section A-A\_1m higher\_10%\_MG.gsz  
 Name: Seismic Undrained  
 Method: Morgenstern-Price  
 Horz Seismic Coef.: 0.155

Seismic Undrained	
21482114_Section A-A_1m higher_10%_MG.gsz	
03/11/2022	1:710

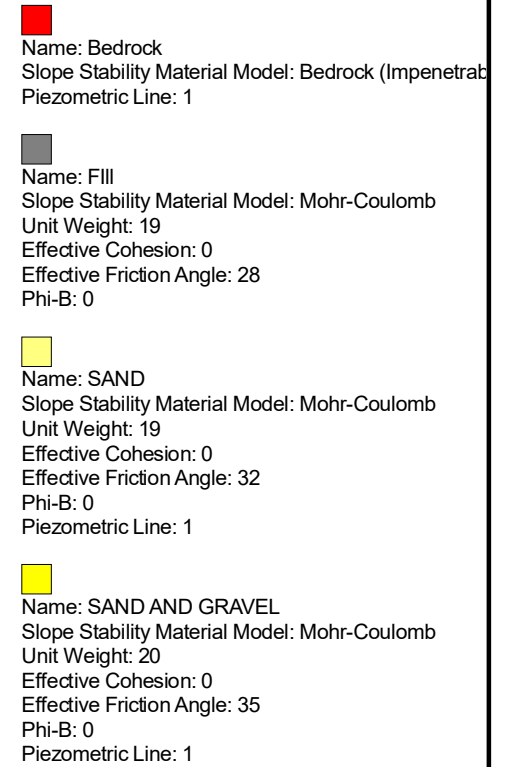
Title: Cross Section B-B  
 File Name: 21482114\_Section B-B\_1m higher\_MG.gsz  
 Name: Static Drained  
 Method: Morgenstern-Price  
 Horz Seismic Coef.: 0

Static Drained	
21482114_Section B-B_1m higher_MG.gsz	
03/17/2022	1:720

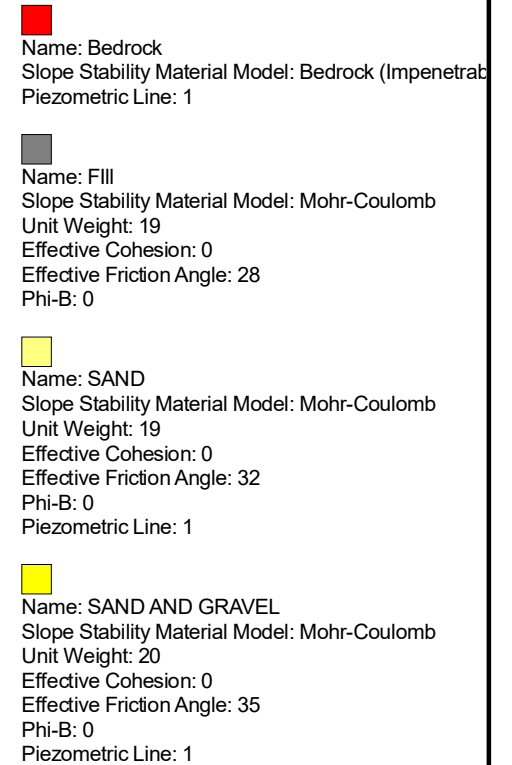
Title: Cross Section B-B  
 File Name: 21482114\_Section B-B\_1m higher\_MG.gsz  
 Name: Static Undrained  
 Method: Morgenstern-Price  
 Horz Seismic Coef.: 0

Static Undrained	
21482114_Section B-B_1m higher_MG.gsz	
03/17/2022	1:720

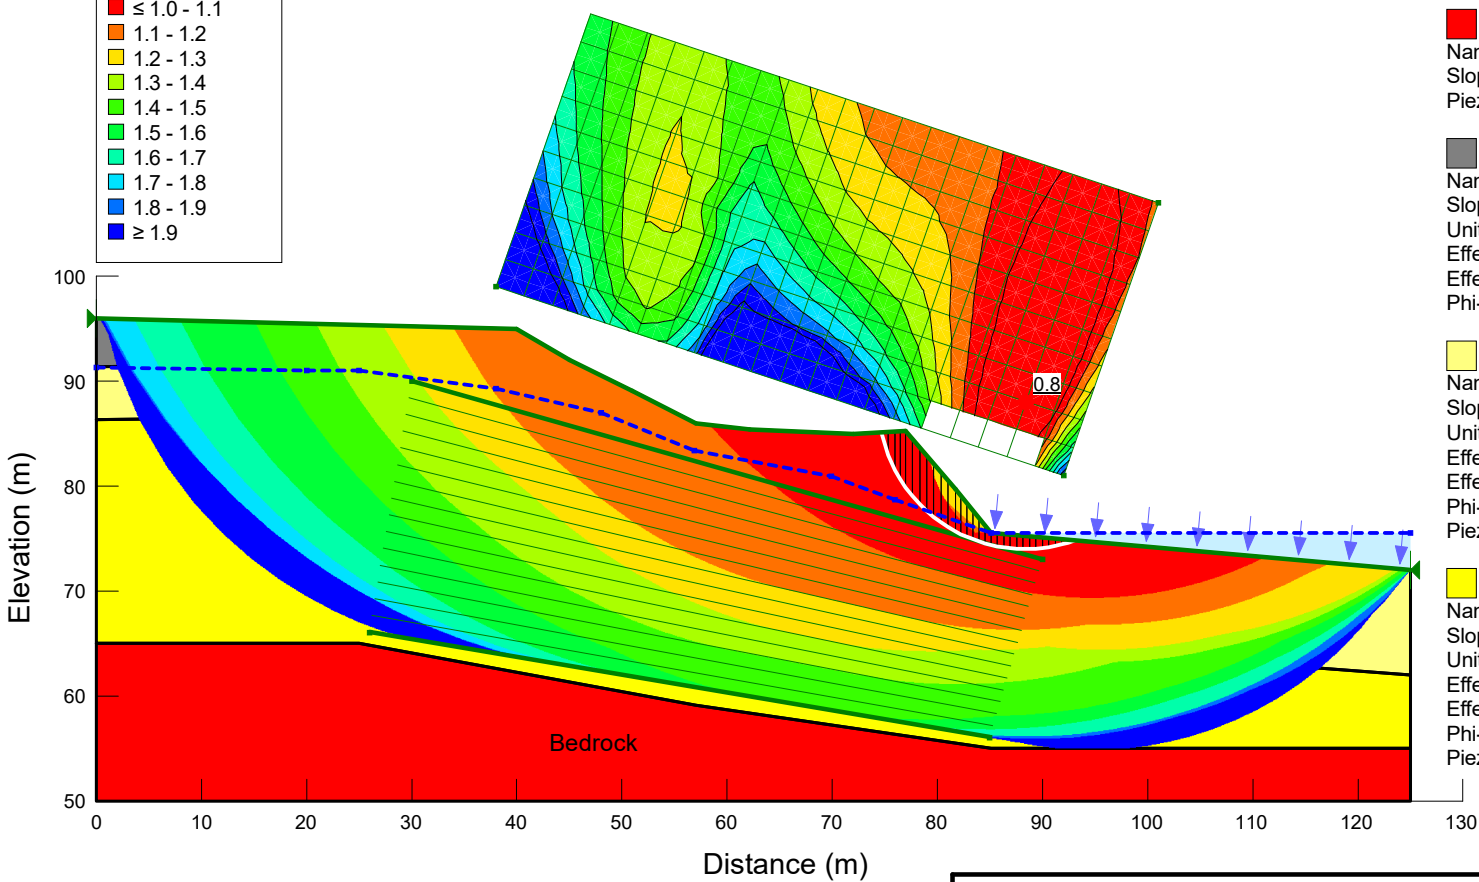
Title: Cross Section B-B  
 File Name: 21482114\_Section B-B\_1m higher\_10%\_MG.gsz  
 Name: Seismic Undrained  
 Method: Morgenstern-Price  
 Horz Seismic Coef.: 0.155

- Name: Bedrock  
 Slope Stability Material Model: Bedrock (Impenetrab  
 Piezometric Line: 1
- Name: Fill  
 Slope Stability Material Model: Mohr-Coulomb  
 Unit Weight: 19  
 Effective Cohesion: 0  
 Effective Friction Angle: 30.8  
 Phi-B: 0
- Name: SAND  
 Slope Stability Material Model: Mohr-Coulomb  
 Unit Weight: 19  
 Effective Cohesion: 0  
 Effective Friction Angle: 35.2  
 Phi-B: 0  
 Piezometric Line: 1
- Name: SAND AND GRAVEL  
 Slope Stability Material Model: Mohr-Coulomb  
 Unit Weight: 20  
 Effective Cohesion: 0  
 Effective Friction Angle: 38.5  
 Phi-B: 0  
 Piezometric Line: 1

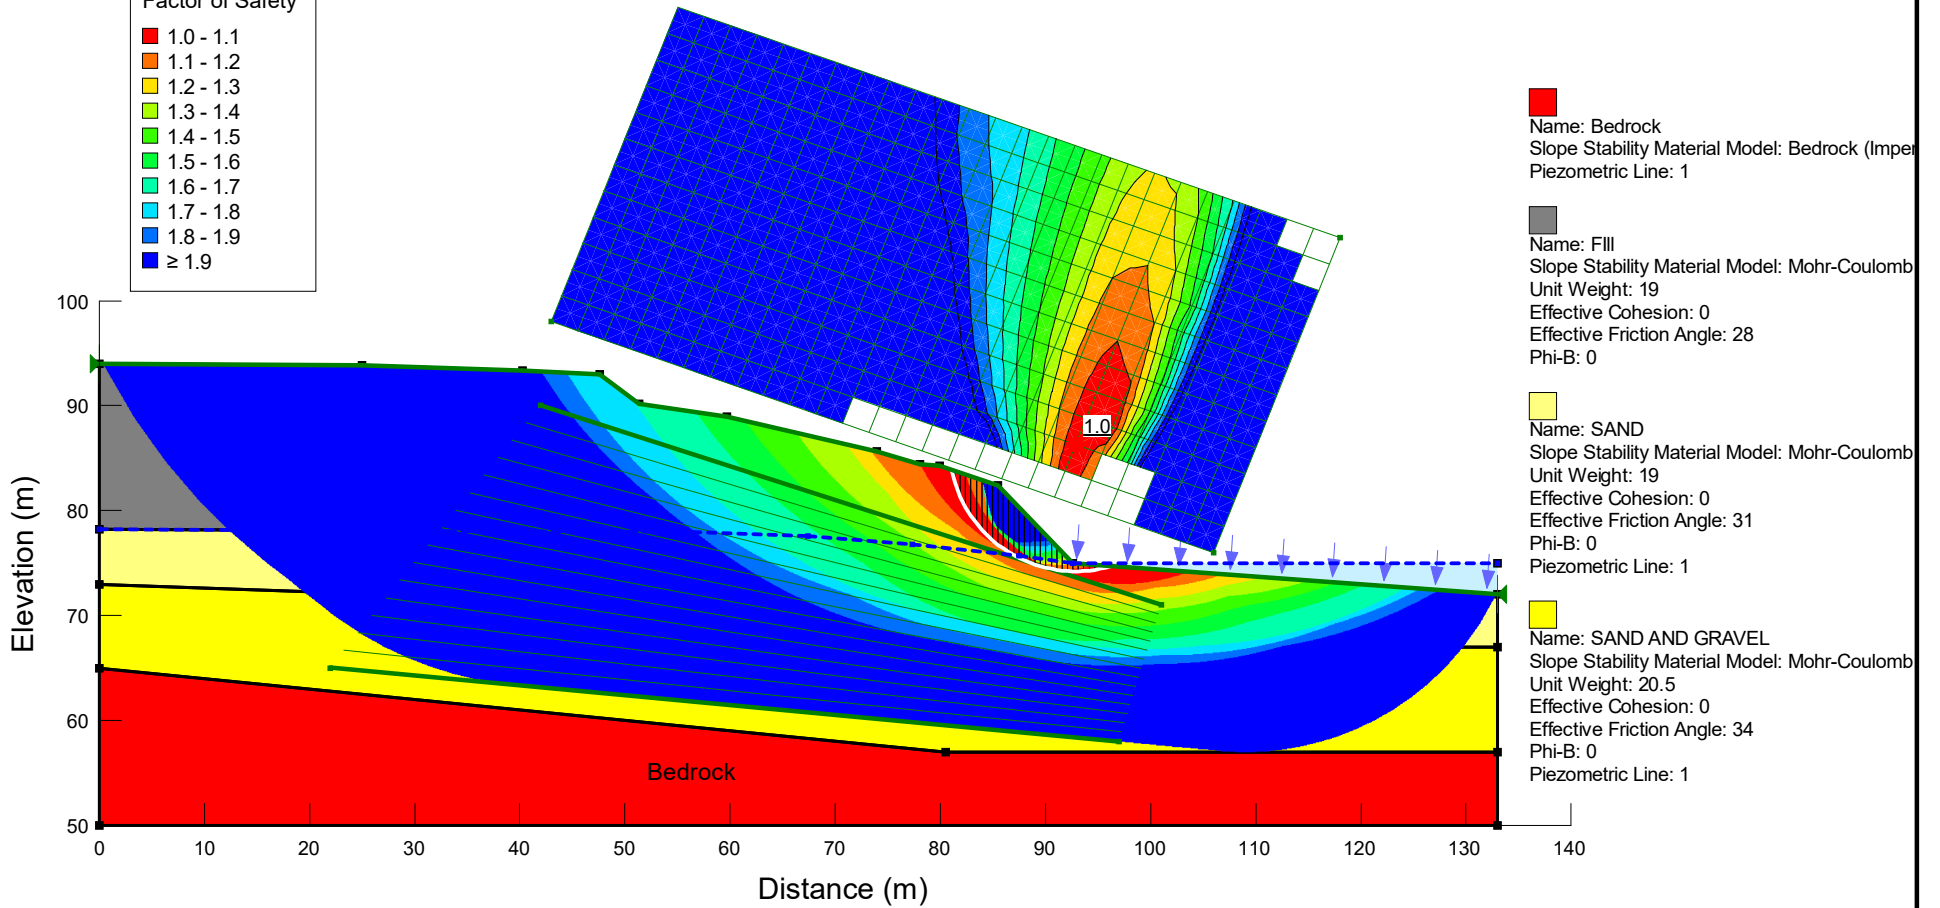
Static Drained	
21482114_Section C-C_1m higher_MG.gsz	
03/11/2022	1:720

Title: St Mary's Site  
 File Name: 21482114\_Section C-C\_1m higher\_MG.gsz  
 Name: Static Drained  
 Method: Morgenstern-Price  
 Horz Seismic Coef.: 0

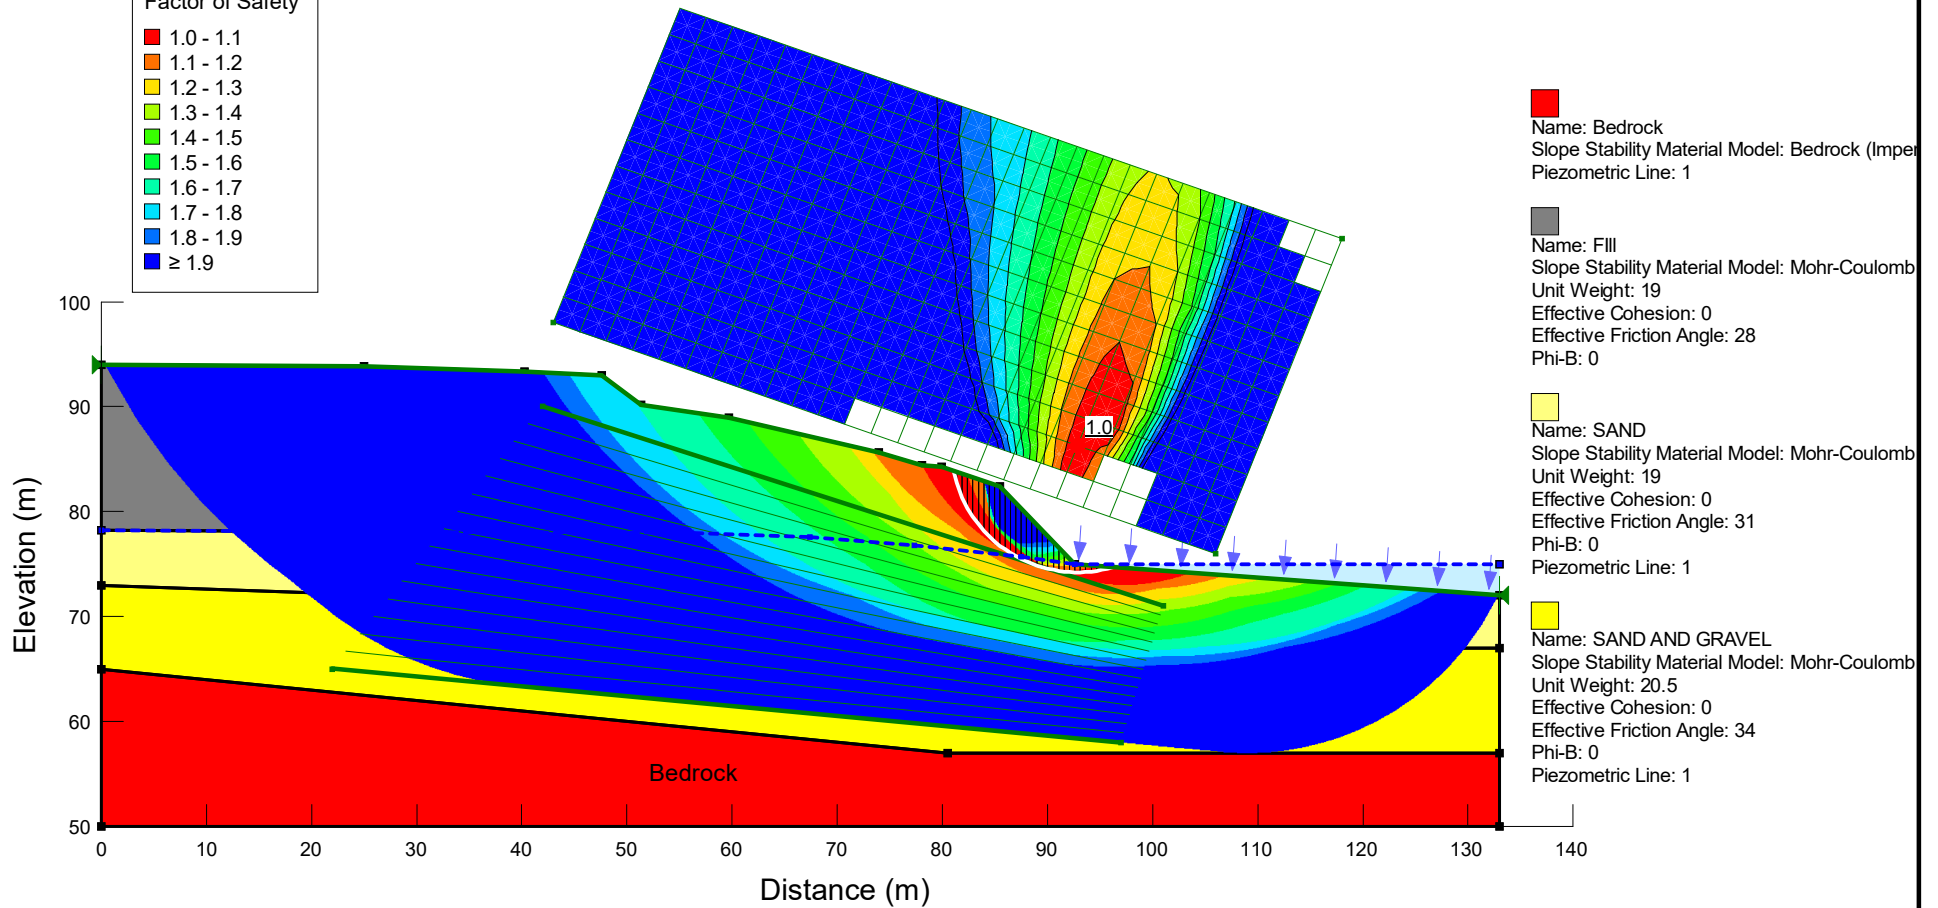
Title: St Mary's Site  
 File Name: 21482114\_Section C-C\_1m higher\_MG.gsz  
 Name: Static Undrained  
 Method: Morgenstern-Price  
 Horz Seismic Coef.: 0

- Name: Bedrock  
Slope Stability Material Model: Bedrock (Imper  
Piezometric Line: 1
- Name: Fill  
Slope Stability Material Model: Mohr-Coulomb  
Unit Weight: 19  
Effective Cohesion: 0  
Effective Friction Angle: 28  
Phi-B: 0
- Name: SAND  
Slope Stability Material Model: Mohr-Coulomb  
Unit Weight: 19  
Effective Cohesion: 0  
Effective Friction Angle: 31  
Phi-B: 0  
Piezometric Line: 1
- Name: SAND AND GRAVEL  
Slope Stability Material Model: Mohr-Coulomb  
Unit Weight: 20.5  
Effective Cohesion: 0  
Effective Friction Angle: 34  
Phi-B: 0  
Piezometric Line: 1

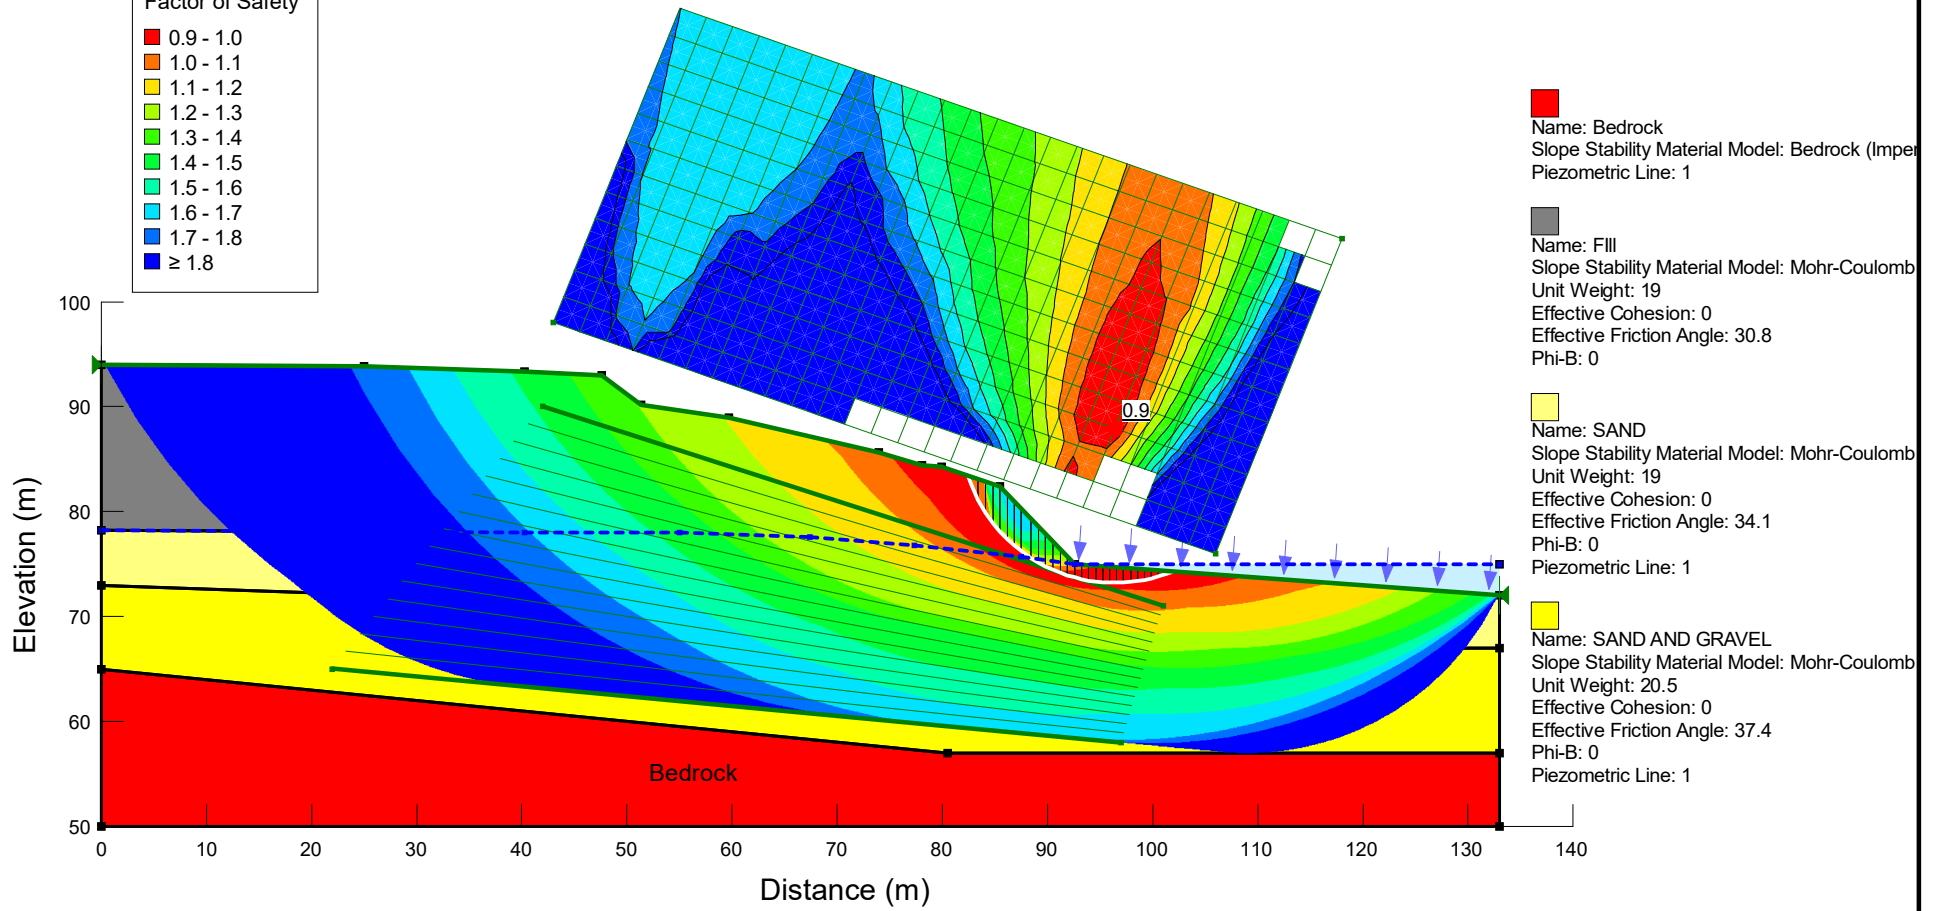
Title: St Mary's Site  
 File Name: 21482114\_Section C-C\_1m higher\_10%\_MG.gsz  
 Name: Seismic Undrained  
 Method: Morgenstern-Price  
 Horz Seismic Coef.: 0.155

- Name: Bedrock  
Slope Stability Material Model: Bedrock (Imper  
Piezometric Line: 1
- Name: Fill  
Slope Stability Material Model: Mohr-Coulomb  
Unit Weight: 19  
Effective Cohesion: 0  
Effective Friction Angle: 30.8  
Phi-B: 0
- Name: SAND  
Slope Stability Material Model: Mohr-Coulomb  
Unit Weight: 19  
Effective Cohesion: 0  
Effective Friction Angle: 34.1  
Phi-B: 0  
Piezometric Line: 1
- Name: SAND AND GRAVEL  
Slope Stability Material Model: Mohr-Coulomb  
Unit Weight: 20.5  
Effective Cohesion: 0  
Effective Friction Angle: 37.4  
Phi-B: 0  
Piezometric Line: 1

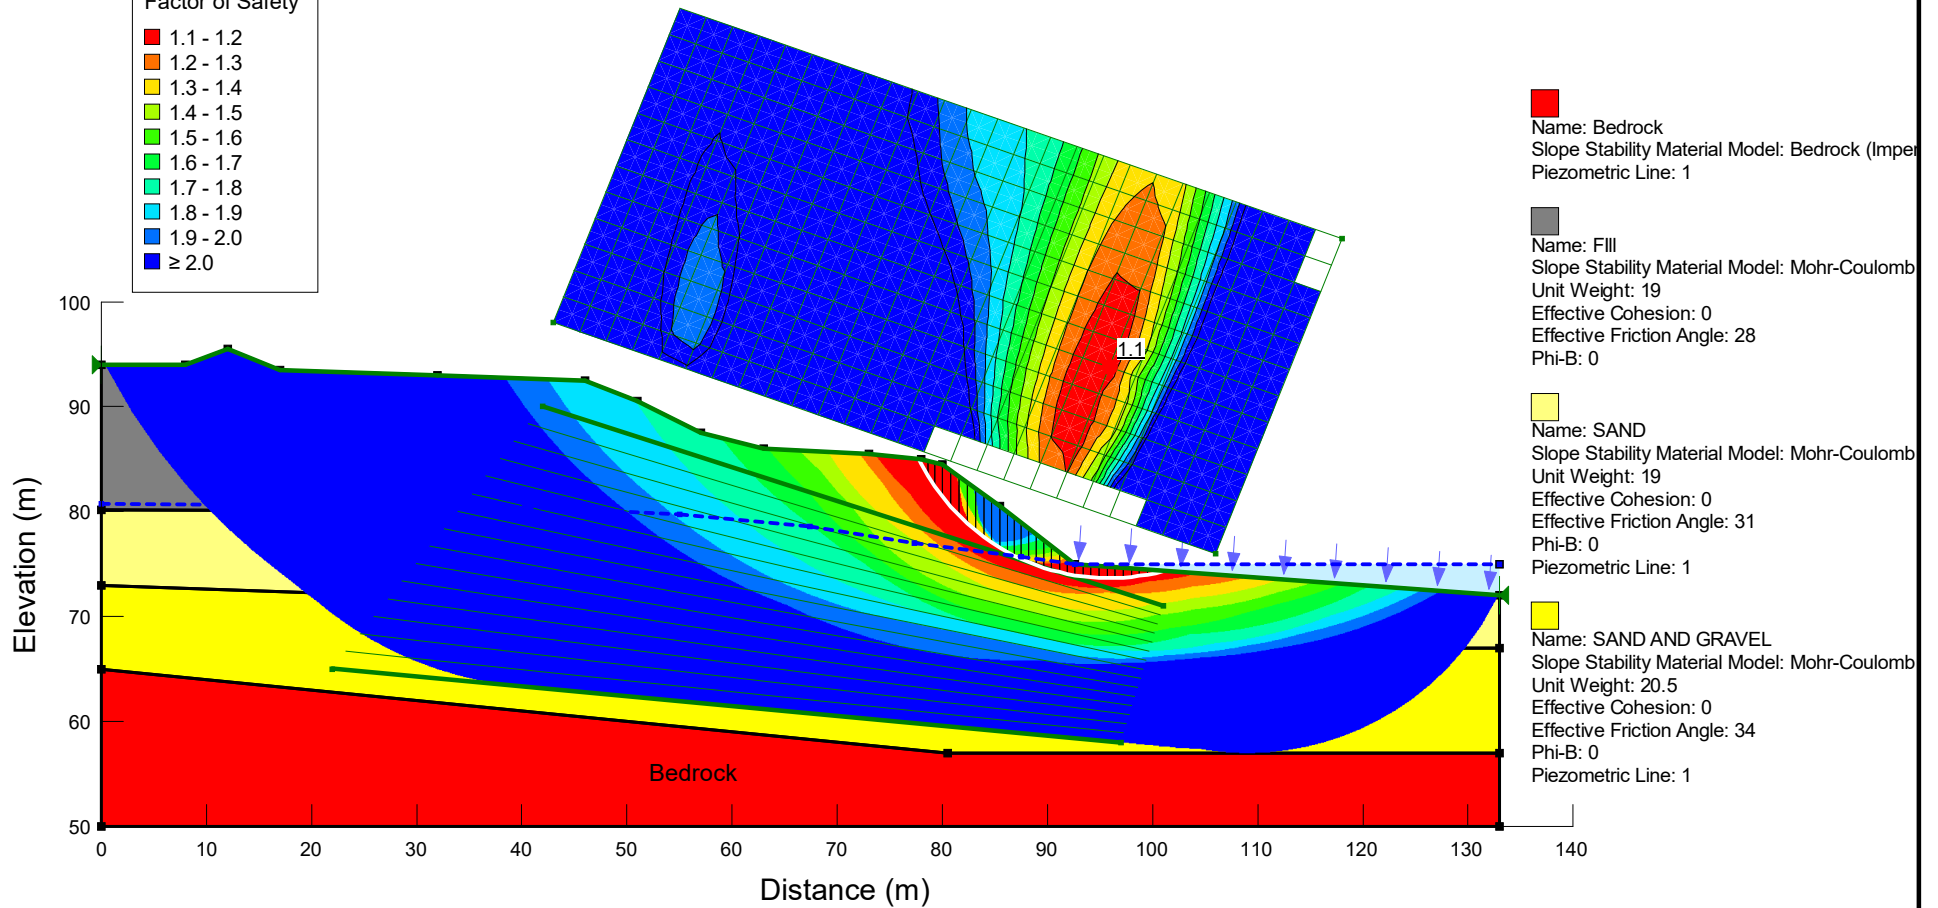
Static Undrained	
21482114_Section D-D_1m higher_MG.gsz	
03/11/2022	1:720

Title: Cross Section D-D  
 File Name: 21482114\_Section D-D\_1m higher\_MG.gsz  
 Name: Static Undrained  
 Method: Morgenstern-Price  
 Horz Seismic Coef.: 0

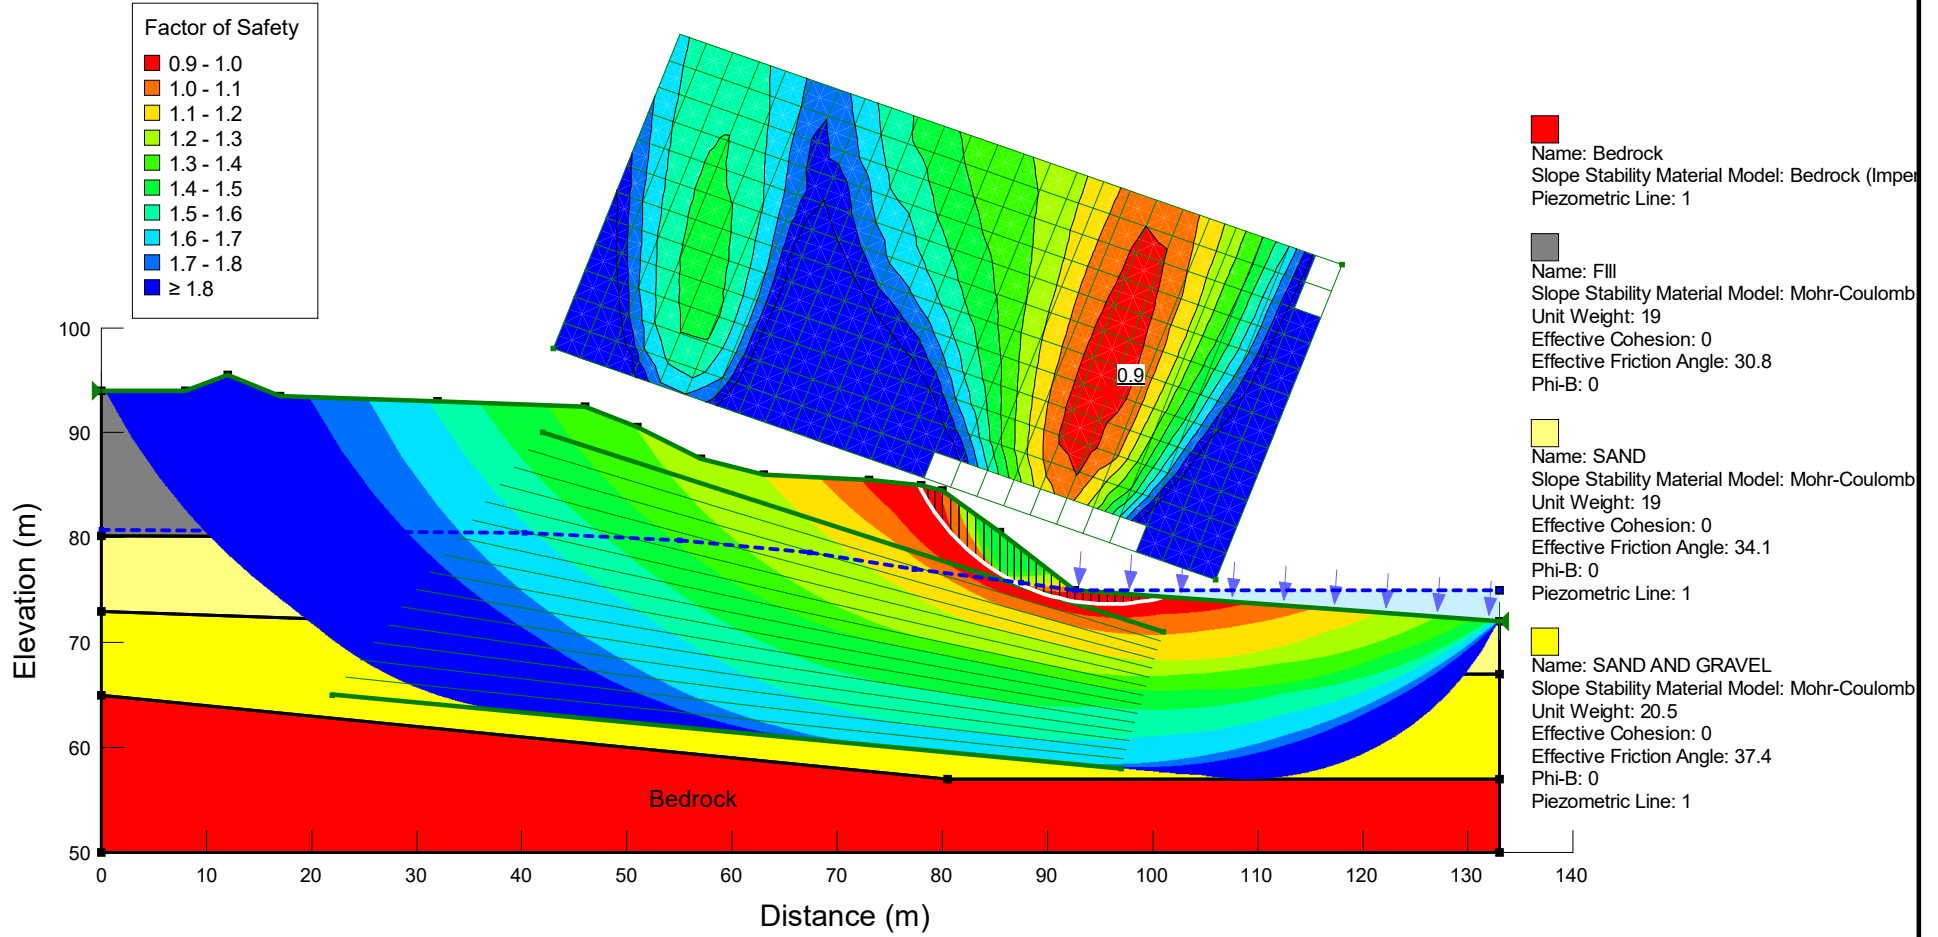
Title: Cross Section D-D  
 File Name: 21482114\_Section D-D\_1m higher\_10%\_MG.gsz  
 Name: Seismic Undrained  
 Method: Morgenstern-Price  
 Horz Seismic Coef.: 0.155

- Name: Bedrock  
Slope Stability Material Model: Bedrock (Imper  
Piezometric Line: 1
- Name: Fill  
Slope Stability Material Model: Mohr-Coulomb  
Unit Weight: 19  
Effective Cohesion: 0  
Effective Friction Angle: 30.8  
Phi-B: 0
- Name: SAND  
Slope Stability Material Model: Mohr-Coulomb  
Unit Weight: 19  
Effective Cohesion: 0  
Effective Friction Angle: 34.1  
Phi-B: 0  
Piezometric Line: 1
- Name: SAND AND GRAVEL  
Slope Stability Material Model: Mohr-Coulomb  
Unit Weight: 20.5  
Effective Cohesion: 0  
Effective Friction Angle: 37.4  
Phi-B: 0  
Piezometric Line: 1

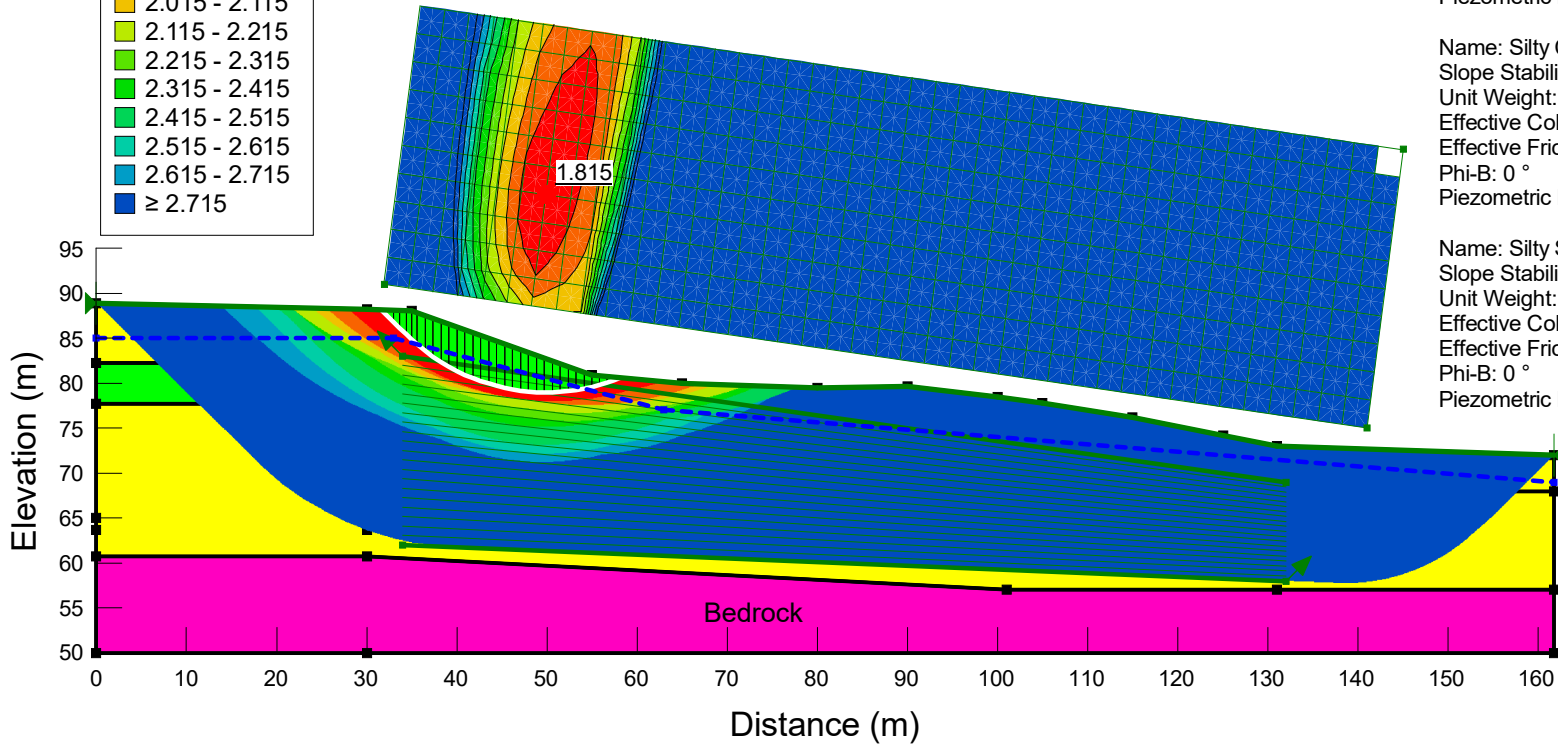
- 1.815 - 1.915
- 1.915 - 2.015
- 2.015 - 2.115
- 2.115 - 2.215
- 2.215 - 2.315
- 2.315 - 2.415
- 2.415 - 2.515
- 2.515 - 2.615
- 2.615 - 2.715
- ≥ 2.715

1.1 Static Drained	
21482114_Section F-F_1m higher_MG.gsz	
03/11/2022	1:840

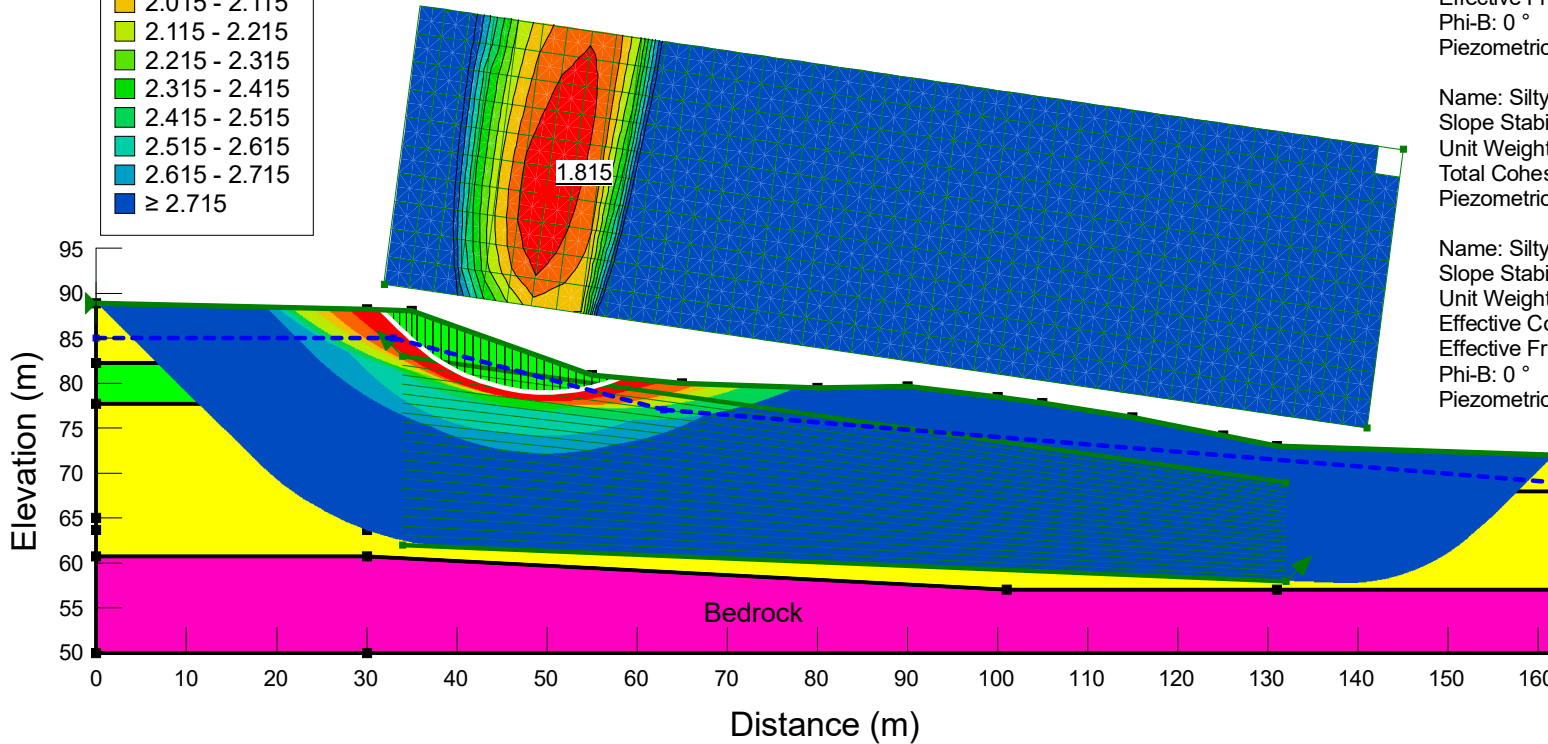
Title: Taggart/St Mary Site/Ottawa  
 File Name: 21482114\_Section F-F\_1m higher\_MG.gsz  
 Name: 1.2 Static Undrained  
 Method: Morgenstern-Price  
 Horz Seismic Coef.: 0

Name: Silty Clay (phi=0)  
 Slope Stability Material Model: Undrained (Phi=0)  
 Unit Weight: 16.5 kN/m<sup>3</sup>  
 Total Cohesion: 75 kPa  
 Piezometric Line: 1

Name: Silty Sand  
 Slope Stability Material Model: Mohr-Coulomb  
 Unit Weight: 20 kN/m<sup>3</sup>  
 Effective Cohesion: 0 kPa  
 Effective Friction Angle: 34 °  
 Phi-B: 0 °  
 Piezometric Line: 1

1.2 Static Undrained	
21482114_Section F-F_1m higher_MG.gsz	
03/11/2022	1:840
