DRAFT REPORT

**Geotechnical Assessment**  
**Proposed Residential Development**  
*3930 and 3960 Riverside Drive, Ottawa, Ontario*

21482114-3000

December 22, 2022

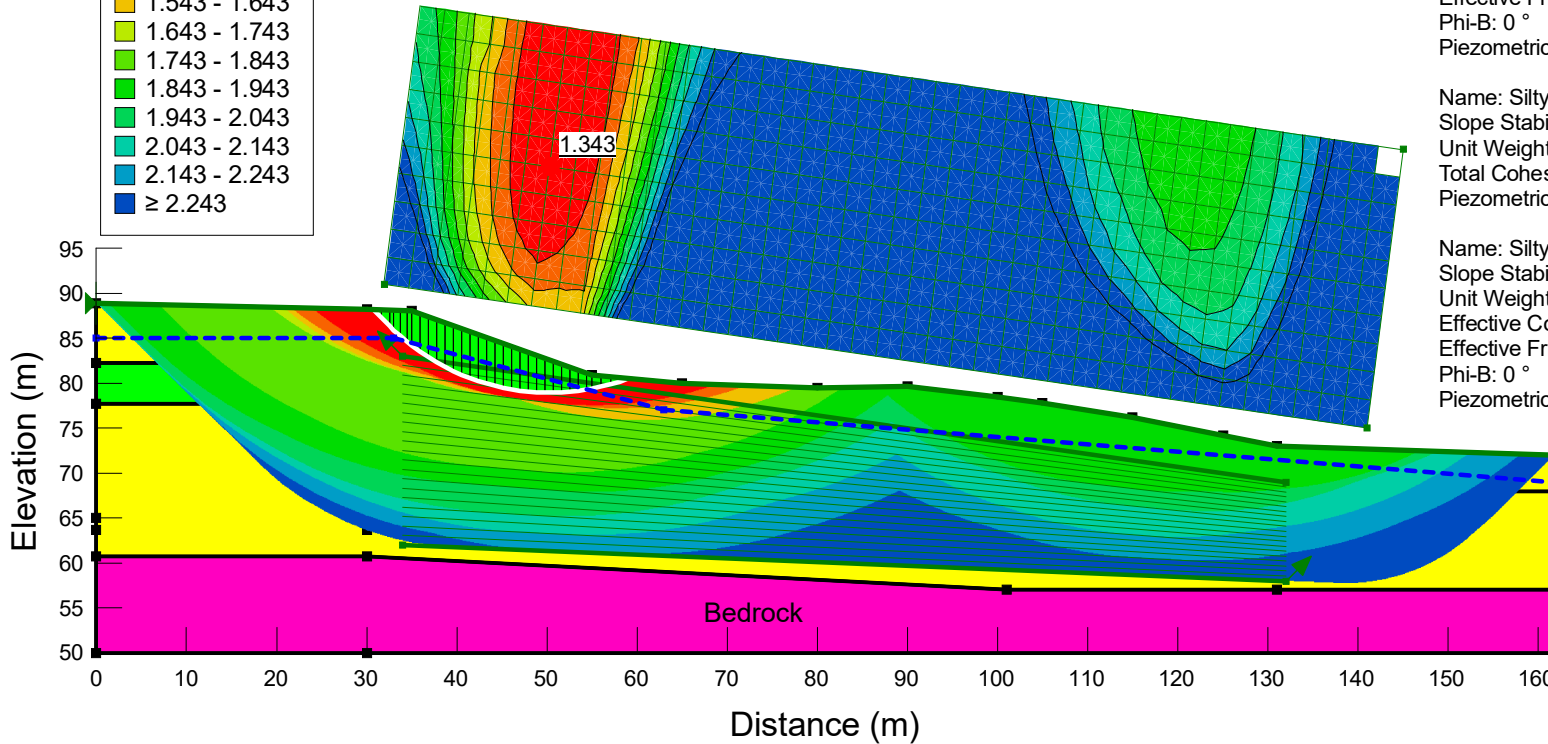
Title: Taggart/St Mary Site/Ottawa  
 File Name: 21482114\_Section F-F\_1m higher\_10%\_MG.gsz  
 Name: 1.3 Seismic Undrained  
 Method: Morgenstern-Price  
 Horz Seismic Coef.: 0.155

Name: Silty Clay (phi=0)  
 Slope Stability Material Model: Undrained (Phi=0)  
 Unit Weight: 16.5 kN/m<sup>3</sup>  
 Total Cohesion: 82.5 kPa  
 Piezometric Line: 1

Name: Silty Sand  
 Slope Stability Material Model: Mohr-Coulomb  
 Unit Weight: 20 kN/m<sup>3</sup>  
 Effective Cohesion: 0 kPa  
 Effective Friction Angle: 37.4 °  
 Phi-B: 0 °  
 Piezometric Line: 1

1.3 Seismic Undrained	
21482114_Section F-F_1m higher_10%_MG.gsz	
03/11/2022	1:840

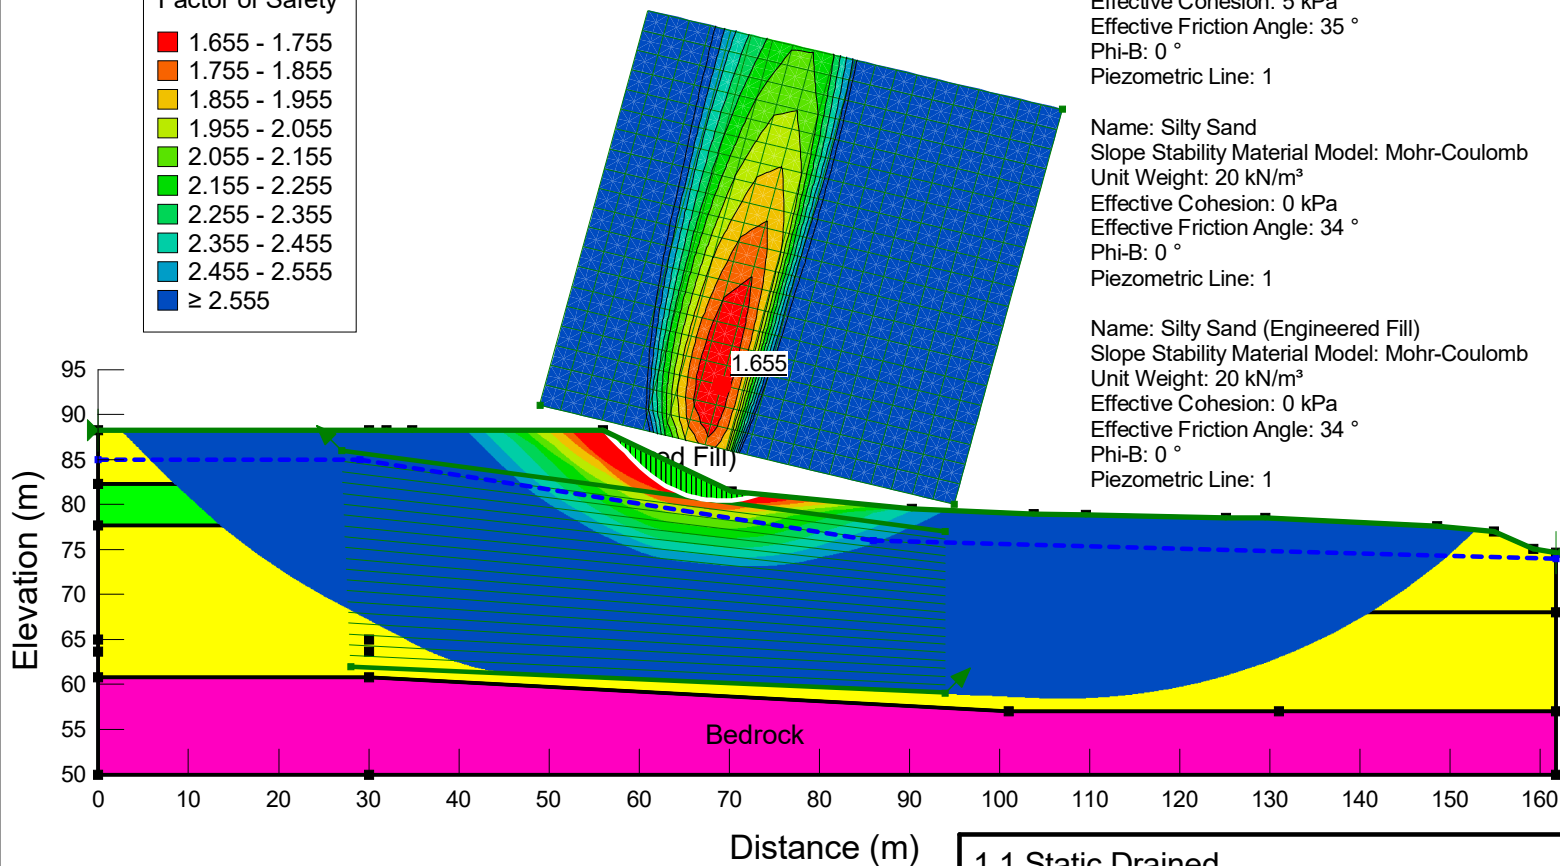
Title: Taggart/St Mary Site/Ottawa  
 File Name: 21482114\_Section G-G\_1m higher\_MG.gsz  
 Name: 1.1 Static Drained  
 Method: Morgenstern-Price  
 Horz Seismic Coef.: 0

Name: Silty Sand  
 Slope Stability Material Model: Mohr-Coulomb  
 Unit Weight: 20 kN/m<sup>3</sup>  
 Effective Cohesion: 0 kPa  
 Effective Friction Angle: 34 °  
 Phi-B: 0 °  
 Piezometric Line: 1

Name: Silty Sand (Engineered Fill)  
 Slope Stability Material Model: Mohr-Coulomb  
 Unit Weight: 20 kN/m<sup>3</sup>  
 Effective Cohesion: 0 kPa  
 Effective Friction Angle: 34 °  
 Phi-B: 0 °  
 Piezometric Line: 1

1.1 Static Drained	
21482114_Section G-G_1m higher_MG.gsz	
03/11/2022	1:840

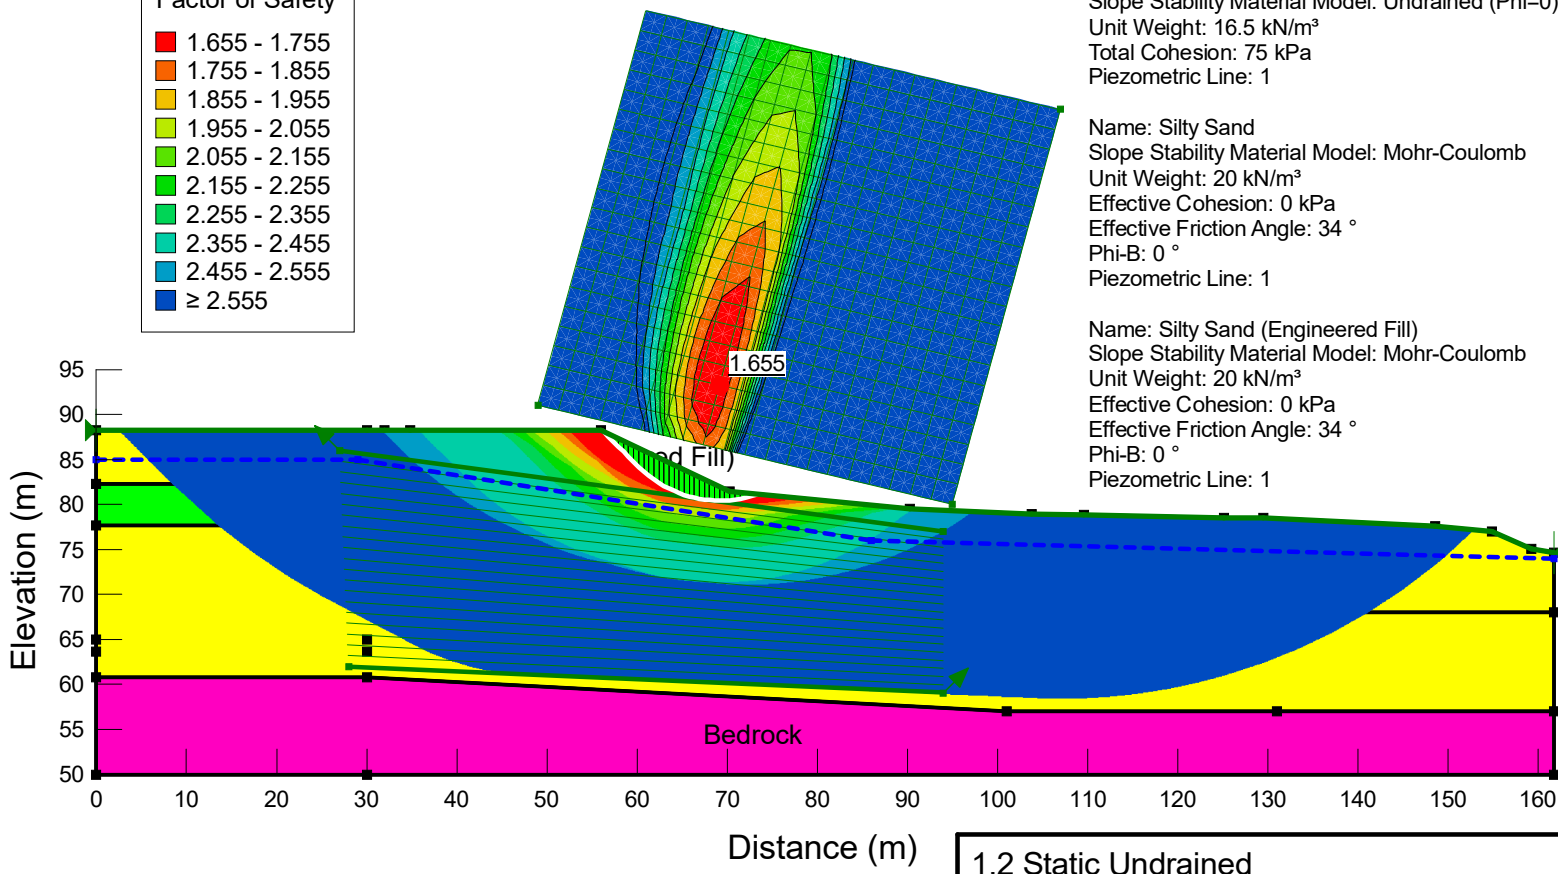
Title: Taggart/St Mary Site/Ottawa  
 File Name: 21482114\_Section G-G\_1m higher\_MG.gsz  
 Name: 1.2 Static Undrained  
 Method: Morgenstern-Price  
 Horz Seismic Coef.: 0

Name: Silty Sand  
 Slope Stability Material Model: Mohr-Coulomb  
 Unit Weight: 20 kN/m<sup>3</sup>  
 Effective Cohesion: 0 kPa  
 Effective Friction Angle: 34 °  
 Phi-B: 0 °  
 Piezometric Line: 1

Name: Silty Sand (Engineered Fill)  
 Slope Stability Material Model: Mohr-Coulomb  
 Unit Weight: 20 kN/m<sup>3</sup>  
 Effective Cohesion: 0 kPa  
 Effective Friction Angle: 34 °  
 Phi-B: 0 °  
 Piezometric Line: 1

1.2 Static Undrained	
21482114_Section G-G_1m higher_MG.gsz	
03/11/2022	1:840

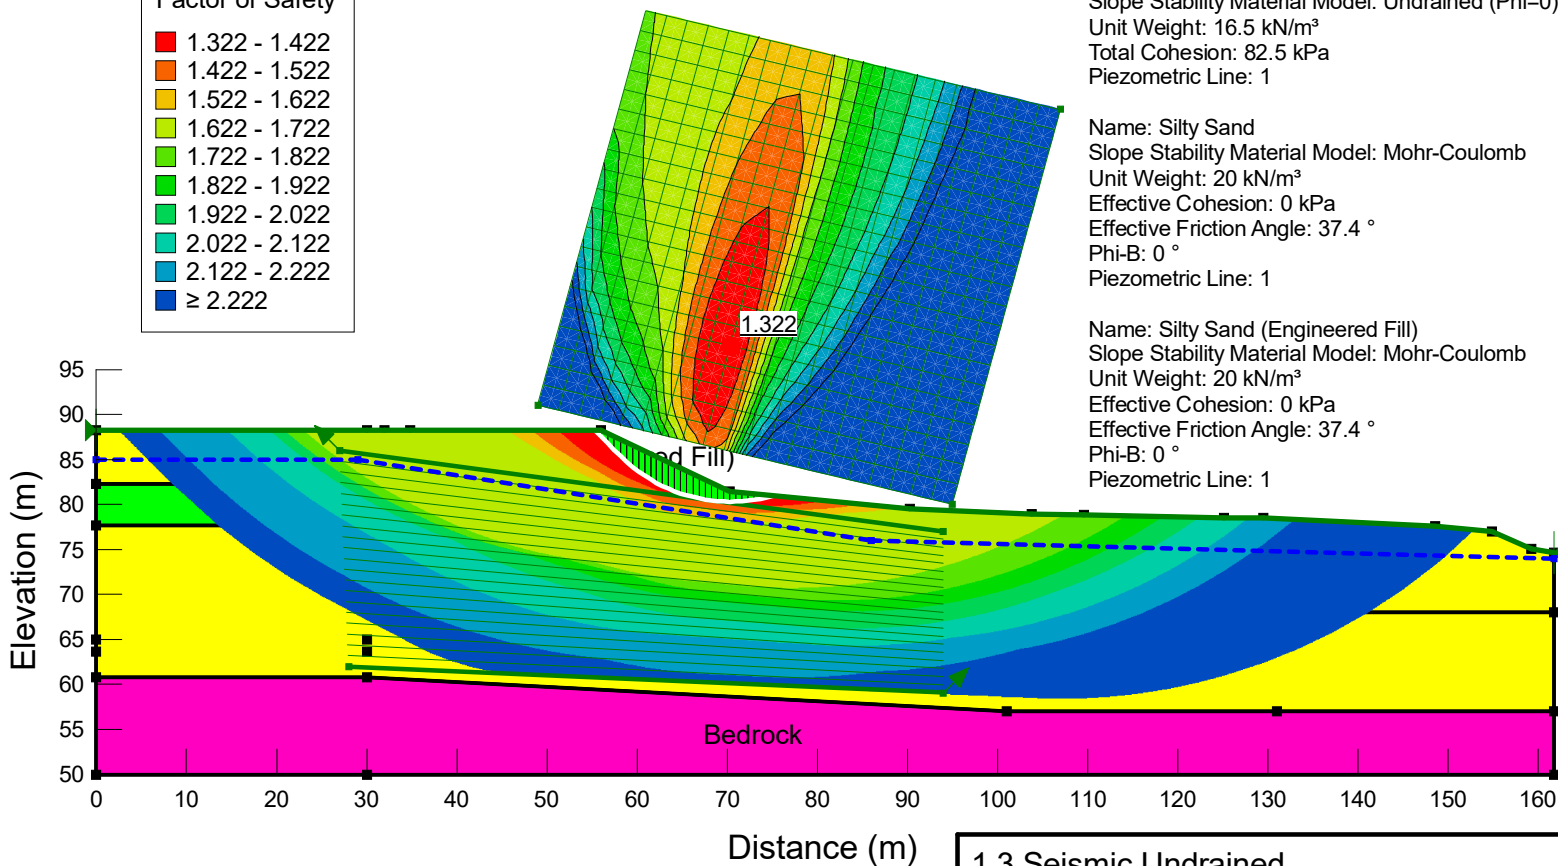
Title: Taggart/St Mary Site/Ottawa  
 File Name: 21482114\_Section G-G\_1m higher\_10%\_MG.gsz  
 Name: 1.3 Seismic Undrained  
 Method: Morgenstern-Price  
 Horz Seismic Coef.: 0.155

Name: Silty Sand  
 Slope Stability Material Model: Mohr-Coulomb  
 Unit Weight: 20 kN/m<sup>3</sup>  
 Effective Cohesion: 0 kPa  
 Effective Friction Angle: 37.4 °  
 Phi-B: 0 °  
 Piezometric Line: 1

Name: Silty Sand (Engineered Fill)  
 Slope Stability Material Model: Mohr-Coulomb  
 Unit Weight: 20 kN/m<sup>3</sup>  
 Effective Cohesion: 0 kPa  
 Effective Friction Angle: 37.4 °  
 Phi-B: 0 °  
 Piezometric Line: 1

1.3 Seismic Undrained	
21482114_Section G-G_1m higher_10%_MG.gsz	
03/11/2022	1:840

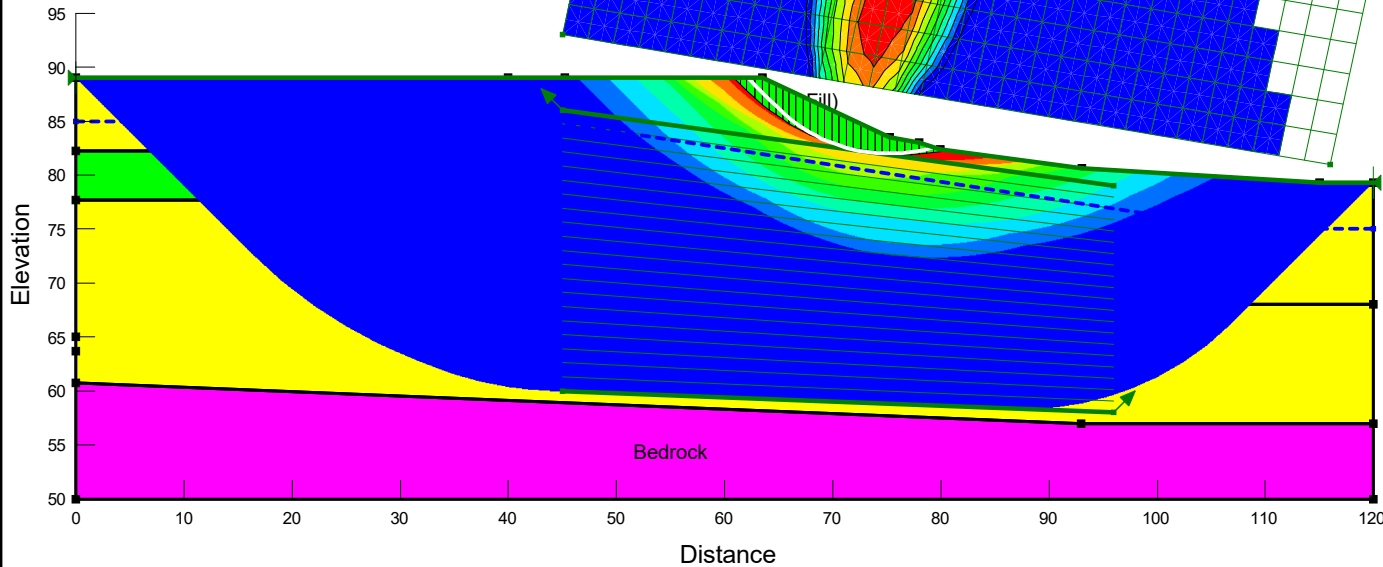
Title: Slope Cross Section H-H  
 File Name: 21482114\_Section H-H\_1m higher\_MG.gsz  
 Name: 2.1 Static Drained  
 Method: Morgenstern-Price  
 Horz Seismic Coef.: 0  
 Scale: 1:700

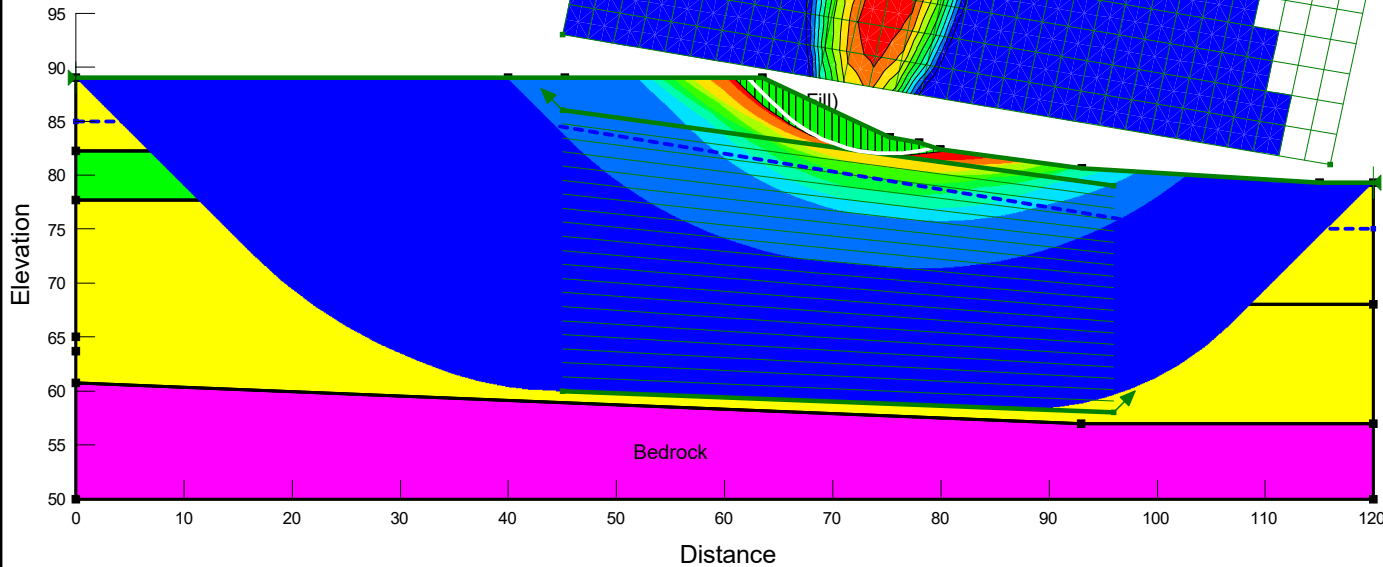
Title: Slope Cross Section H-H  
 File Name: 21482114\_Section H-H\_1m higher\_MG.gsz  
 Name: 2.2 Static Undrained  
 Method: Morgenstern-Price  
 Horz Seismic Coef.: 0  
 Scale: 1:700

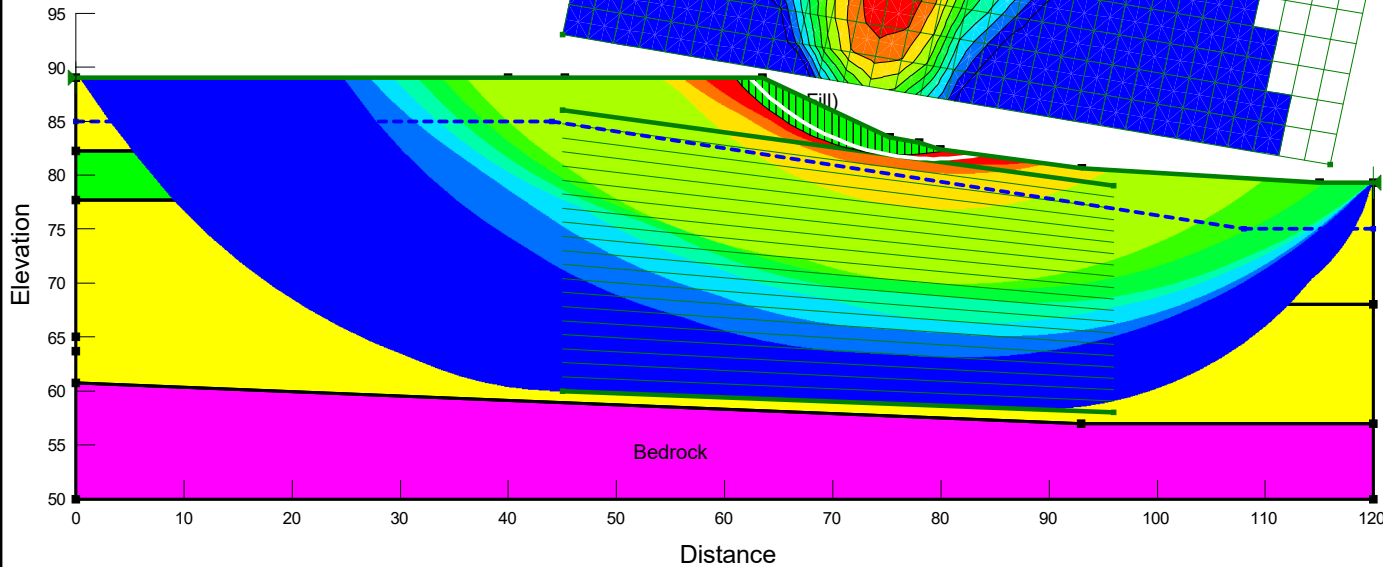
Title: Slope Cross Section H-H  
 File Name: 21482114\_Section H-H\_1m higher\_10%\_MG.gsz  
 Name: 2.3 Seismic Undrained  
 Method: Morgenstern-Price  
 Horz Seismic Coef.: 0.155  
 Scale: 1:700

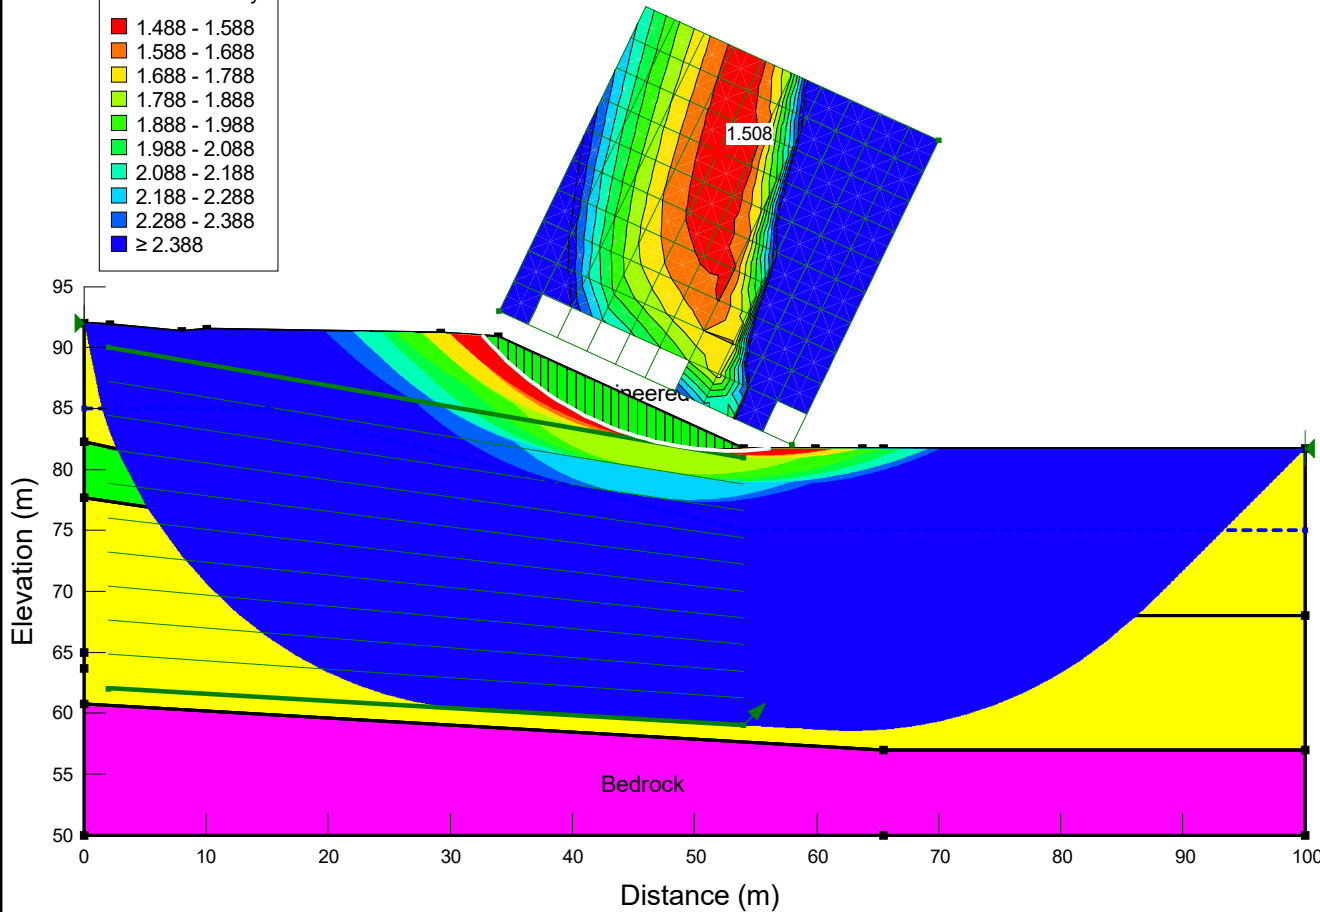
Title: Cross Section I-I  
 File Name: 21482114\_Section I-I\_1m higher\_MG.gsz  
 Name: 3.1 Static Drained  
 Method: Morgenstern-Price  
 Scale: 1:620  
 Horz Seismic Coef.: 0

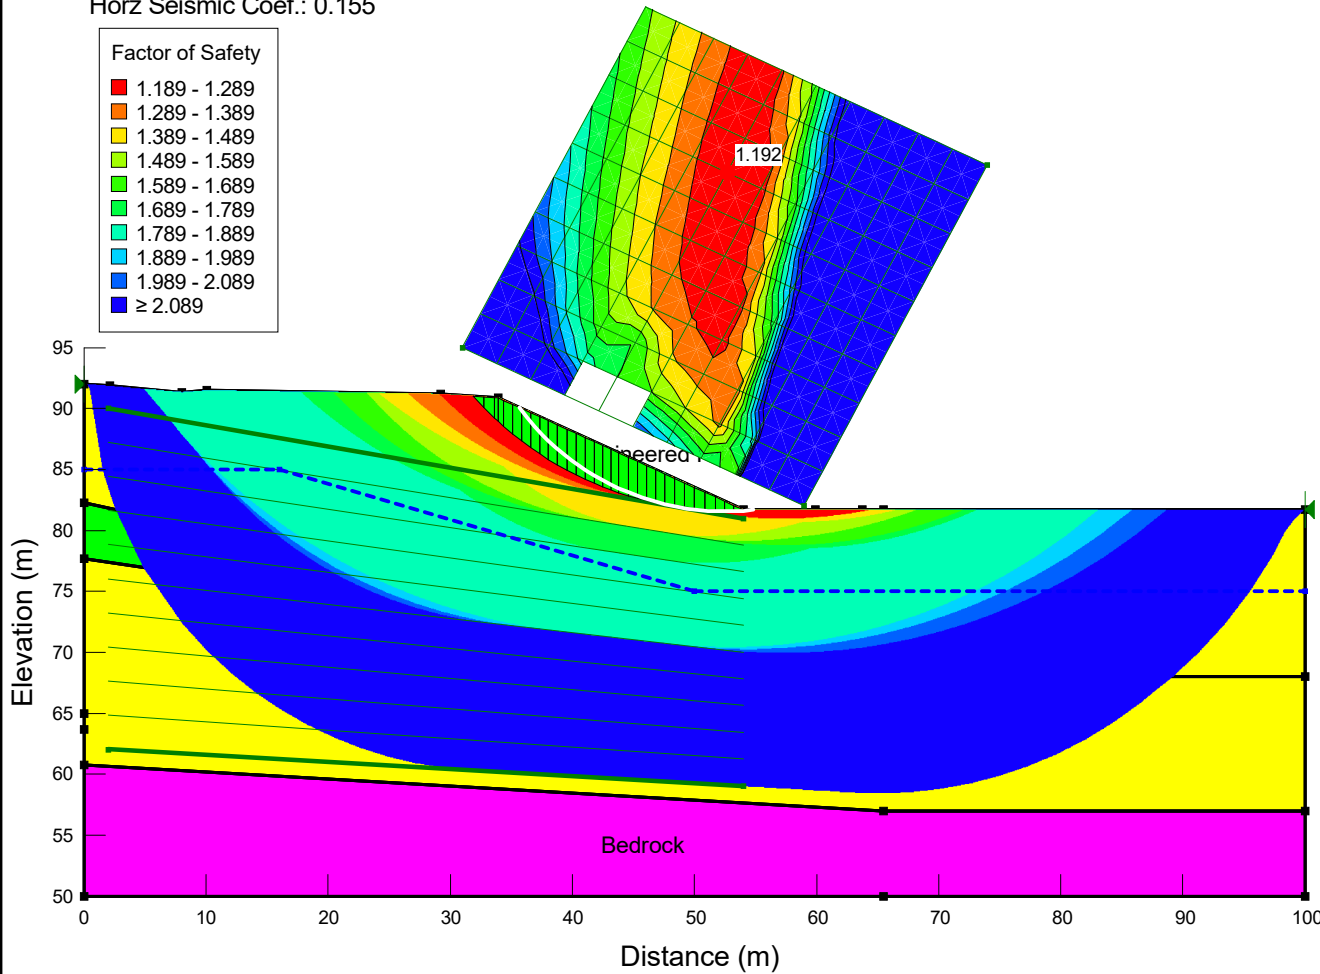
Title: Cross Section I-I  
 File Name: 21482114\_Section I-I\_1m higher\_10%\_MG.gsz  
 Name: 3.3 Seismic Undrained  
 Method: Morgenstern-Price  
 Scale: 1:620  
 Horz Seismic Coef.: 0.155

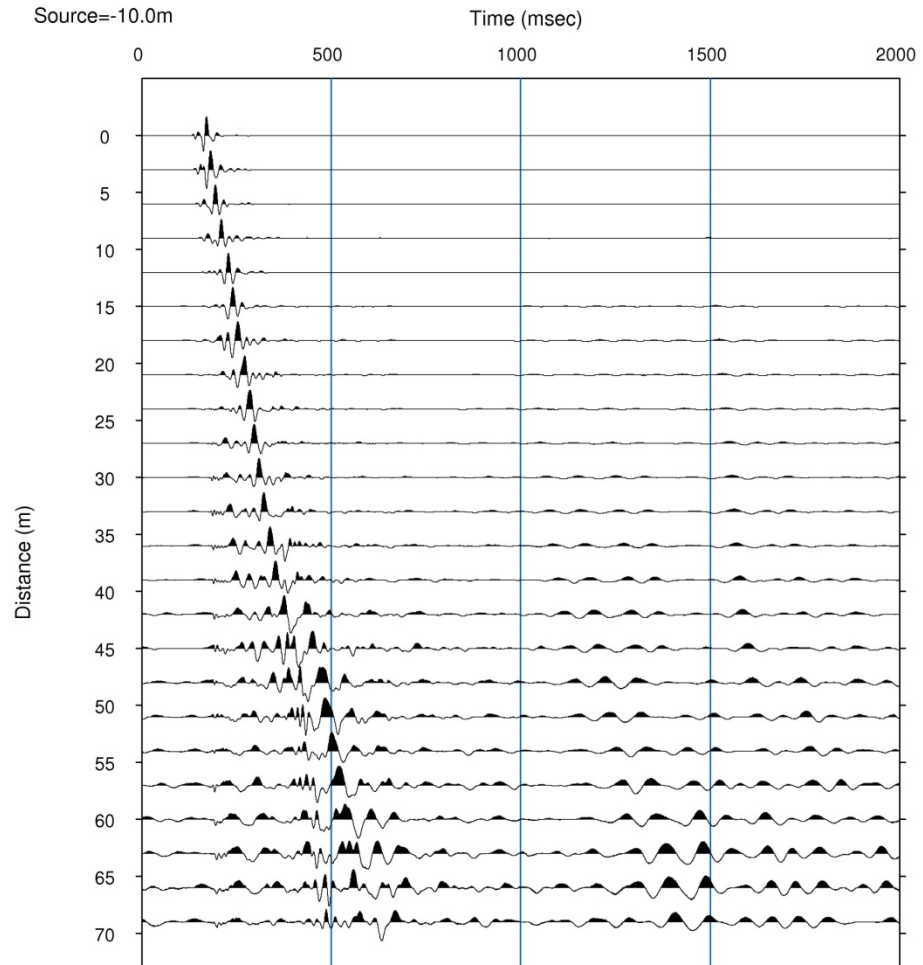
Figure 1: Typical seismic record collected along MASW Line1.

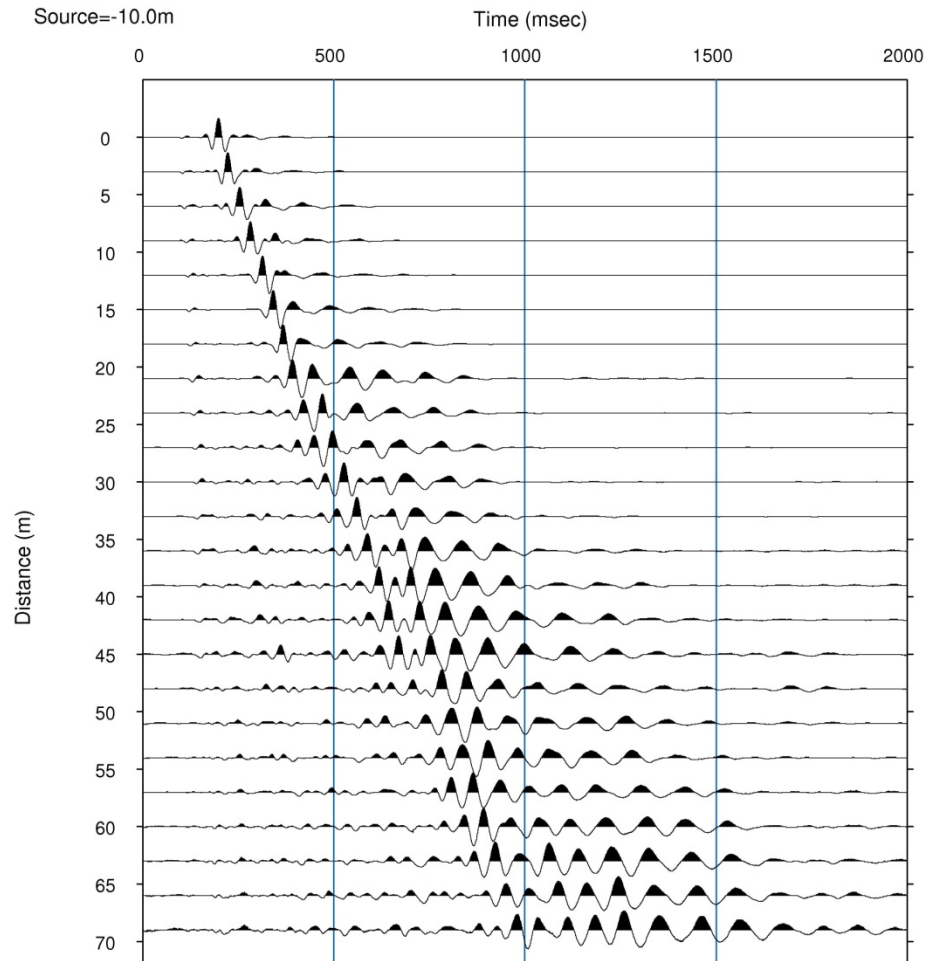
Figure 2: Typical seismic record collected along MASW Line 2.

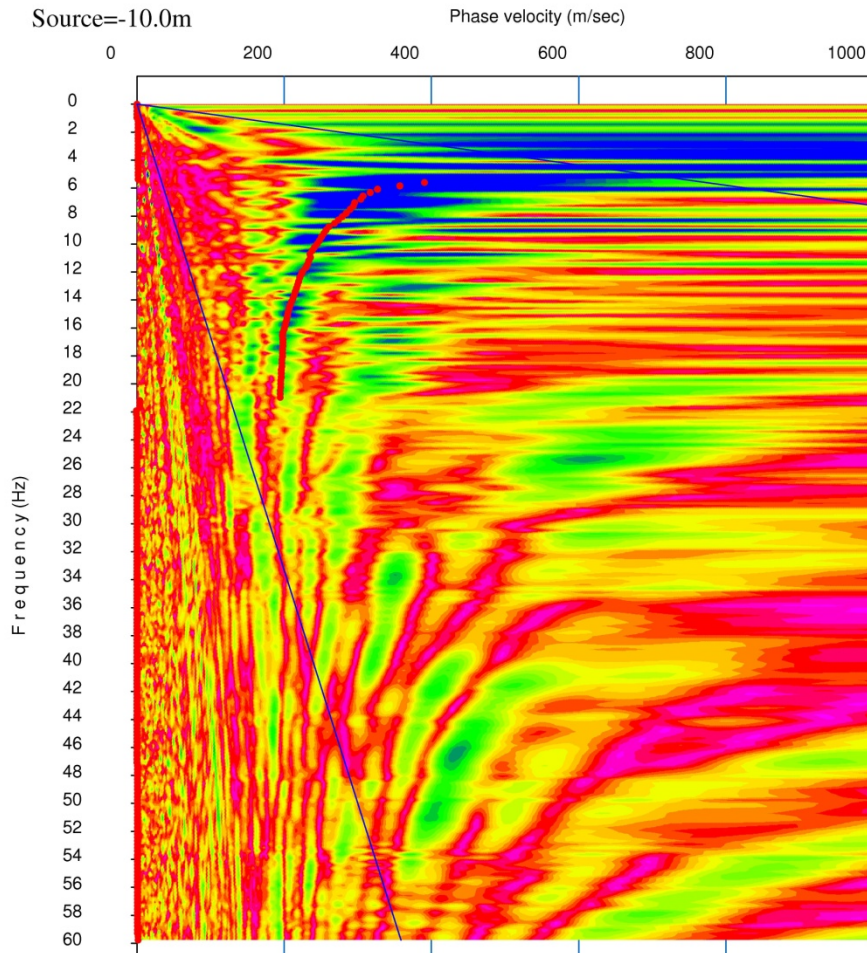
Figure 3: MASW Dispersion Curve Picks for Line 1 (red dots).

Processing of the MASW data was completed using the SeisImager/SW software package (Geometrics Inc.). The calculated phase velocities for a seismic shot point were combined and the dispersion curve generated by choosing the minimum phase velocity calculated for each frequency component as shown on Figures 3 and 4. Shear wave velocity profiles were generated through inverse modelling to best fit the calculated dispersion curves.

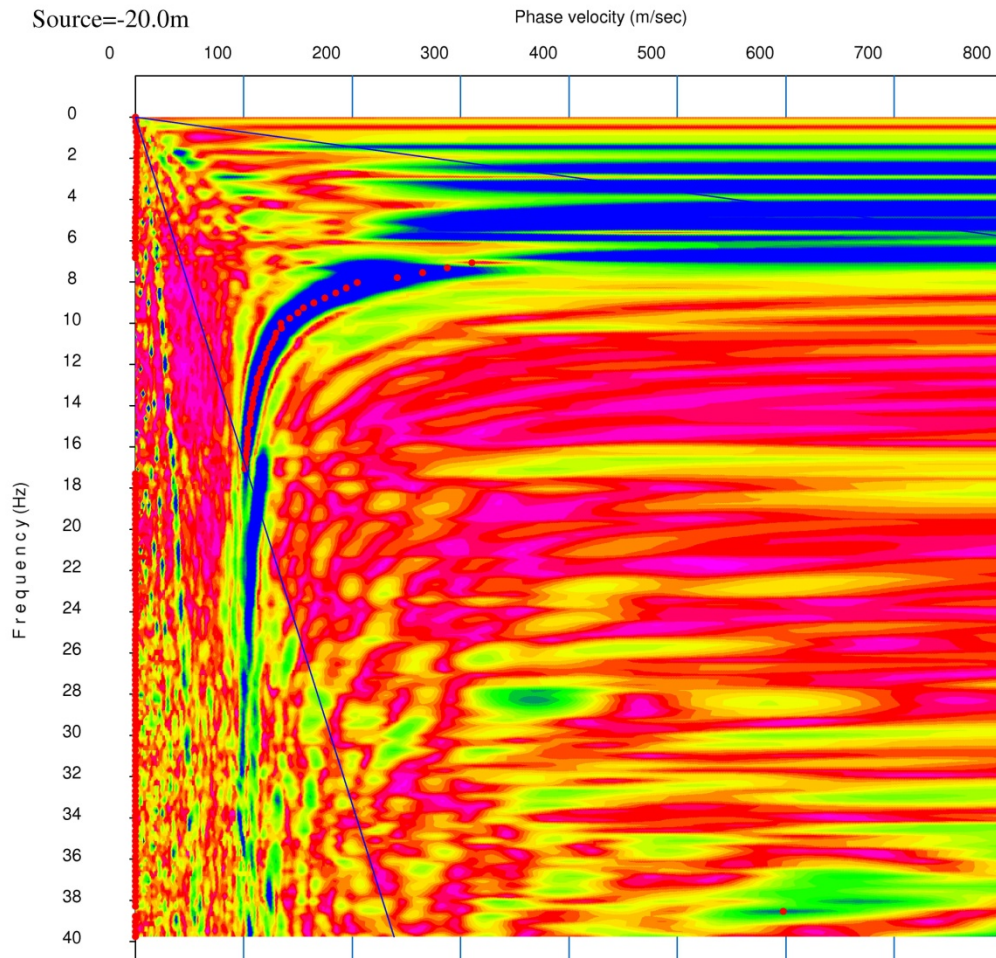
Figure 4: MASW Dispersion Curve Picks for Line 2 (red dots).

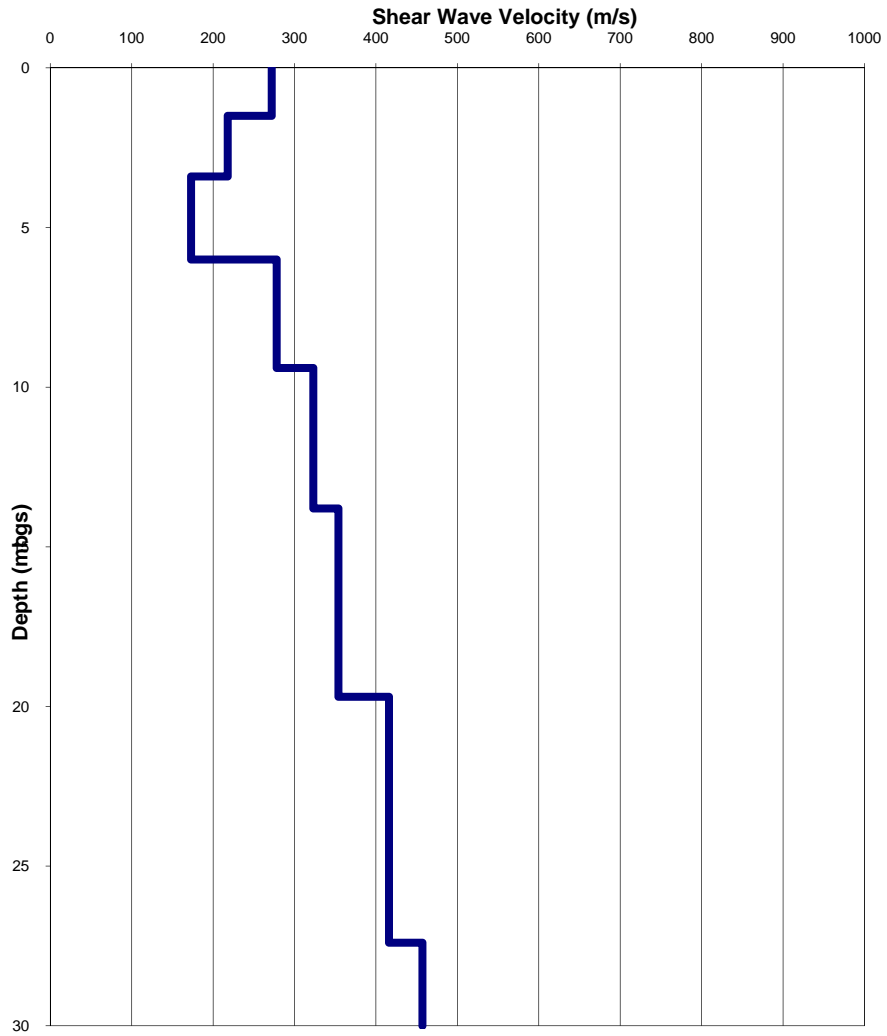
Figure 5: MASW Modelled Shear Wave Velocity Depth profile for MASW Line 1.

The MASW test results are presented in Figures 5 and 6, which present the calculated shear wave velocity profiles measured from the field testing at the two locations. The results at each line have been inferred using a weight drop located at 10 m from the first geophone. The field collected dispersion curves are compared with the model generated dispersion curves on Figures 7 and 8. At MASW Line 1 there is a good correlation between the field collected and model calculated dispersion curves, with a root mean squared error of 3.5%. At MASW Line 2 there is an excellent correlation between the field collected and model calculated dispersion curves, with a root mean squared error of 0.8%.

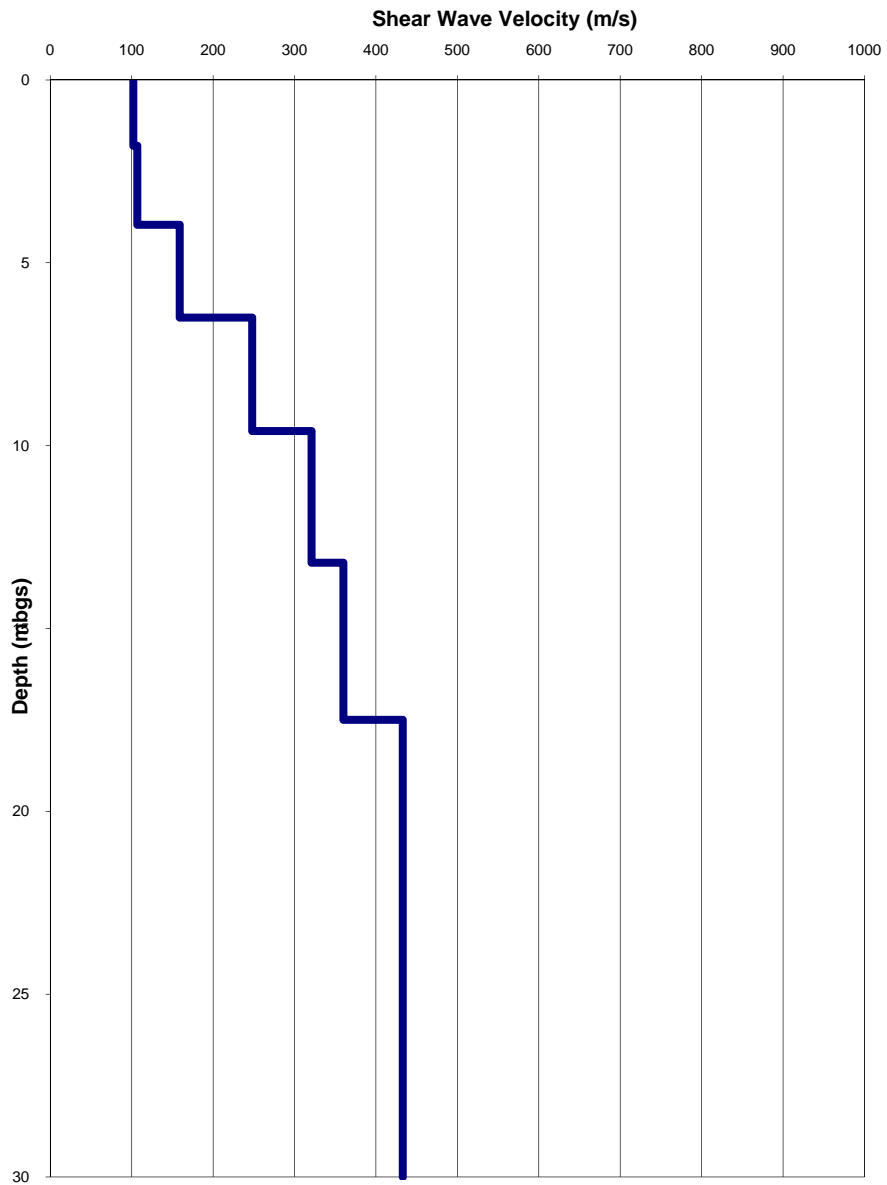
Figure 6: MASW Modelled Shear Wave Velocity Depth profile for MASW Line 2.

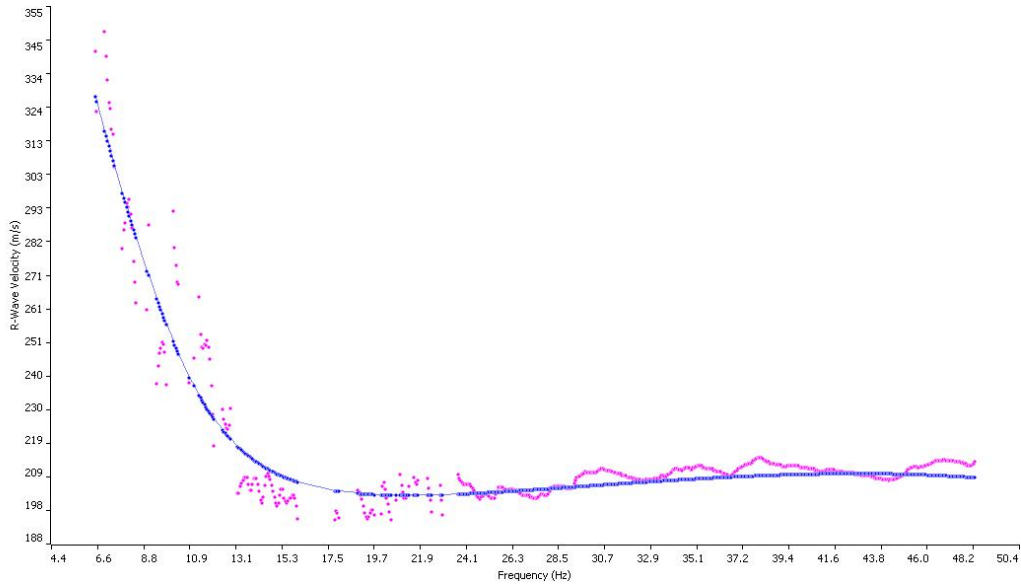
Figure 7: Comparison of Field (pink dots) vs. Modelled Data (blue dots) for the MASW Line 1.

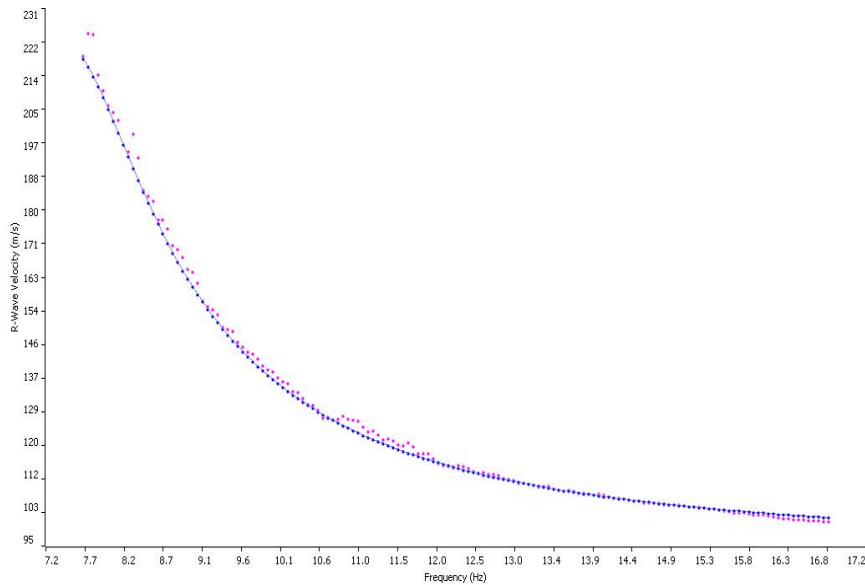
Figure 8: Comparison of Field (pink dots) vs. Modelled Data (blue dots) for the MASW Line 2.
