Geotechnical Investigation

Carp Airport Servicing and Residential Development – Phase 1

Carp Road
(Carp) Ottawa, Ontario

Report PG2450-2, Revision 1, dated January 16, 2023

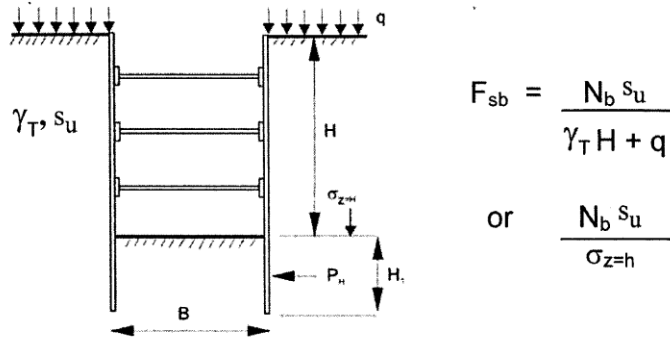
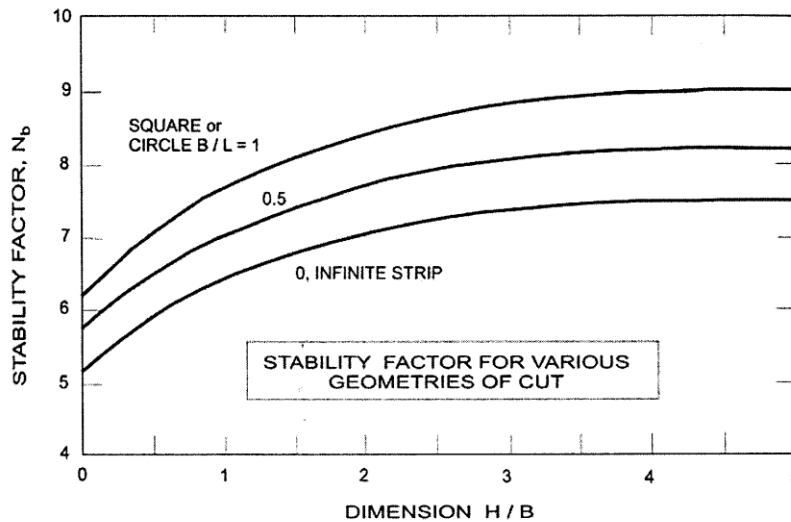
Figure 1 - Stability Factor for Various Geometries of Cut

In the case of soft to firm clays, **a factor of safety of 2 is recommended** for base stability.

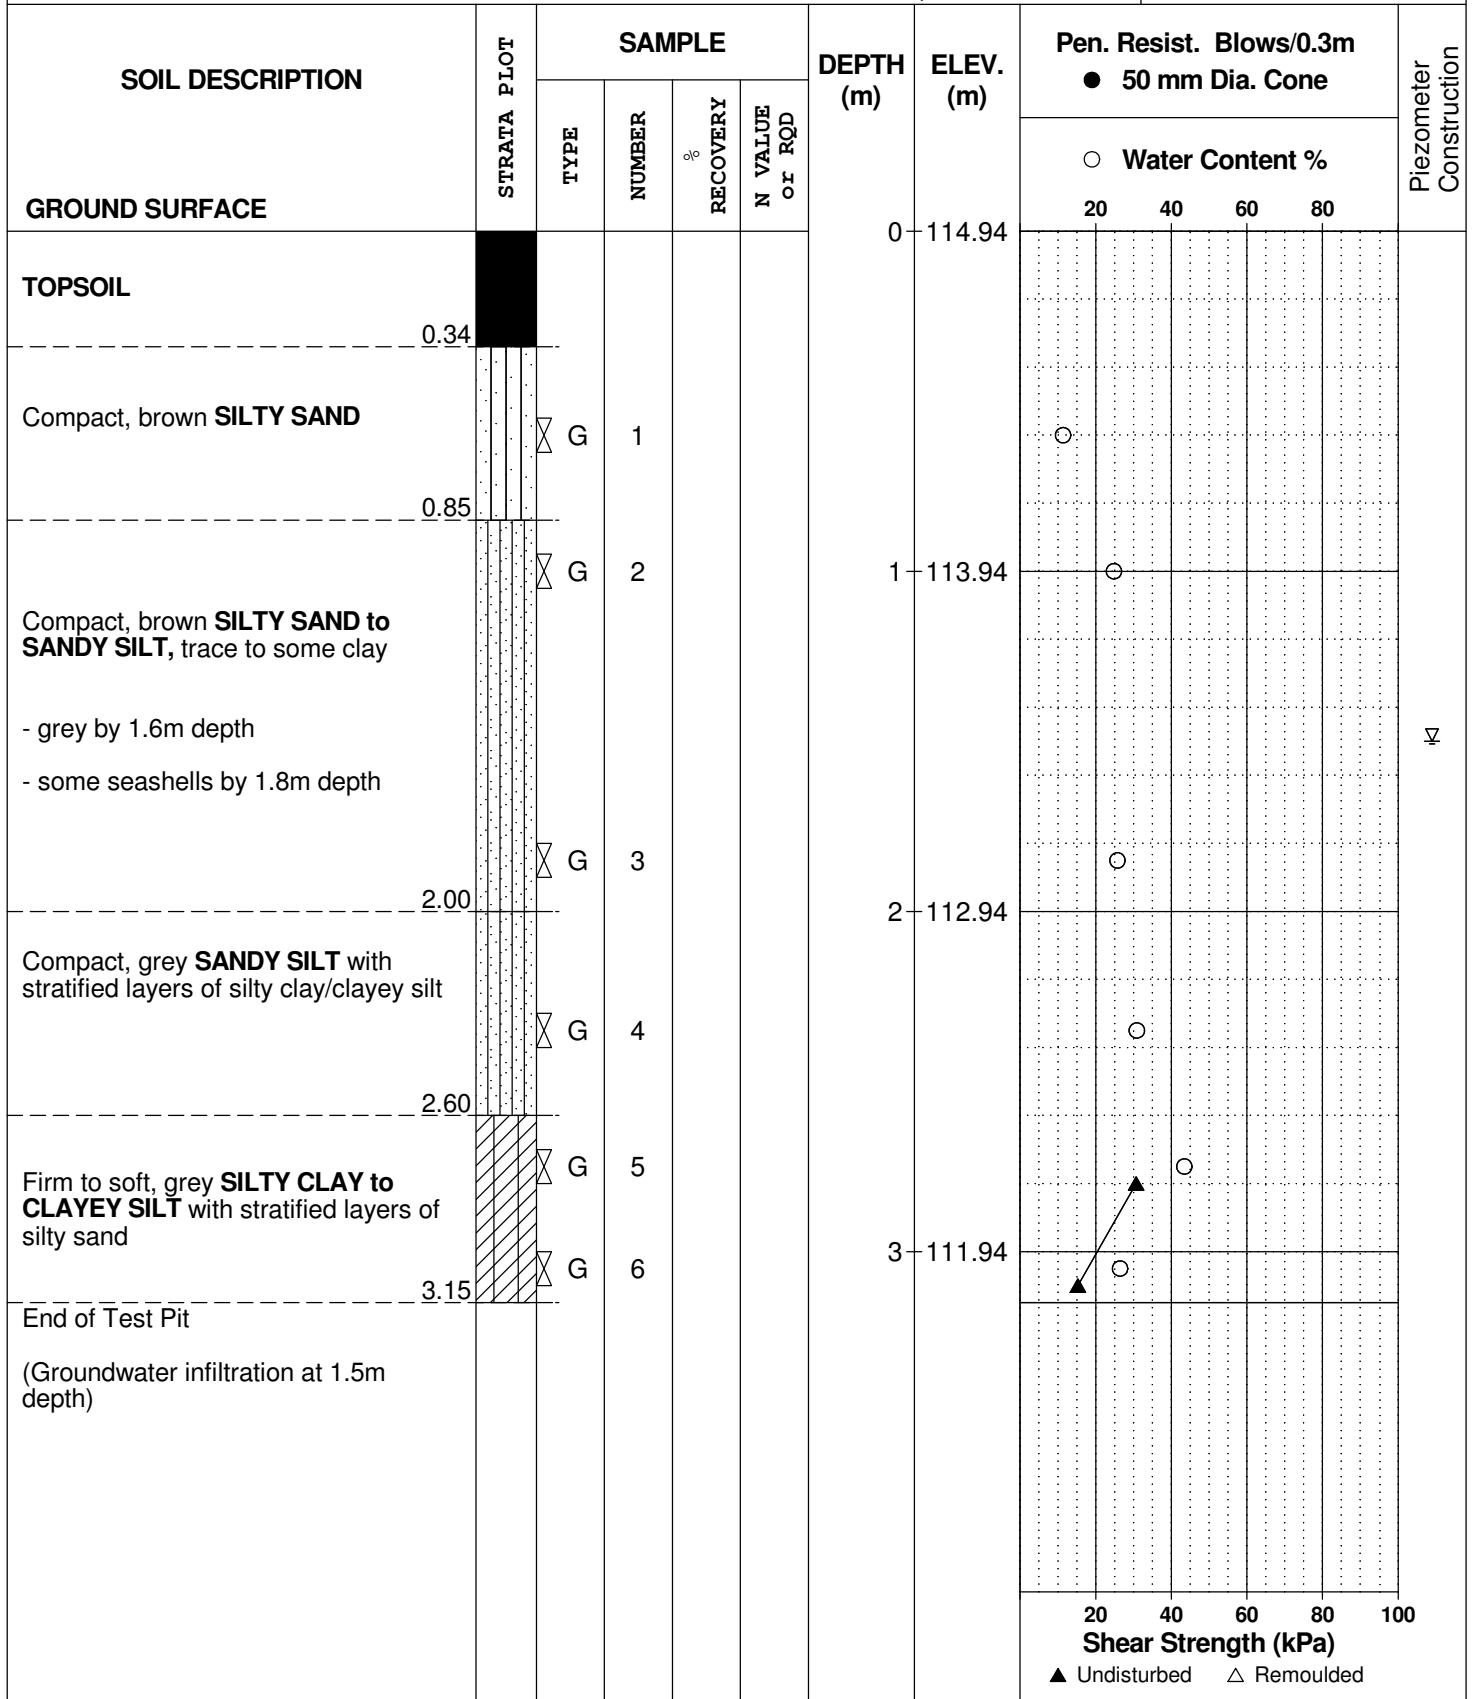
HOLE NO.
TP 2-22

SOIL DESCRIPTION	STRATA PLOT	SAMPLE				DEPTH (m)	ELEV. (m)	Pen. Resist. Blows/0.3m ● 50 mm Dia. Cone				Piezometer Construction
		TYPE	NUMBER	RECOVERY %	N VALUE or RQD			○ Water Content %				
GROUND SURFACE						0	116.59	20	40	60	80	
TOPSOIL												
	0.28											
Loose to compact, brown SILTY SAND		△ G	1			1	115.59					▽
	2.00											
Loose to compact, grey SILTY SAND to SANDY SILT - some seashells by 1.9m depth - stratified layers of silty clay/clayey silt by 2.8m depth		△ G	3			2	114.59					
	3.00											
End of Test Pit (Groundwater infiltration at 1.3m depth)		△ G	5			3	113.59					
								20	40	60	80	100
								Shear Strength (kPa)				
								▲ Undisturbed △ Remoulded

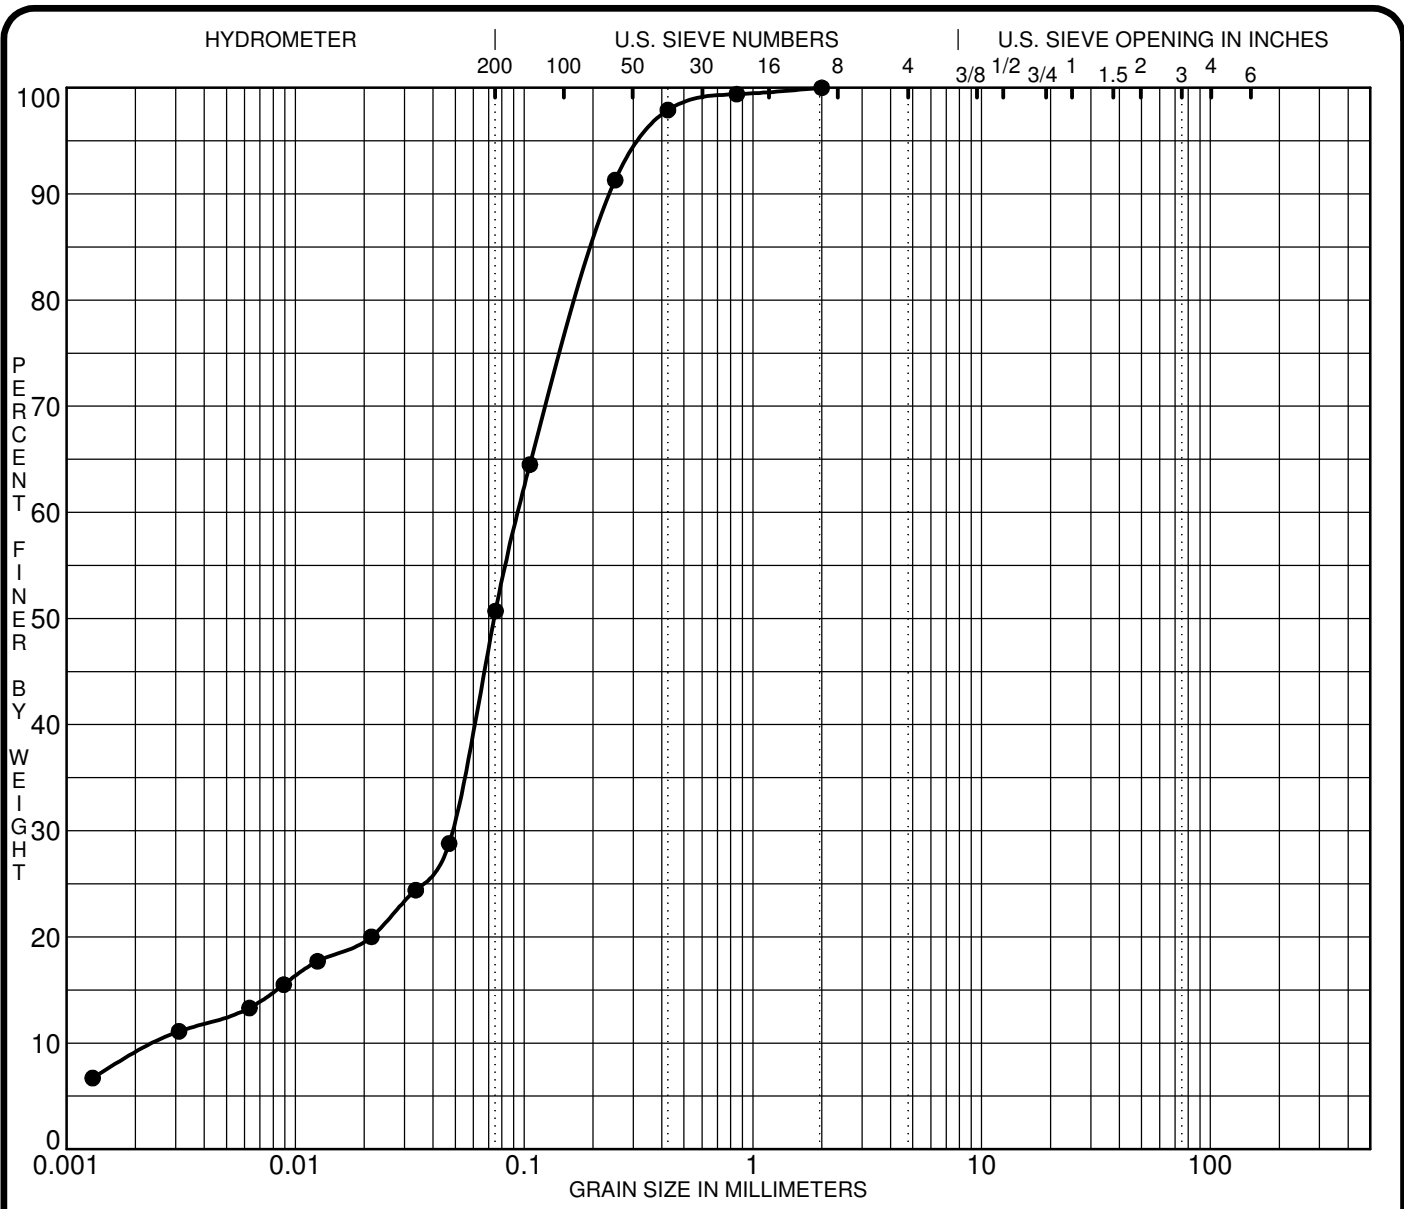
GRAIN SIZE DISTRIBUTION

Specimen Identification	Classification					MC%	LL	PL	PI	Cc	Cu
● TP 5-22 G5	Silty Sand to Sandy Silt					22.2				9.84	38.0
☒											
▲											
★											
Specimen Identification	D100	D60	D30	D10	%Gravel	%Sand	%Silt	%Clay			
● TP 5-22 G5	2.00	0.09	0.048	0.0025	0.0	49.3	41.2	9.5			
☒											
▲											
★

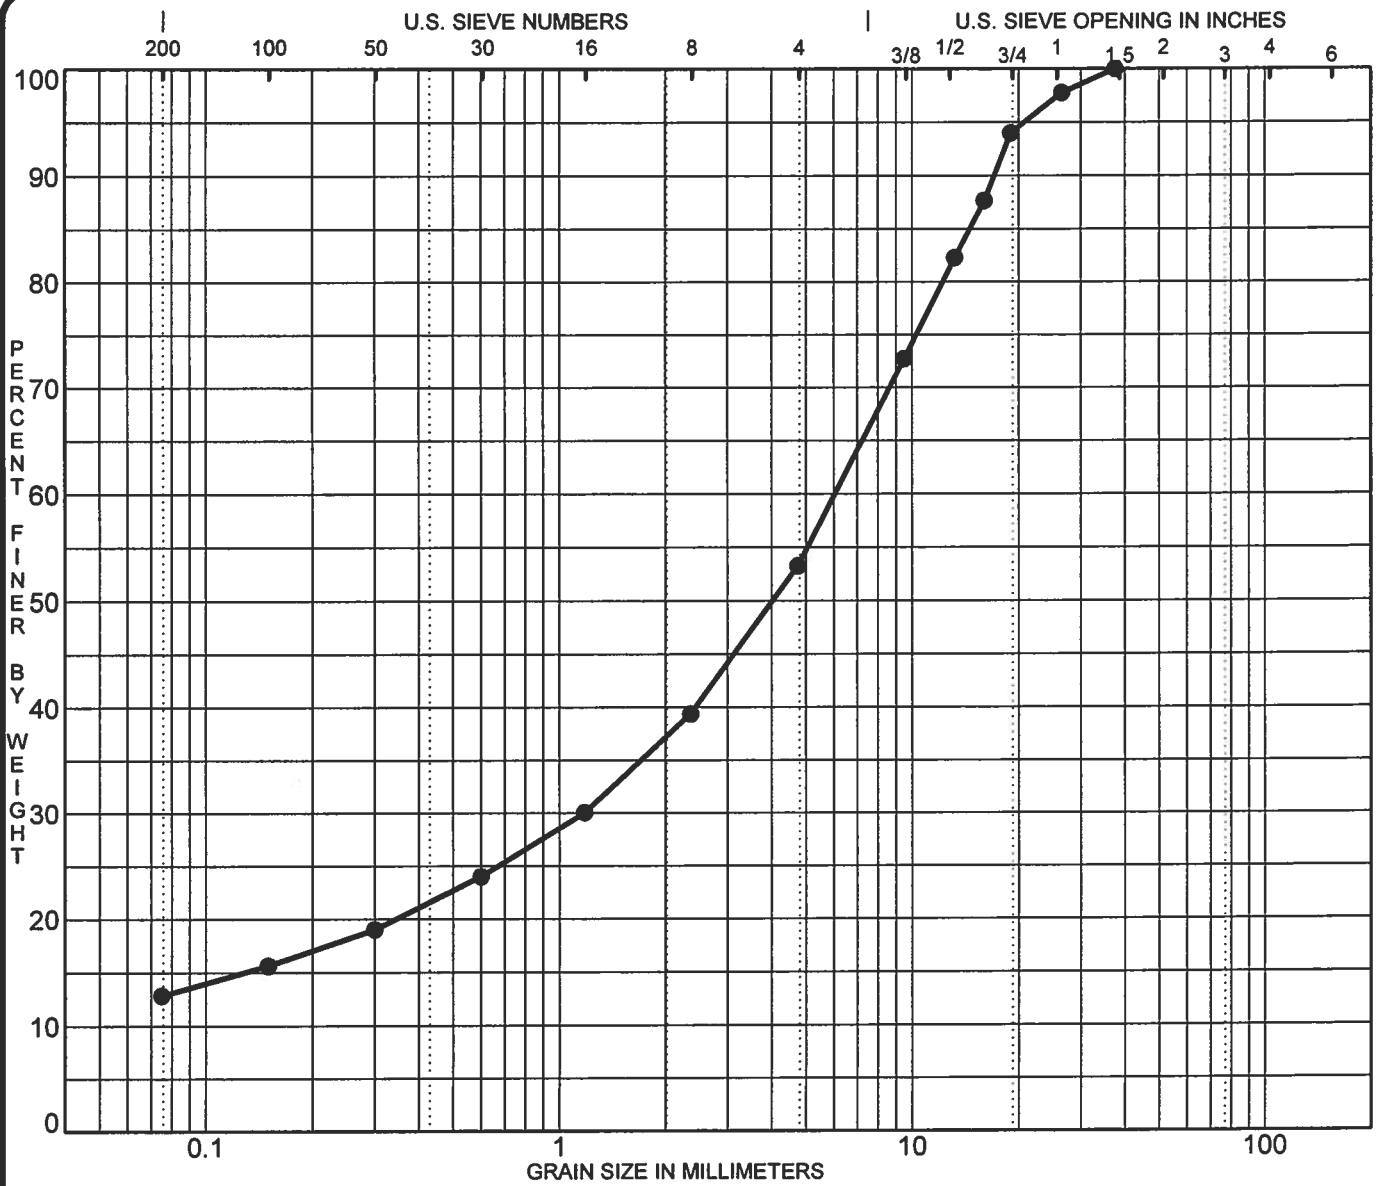
GRAIN SIZE DISTRIBUTION

Specimen Identification	Classification				MC%	LL	PL	PI	Cc	Cu
● BH 2-11 AU 1	Granular crushed stone with silty sand									
☒										
▲										
★	Based on ASTM D 2487									
Specimen Identification	D100	D60	D30	D10	%Gravel	%Sand	%Silt	%Clay		
● BH 2-11 AU 1	37.50	6.04	1.174		46.7	40.4	12.8			
☒										
▲										
★

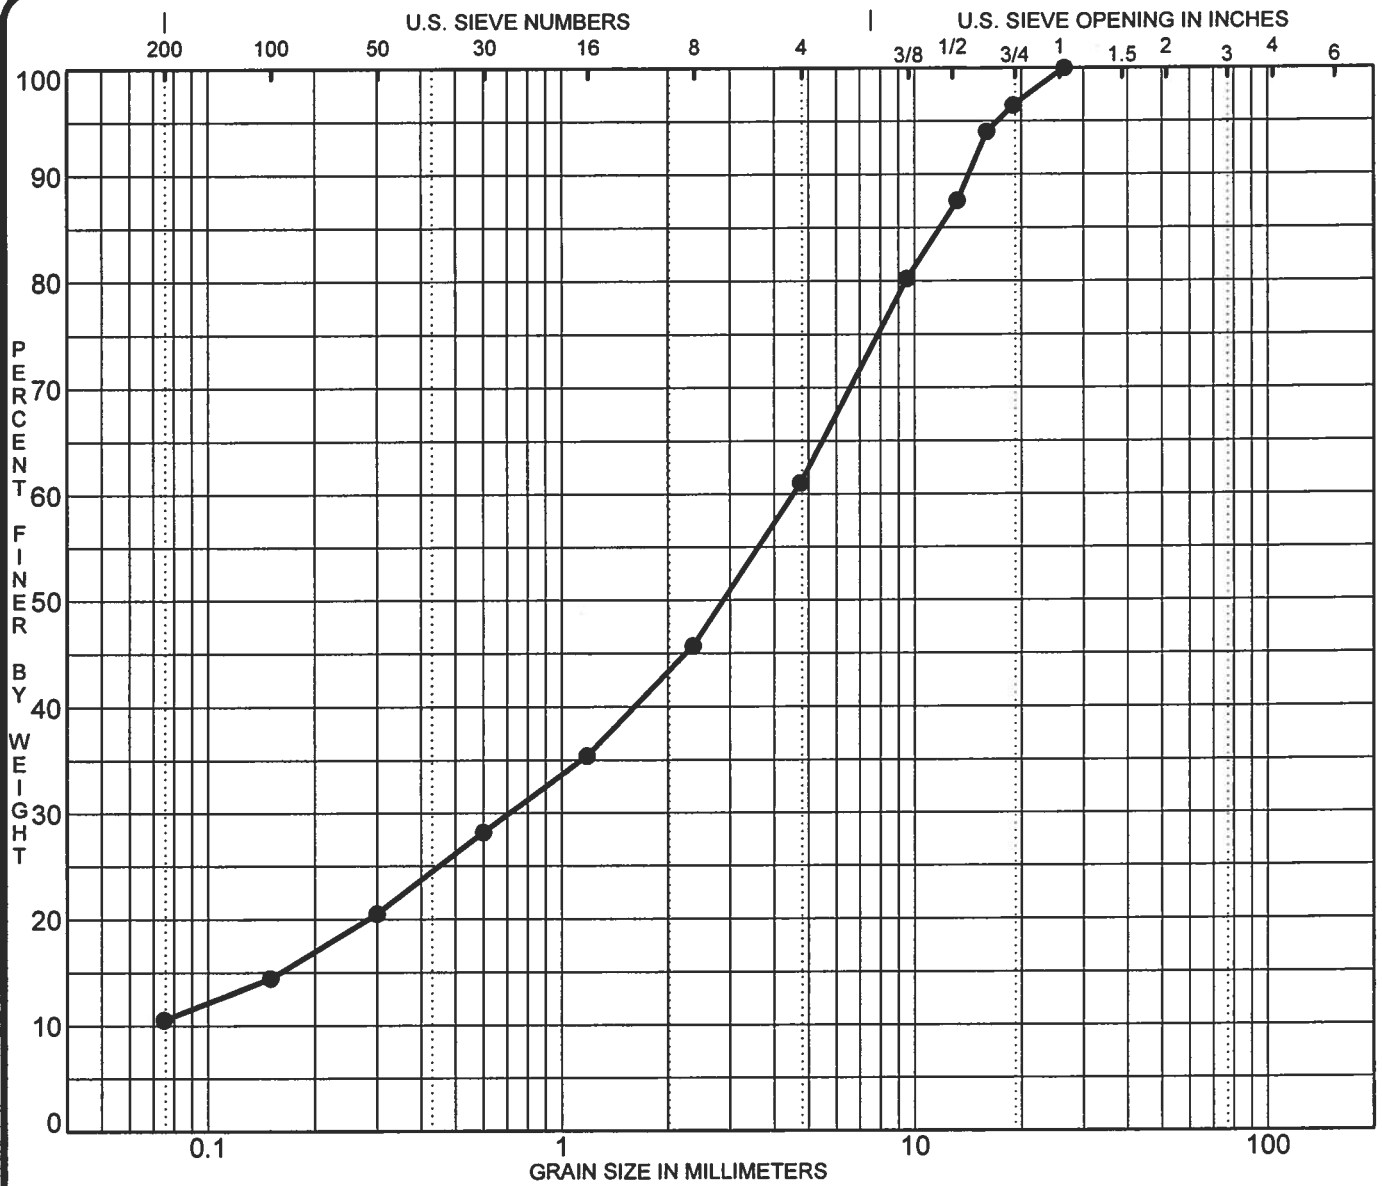
GRAIN SIZE DISTRIBUTION

Specimen Identification	Classification				MC%	LL	PL	PI	Cc	Cu
● BH26-11 AU 1	Silty sand with granular crushed stone								1.64	66.3
☒										
▲										
★	Based on ASTM D 2487									
Specimen Identification	D100	D60	D30	D10	%Gravel	%Sand	%Silt	%Clay		
● BH26-11 AU 1	26.50	4.53	0.712		39.0	50.5	10.5			
☒										
▲										
★

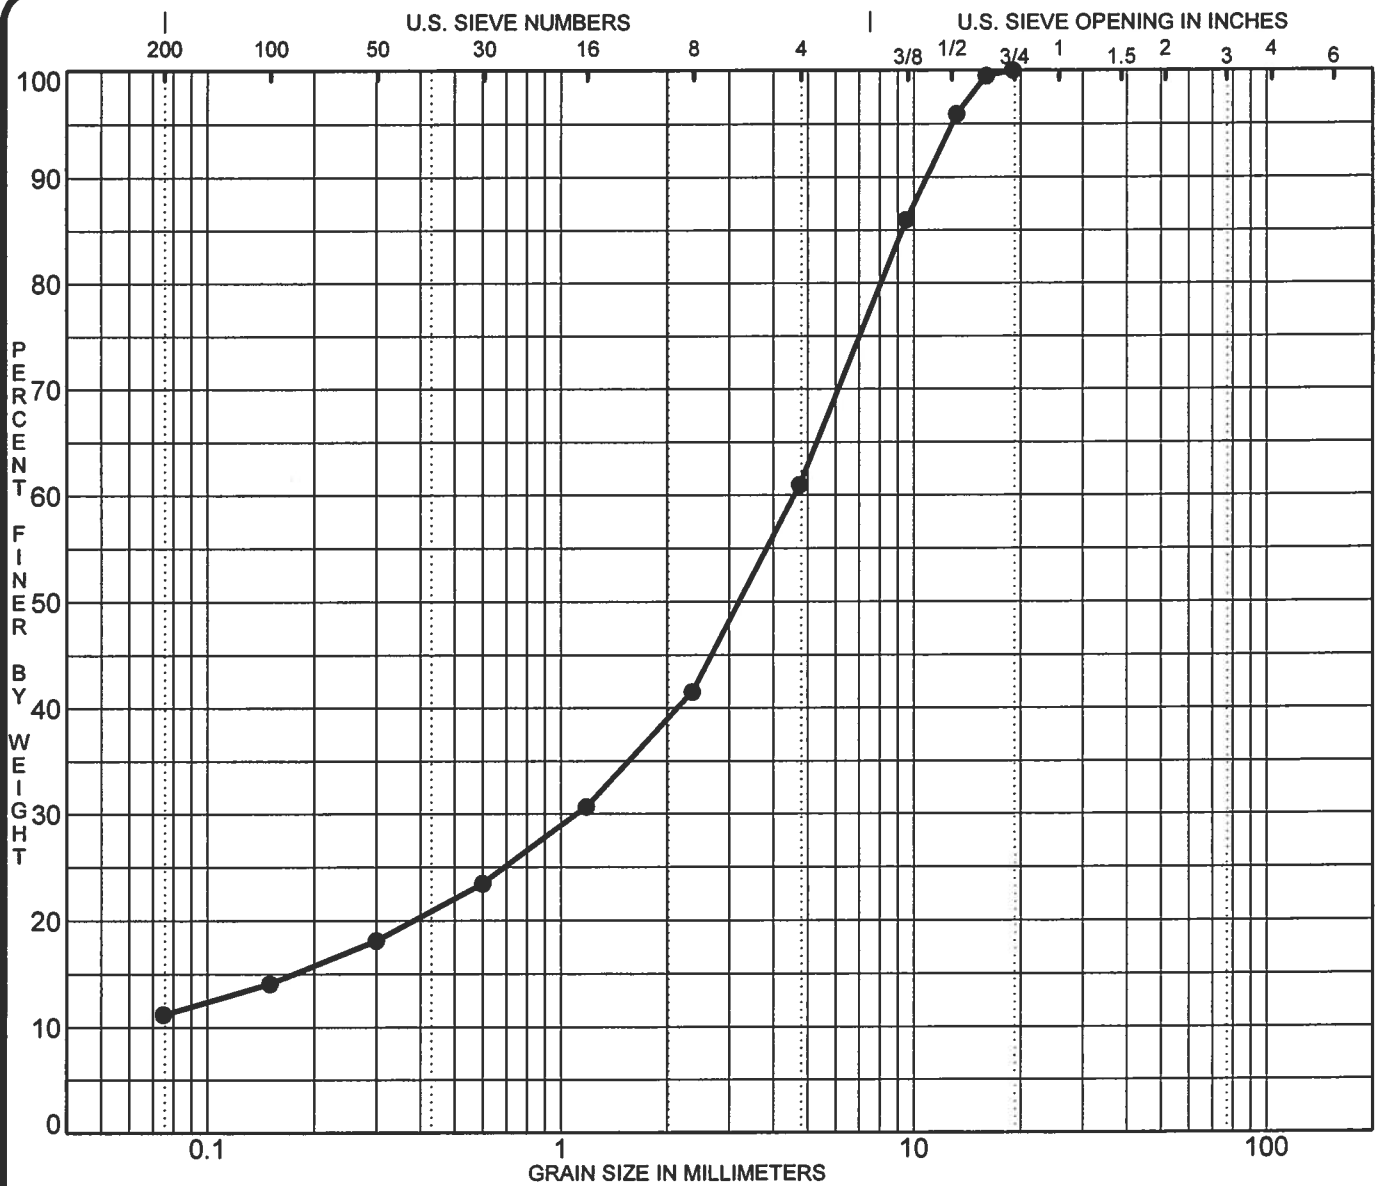
GRAIN SIZE DISTRIBUTION

Specimen Identification	Classification				MC%	LL	PL	PI	Cc	Cu
● BH37-11 AU 1	Silty sand with granular crushed stone								4.77	81.7
☒										
▲										
★	Based on ASTM D 2487									
Specimen Identification	D100	D60	D30	D10	%Gravel	%Sand	%Silt	%Clay		
● BH37-11 AU 1	19.00	4.59	1.108		39.0	49.8	11.2			
☒										
▲										
★

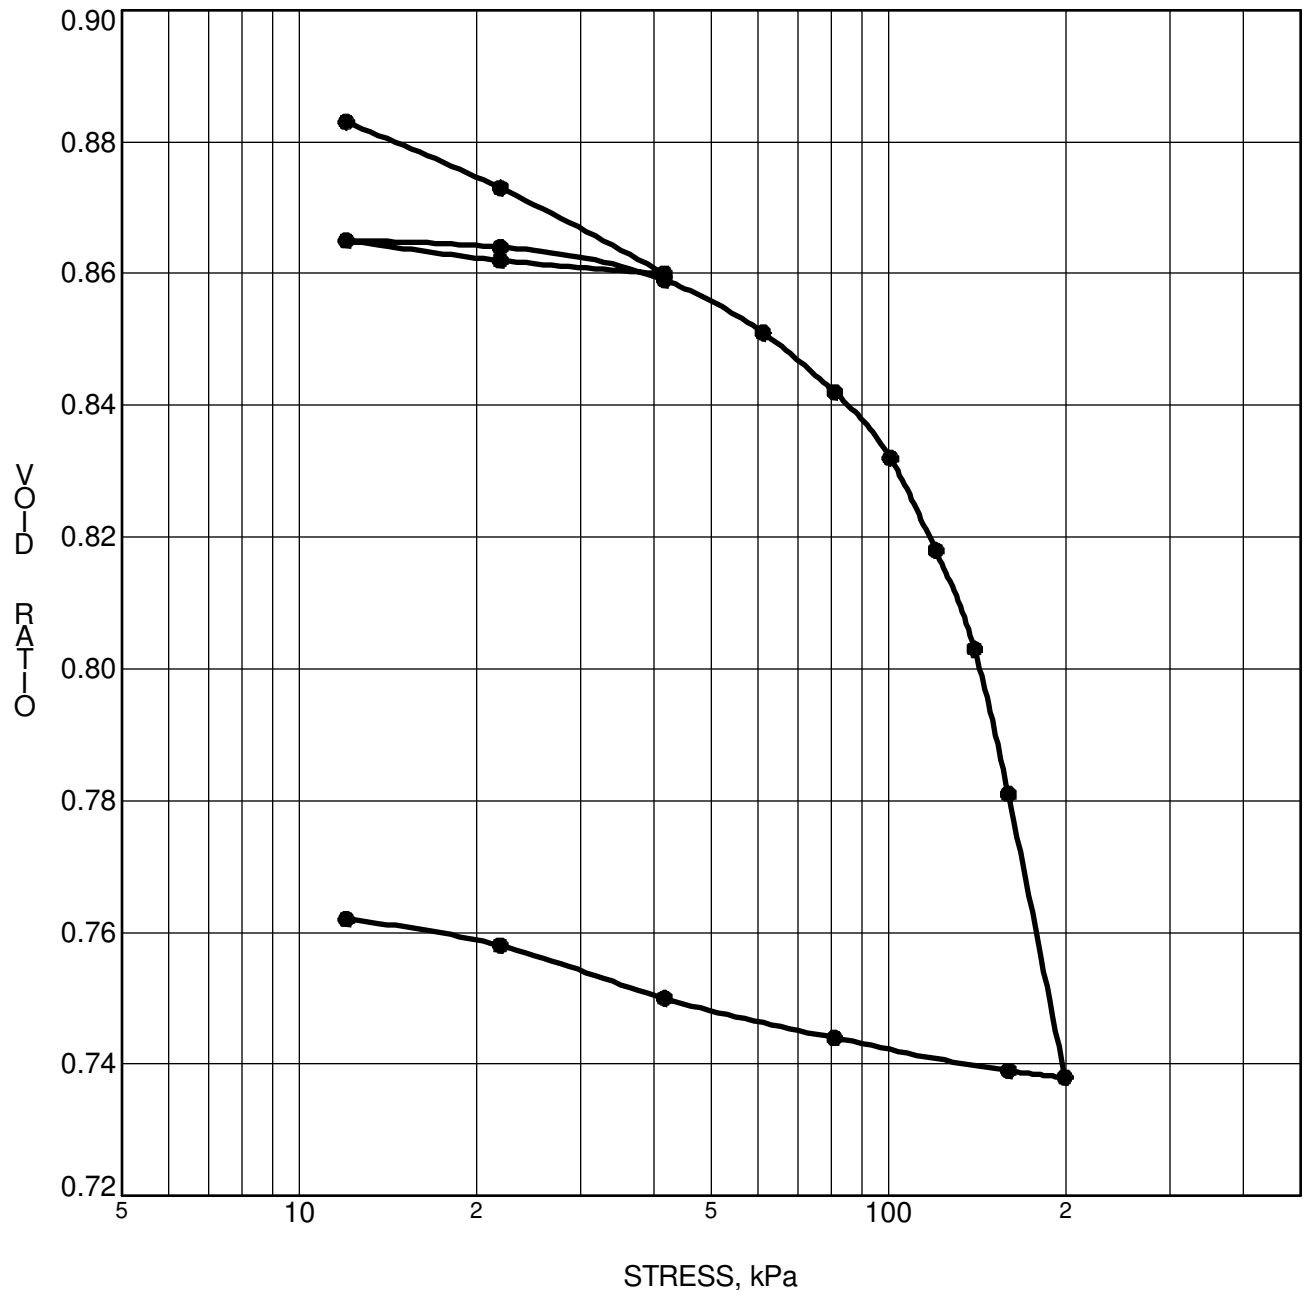
CONSOLIDATION TEST DATA SUMMARY					
Borehole No.	BH41-13	p'_o	52 kPa	C_{cr}	0.011
Sample No.	TW5	p'_c	112 kPa	C_c	0.412
Sample Depth	5.00 m	OC Ratio	2.2	W_o	32.6 %
Sample Elev.	111.13 m	Void Ratio	0.762	Unit Wt.	18.0 kN/m³

**CONSOLIDATION
 TEST**

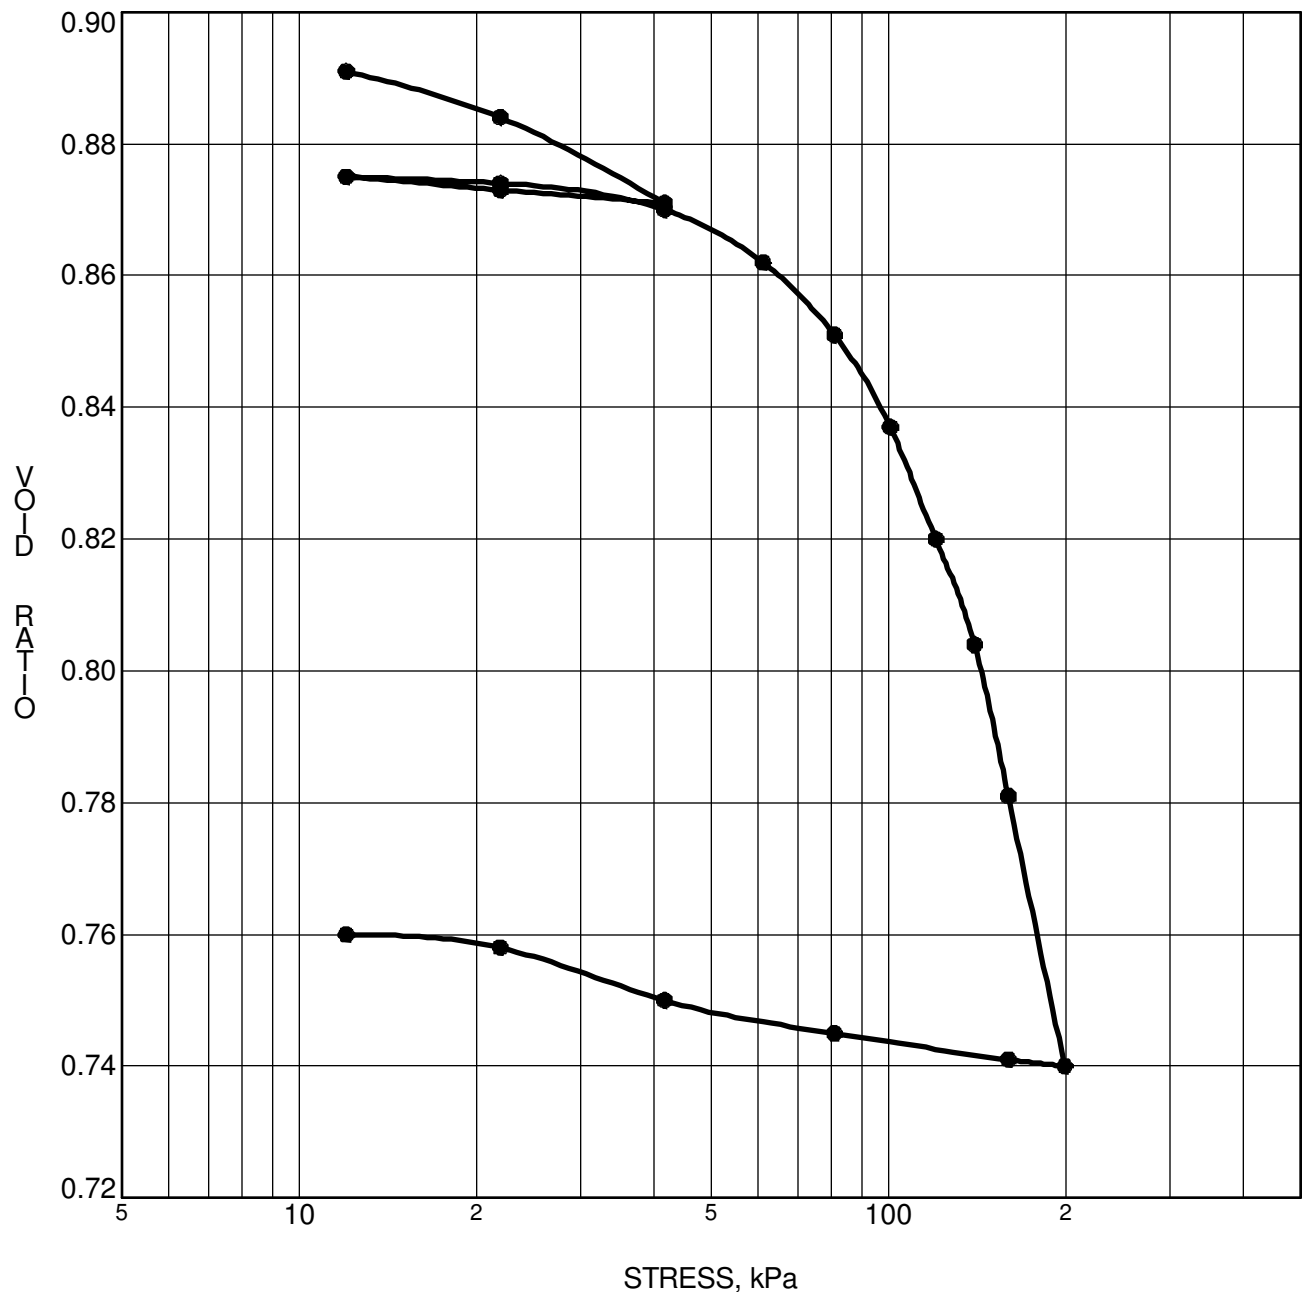
CONSOLIDATION TEST DATA SUMMARY					
Borehole No.	BH42-13	p'_o	57 kPa	C_{cr}	0.009
Sample No.	TW 6	p'_c	97 kPa	C_c	0.370
Sample Depth	5.03 m	OC Ratio	1.7	W_o	32.9 %
Sample Elev.	109.92 m	Void Ratio	0.905	Unit Wt.	18.0 kN/m³

**CONSOLIDATION
 TEST**

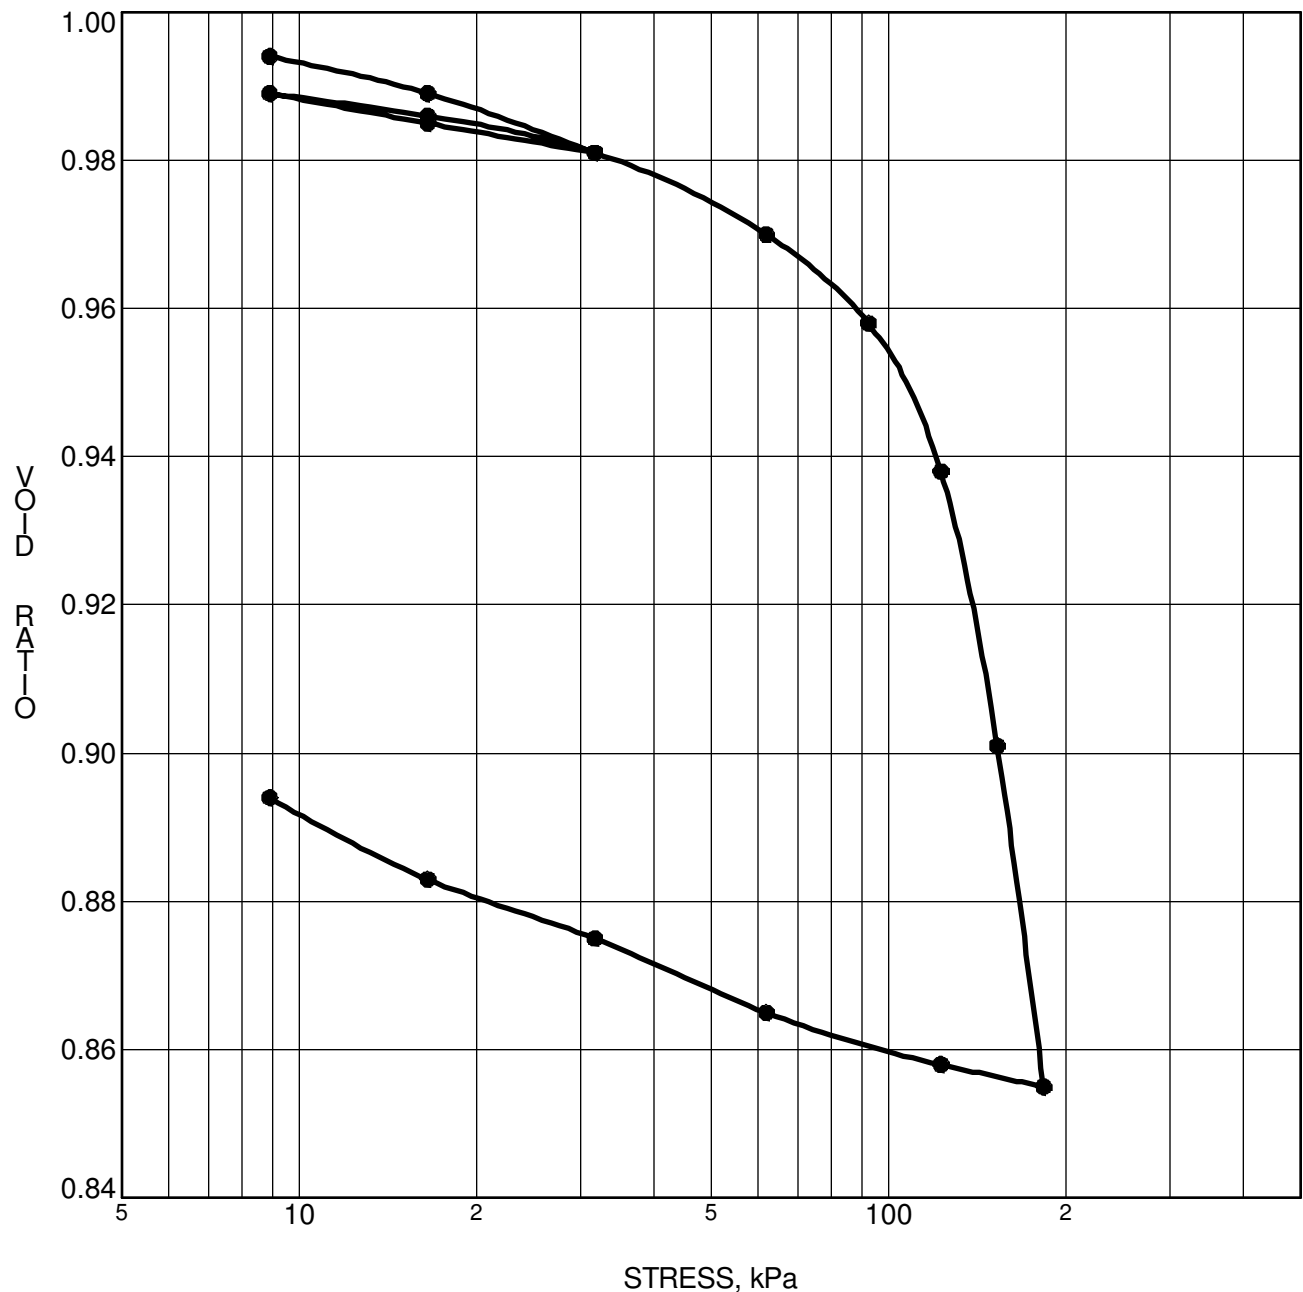
CONSOLIDATION TEST DATA SUMMARY					
Borehole No.	BH43-13	p'_o	56 kPa	C_{cr}	0.016
Sample No.	TW 7	p'_c	104 kPa	C_c	0.390
Sample Depth	5.56 m	OC Ratio	1.9	W_o	36.4 %
Sample Elev.	111.24 m	Void Ratio	1.001	Unit Wt.	18.0 kN/m³

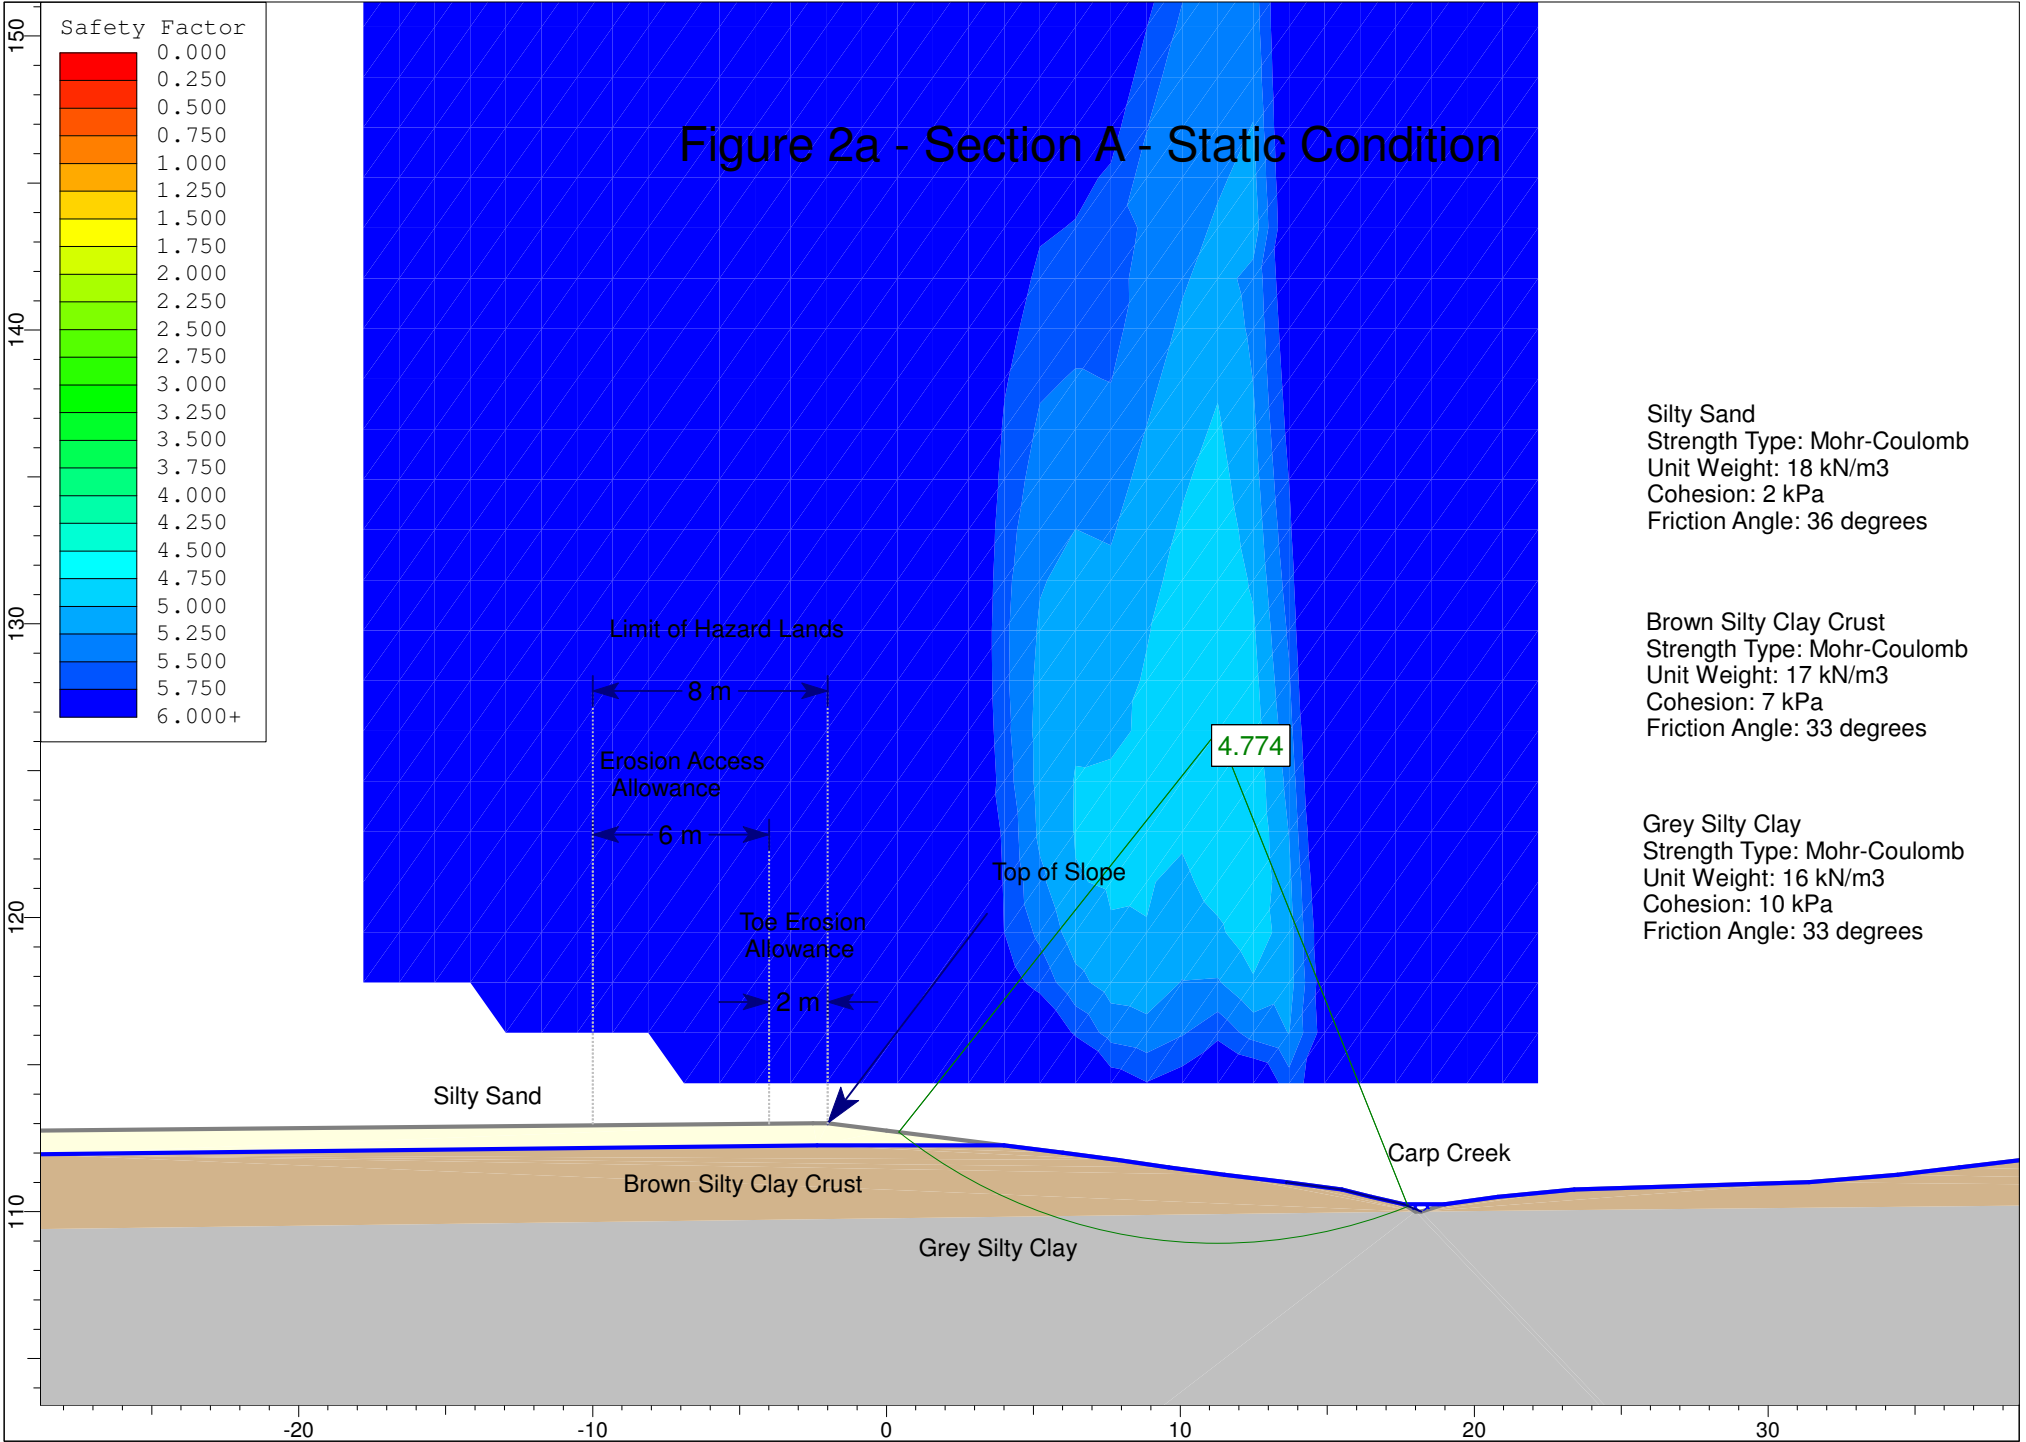
Figure 2a - Section A - Static Condition

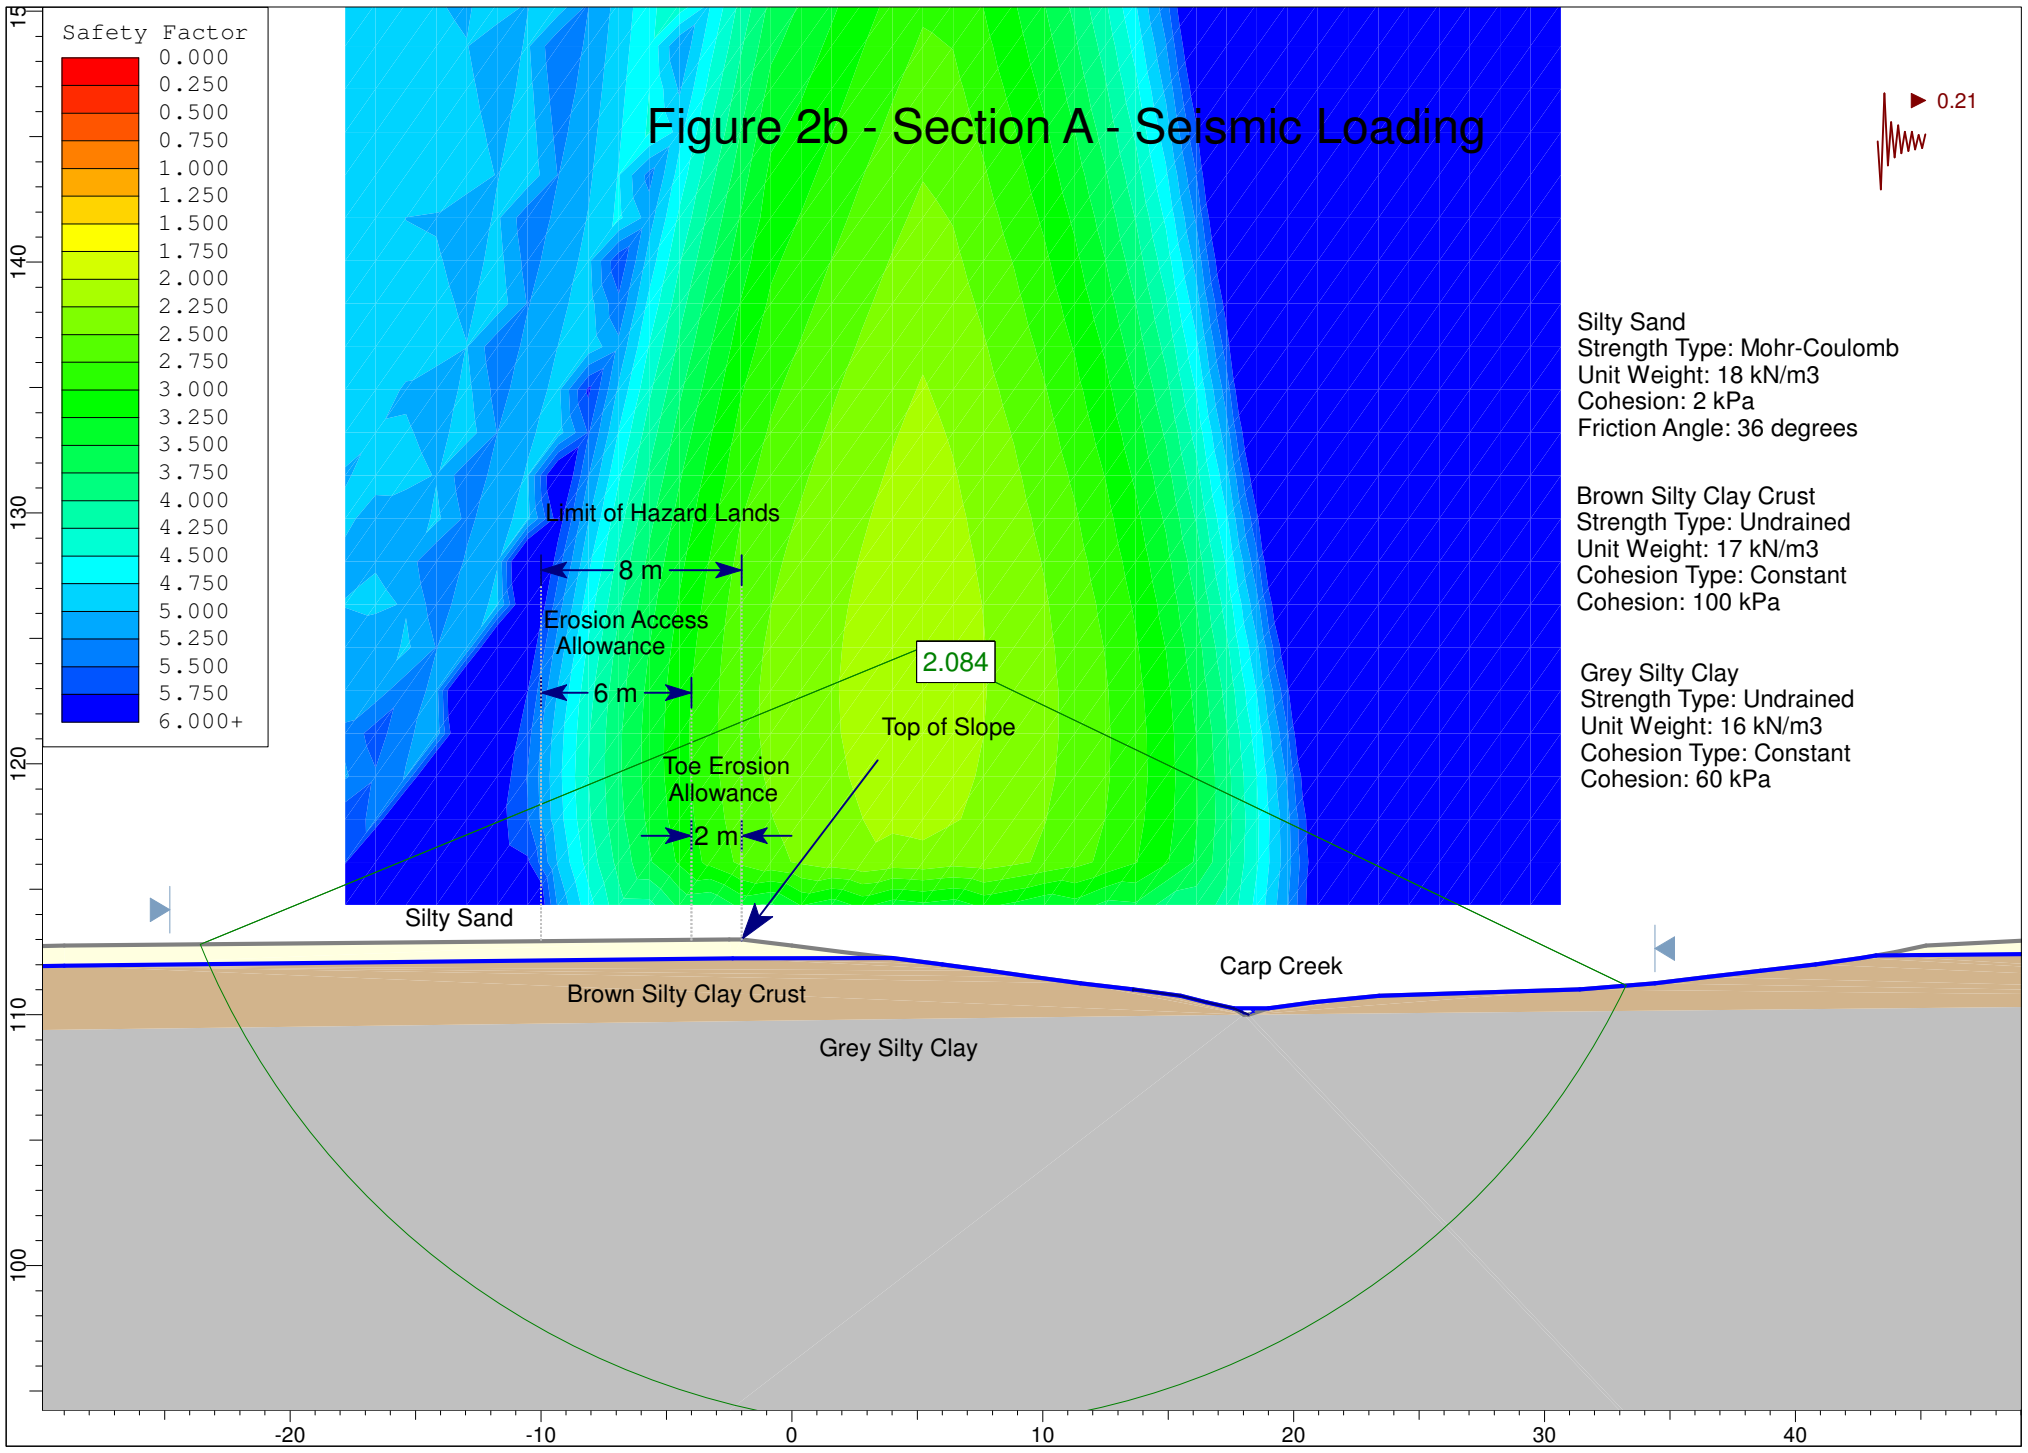
Figure 2b - Section A - Seismic Loading
