Geotechnical Investigation

Carp Airport Servicing and Residential Development – Phase 1

Carp Road
(Carp) Ottawa, Ontario

Report PG2450-2, Revision 1, dated January 16, 2023

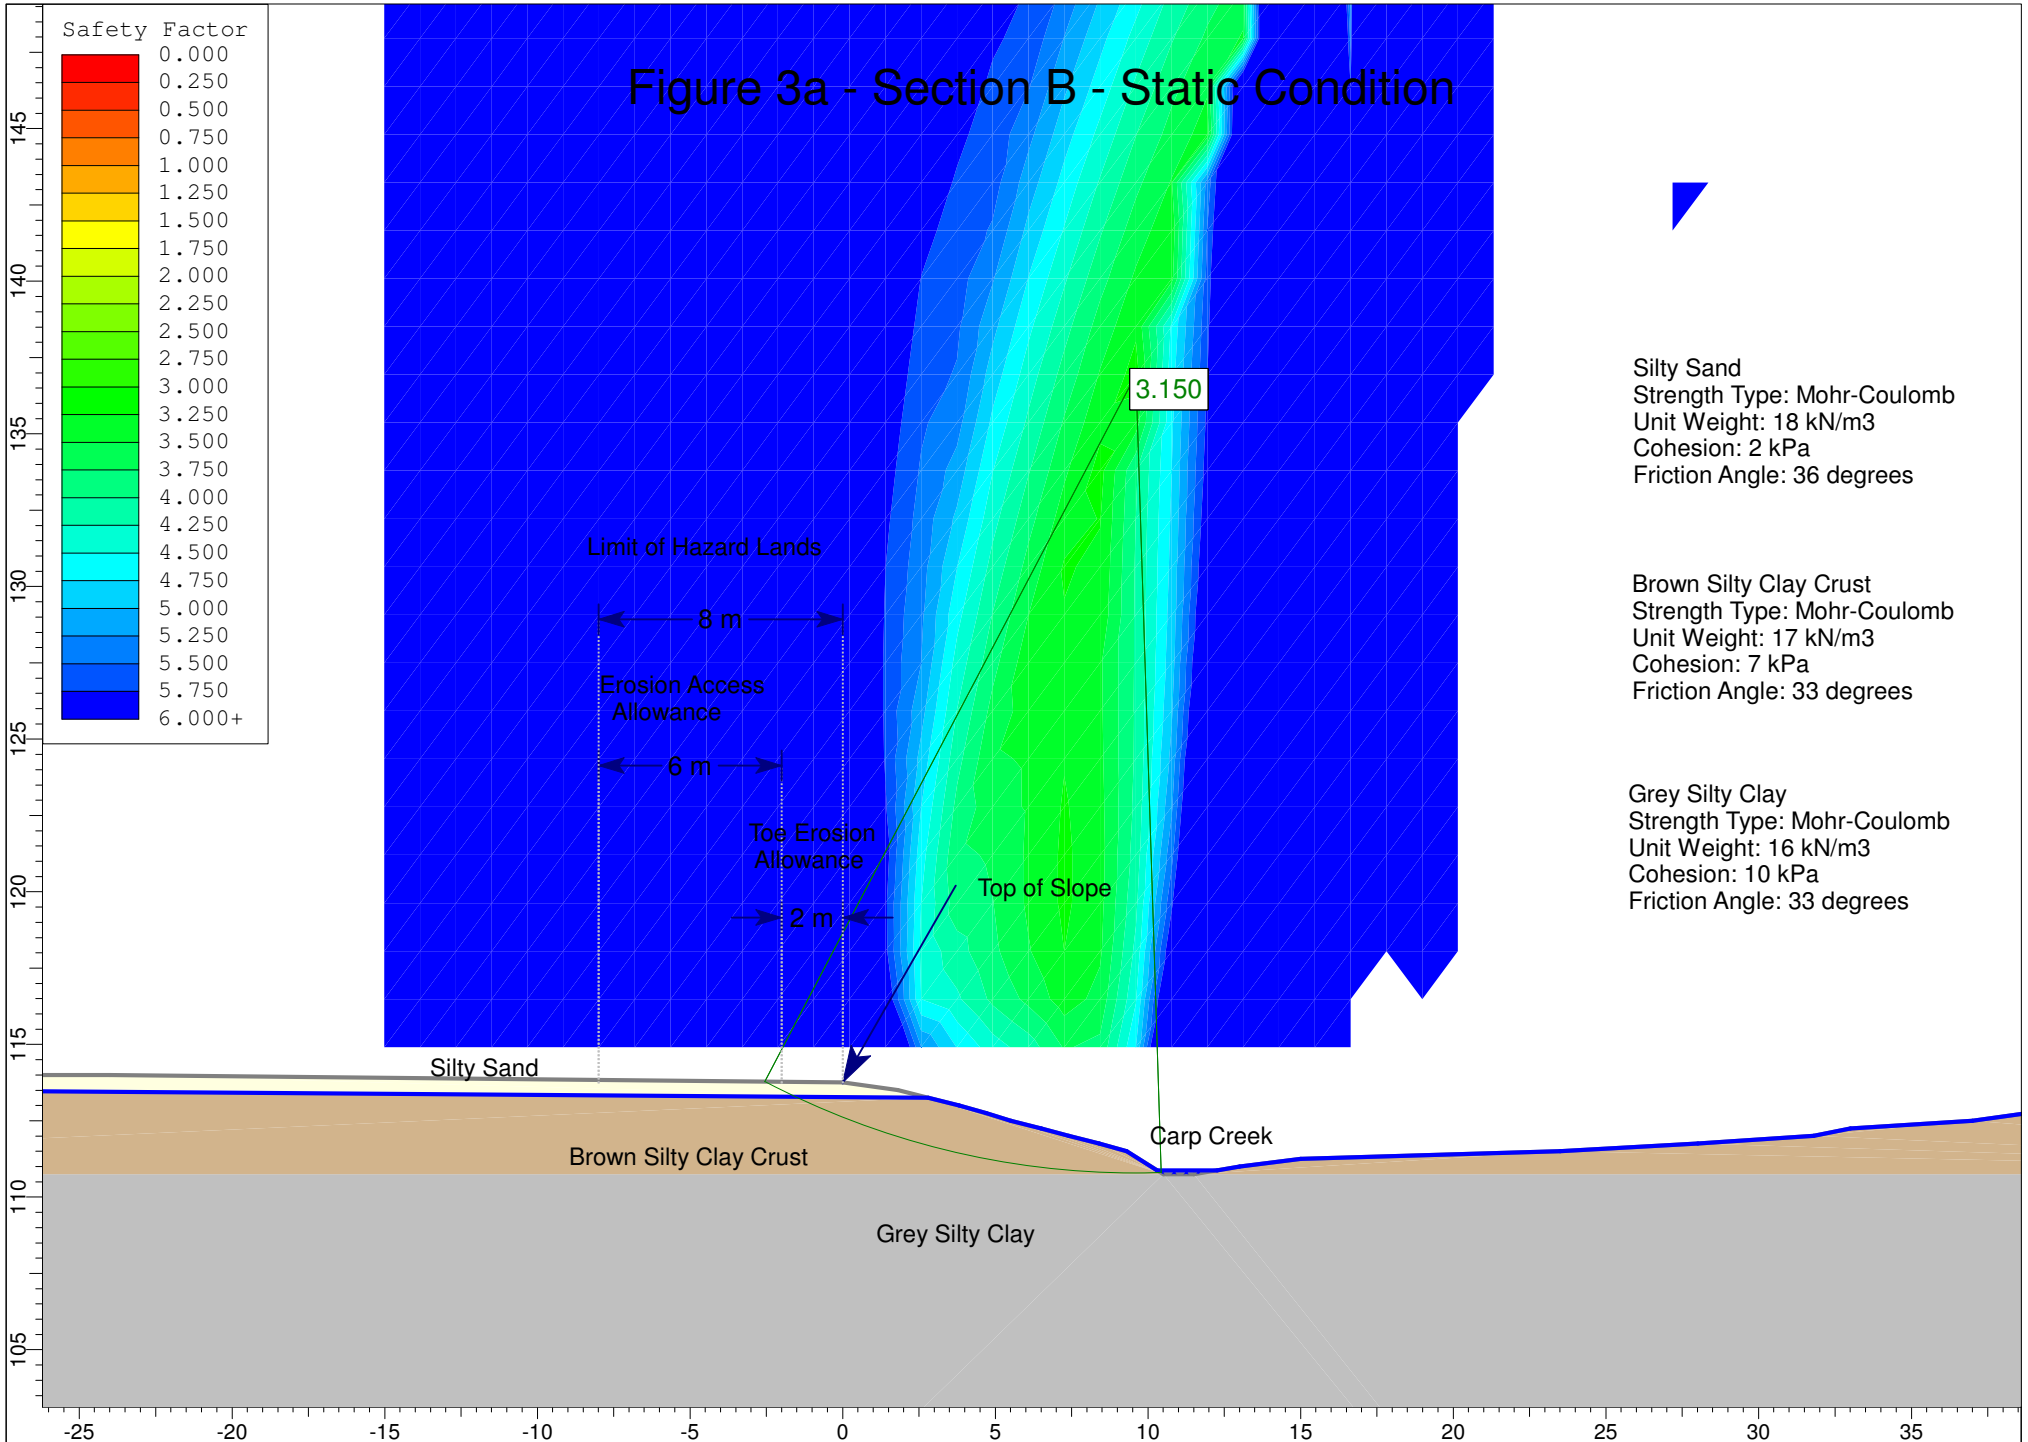
Figure 3a - Section B - Static Condition

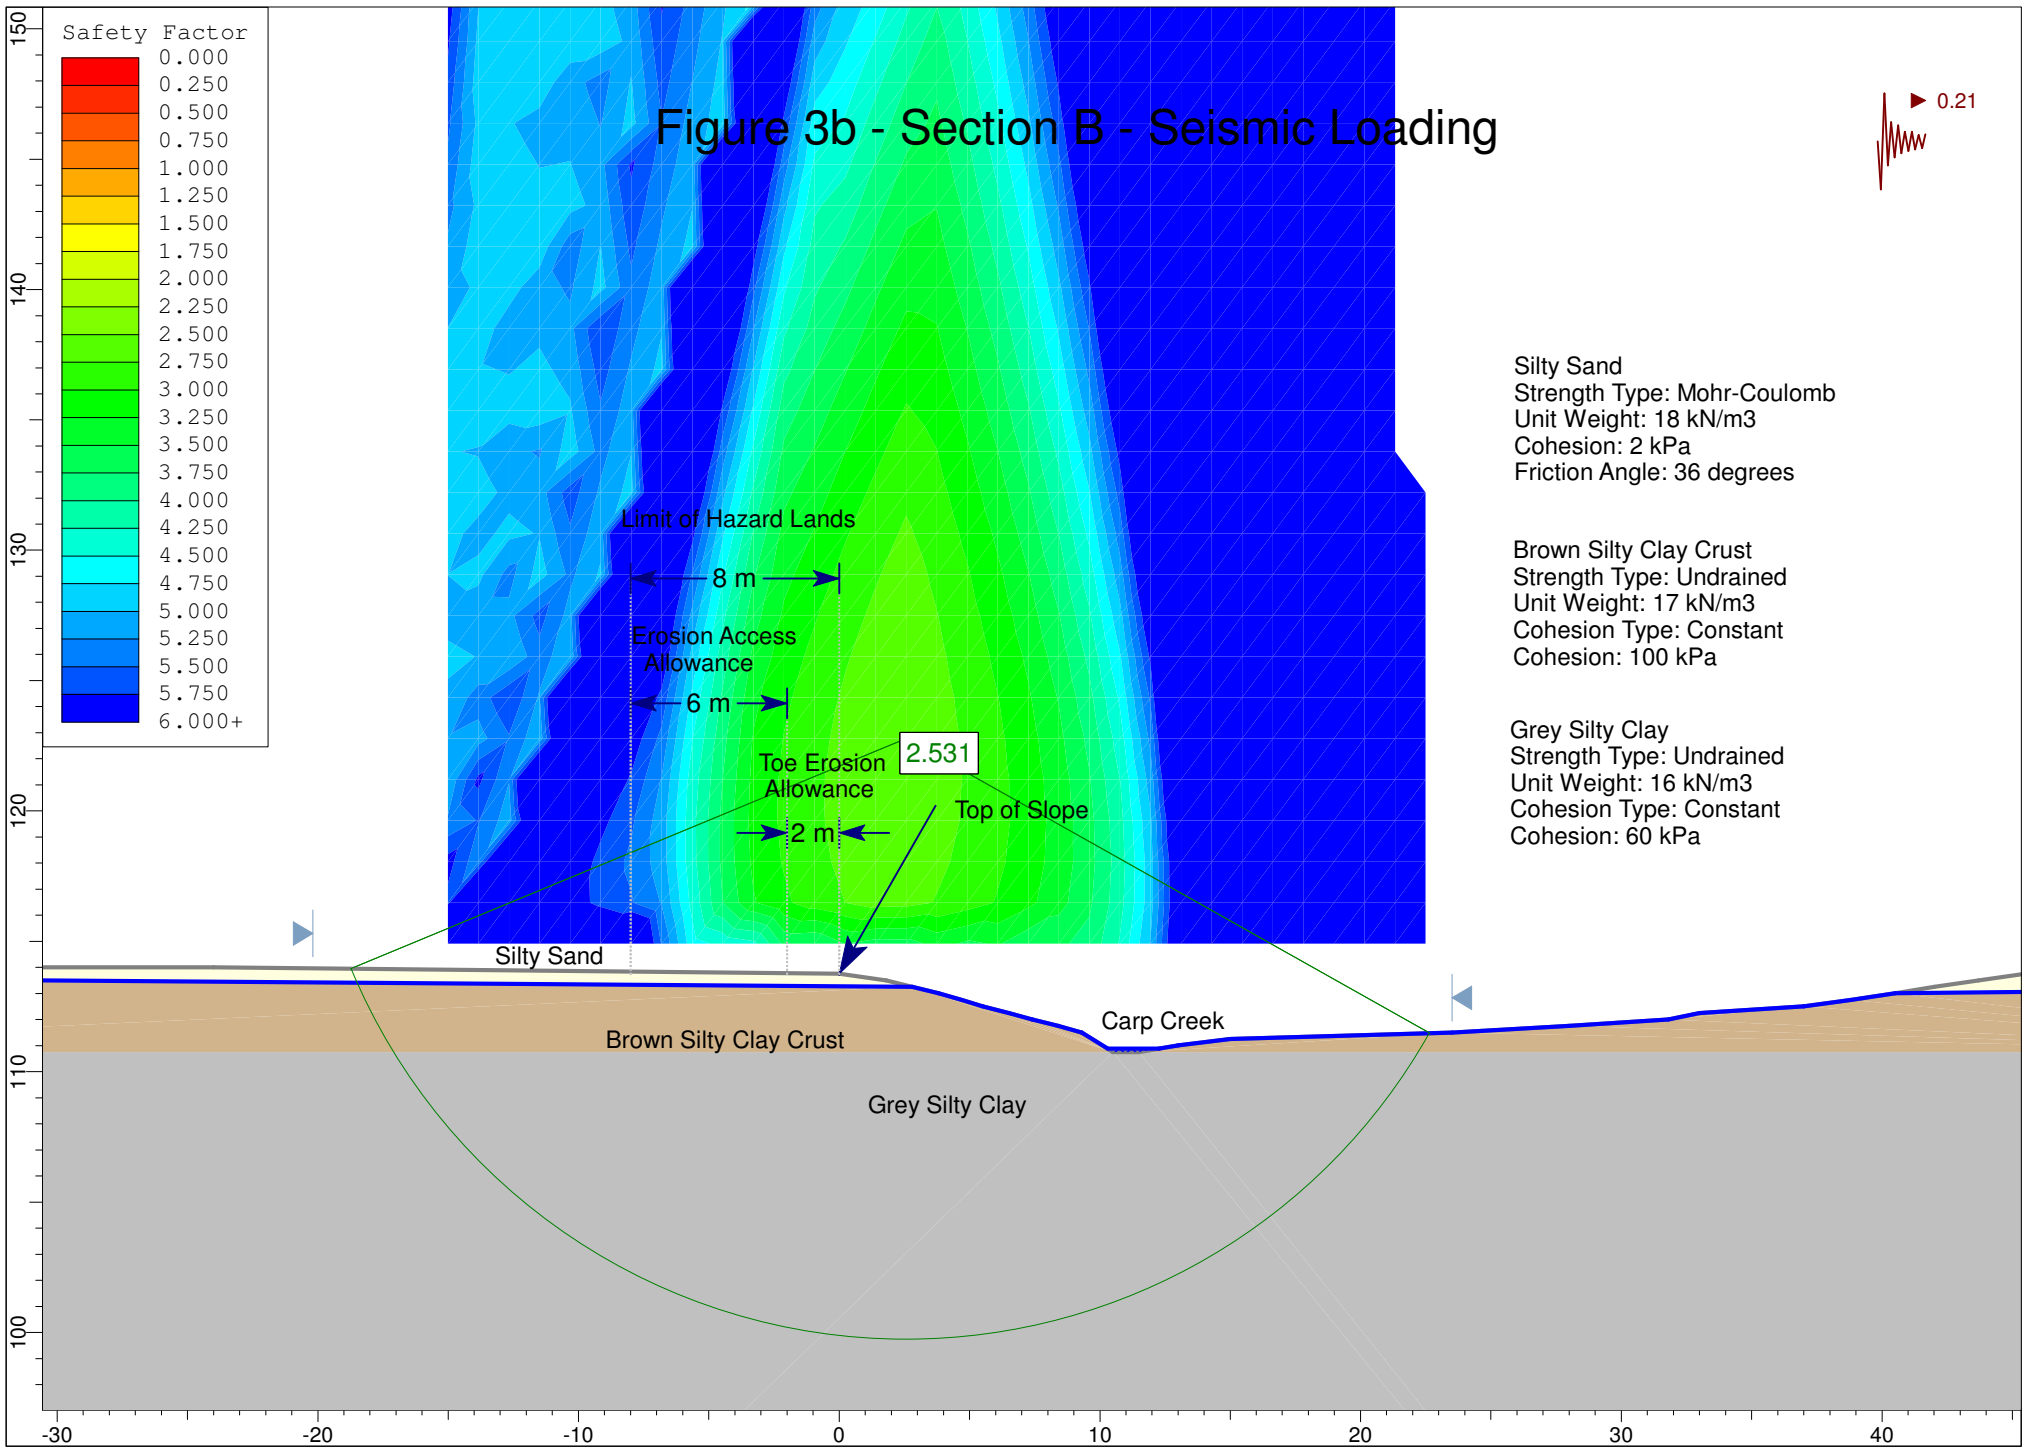
Figure 3b - Section B - Seismic Loading

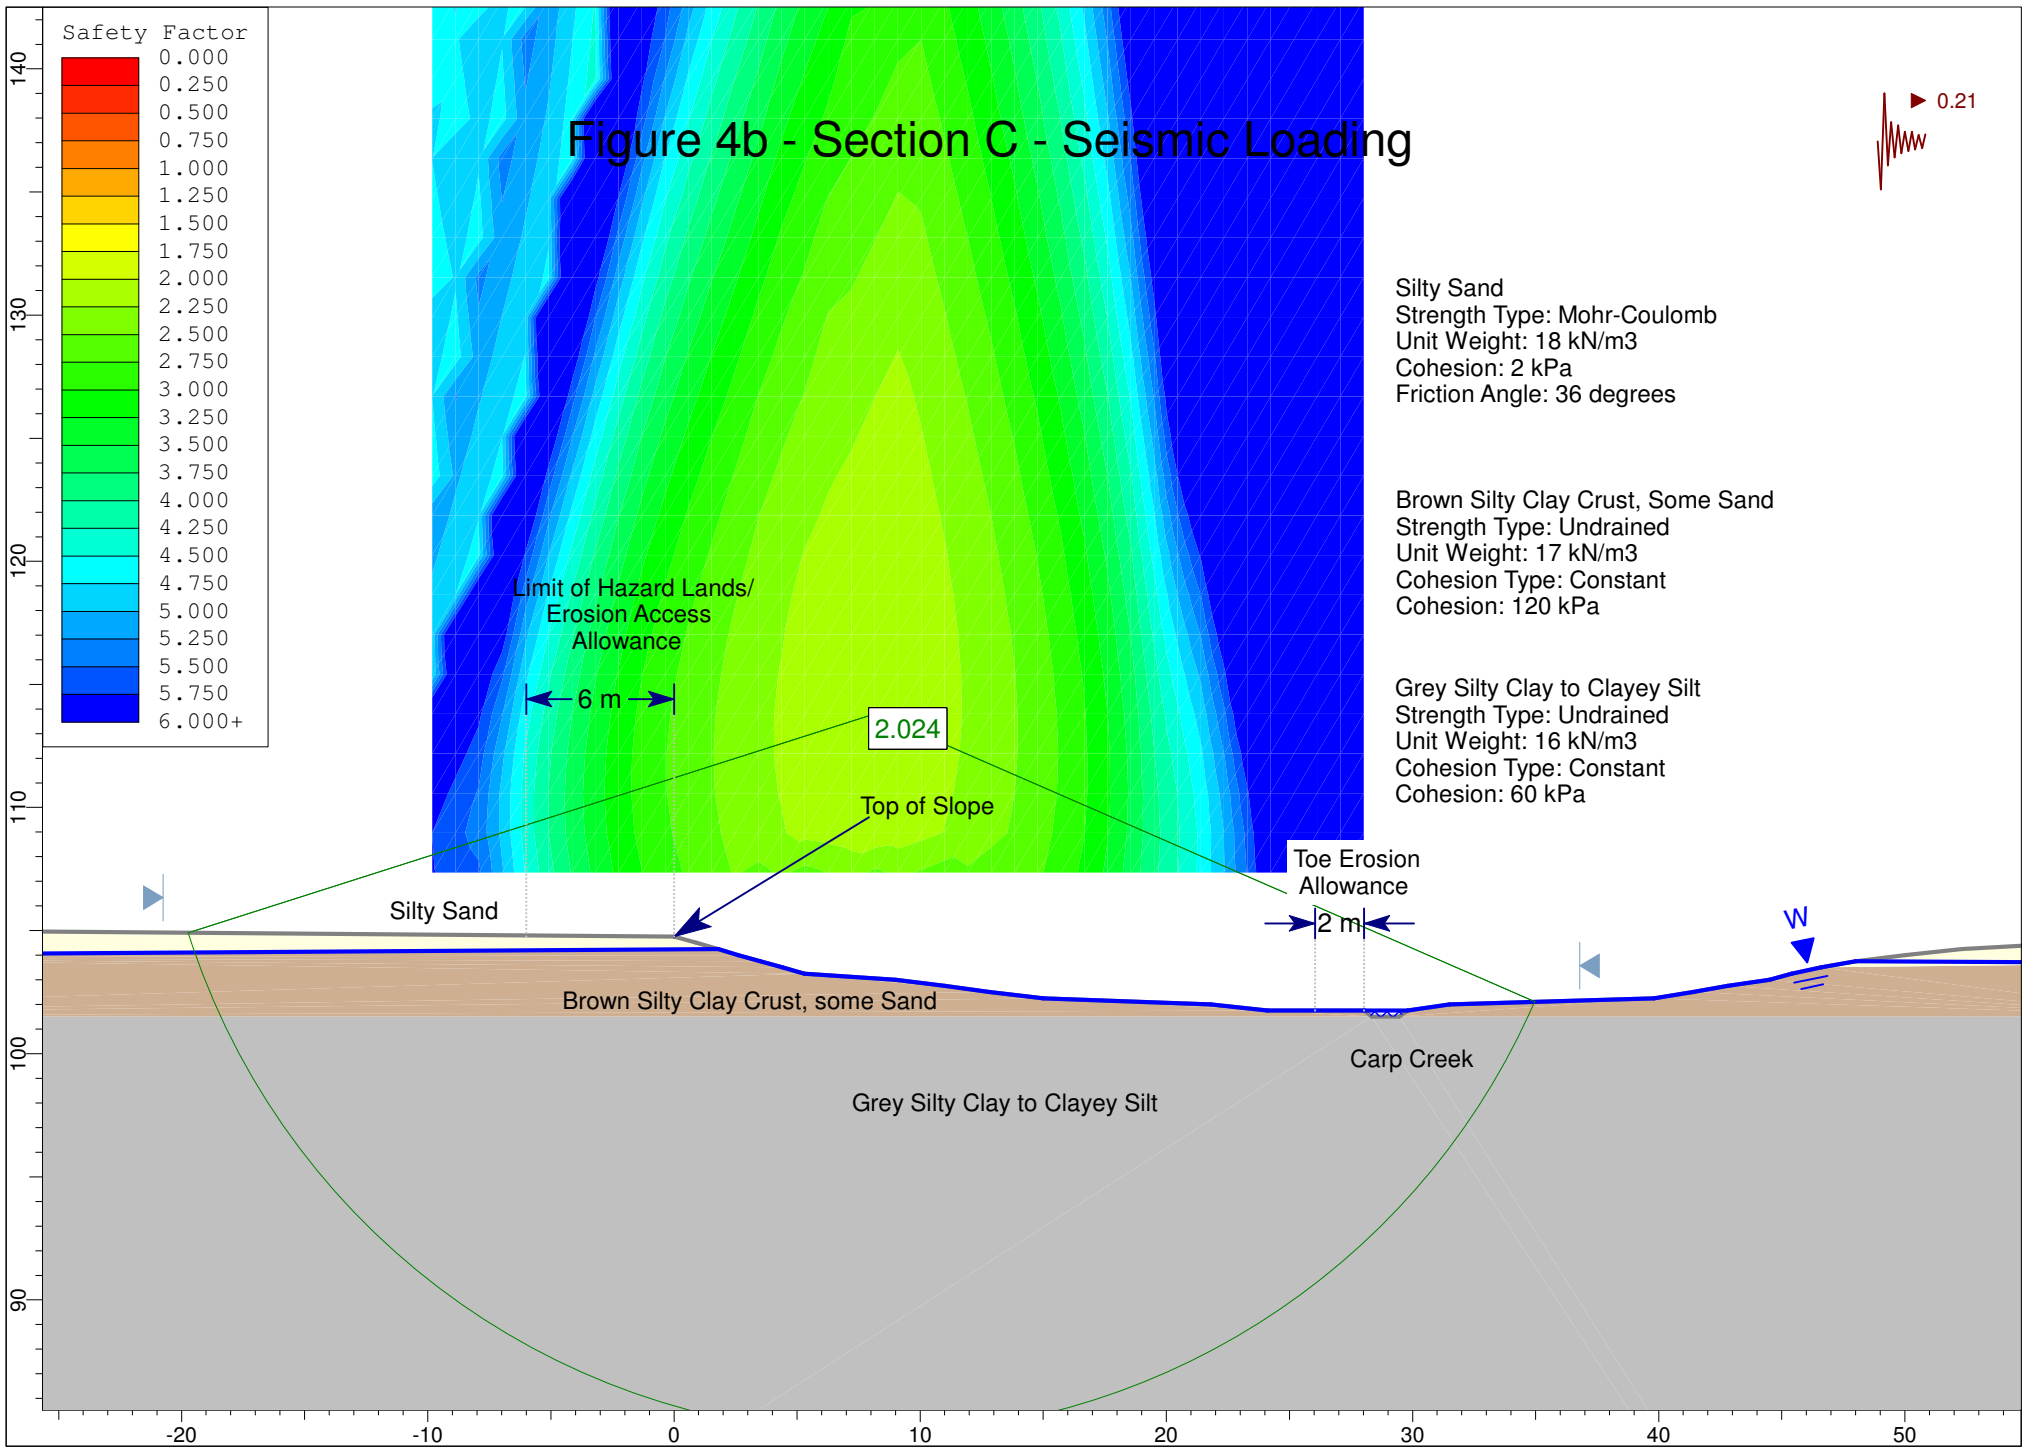
Figure 4b - Section C - Seismic Loading

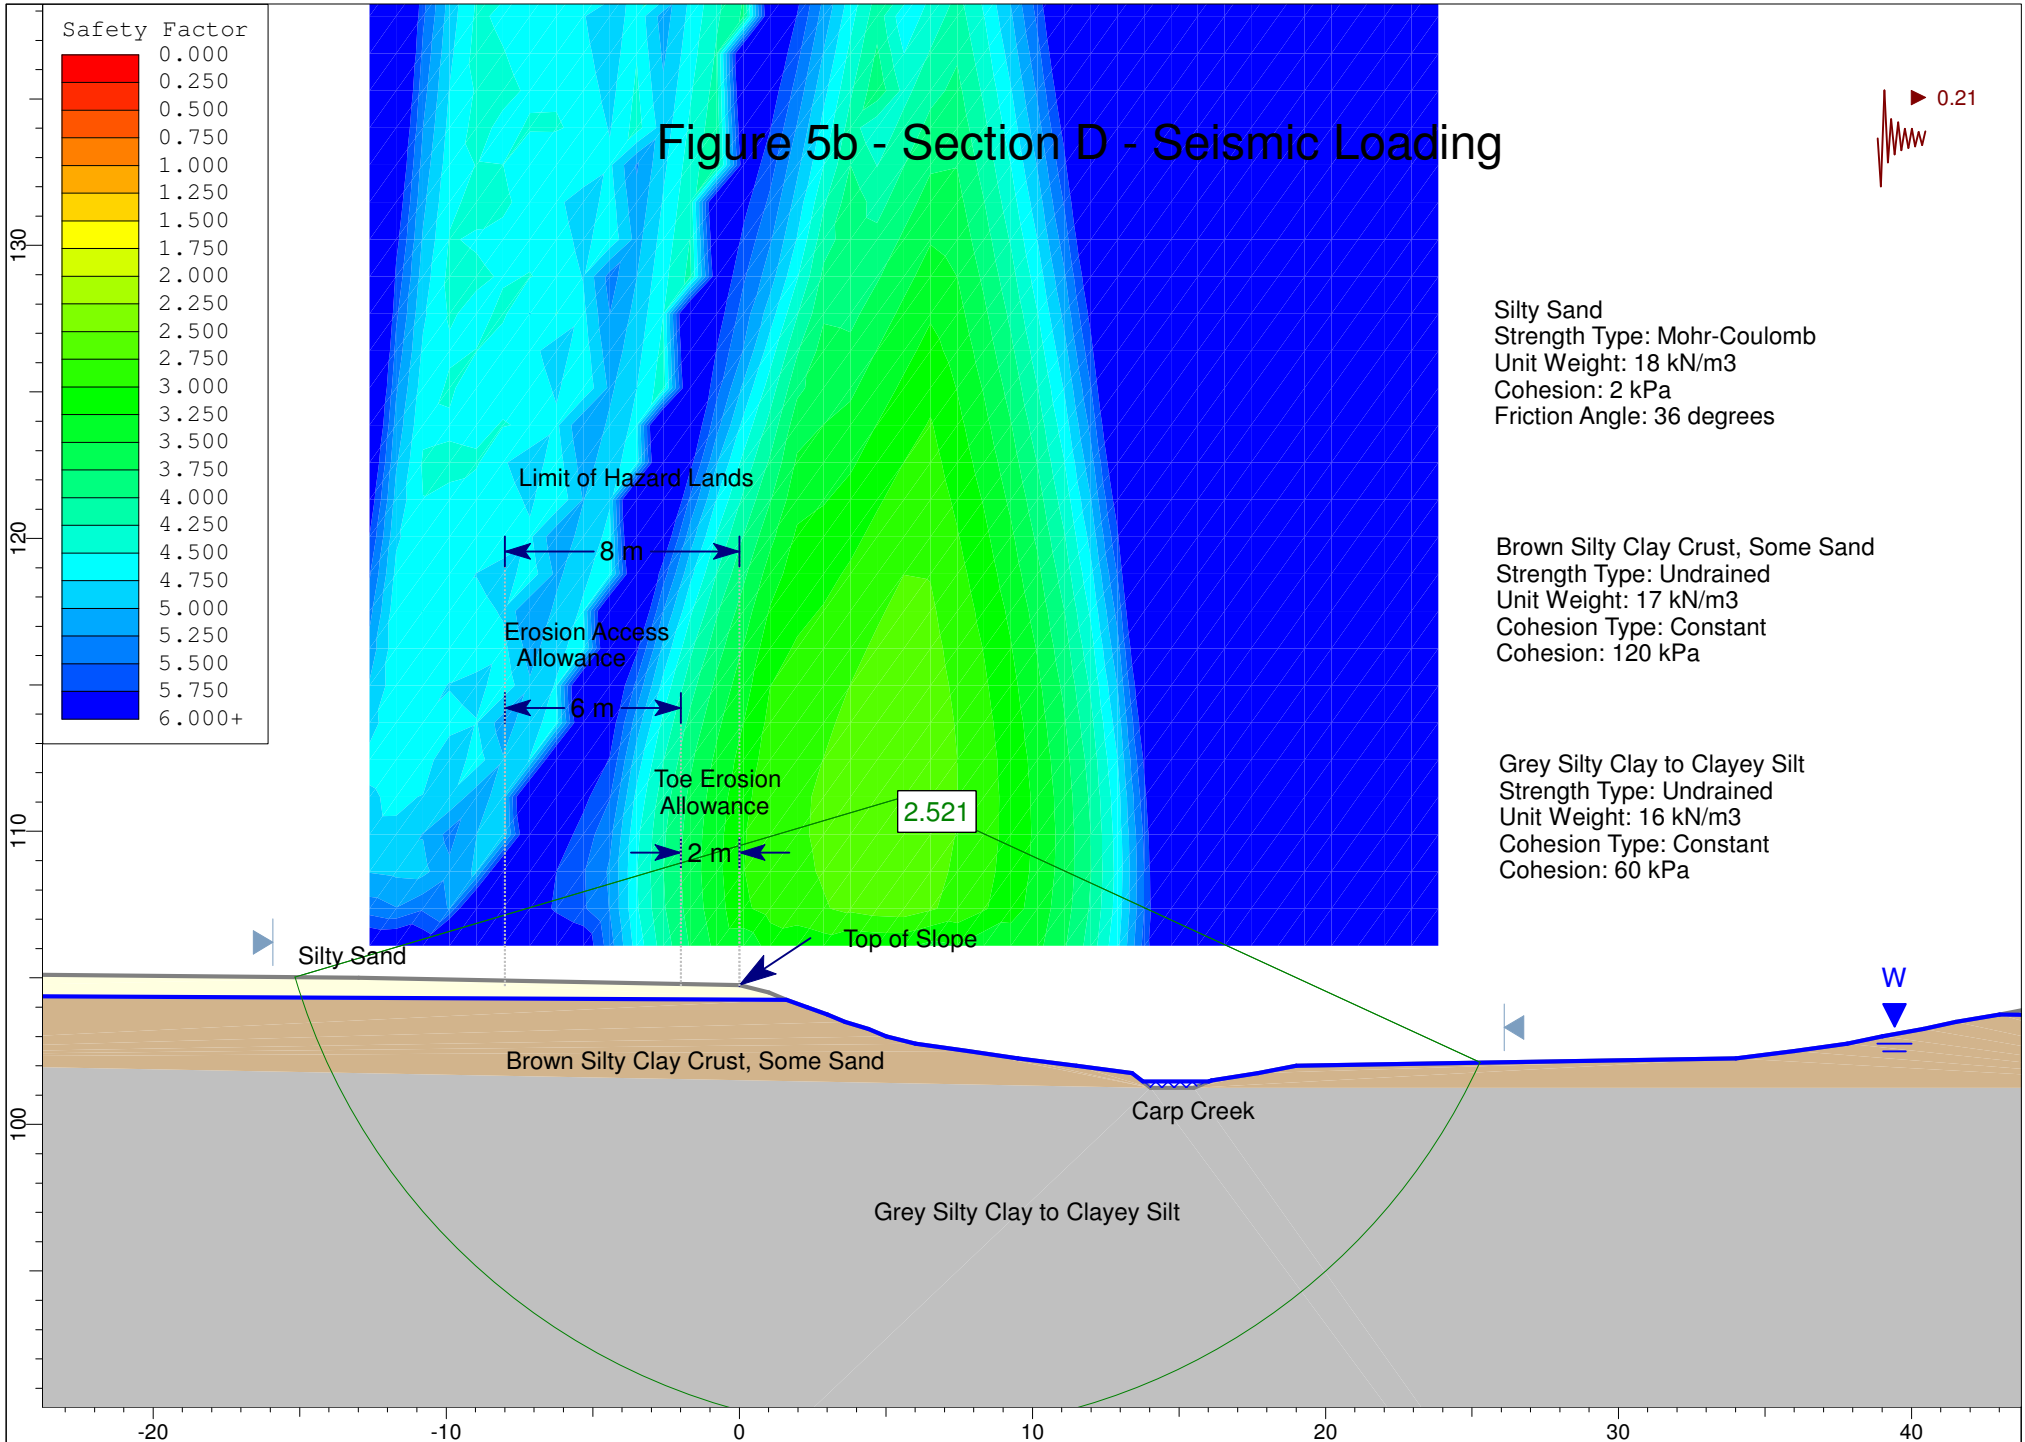
Figure 5b - Section D - Seismic Loading

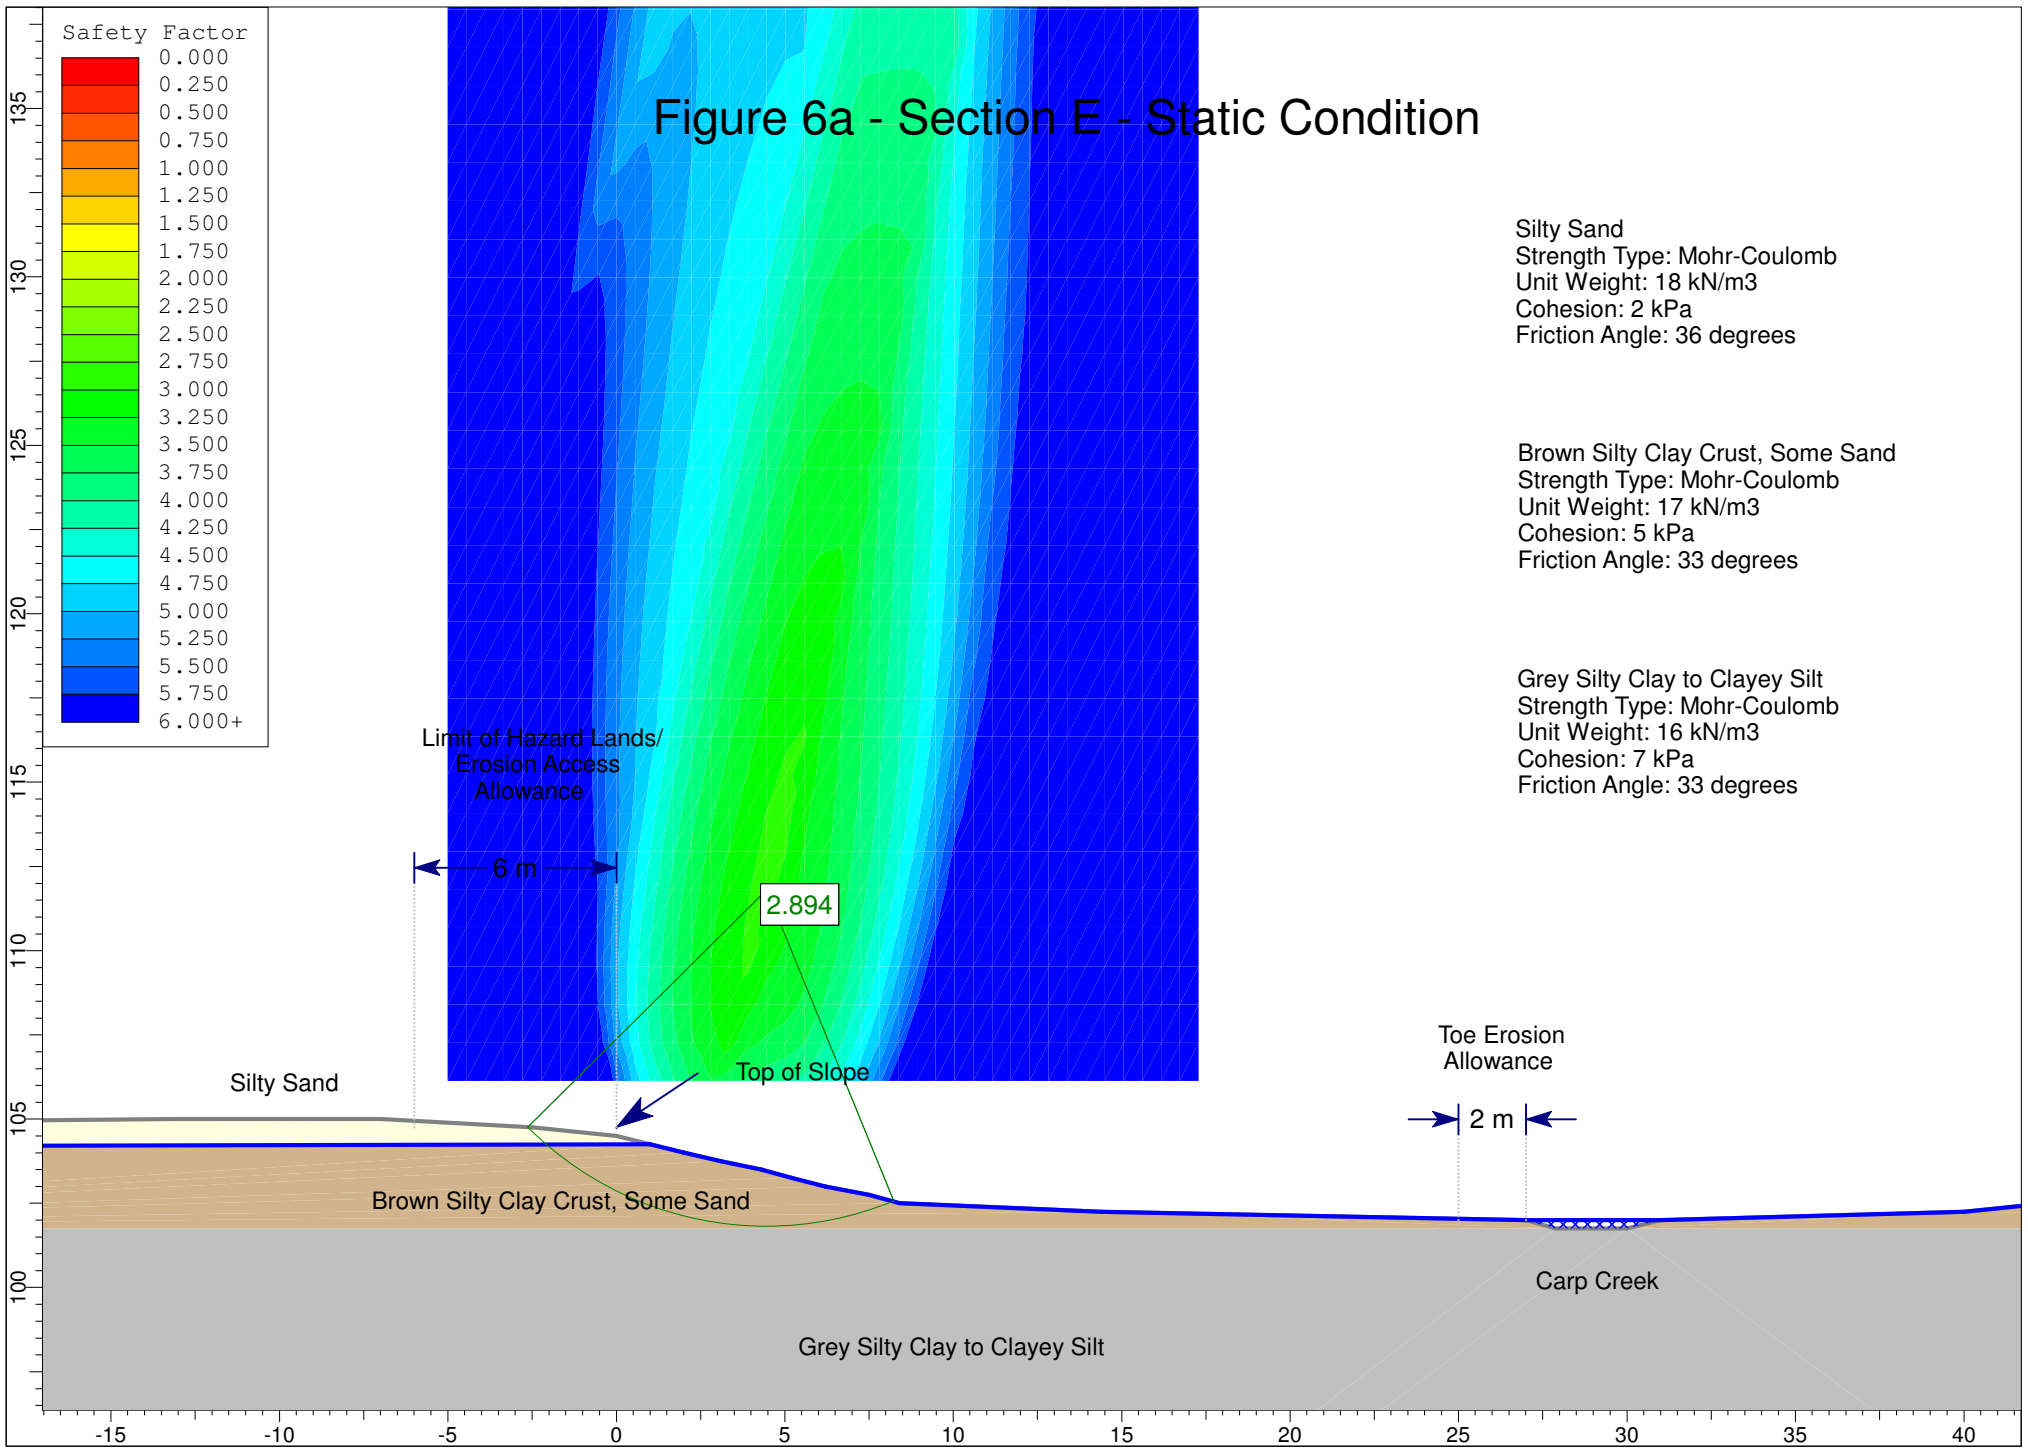
Figure 6a - Section E - Static Condition

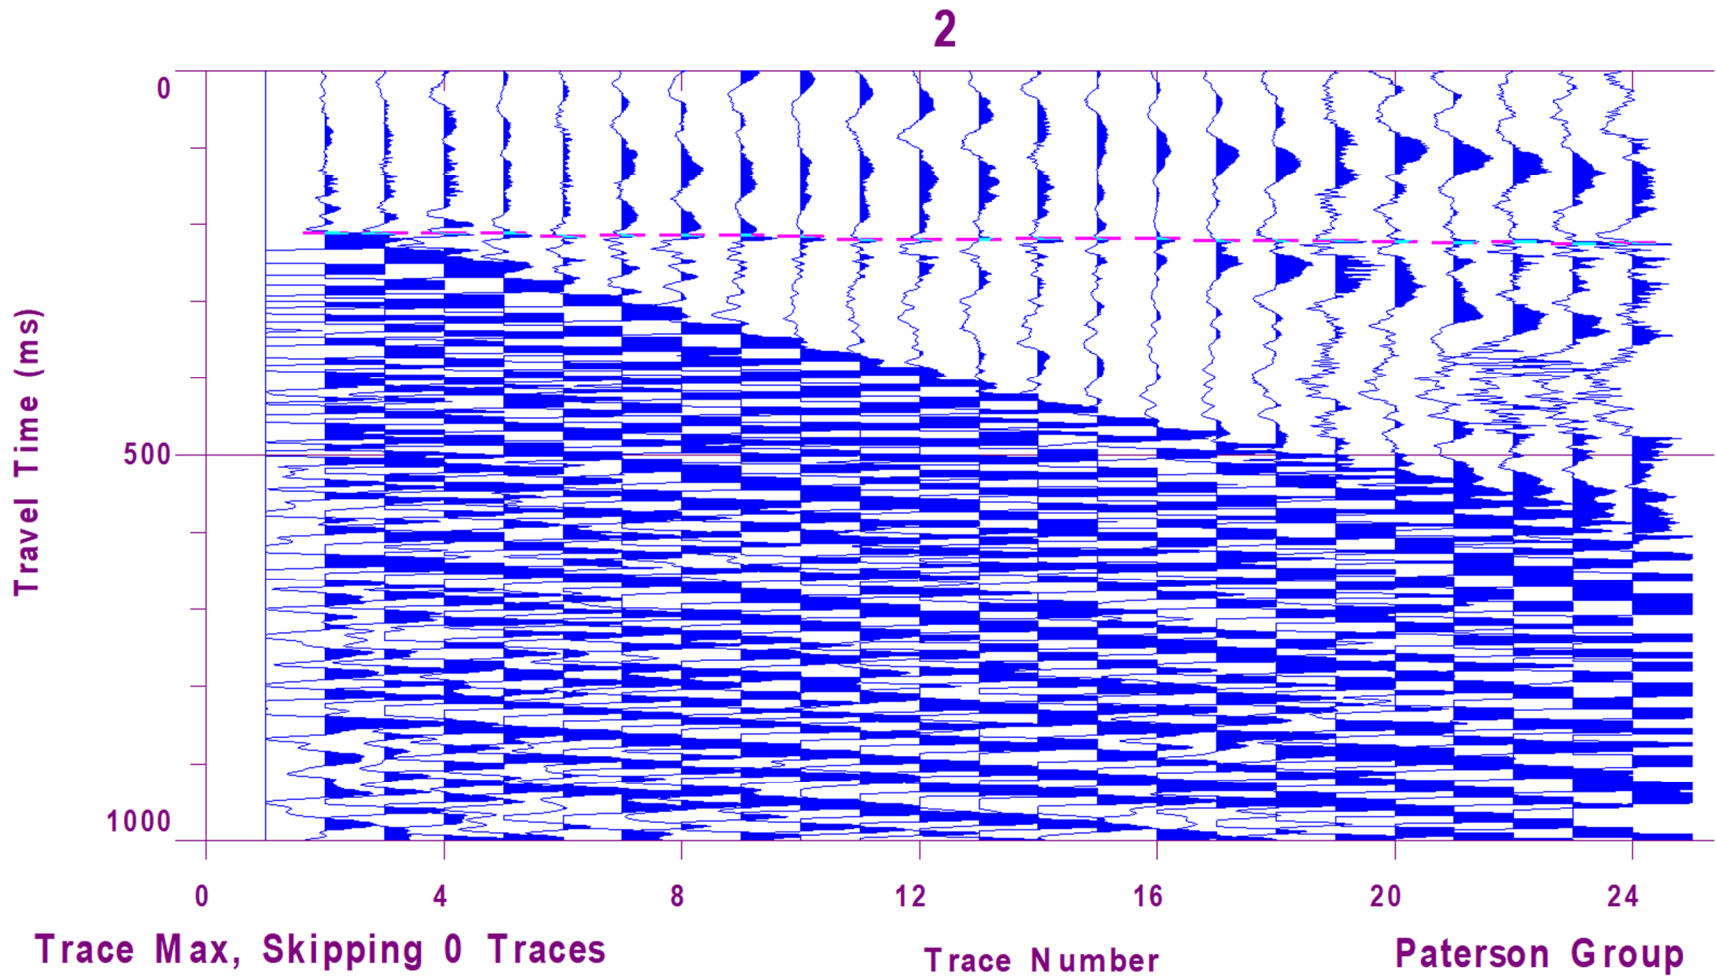
Figure 8 - West Array – Shear Wave Velocity Profile at Shot Location -30 m

The interpretation is repeated at each shot location to provide an average shear wave velocity, V_{s30} , of the upper 30 m profile, immediately below the building's foundation. The layer intercept times, velocities from different layers and critical distances are interpreted from the shear wave records to compute the bedrock depth at each location.

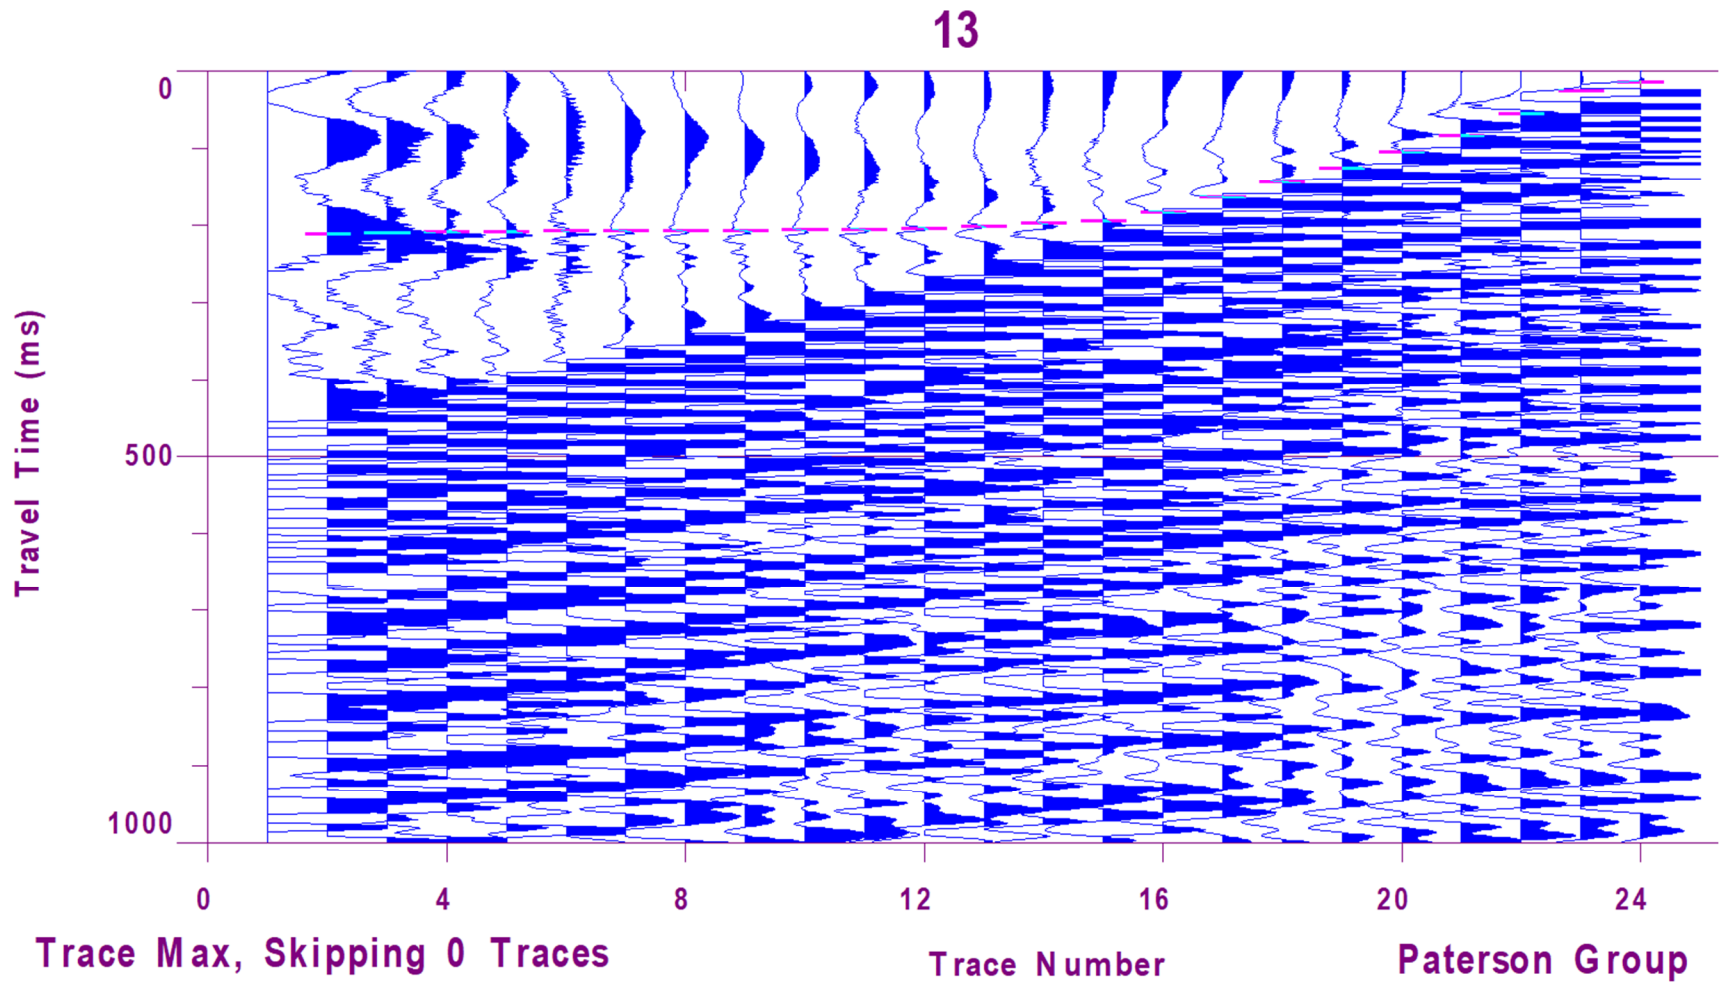
Figure 9 - West Array – Shear Wave Velocity Profile at Shot Location 3 m

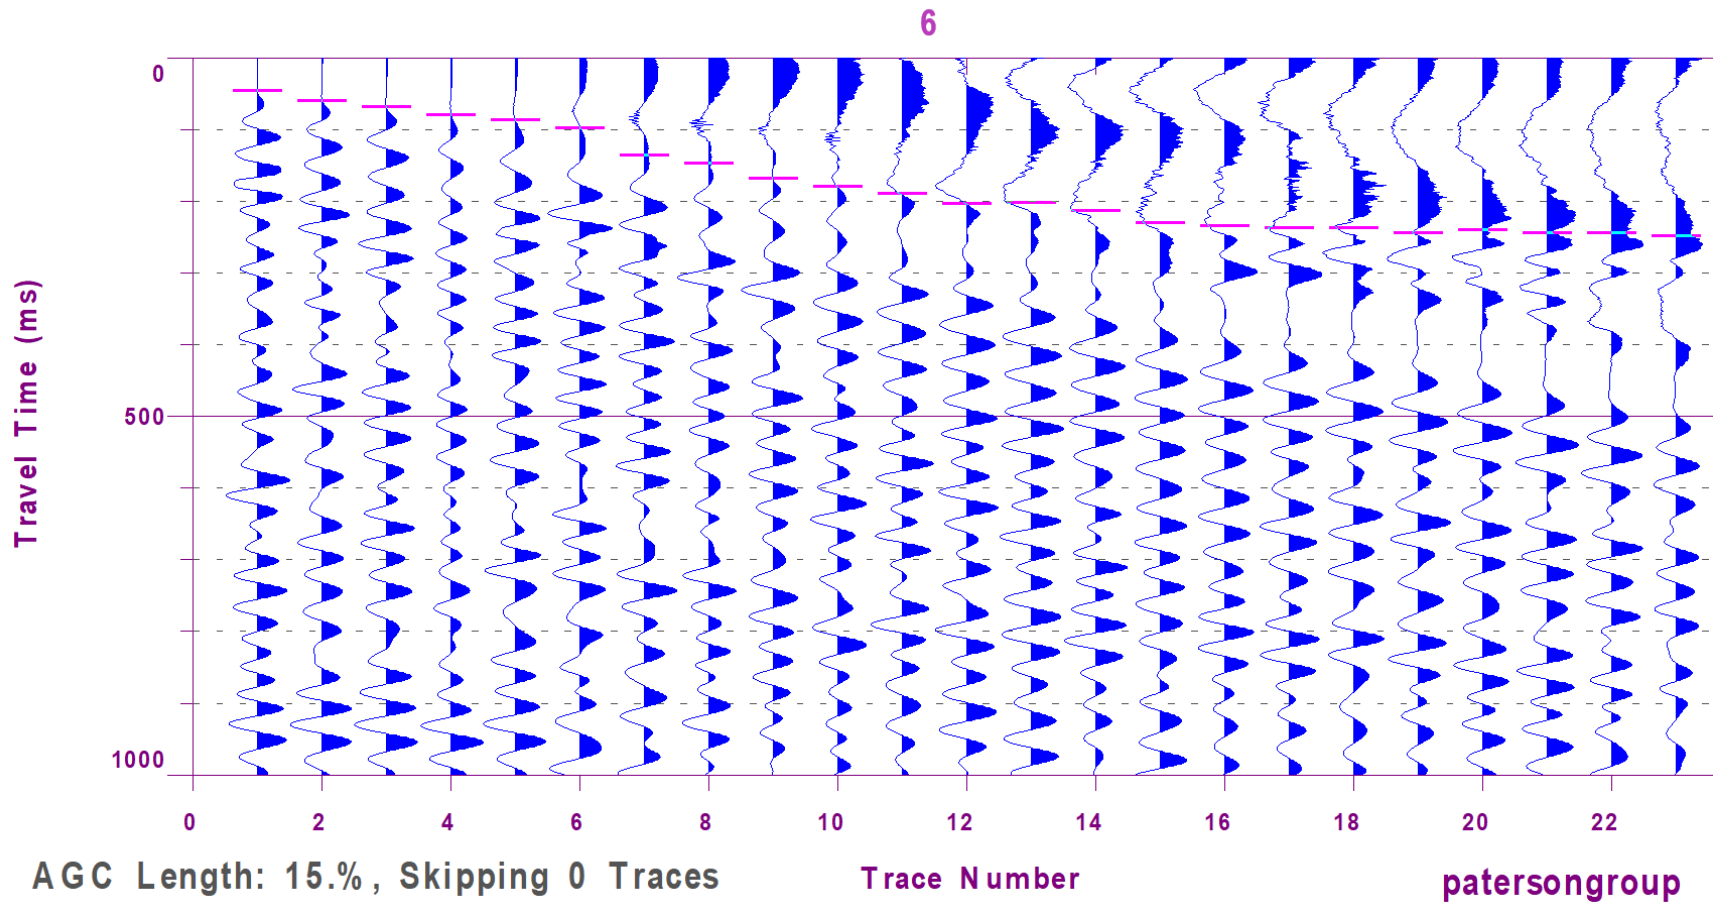
Figure 11 - East Array – Shear Wave Velocity Profile at Shot Location -4.5 m
