Geotechnical Investigation

Carp Airport Servicing and Residential Development – Phase 1

Carp Road
(Carp) Ottawa, Ontario

Report PG2450-2, Revision 1, dated January 16, 2023

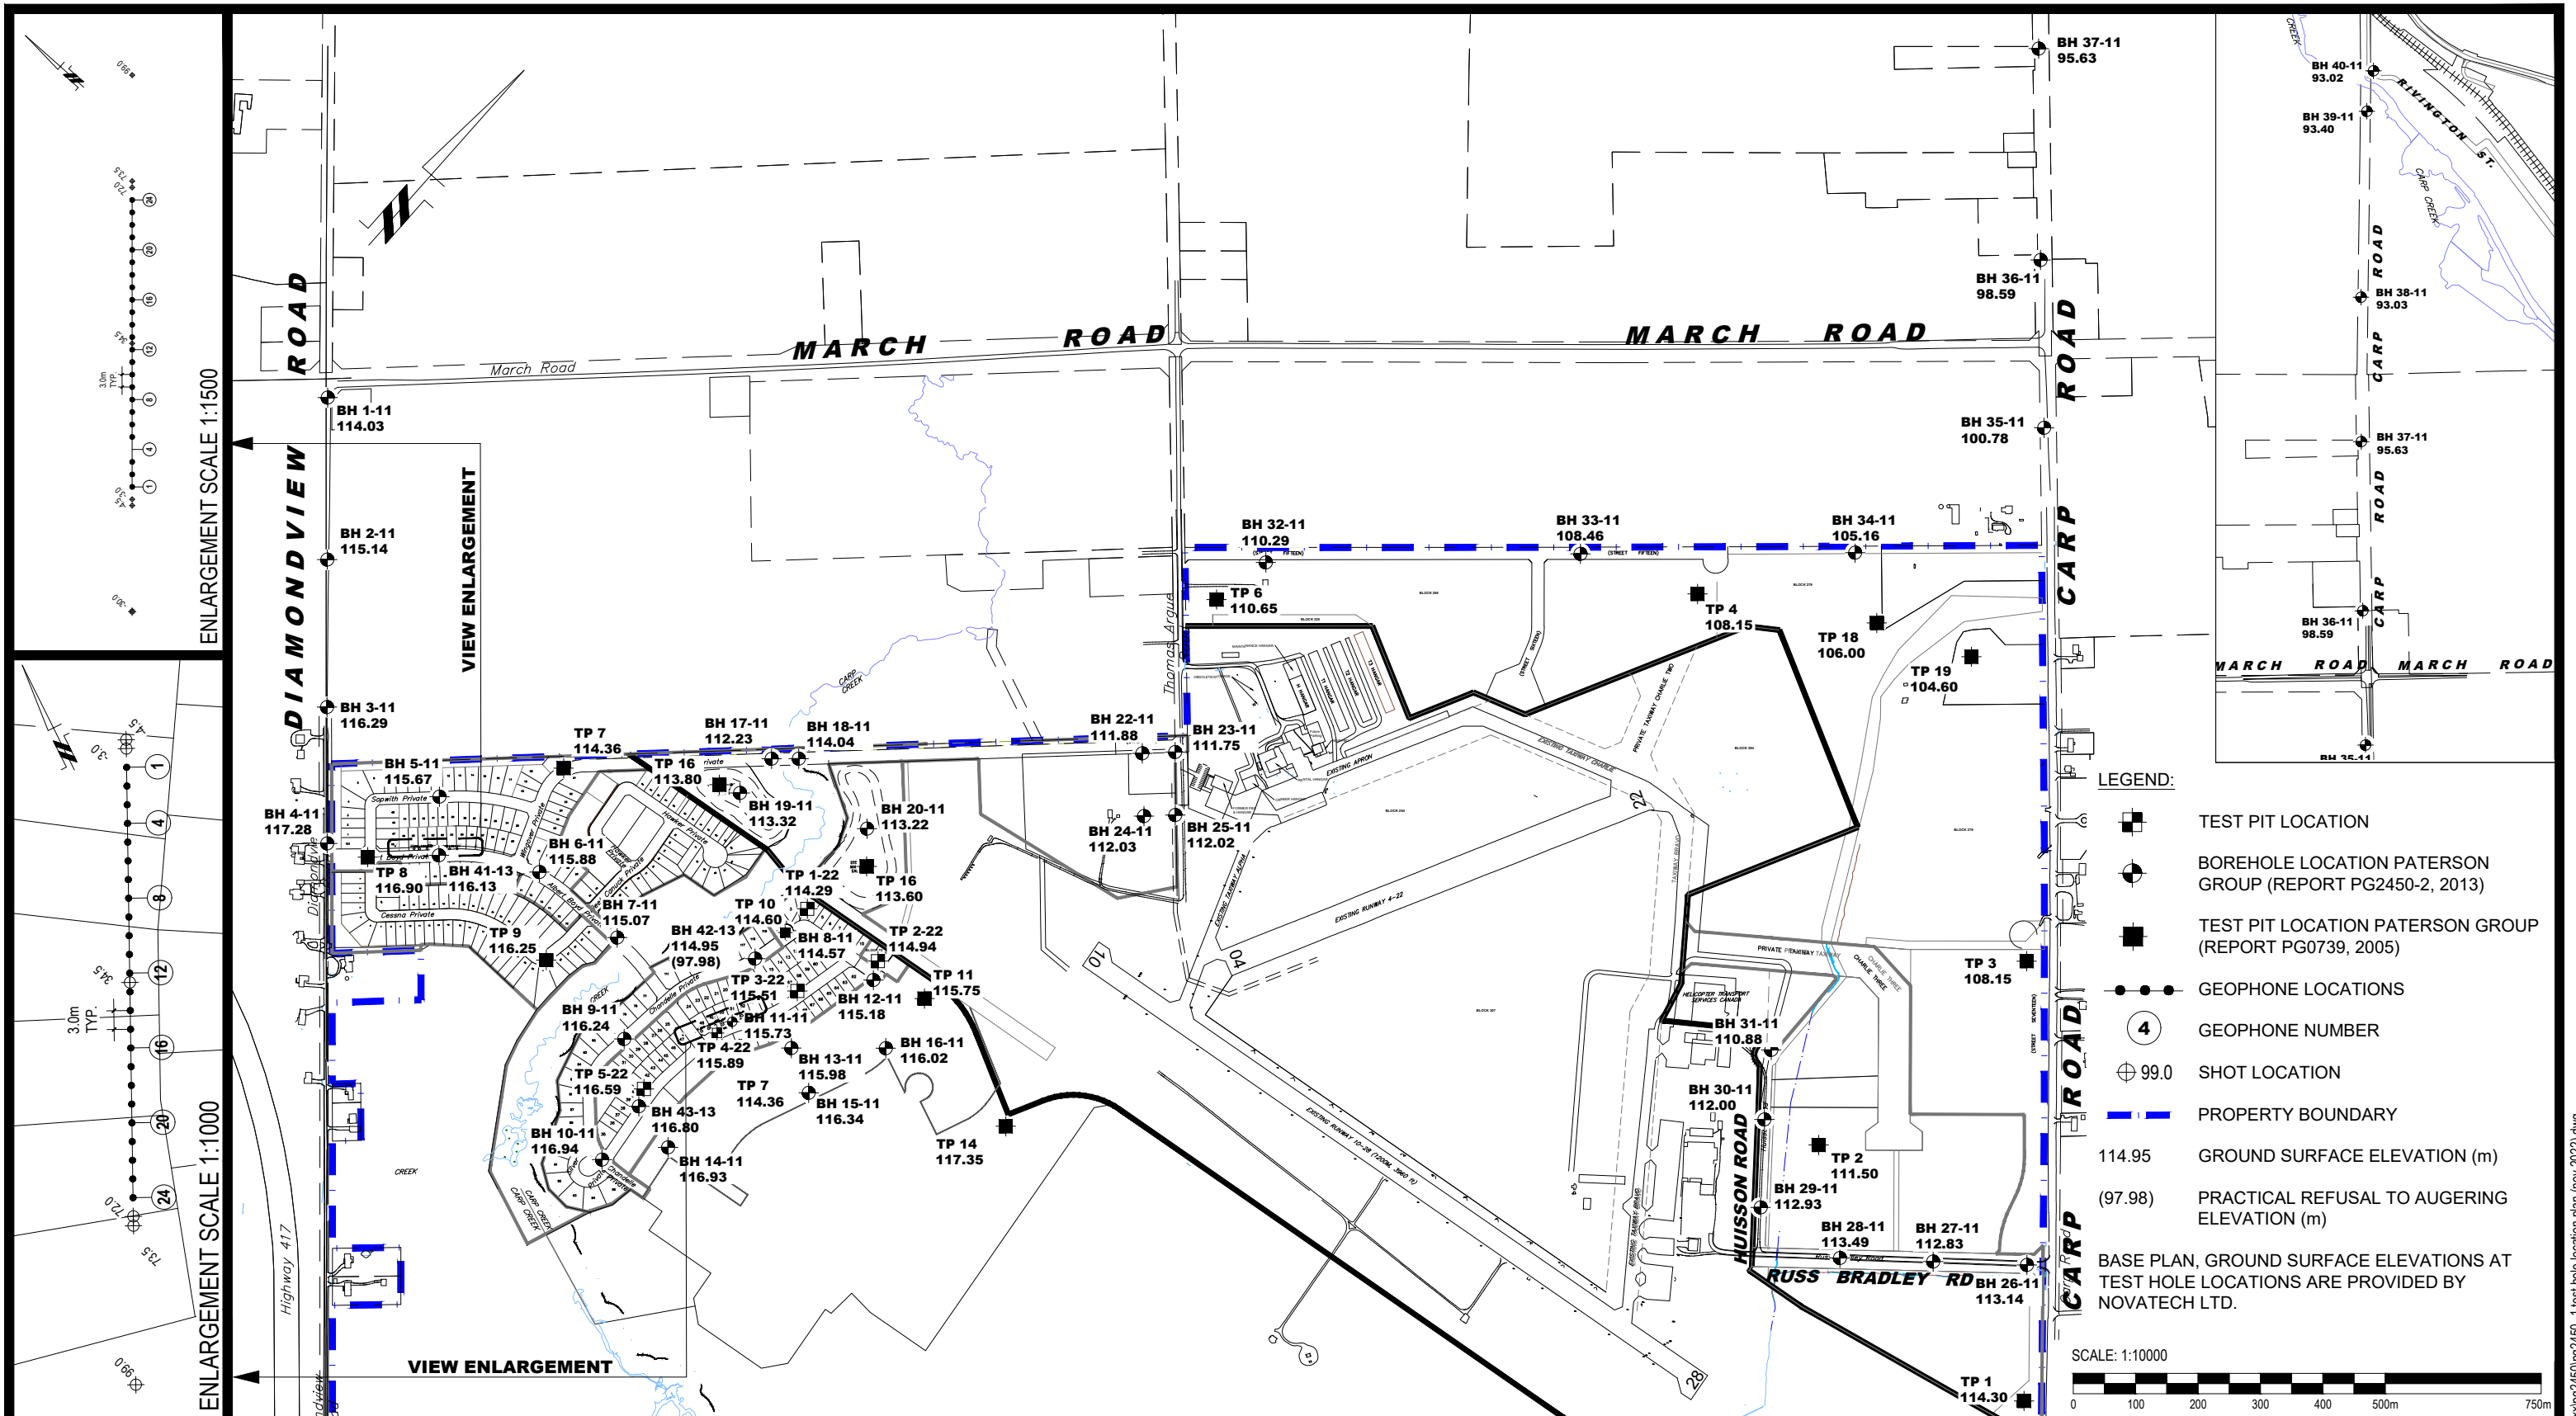
WEST CAPITAL DEVELOPMENTS
GEOTECHNICAL INVESTIGATION
CARP AIRPORT RESIDENTIAL DEVELOPMENT
ONTARIO

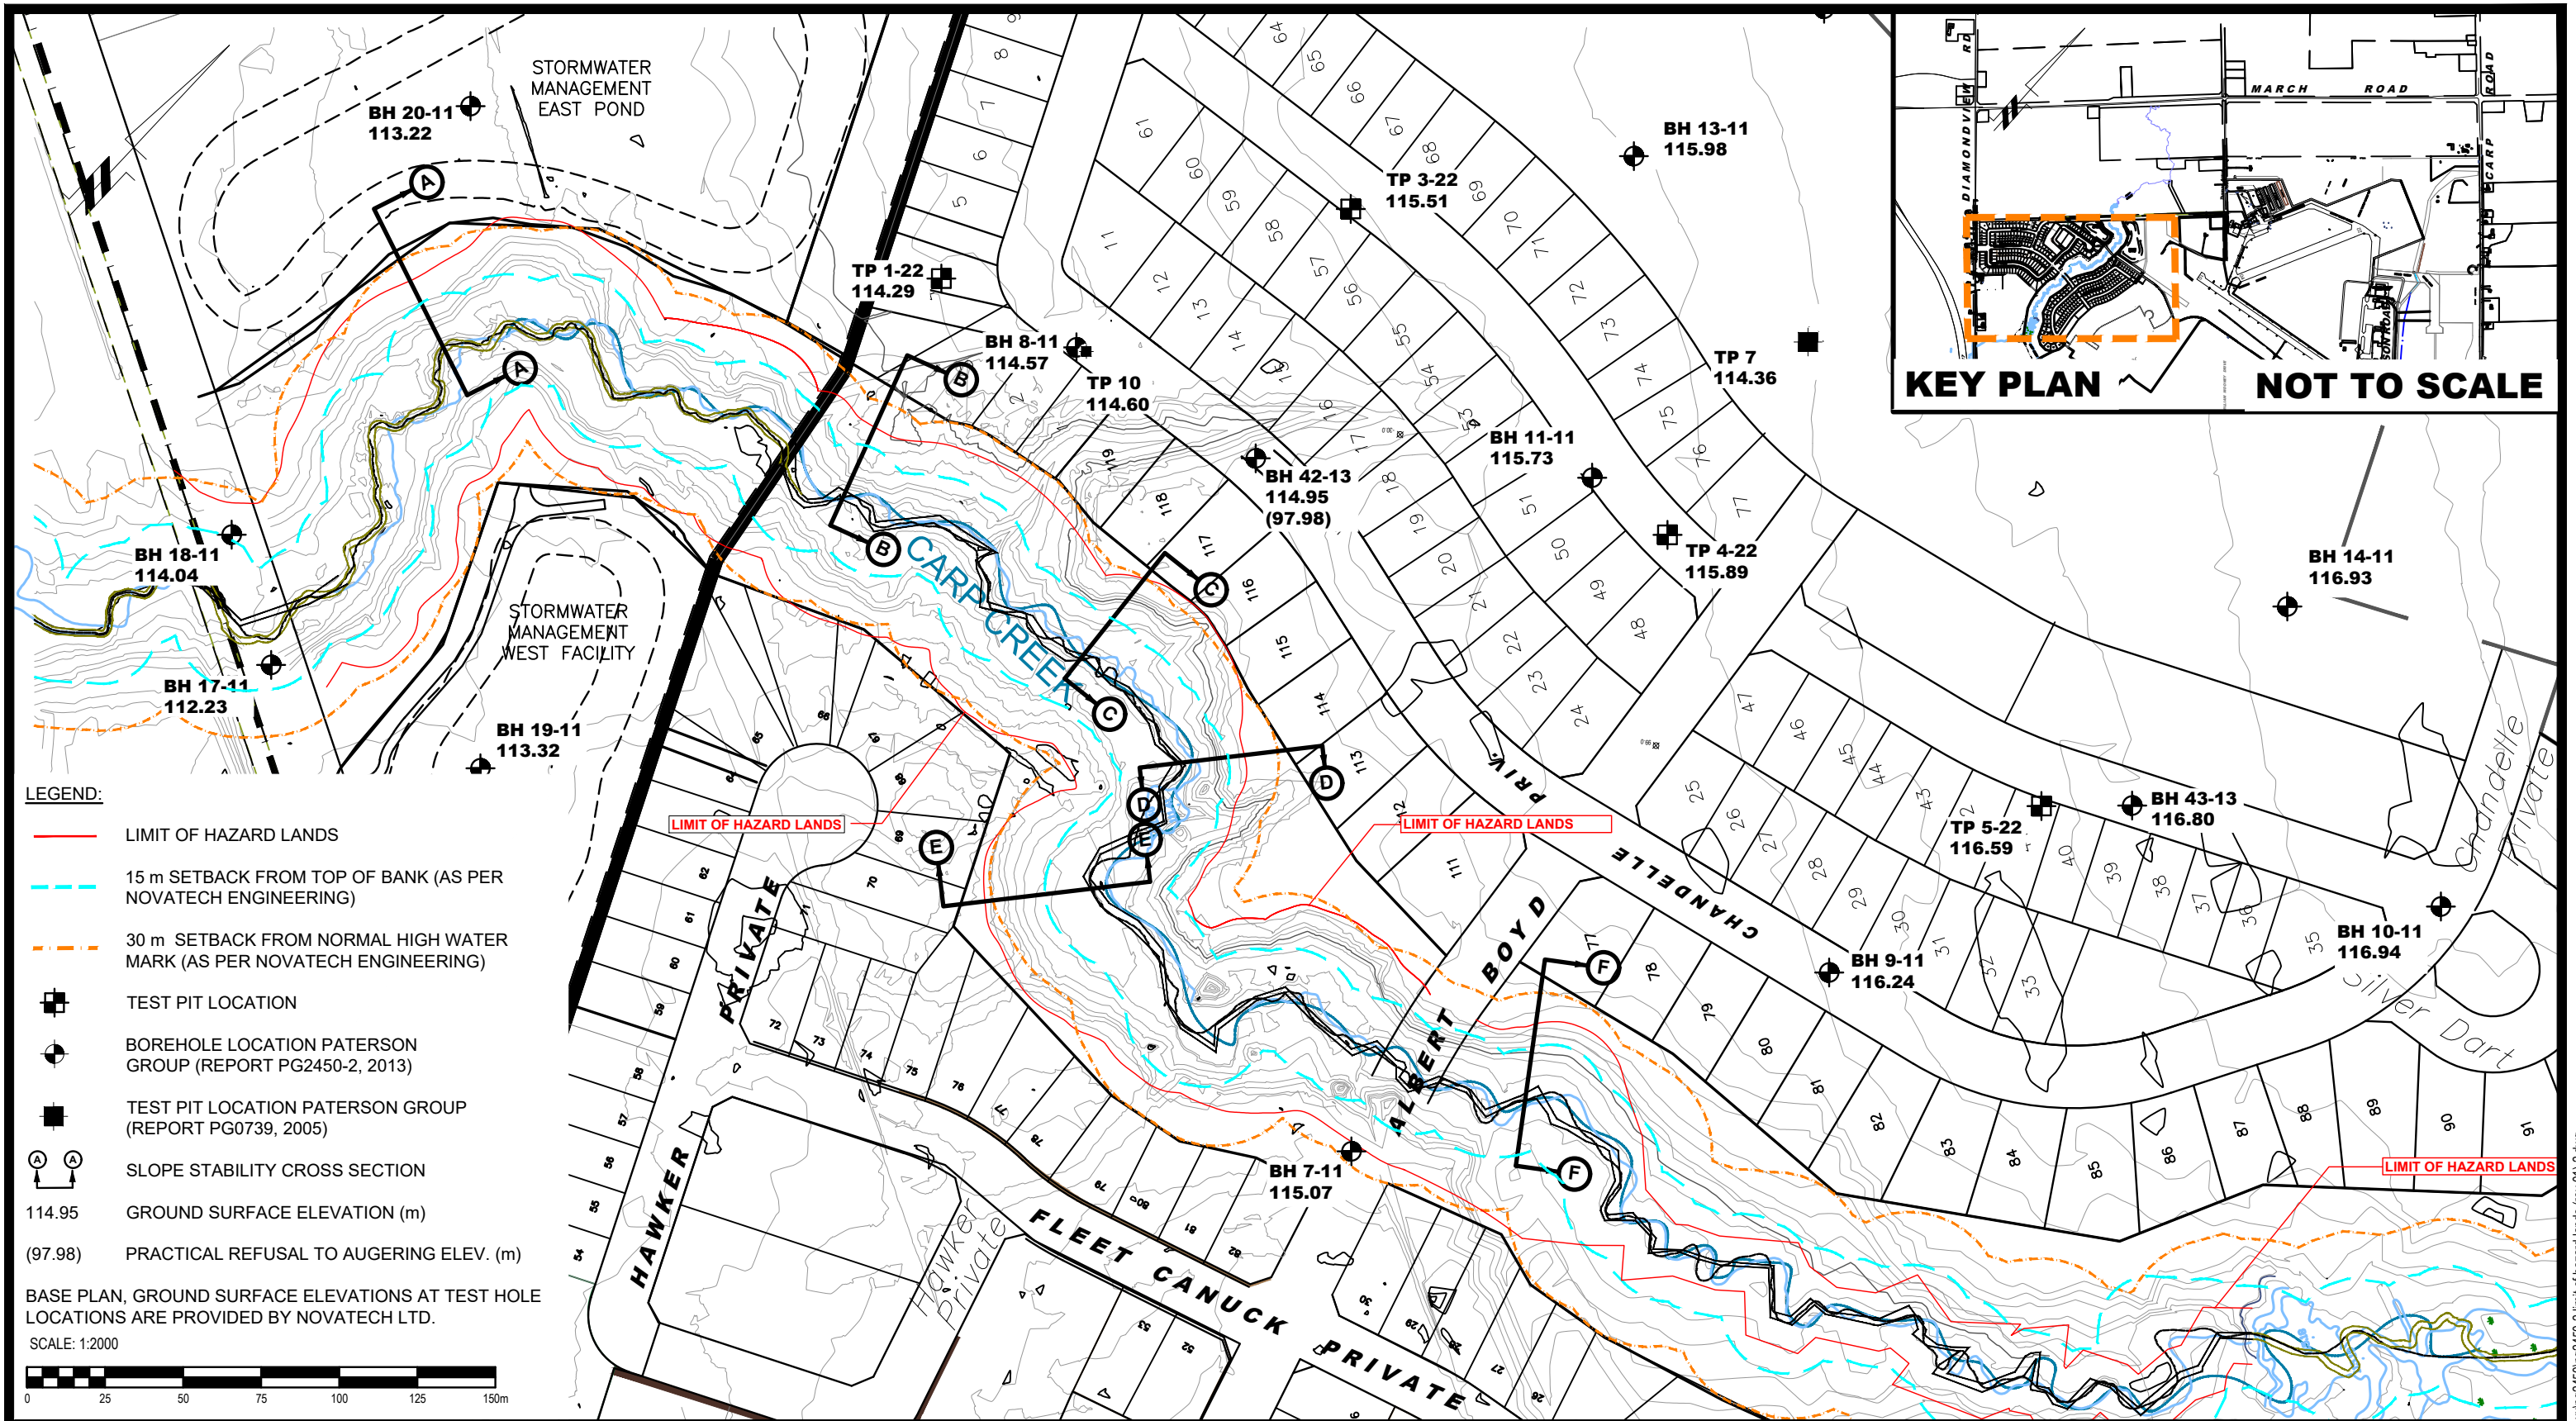
- LEGEND:**
- LIMIT OF HAZARD LANDS
 - - - 15 m SETBACK FROM TOP OF BANK (AS PER NOVATECH ENGINEERING)
 - - - 30 m SETBACK FROM NORMAL HIGH WATER MARK (AS PER NOVATECH ENGINEERING)
 - TEST PIT LOCATION
 - BOREHOLE LOCATION PATERSON GROUP (REPORT PG2450-2, 2013)
 - TEST PIT LOCATION PATERSON GROUP (REPORT PG0739, 2005)
 - SLOPE STABILITY CROSS SECTION
 - 114.95 GROUND SURFACE ELEVATION (m)
 - (97.98) PRACTICAL REFUSAL TO AUGERING ELEV. (m)
- BASE PLAN, GROUND SURFACE ELEVATIONS AT TEST HOLE LOCATIONS ARE PROVIDED BY NOVATECH LTD.
- SCALE: 1:2000
-

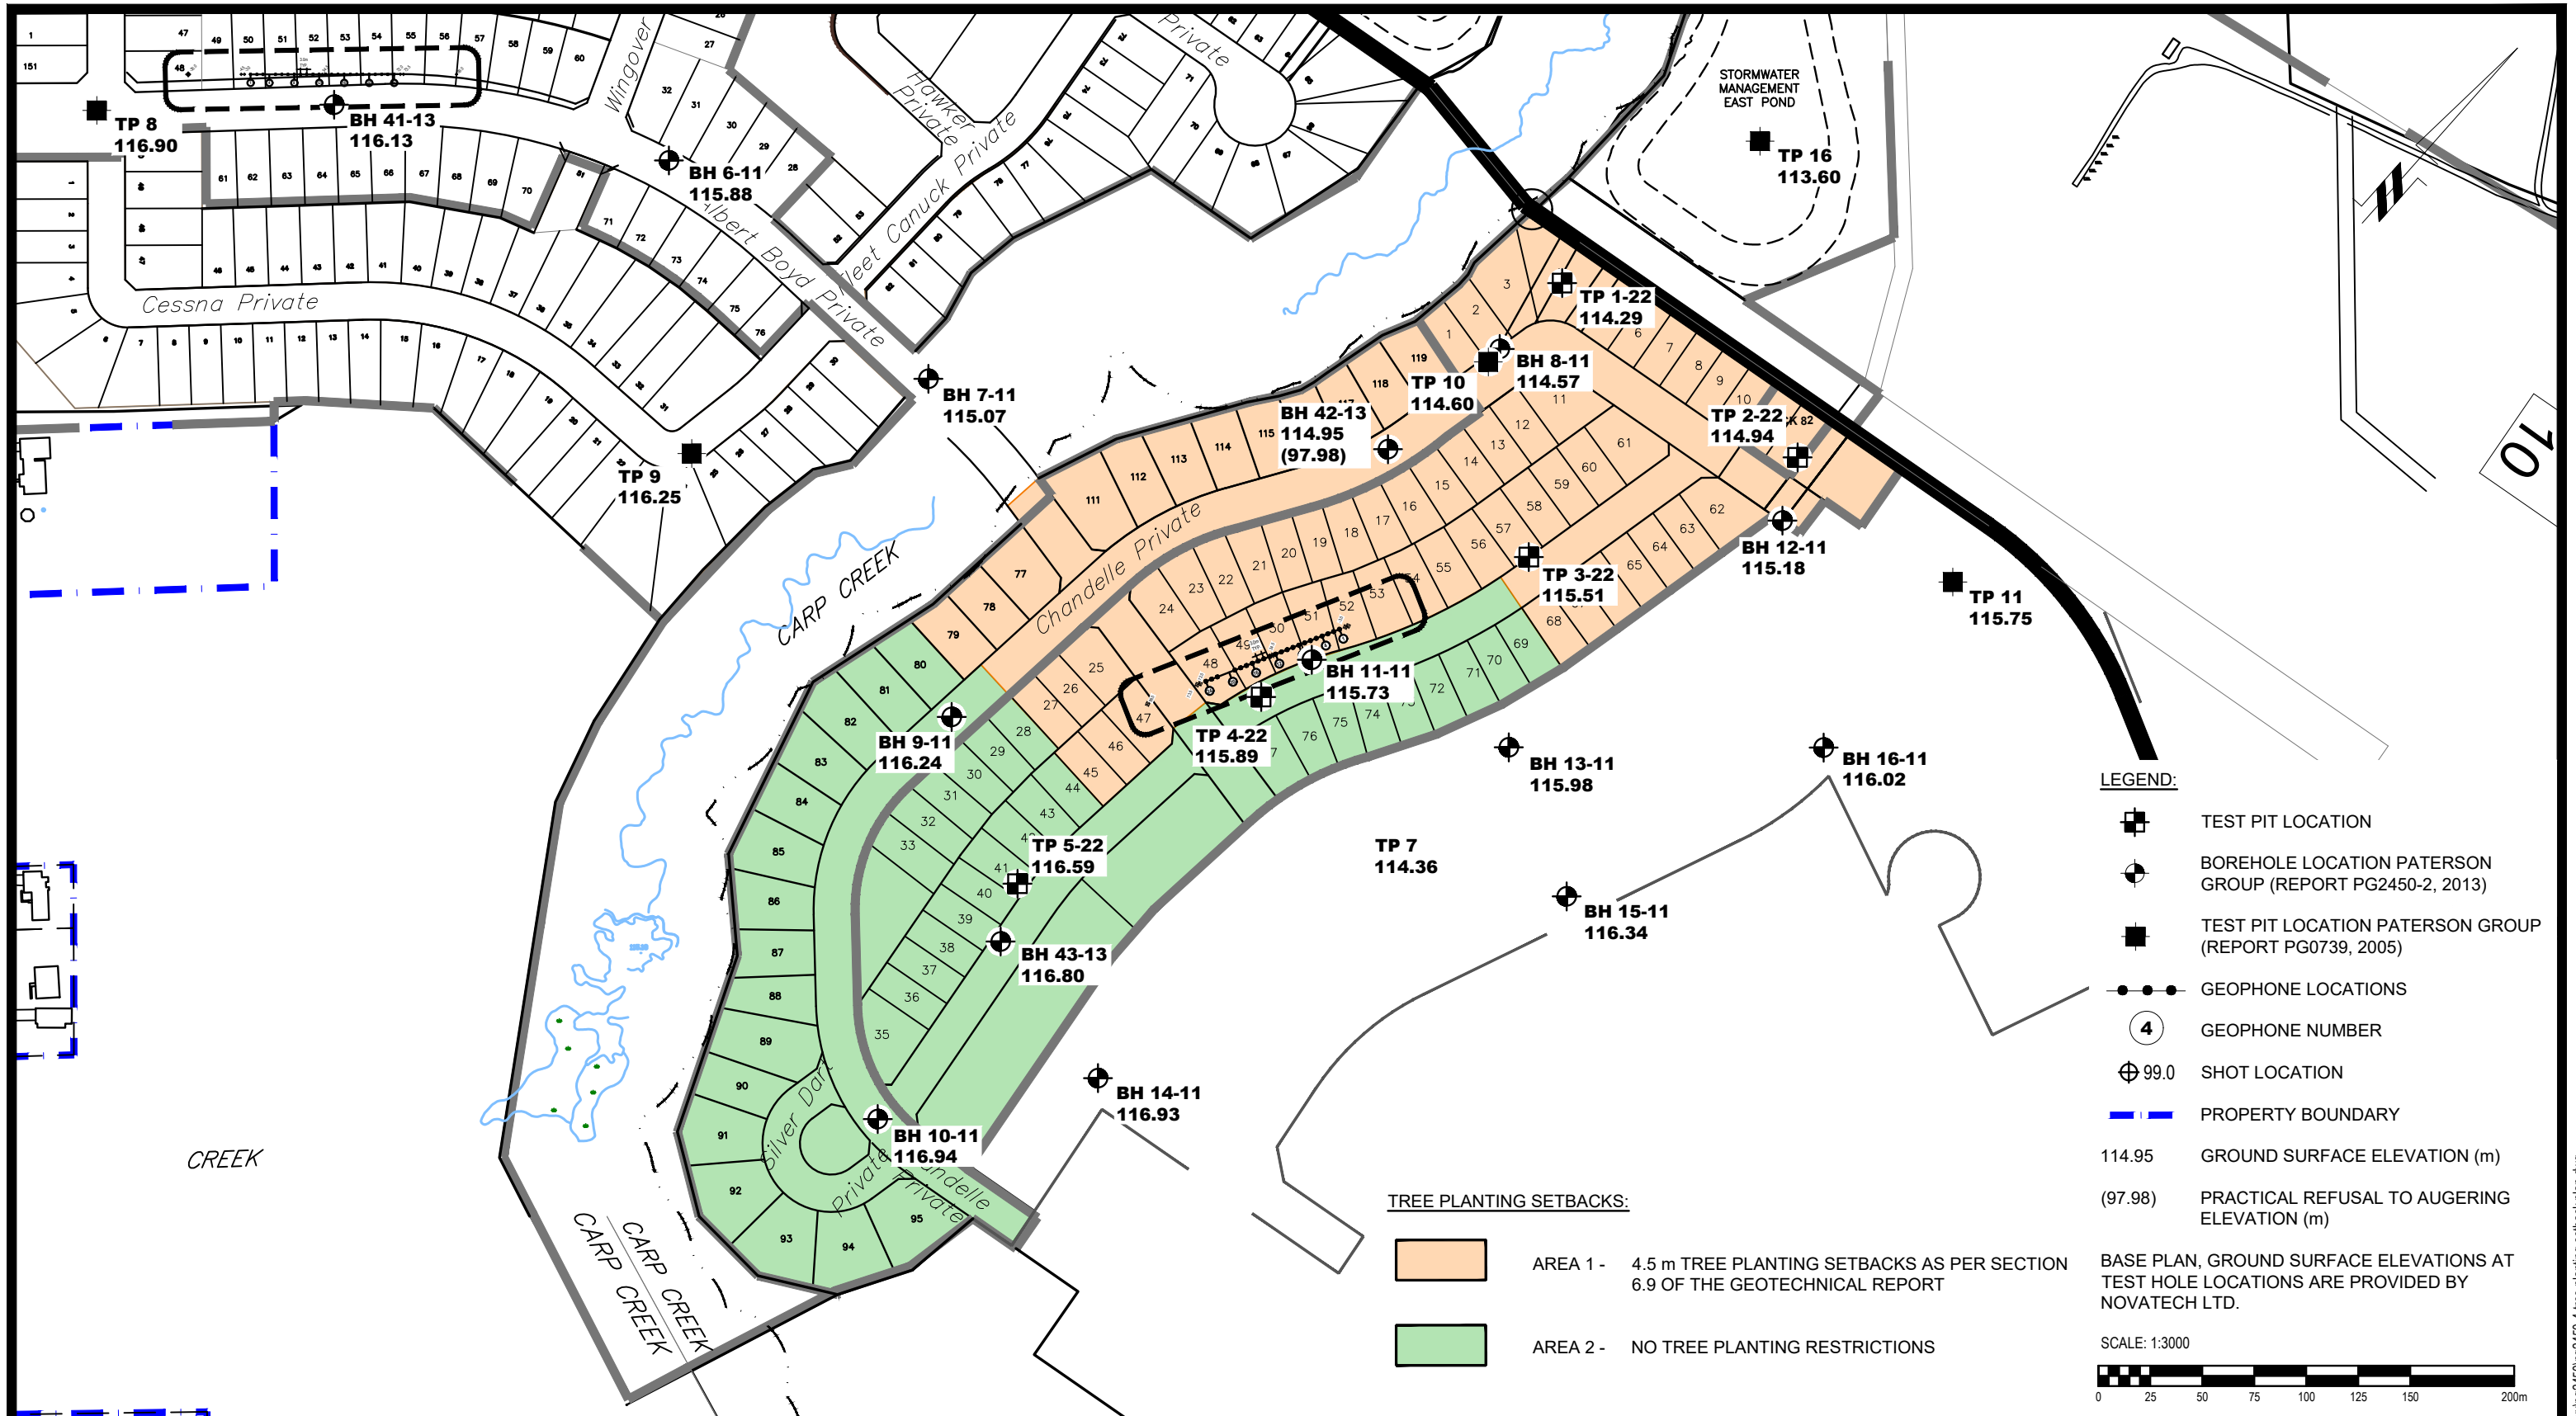
- TREE PLANTING SETBACKS:**
- AREA 1 - 4.5 m TREE PLANTING SETBACKS AS PER SECTION 6.9 OF THE GEOTECHNICAL REPORT
 - AREA 2 - NO TREE PLANTING RESTRICTIONS
