**Phase One  
Environmental Site Assessment**

725 Somerset Street West  
Ottawa, Ontario

1303263 BC ULC.  
725 Somerset Street West  
Ottawa, Ontario  
K1R 6P7

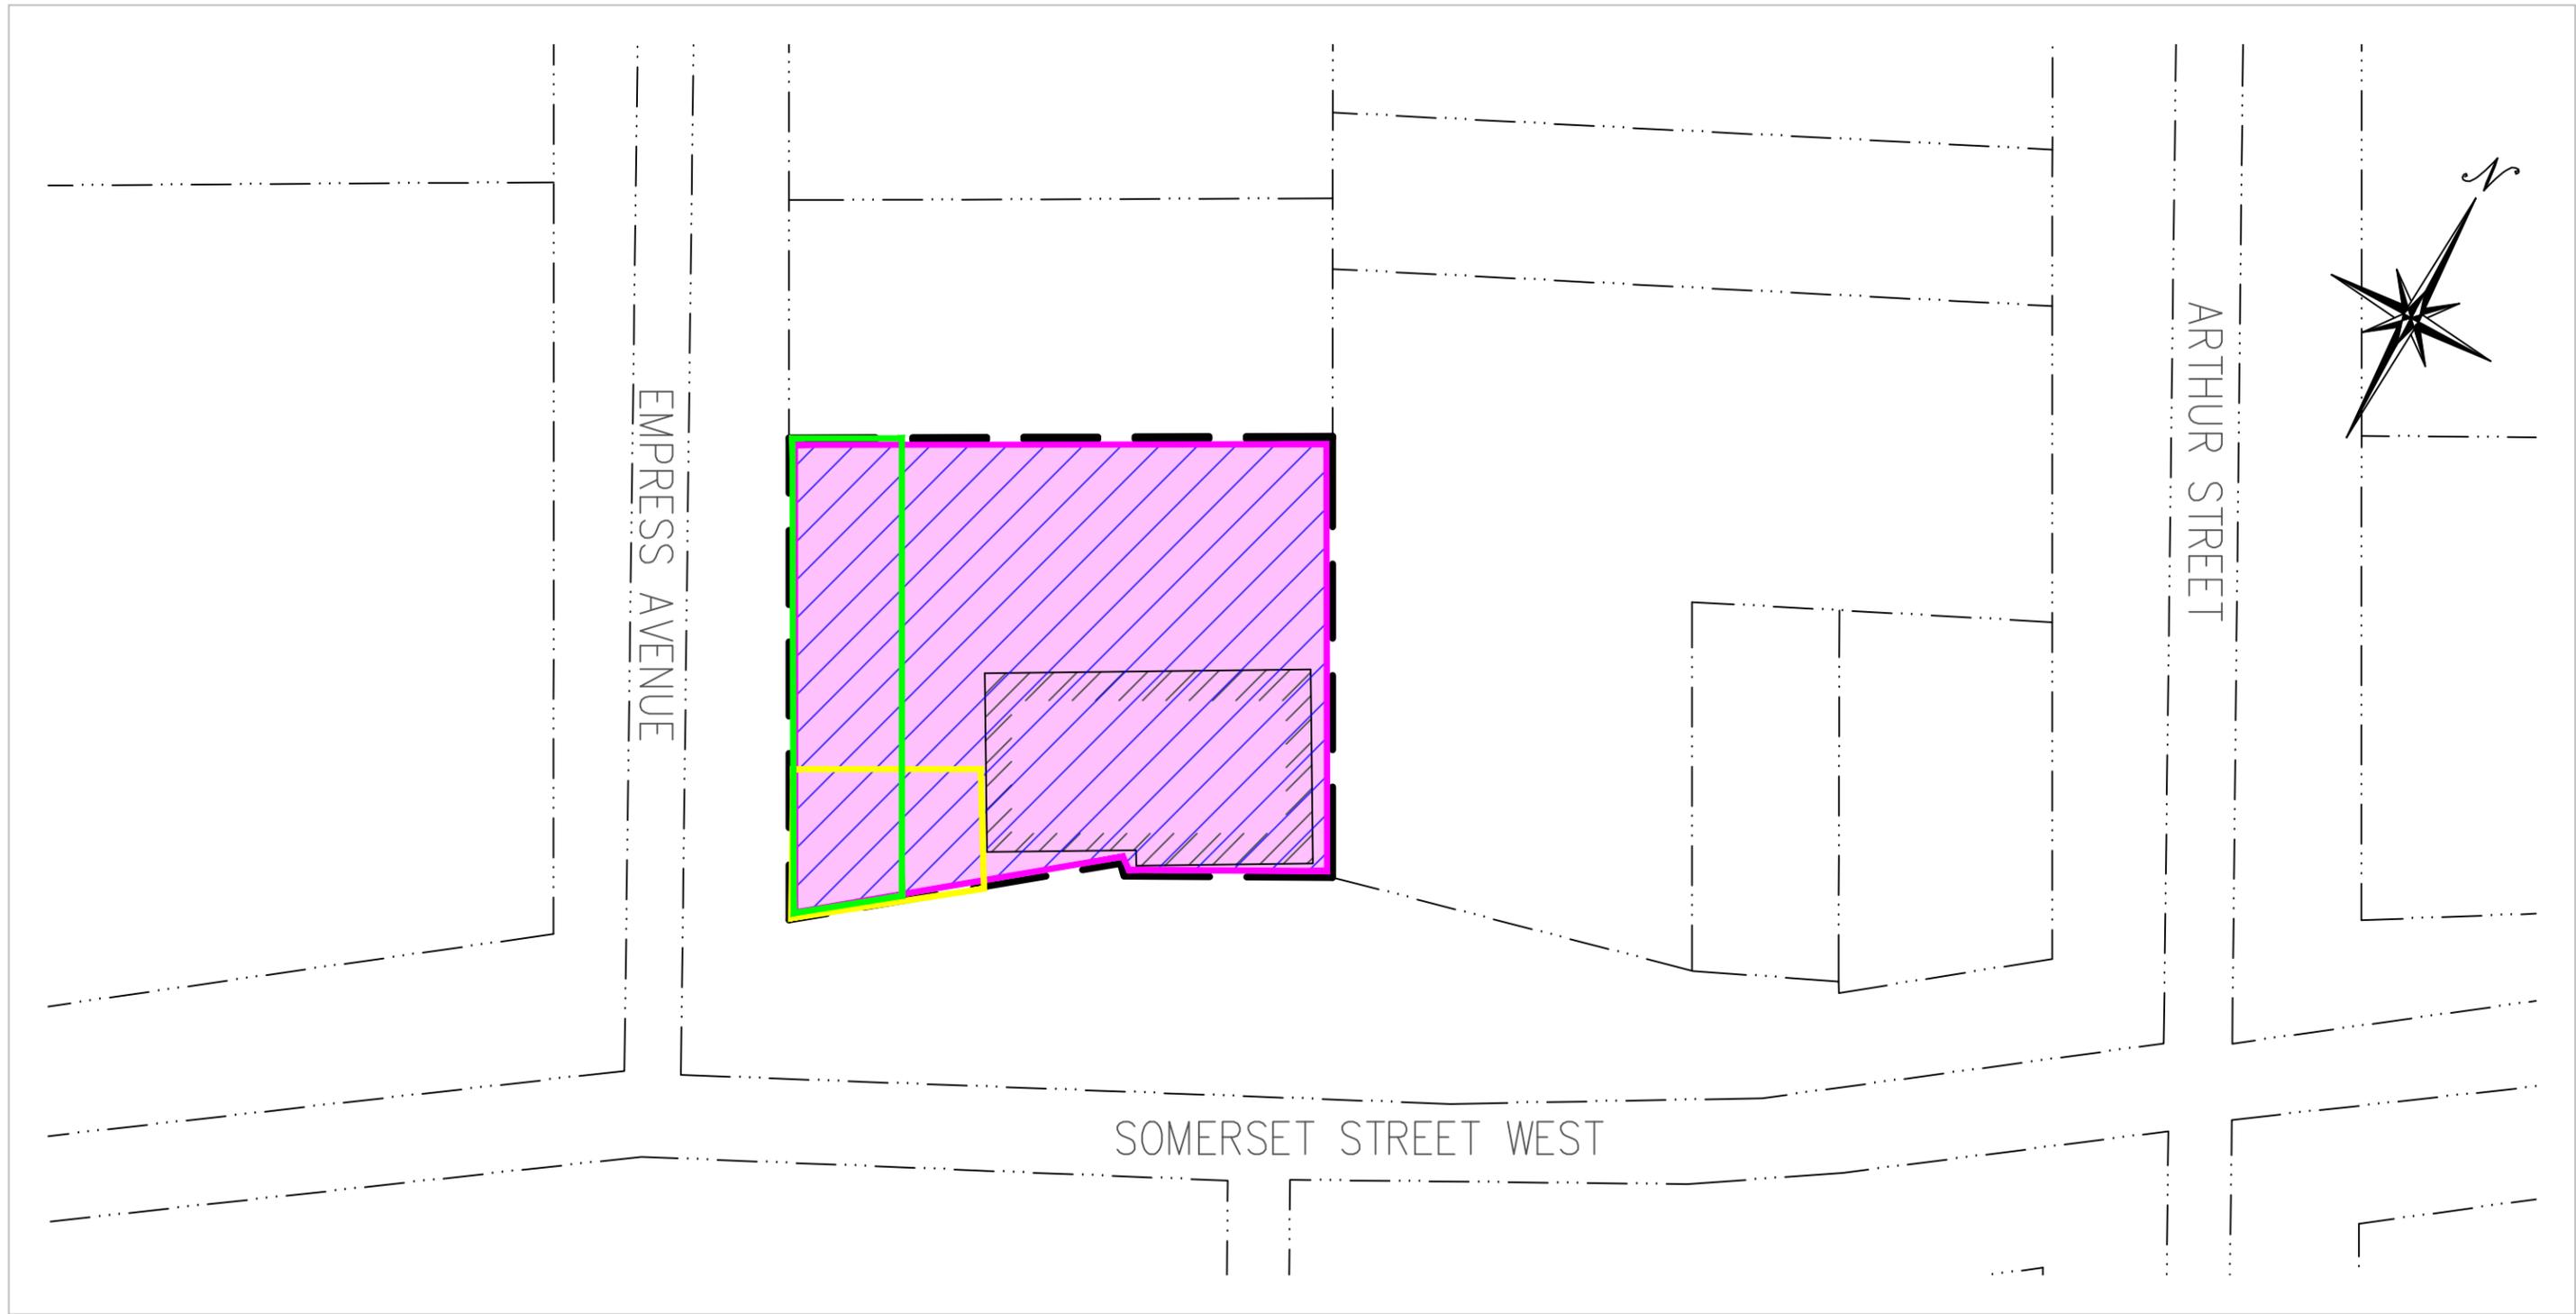
**FIGURE 3**

- APEC 1 (AS DEFINED IN REPORT)
- APEC 2 (AS DEFINED IN REPORT)
- APEC 3 & APEC 4 (AS DEFINED IN REPORT)
- APEC 5 & APEC 6 (AS DEFINED IN REPORT)

APEC	Location	Comments	Contaminants of Potential Concern	Media Potentially Impacted
APEC 1	Entirety of Site	<b>PCA Other:</b> Use of formaldehyde and other associated chemicals. Related to the former funeral parlor operations and likely storage of chemicals.	Metals, VOCs, formaldehyde.	Soil and groundwater
APEC 2	Entirety of Site	<b>PCA 30:</b> Importation of Fill Material of Unknown Quality. To address the likely presence of fill of unknown origin.	VOC, PHC, Metals, Inorganics.	Soil
APEC 3	Southwest corner of the Site	<b>PCA 28:</b> Gasoline and Associated Products Storage in Fixed Tanks.  <b>PCA 52:</b> Storage, maintenance, fuelling and repair of equipment, vehicles and materials used to maintain transportation systems.  To address possible impacts associated with the historical neighbouring automotive garage and fuel handling facility.	VOC, PHC, Metals and PAH.	Soil and Groundwater
APEC 4	Southern portion of the Site	<b>PCA Other:</b> Waste Generators. To address the records retrieved of light fuel and pigments/coatings/paints up-gradient of the Site.	VOC, PHC, and Metals.	Soil and Groundwater

APEC 5	Western portion of the Site	<b>PCA 28:</b> Gasoline and Associated Products Storage in Fixed Tanks. To address the records of the former boiler system in the basement of the property to the west of the Site.	PAH, VOC and PHC.	Soil and Groundwater
APEC 6	Southern portion of the Site	<b>PCA Other:</b> Spills. To address the records of spills retrieved up-gradient of the Site.	VOC, PHC, Metals and PAH	Soil and Groundwater

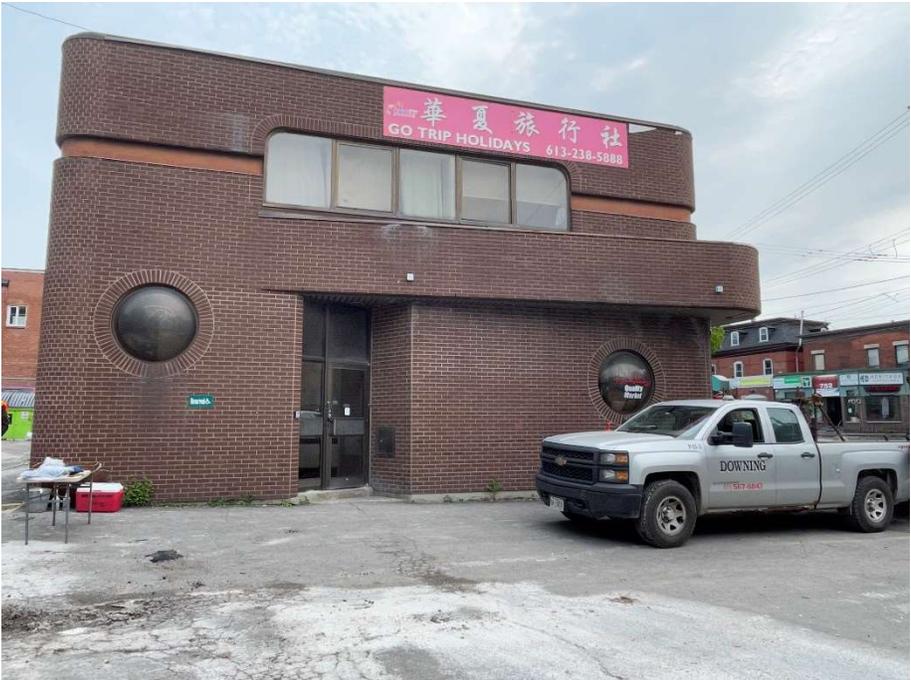
Photograph No. 1

Date: 5/16/2023	
Description  General Site Conditions, western face of existing building on the property.

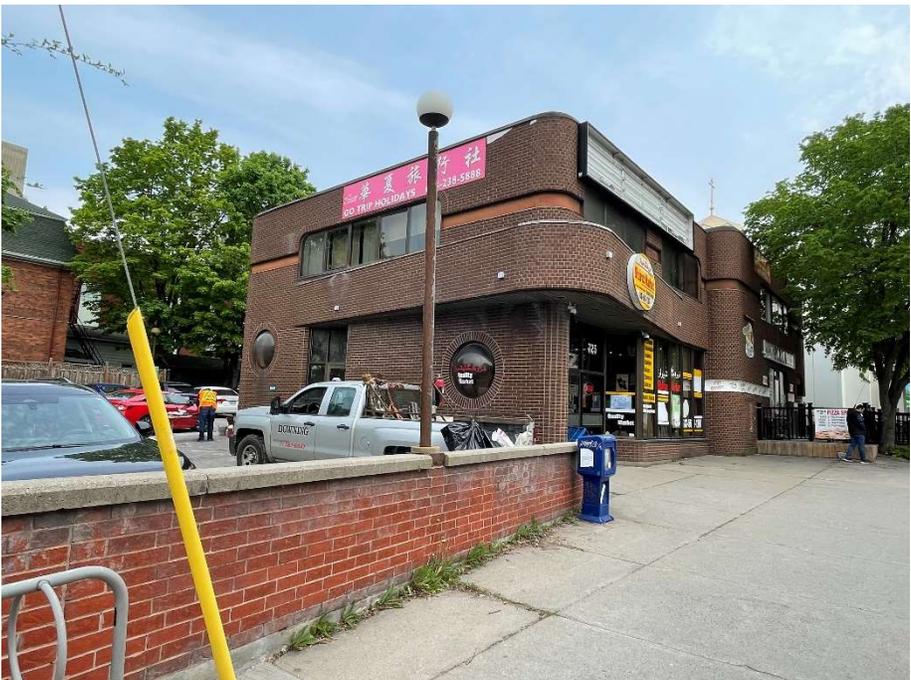
Photograph No. 2

Date: 5/16/2023	
Description  Along southern perimeter of the Site, from west facing east.

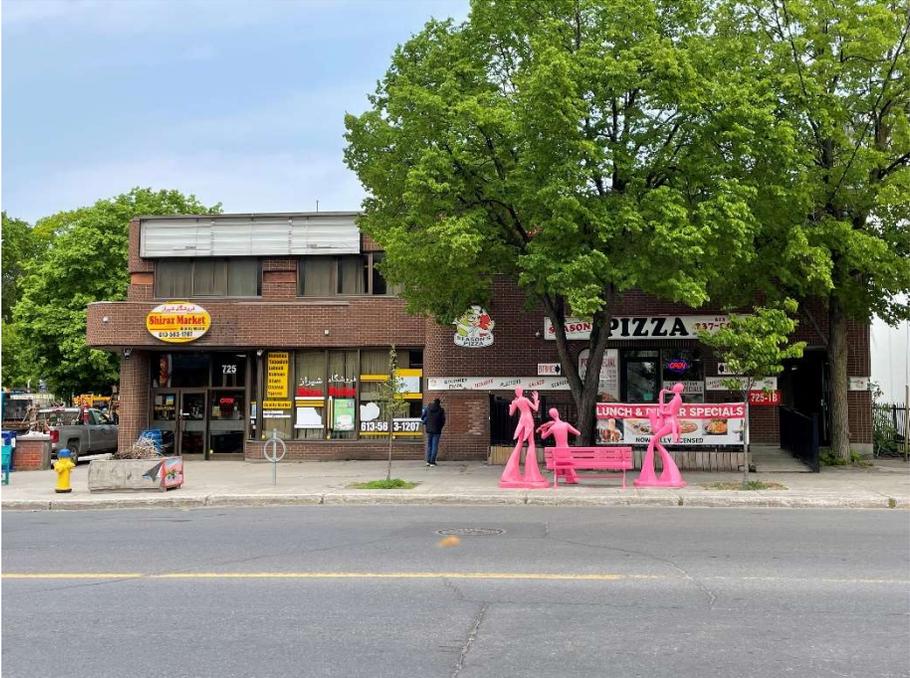
Photograph No. 3

Date: 5/16/2023	
Description  From south of Somerset Street West facing north towards the southern face of the existing development on the Site.

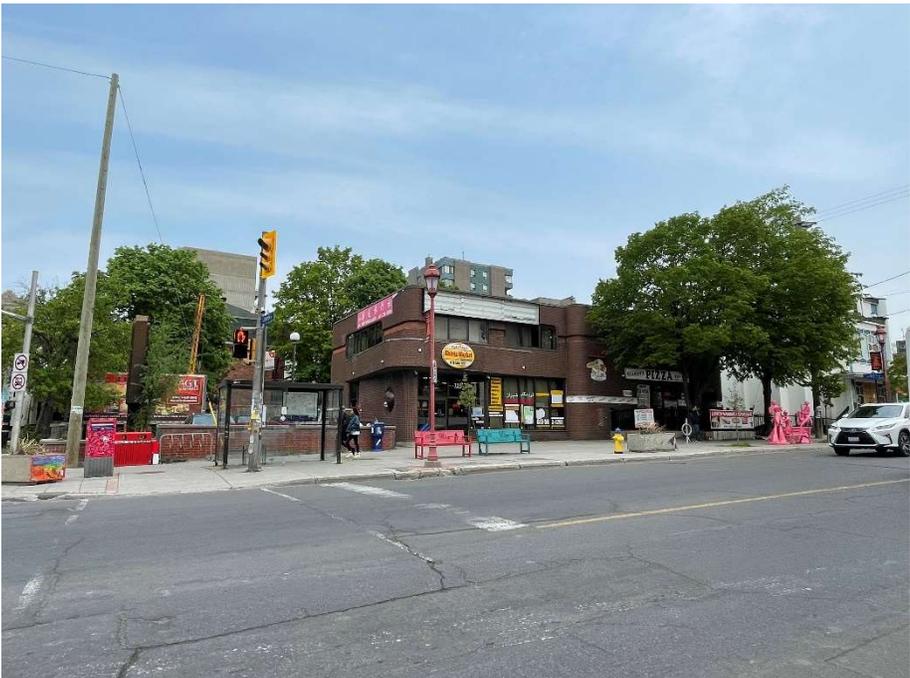
Photograph No. 4

Date: 5/16/2023	
Description  Somerset Street West facing north towards the south-western portion of the Site.

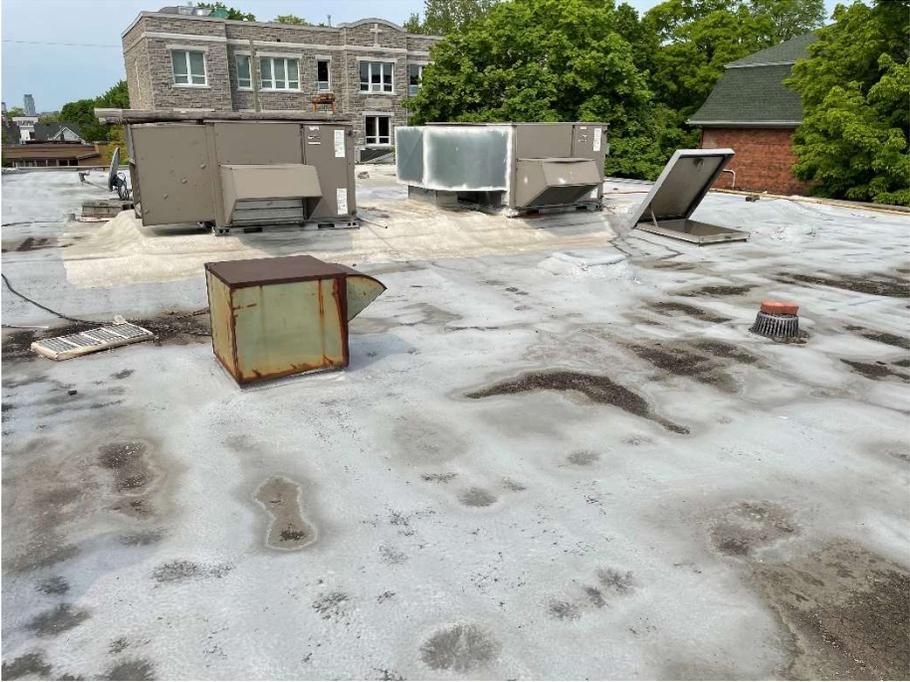
Photograph No. 5

Date: 5/16/2023	
Description Roof top of existing development structure on the Site.

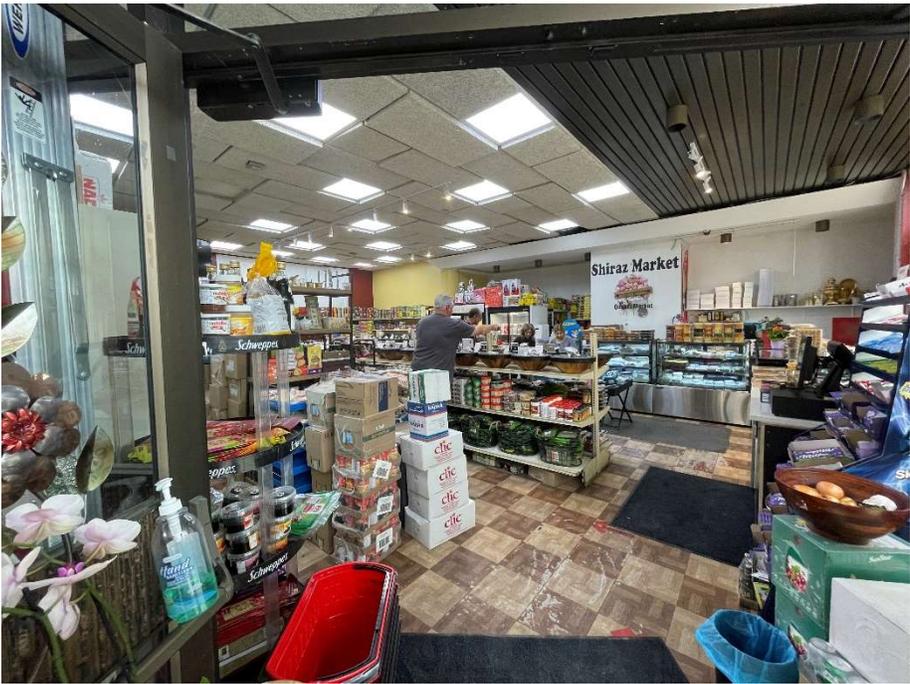
Photograph No. 6

Date: 5/16/2023	
Description General interior conditions of retailer within the development on the Site.

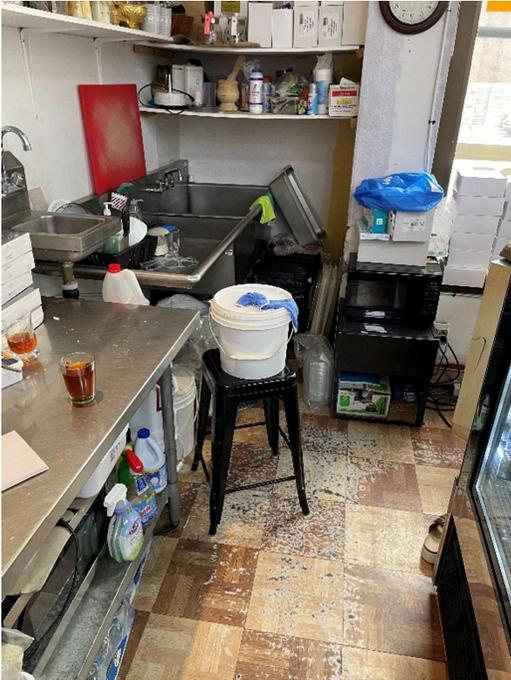
Photograph No. 9

Date: 5/16/2023	
Description  Typical conditions of restaurant kitchen facility present on the Site.

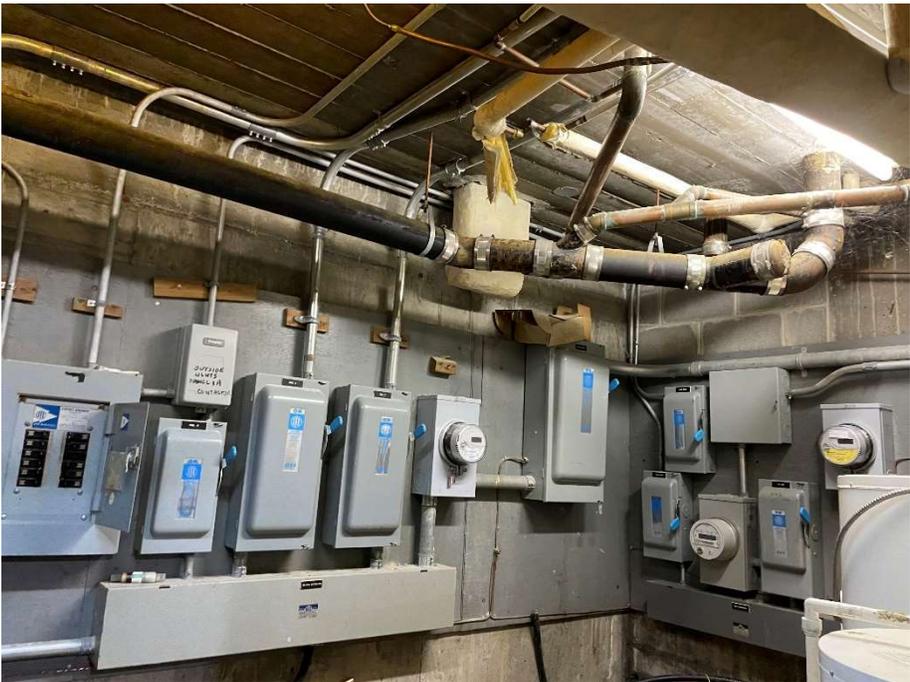
Photograph No. 10

Date: 5/16/2023	
Description  Electrical panelling located in the basement of the development on the Site.
