# Geotechnical Investigation Proposed Residential Development

3432 Greenbank Road Ottawa, Ontario

Prepared for Minto Communities Inc.

Report PG5348-1 Revision 5 dated August 10, 2023

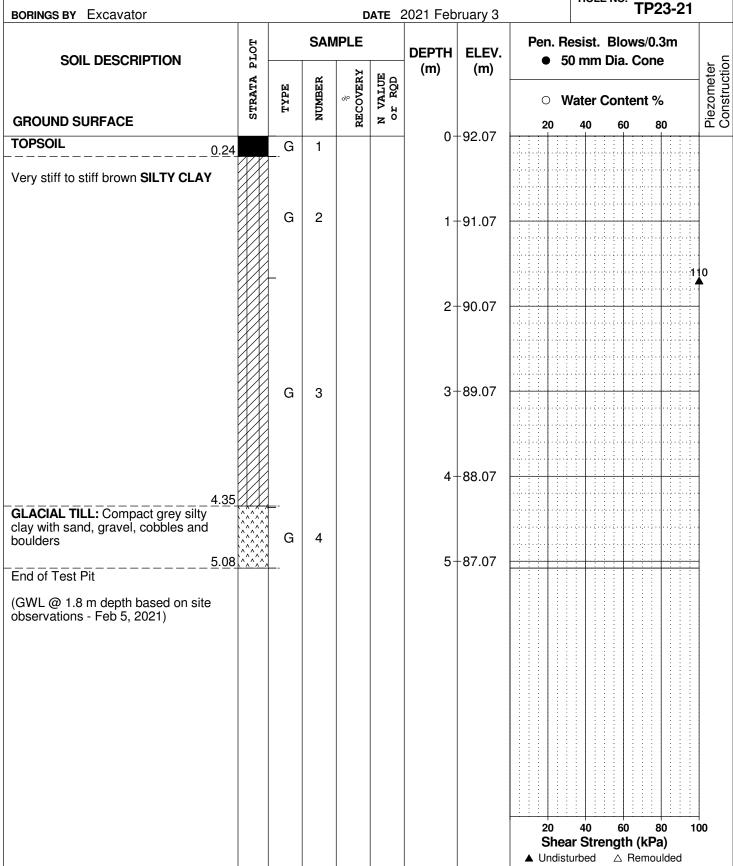
**DATUM** Geodetic FILE NO. **PG5348 REMARKS** HOLE NO. **TP23-21 BORINGS BY** Excavator DATE 2021 February 3

**SOIL PROFILE AND TEST DATA**

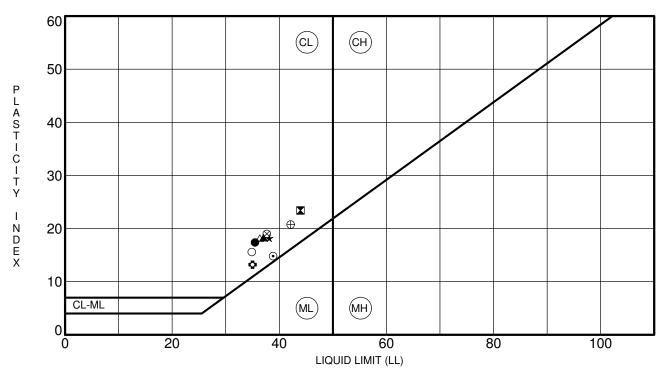
S	pecimen Identification	LL	PL	PI	Fines	Classification
•	TP 4-21 G4	35	18	17	93.0	CL= Inorganic Clays of Low Plasticity
	TP 5-21 G3	44	21	23		<b>CL= Inorganic Clays of Low Plasticity</b>
lack	TP 6-21 G3	37	19	18		CL= Inorganic Clays of Low Plasticity
*	TP 7-21 G2	38	20	18		<b>CL= Inorganic Clays of Low Plasticity</b>
$\odot$	TP 8-21 G2	39	24	15	88.6	CL= Inorganic Clays of Low Plasticity
0	TP 9-21 G2	35	22	13		CL= Inorganic Clays of Low Plasticity
	TP10-21 G2	35	19	16		CL= Inorganic Clays of Low Plasticity
	TP11-21 G2	36	18	18		CL= Inorganic Clays of Low Plasticity
$\otimes$	TP12-21 G3	38	19	19	71.8	CL= Inorganic Clays of Low Plasticity
$\oplus$	TP13-21 G2	42	21	21		CL= Inorganic Clays of Low Plasticity

ATTERBERG LIMITS'
RESULTS

Atterberg limits testing, as well as associated moisture content testing, was completed on the recovered silty clay samples at selected locations throughout the subject site. The results are summarized in Table 2 and presented on the Grain Size Distribution sheet in Appendix 1.

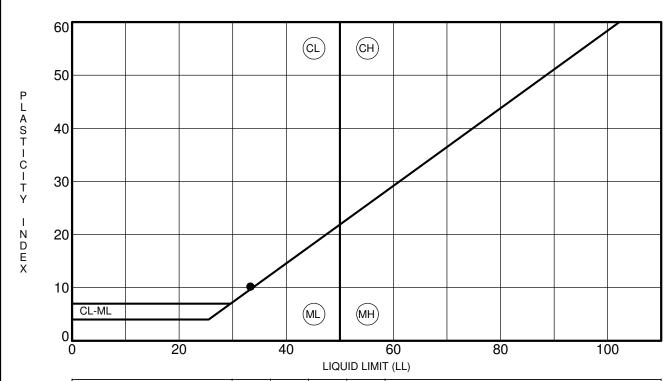
S	Specimen Identification		LL	PL	PI	Fines	Classification
•	BH10-21	SS2	33	23	10		CL - Inorganic clays of low plasticity

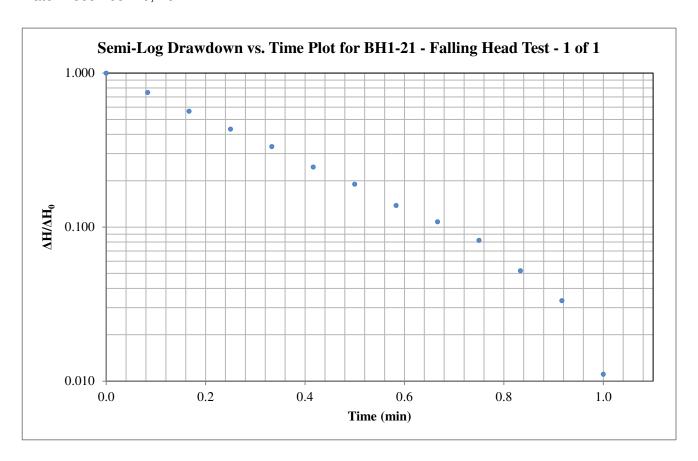
Test Location: BH1-21

Test: Falling Head Test - 1 of 1 Date: December 20, 2021

Hvorslev Horizontal Hydraulic Conductivity

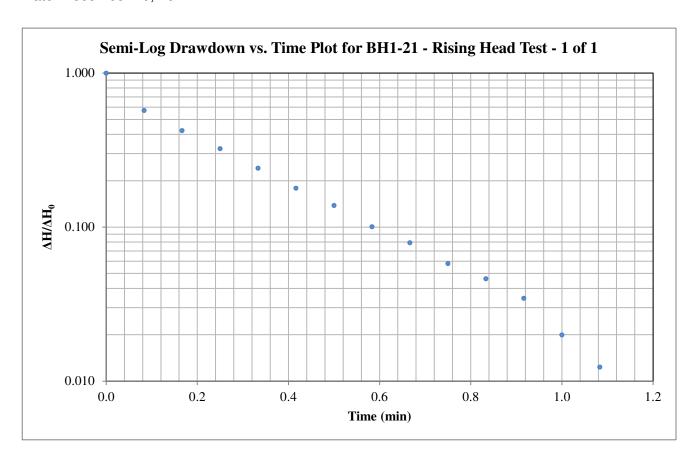
Test Location: BH1-21

Test: Rising Head Test - 1 of 1 Date: December 20, 2021

Hvorslev Horizontal Hydraulic Conductivity

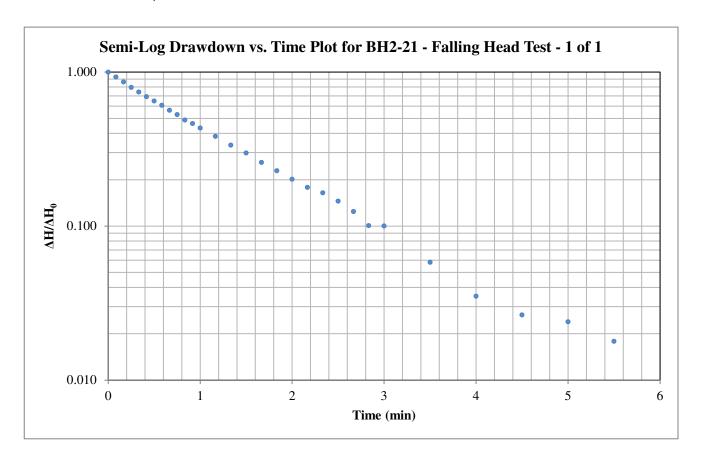
Test Location: BH2-21

Test: Falling Head Test - 1 of 1 Date: December 20, 2021

Hvorslev Horizontal Hydraulic Conductivity

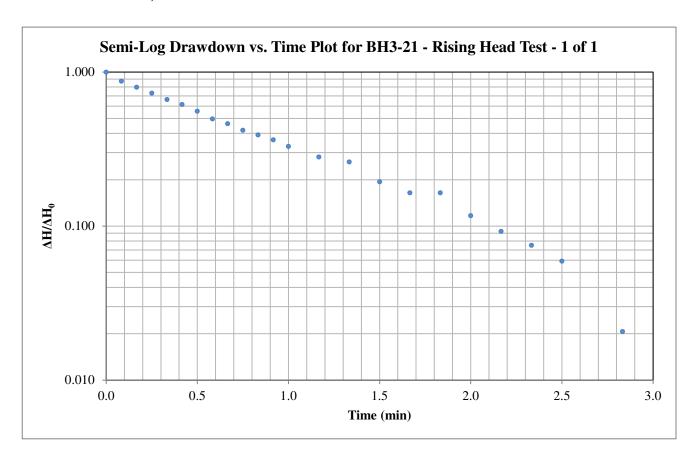
Test Location: BH3-21

Test: Rising Head Test - 1 of 1 Date: December 20, 2021

Hvorslev Horizontal Hydraulic Conductivity

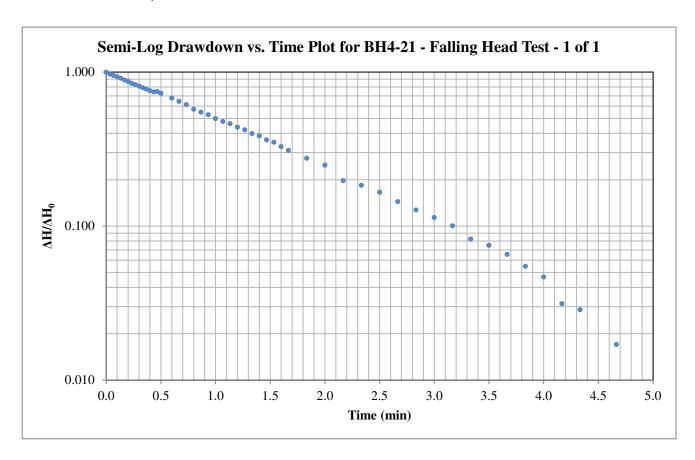
Test Location: BH4-21

Test: Falling Head Test - 1 of 1 Date: December 21, 2021

Hvorslev Horizontal Hydraulic Conductivity

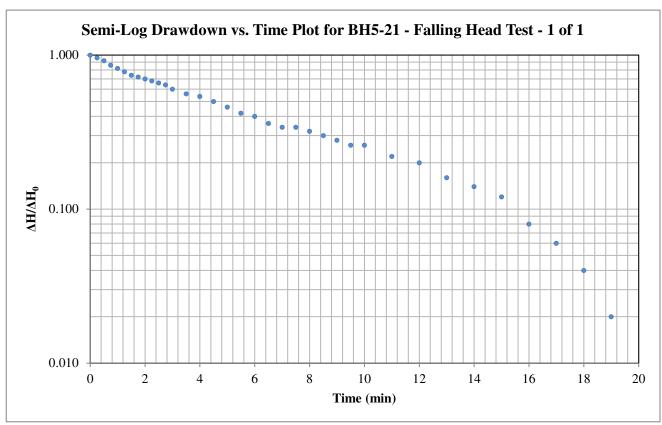
Test Location: BH5-21

Test: Falling Head Test - 1 of 1 Date: December 23, 2021

Hvorslev Horizontal Hydraulic Conductivity

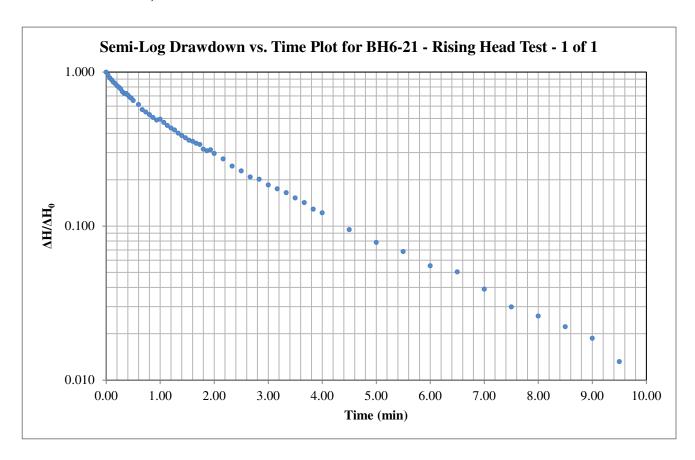
Test Location: BH6-21

Test: Rising Head Test - 1 of 1 Date: December 21, 2021

Hvorslev Horizontal Hydraulic Conductivity

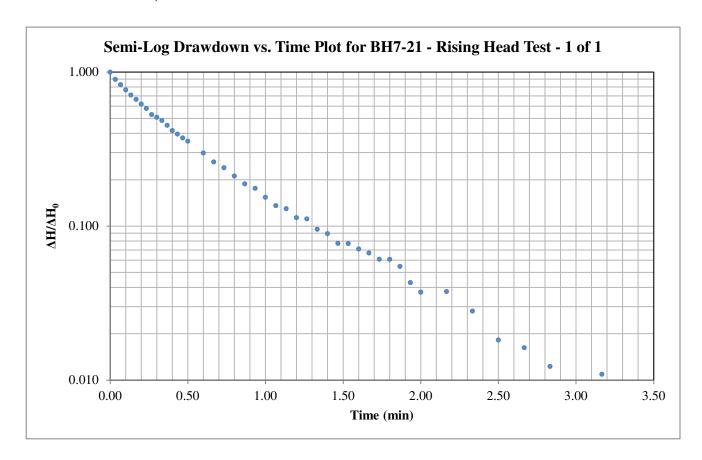
Test Location: BH7-21

Test: Rising Head Test - 1 of 1 Date: December 21, 2021

Hvorslev Horizontal Hydraulic Conductivity

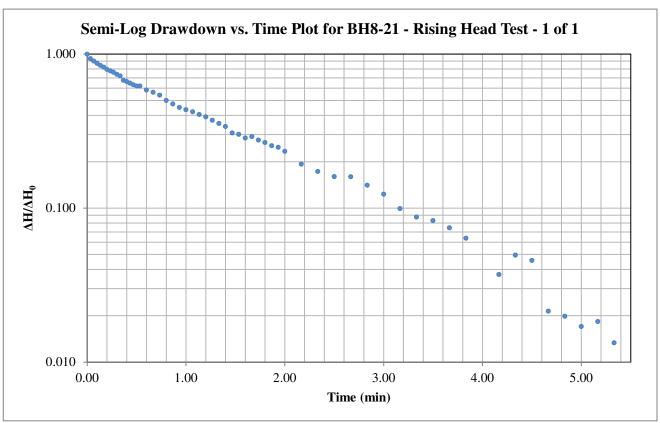
Test Location: BH8-21

Test: Rising Head Test - 1 of 1 Date: December 21, 2021

Hvorslev Horizontal Hydraulic Conductivity

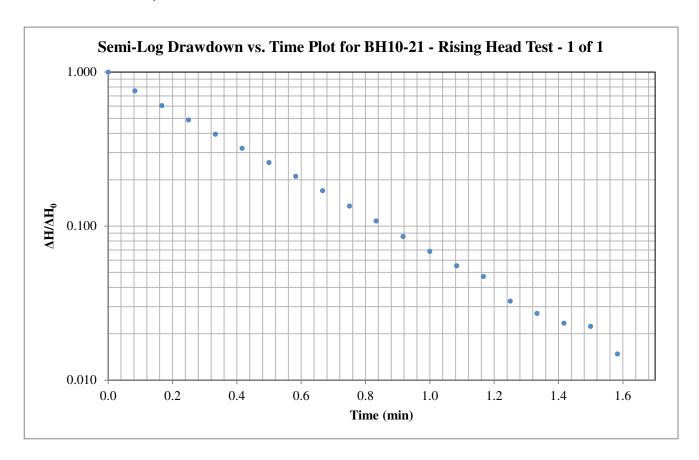
Test Location: BH10-21
Test: Rising Head Test - 1 of 1
Date: December 20, 2021

Hvorslev Horizontal Hydraulic Conductivity
