Geotechnical Investigation

Proposed Residential Development
2009-2013 Prince of Wales Drive
Ottawa, Ontario
Revision 2

LRL File No.: 220528

December 2022, *Revised: November 2023*

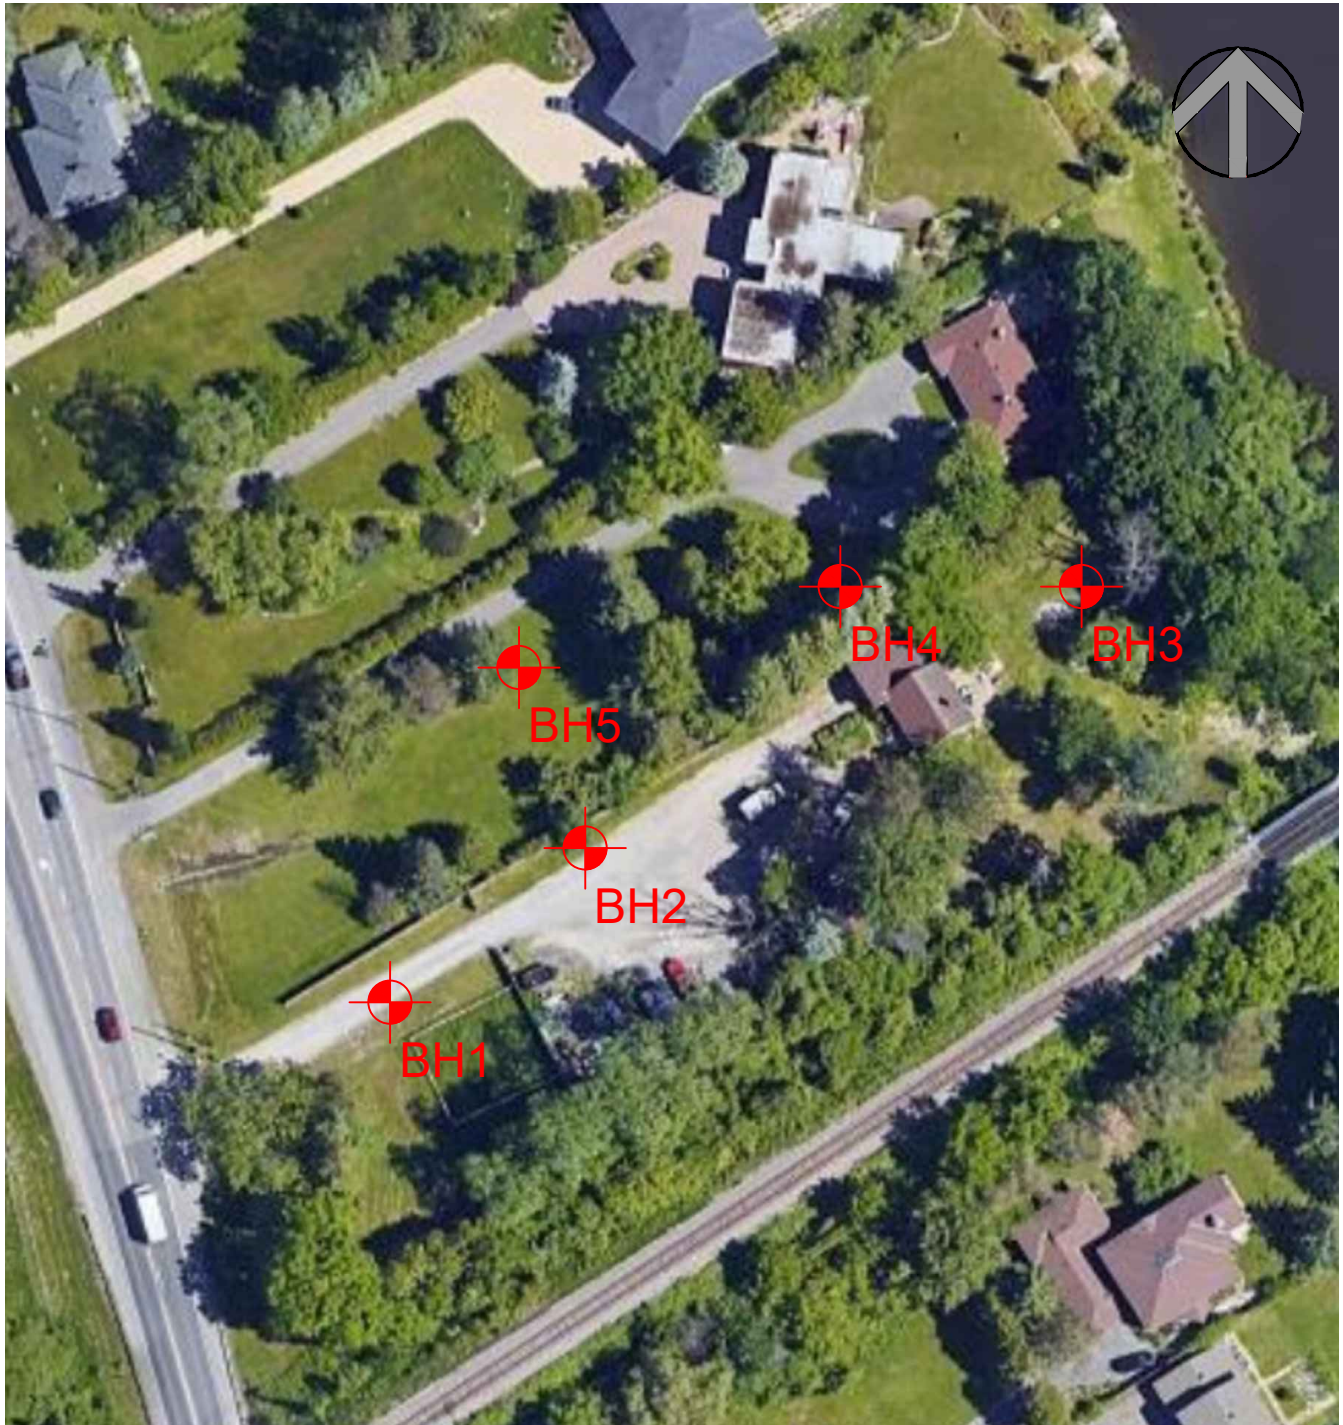
FIGURE 2

The fieldwork for this investigation was carried out on November 28, 2022. Prior to the fieldwork, the site was cleared for the presence of any underground services and utilities. A total of five (5) boreholes were drilled onsite to get a general representation of the site's underlying soil conditions, and labelled BH1 through BH5. The approximate locations of the boreholes are shown in Figure 2 included in **Appendix A**.

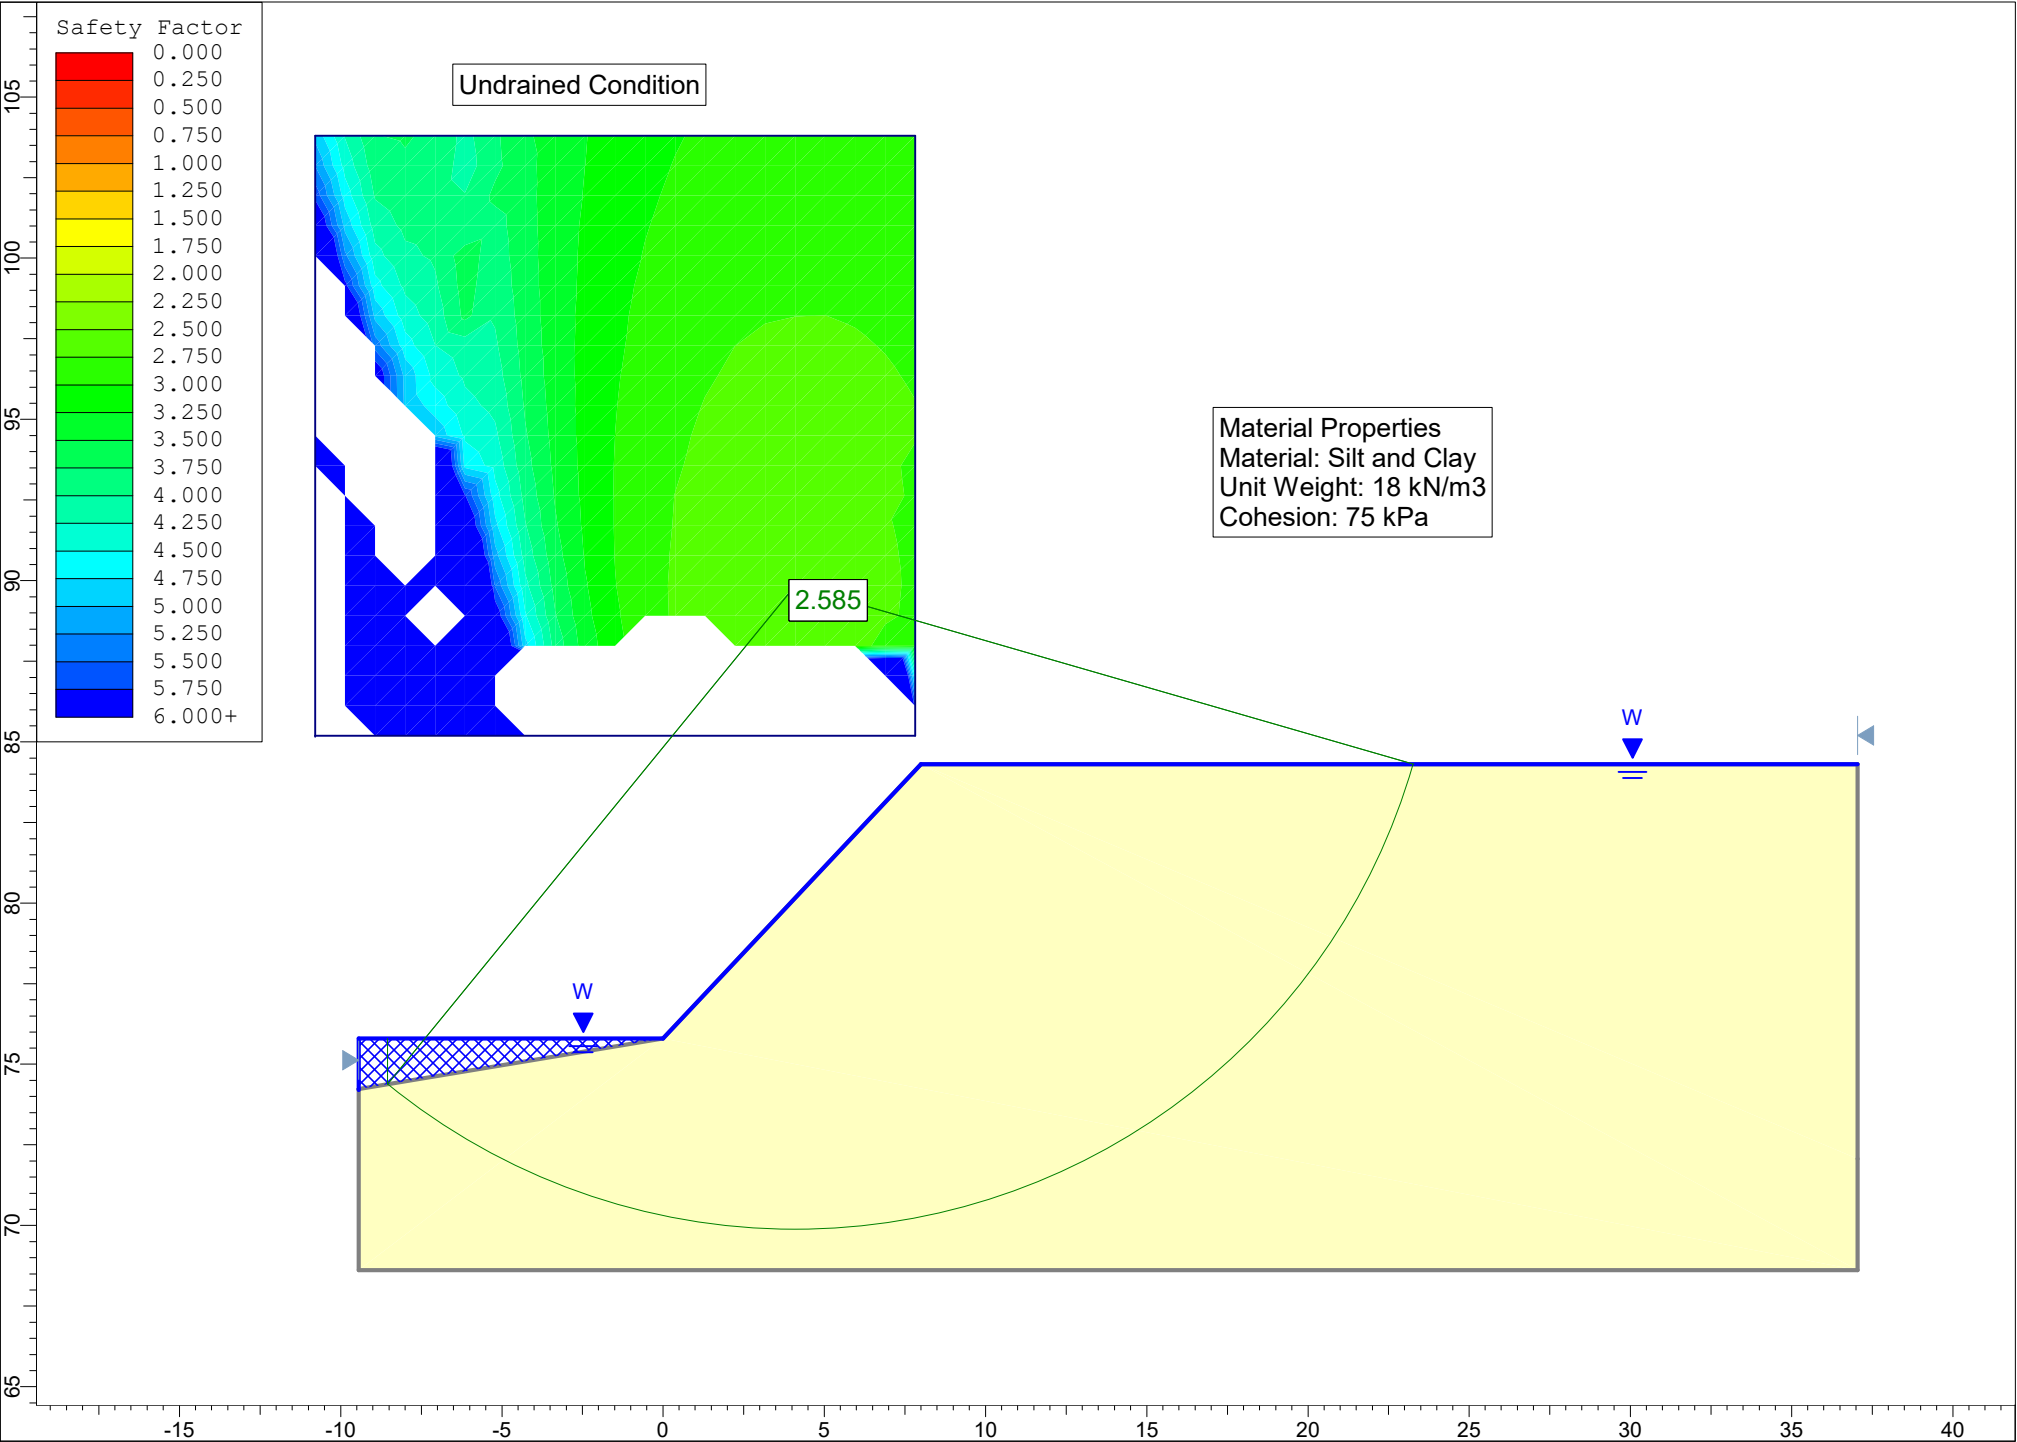
APPENDIX E
Slope Stability Modelling Results

The slope modelling program, Slide 5.0 (Rocscience), was used to implement the Bishop simplified method of slices. A slope profile, considered to be the steepest onsite (worst case scenario) was selected and modeled to check the conditions of the slope. The slope was analyzed under both the undrained (short term failure) and drained (long term failure) conditions.

Drained Condition	Undrained Condition	Seismic
Factor of Safety	0.42	2.59	1.81
Min. Required	1.50	1.50	1.10

These results indicate that the slope is unstable in the drained (long-term) condition. A setback for any permanent structure(s) (dwellings, decks, sheds, gazebos, pools, etc.) from the top of the slope is required to ensure that in the event of a slope failure, the structure(s) will be unharmed. The model was filtered to illustrate the failure surface with a FOS below 1.50.

The Stable Slope Allowance is the area where a factor of safety is less than 1.50 against overall rotational failure. As indicated in the attached model, **a 19.0 m setback is required for Stable Slope Allowance.**

The seismic analysis was performed by incorporating the seismic coefficient (k_h) into the modelling. The peak ground acceleration (PGA) for this area is equal to 0.28 for the 2% in 50 year probability of exceedance as per the NBC 2015. The value for k_h was taken as 50% of the PGA, which equates to 0.14. The minimum factor of safety (FoS) with regards to seismic condition is 1.10.

The results of the analyses are potentially dependent on the assumption of groundwater condition. During the development of this report, no information on the groundwater level was available throughout the year. However, as a conservative approach the analysis was completed assuming full saturation throughout the slope profile.
