Supplemental Phase II Environmental Site Assessment

1531 St. Laurent Boulevard, Ottawa, ON

Katasa Groupe + Développement
Final Report
02105693.001

February 2022

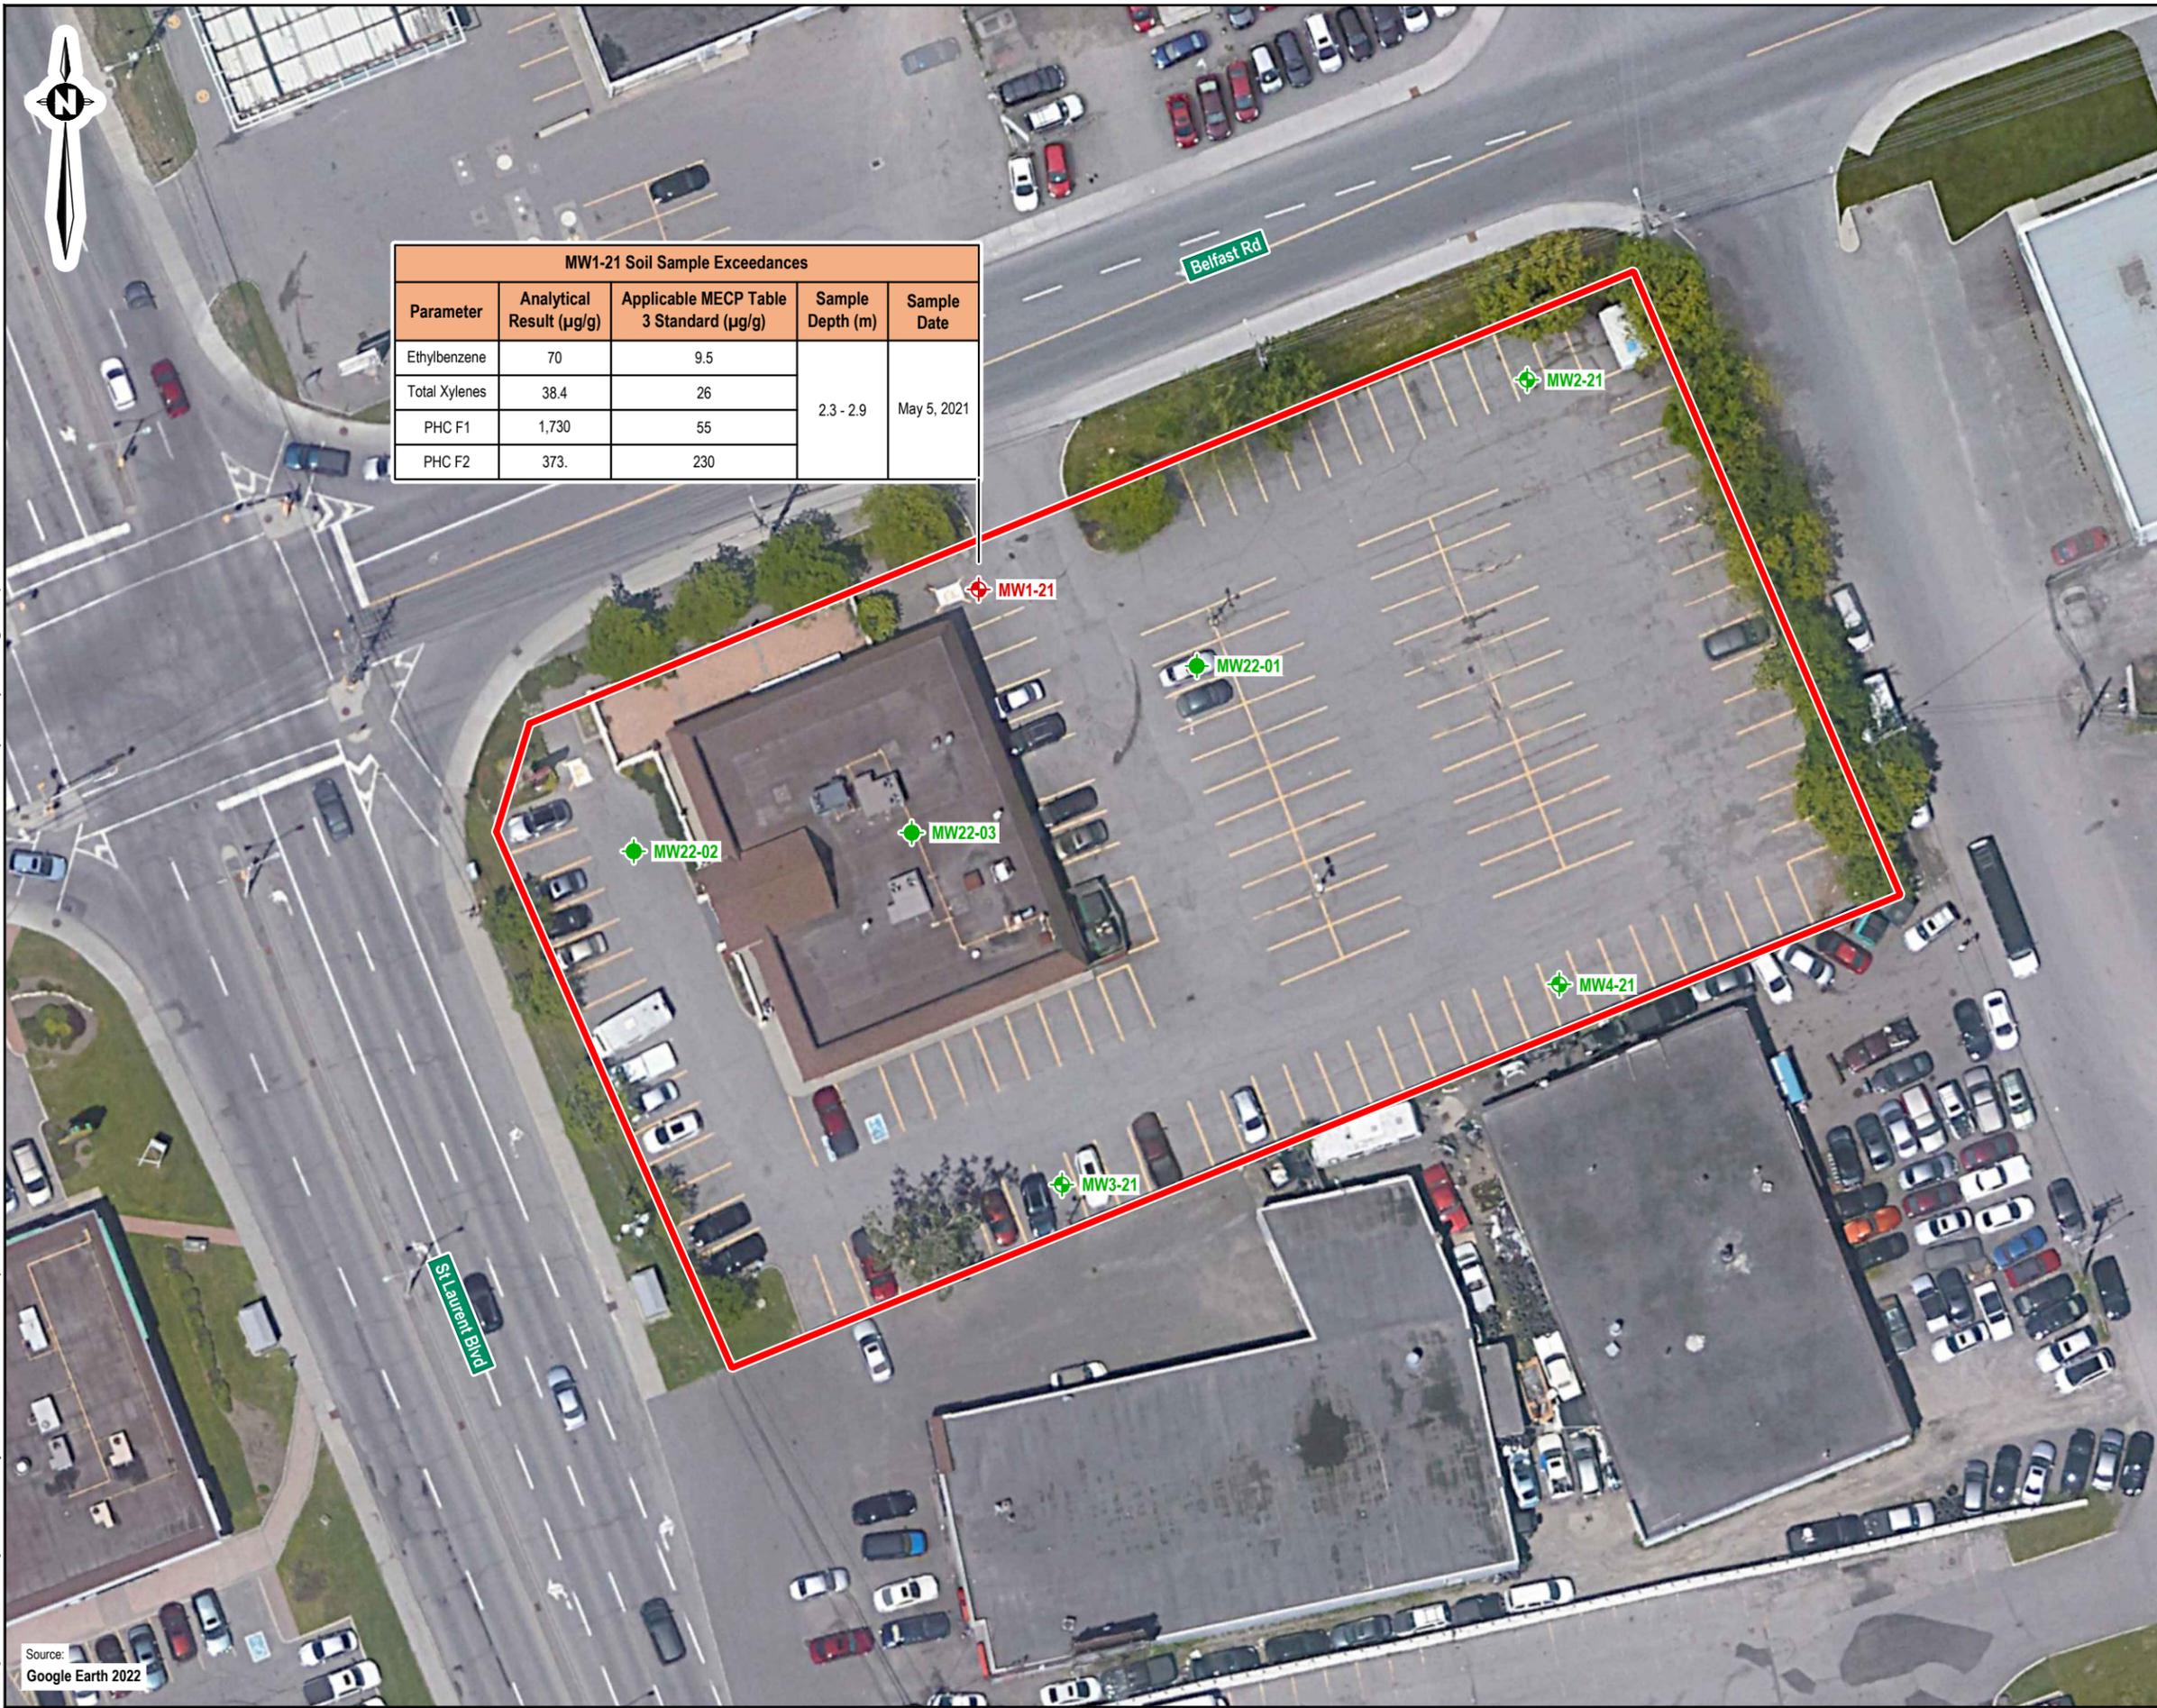
MW1-21 Soil Sample Exceedances				
Parameter	Analytical Result (µg/g)	Applicable MECP Table 3 Standard (µg/g)	Sample Depth (m)	Sample Date
Ethylbenzene	70	9.5	2.3 - 2.9	May 5, 2021
Total Xylenes	38.4	26		
PHC F1	1,730	55		
PHC F2	373.	230

Therefore, based on the results of the Supplemental Phase II ESA, it is estimated that impacted soils in relation to the current Site Condition Standards (i.e., MECP Table 3 standards for Industrial/Commercial/Community Property Use and coarse textured soils) are limited to an area along the northern Site boundary, around borehole location MW1-21 (DST, 2021), from a depth of approximately 1.0 to 3.0 m bgs.

Therefore, based on the results of the Supplemental Phase II ESA, it is estimated that impacted soils in relation to the current Site Condition Standards (i.e., MECP Table 3 standards for Industrial/Commercial/Community Property Use and coarse textured soils) are limited to an area along the northern Site boundary, around borehole location MW1-21, from a depth of approximately 1.0 to 3.0 m bgs.
