Preliminary Geotechnical Investigation Report

Future Commercial Development

2095 Dilworth Road

Englobe Ref No: 02101208.000

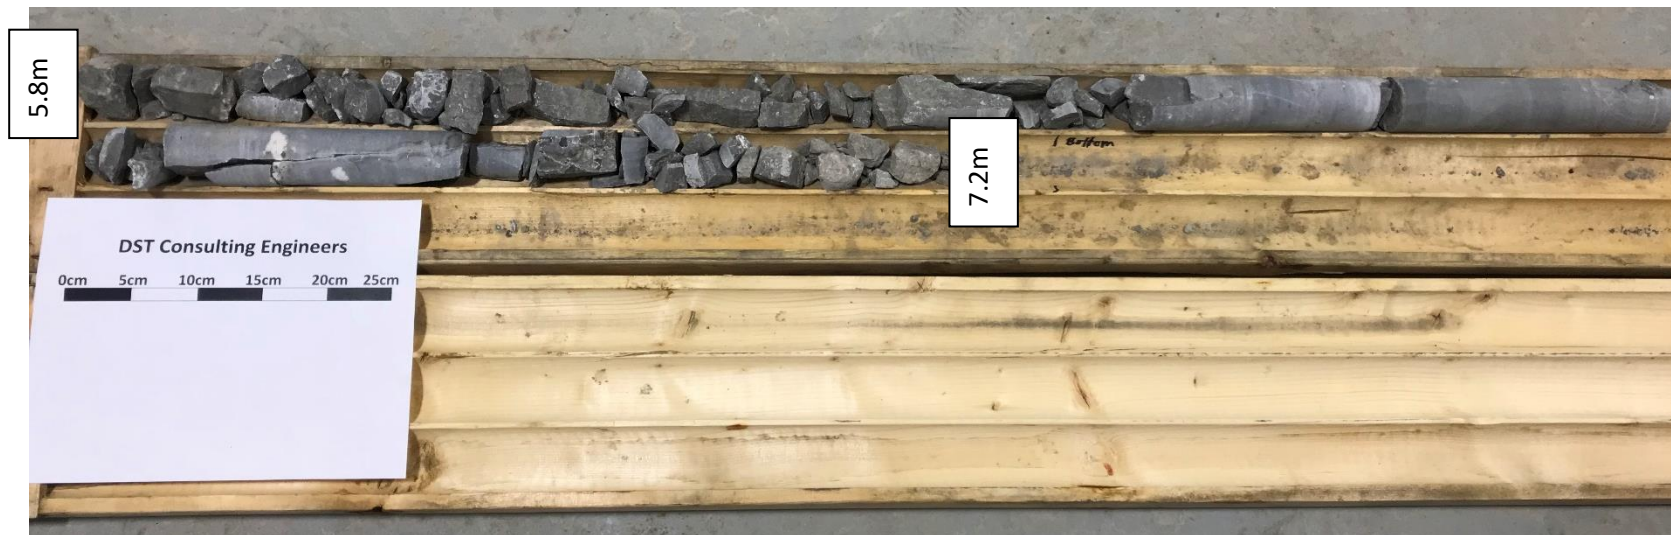
Rock Core Photo No.: 1

Borehole: BH 21-05
