# Hydrogeological Study Report

2095 Dilworth Road

Kars, Ontario

Englobe Ref No: 02101208.000

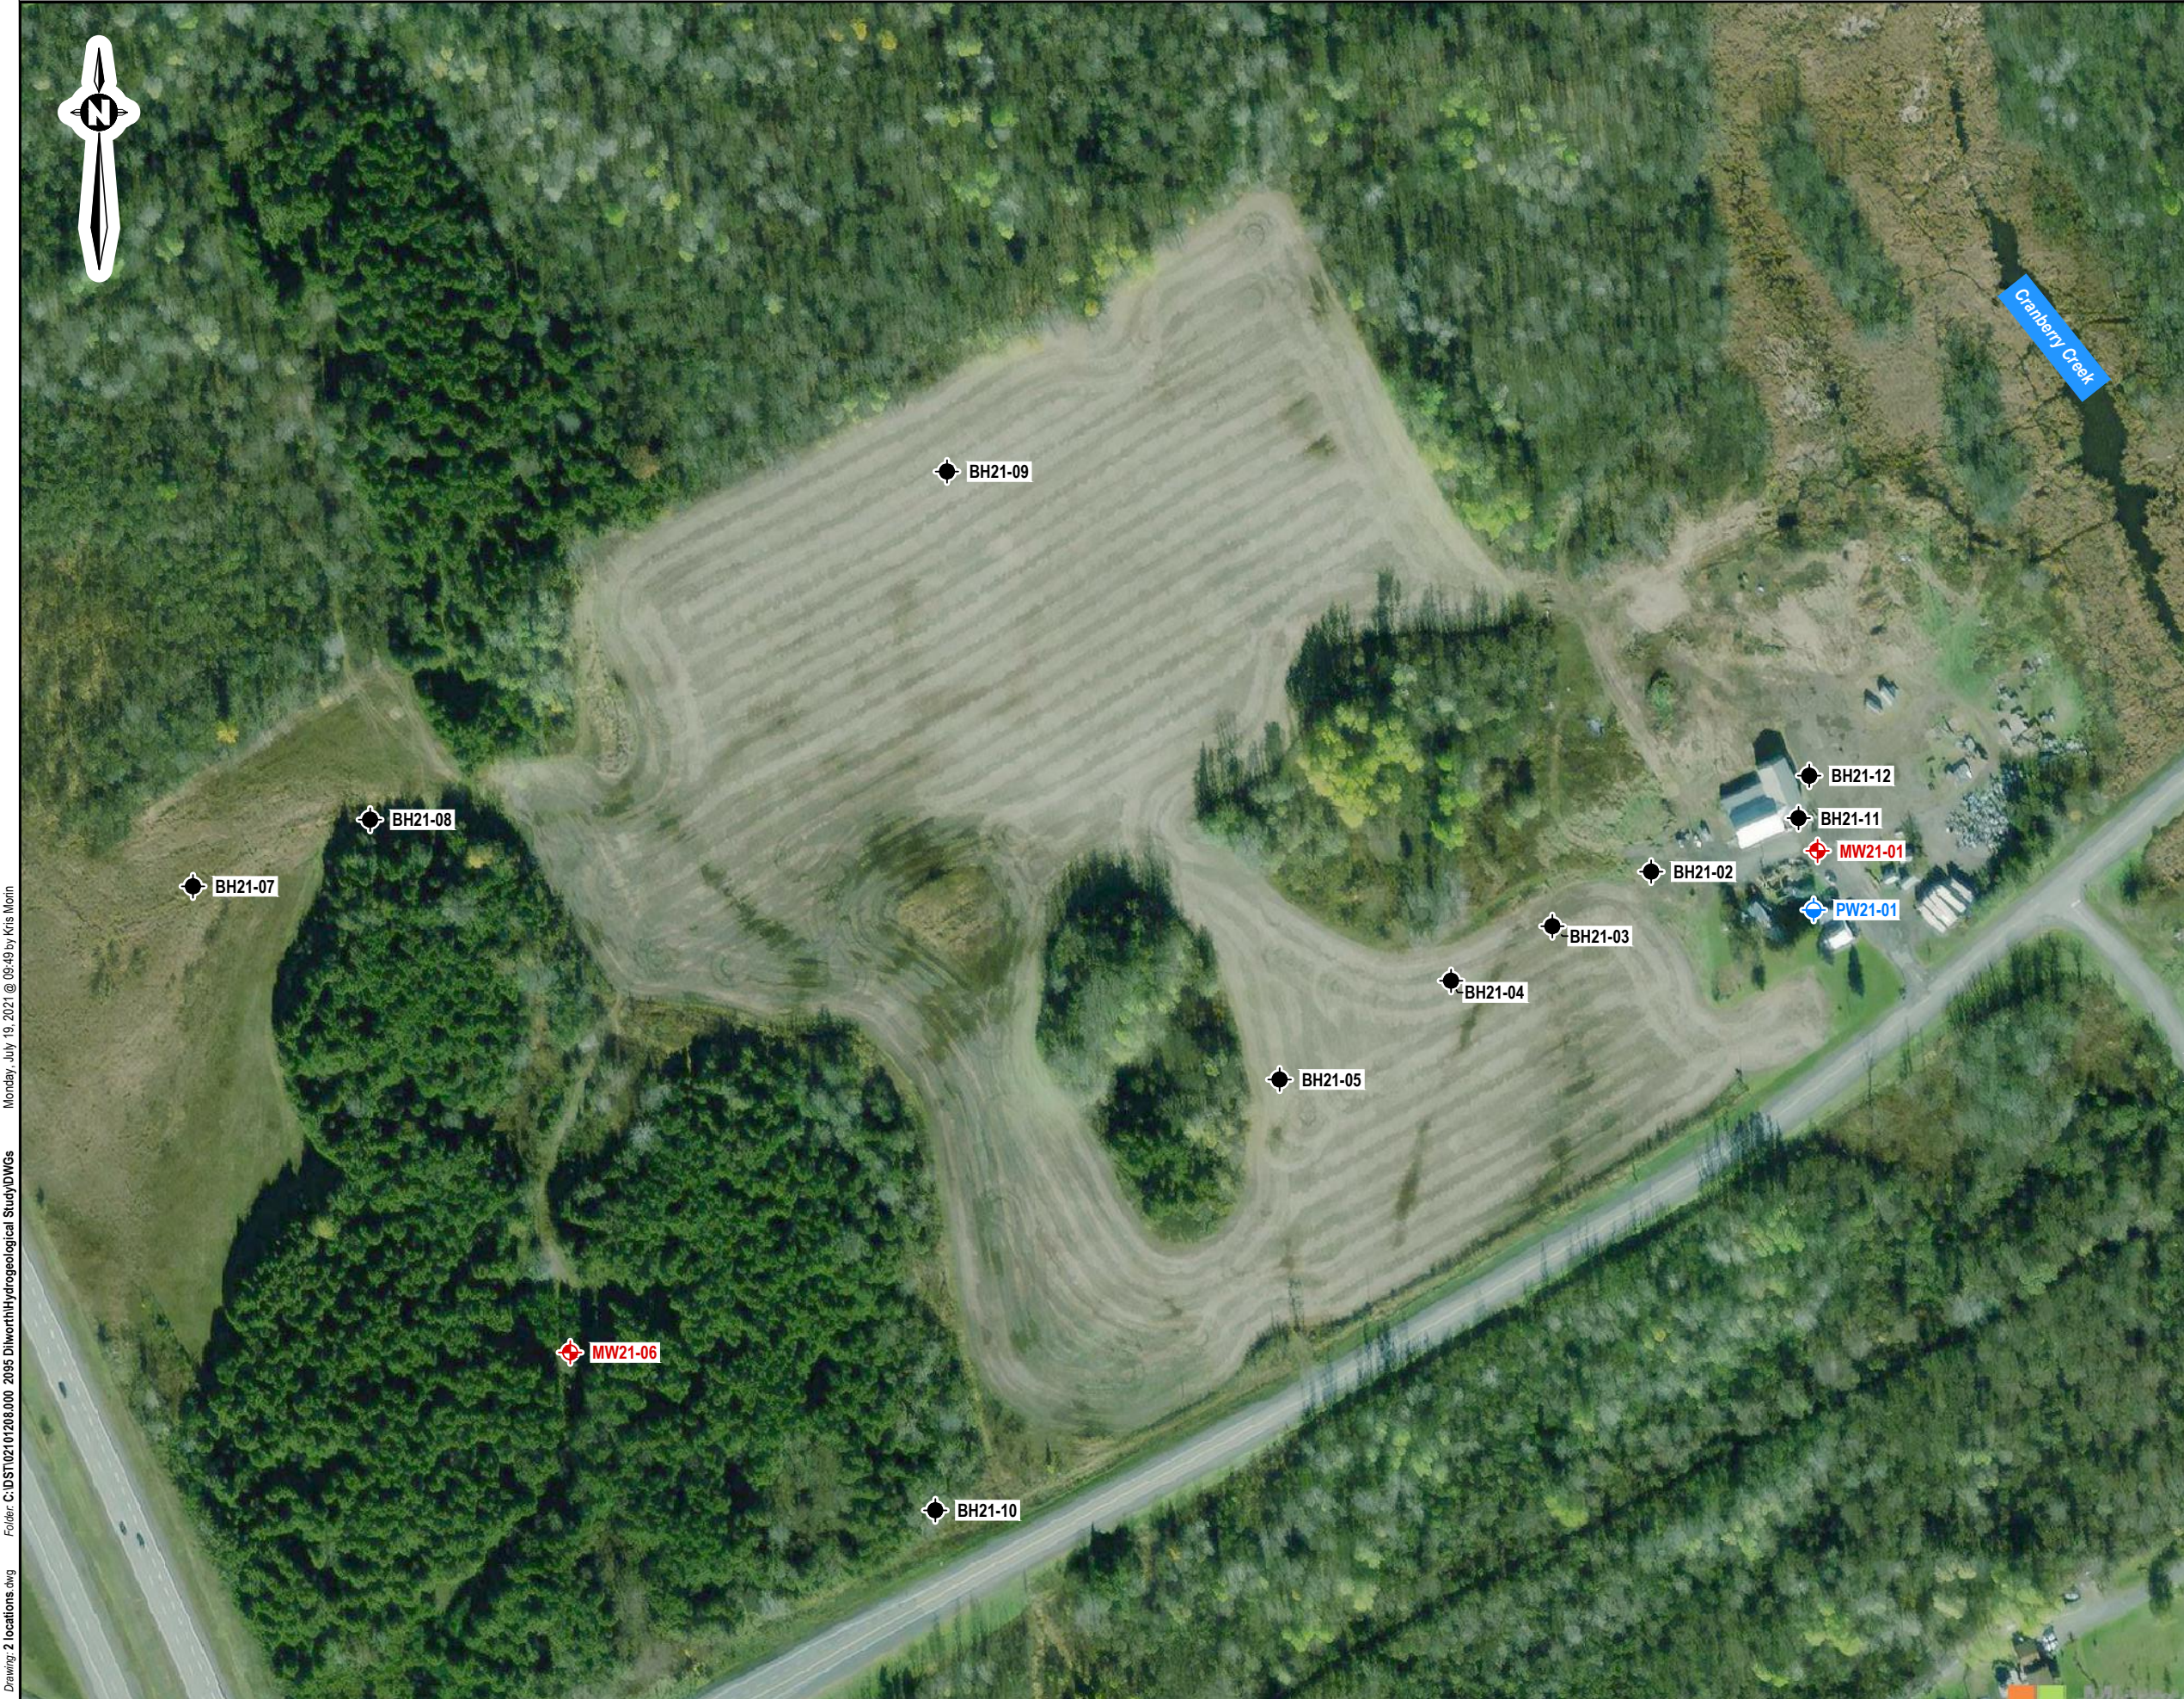
| Figure No. | | 3 | |

- Legend**
- Approximate location of borehole
  - Approximate location of monitoring well
  - Existing water well

In the proposed area of future expansion, the surficial terrain unit is characterized by the presence of silty sand with topsoil mixed organics. In the proposed areas of Buildings 1, 2, and 3 (refer to Figure 3, Appendix A), the surficial terrain units are primarily comprised of silty sand or fill with silty sand. A surficial organics terrain unit was observed to present in the planned area of Building 4 (refer to Figure 3, Appendix A).
