Geotechnical Investigation

Proposed Residential Development
2009-2013 Prince of Wales Drive
Ottawa, Ontario
Revision 3

LRL File No.: 220528

December 2022, *Revised: April 2024*

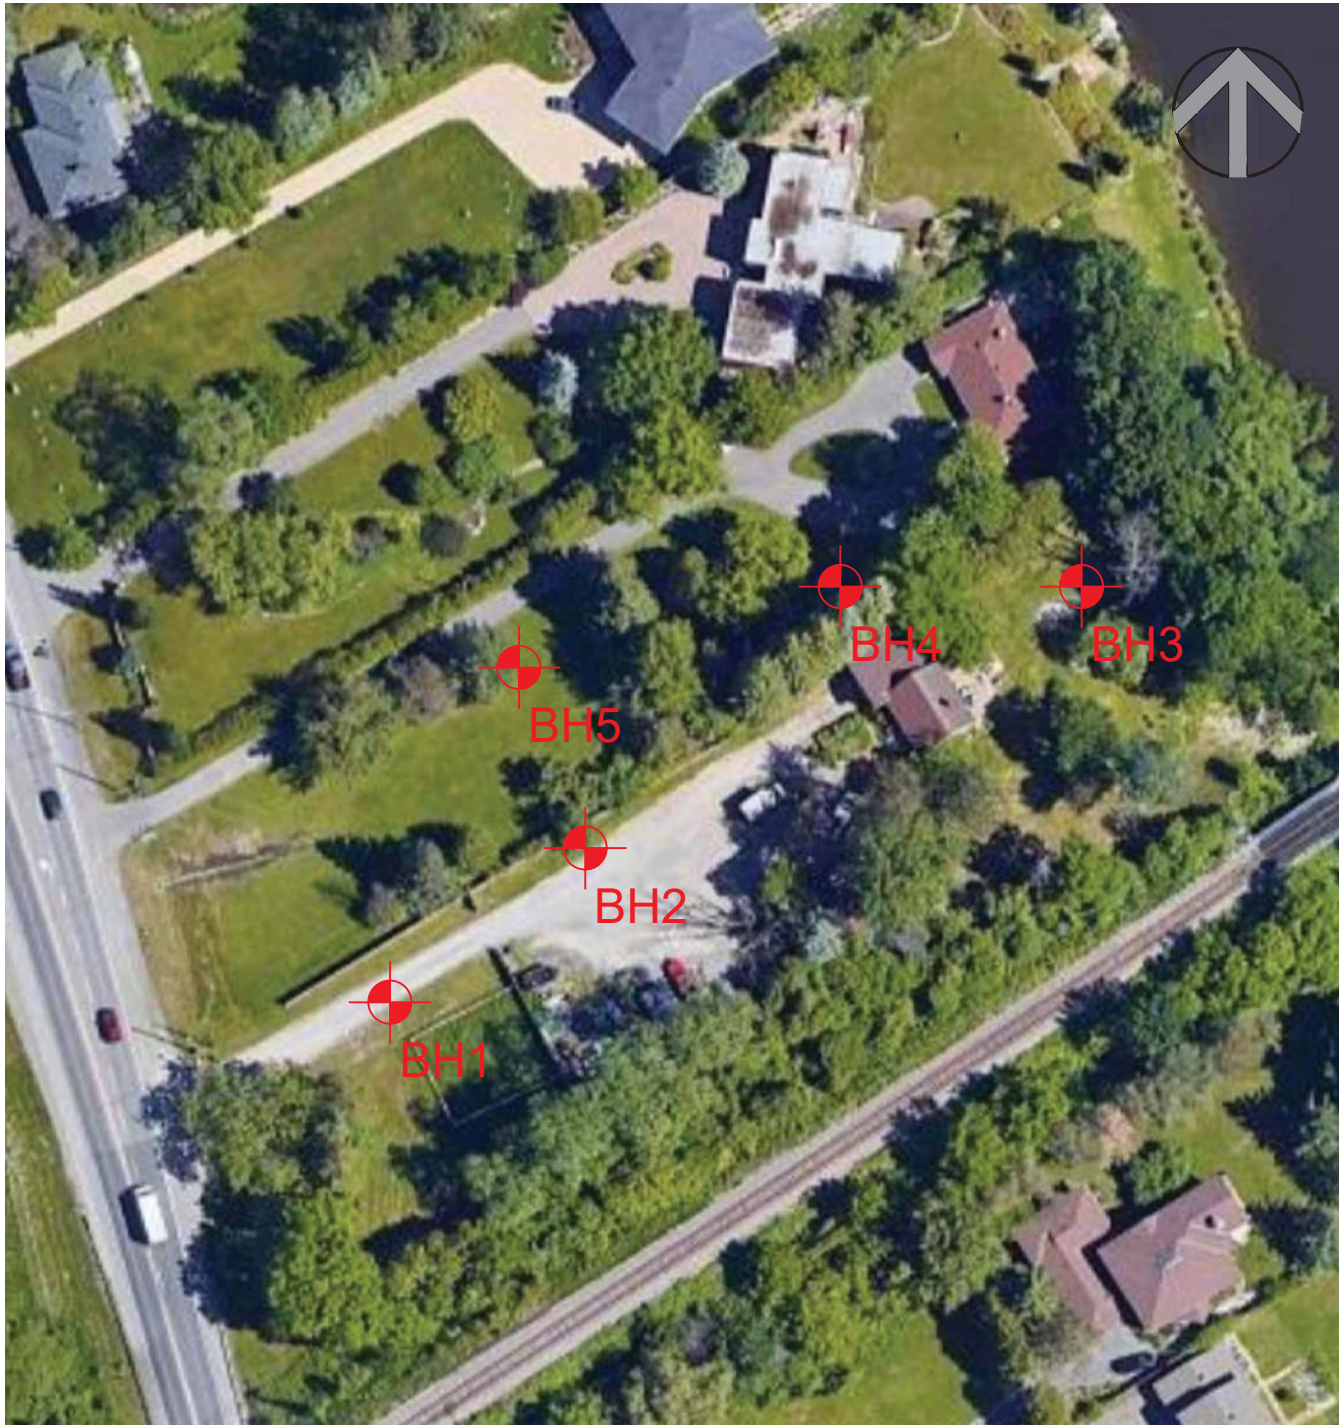
FIGURE 2

The fieldwork for this investigation was carried out on November 28, 2022. Prior to the fieldwork, the site was cleared for the presence of any underground services and utilities. A total of five (5) boreholes were drilled onsite to get a general representation of the site's underlying soil conditions, and labelled BH1 through BH5. The approximate locations of the boreholes are shown in Figure 2 included in **Appendix A**.

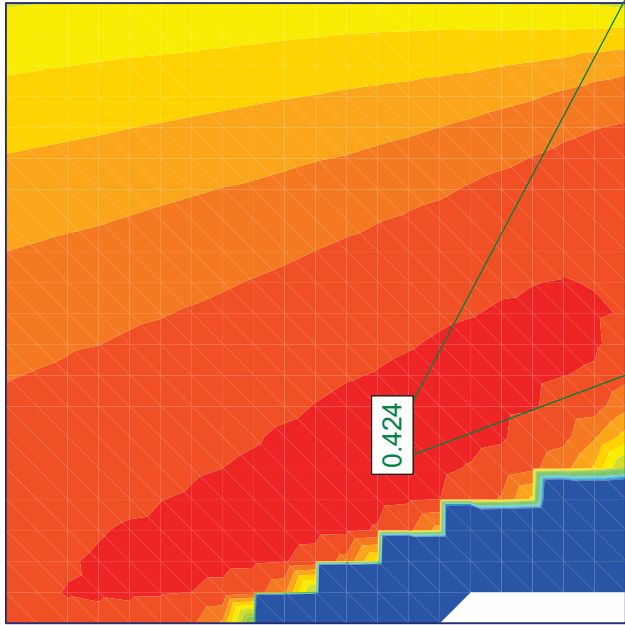
These results indicate that the slope is unstable in the drained (long-term) condition. A setback for any permanent structure(s) (dwellings, decks, sheds, gazebos, pools, etc.) from the top of the slope is required to ensure that in the event of a slope failure, the structure(s) will be unharmed. The model was filtered to illustrate the failure surface with a FOS below 1.50.

The Stable Slope Allowance is the area where a factor of safety is less than 1.50 against overall rotational failure. As indicated in the attached model, **a 19.0 m setback is required for Stable Slope Allowance.**

Material Properties
 Material: Silt and Clay
 Unit Weight: 18 kN/m³
 Cohesion: 5 kPa
 Friction Angle: 36 degrees

19 m

The slope modelling program, Slide 5.0 (Rocscience), was used to implement the Bishop simplified method of slices. A slope profile, considered to be the steepest onsite (worst case scenario) was selected and modeled to check the conditions of the slope. The slope was analyzed under both the undrained (short term failure) and drained (long term failure) conditions.

Drained Condition	Undrained Condition	Seismic
Factor of Safety	0.42	2.59	1.81
Min. Required	1.50	1.50	1.10

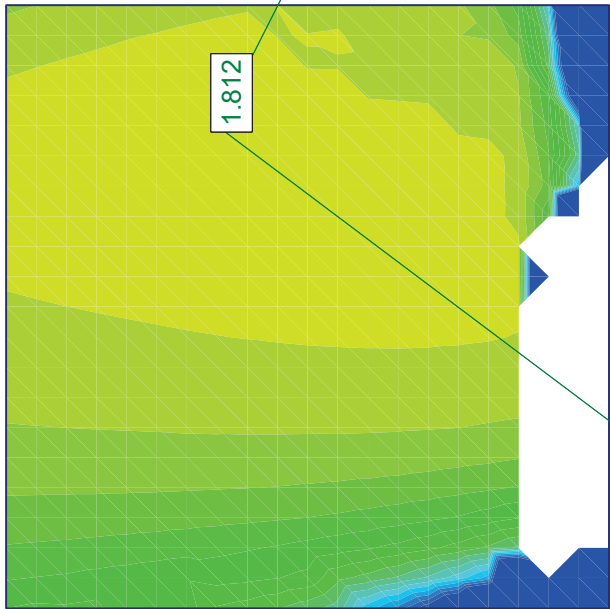
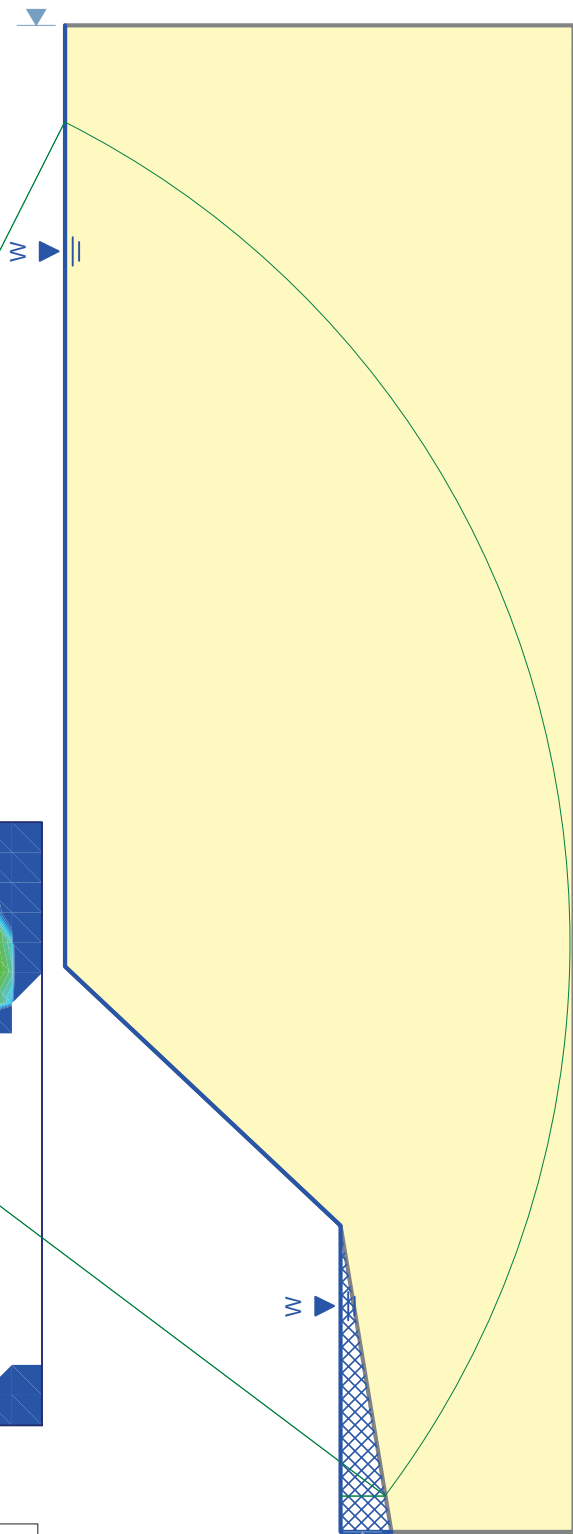
Seismic Condition

The seismic analysis was performed by incorporating the seismic coefficient (k_h) into the modelling. The peak ground acceleration (PGA) for this area is equal to 0.28 for the 2% in 50 year probability of exceedance as per the NBC 2015. The value for k_h was taken as 50% of the PGA, which equates to 0.14. The minimum factor of safety (FoS) with regards to seismic condition is 1.10.

Material Properties
 Material: Silt and Clay
 Unit Weight: 18 kN/m³
 Cohesion: 75 kPa
