**PH4979-LET.01**

**Air Rock Drilling Company Ltd.**  
6659 Franktown Road  
Ottawa (Richmond), Ontario  
K0A 2Z0

Subject: **Scoped Hydrogeological Assessment and Terrain Analysis**  
Proposed Re-Zoning and Site Plan  
6659 Franktown Road, Ottawa (Richmond), Ontario

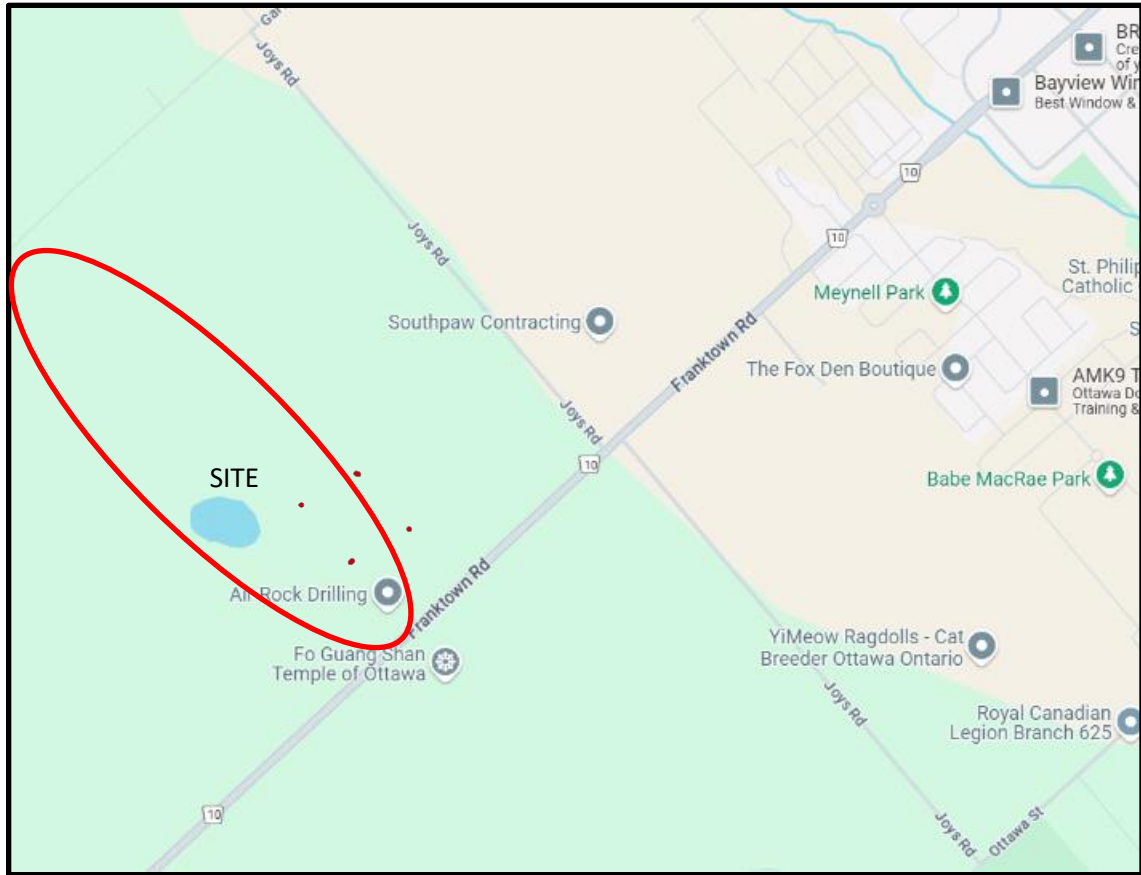
**FIGURE 1**

**KEY PLAN**

The subject site is approximately 40.22 ha in size and is currently occupied by a two-storey residential dwelling and home-based business for well drilling. The Site Plan application is to retroactively provide site plan approval for the existing development. There are no changes to the existing use or to water usage anticipated as part of this Site Plan application. Please refer to Figure-1 Key Plan and Site Plan Drawing P1, dated July 11, 2022 by FOTENN, attached, for the subject site location and layout.

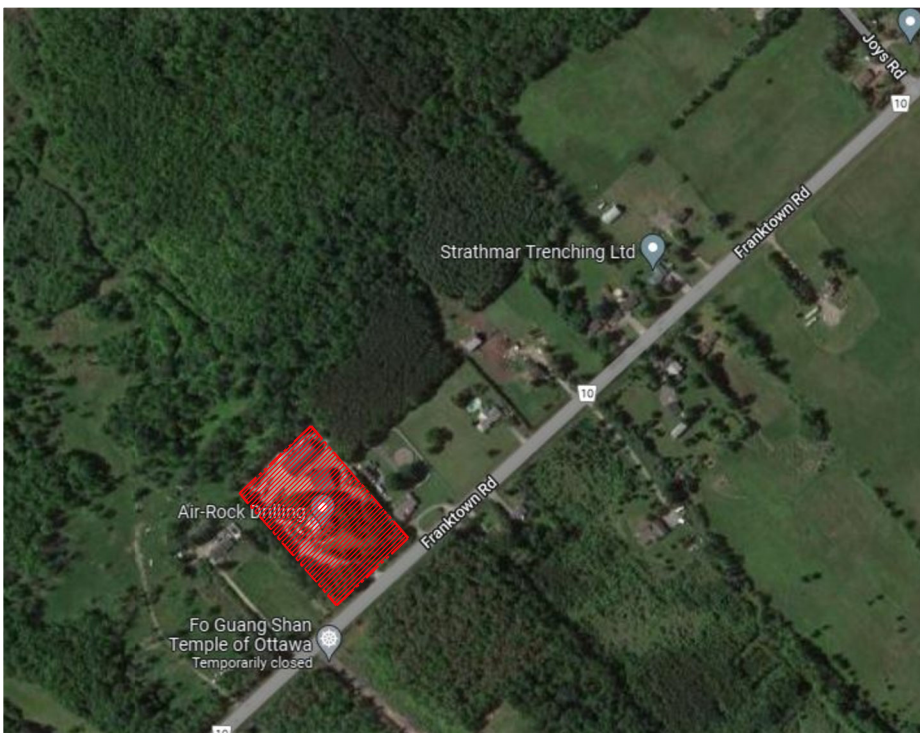
P1

6659  
FRANKTOWN RD  
Concept Plan

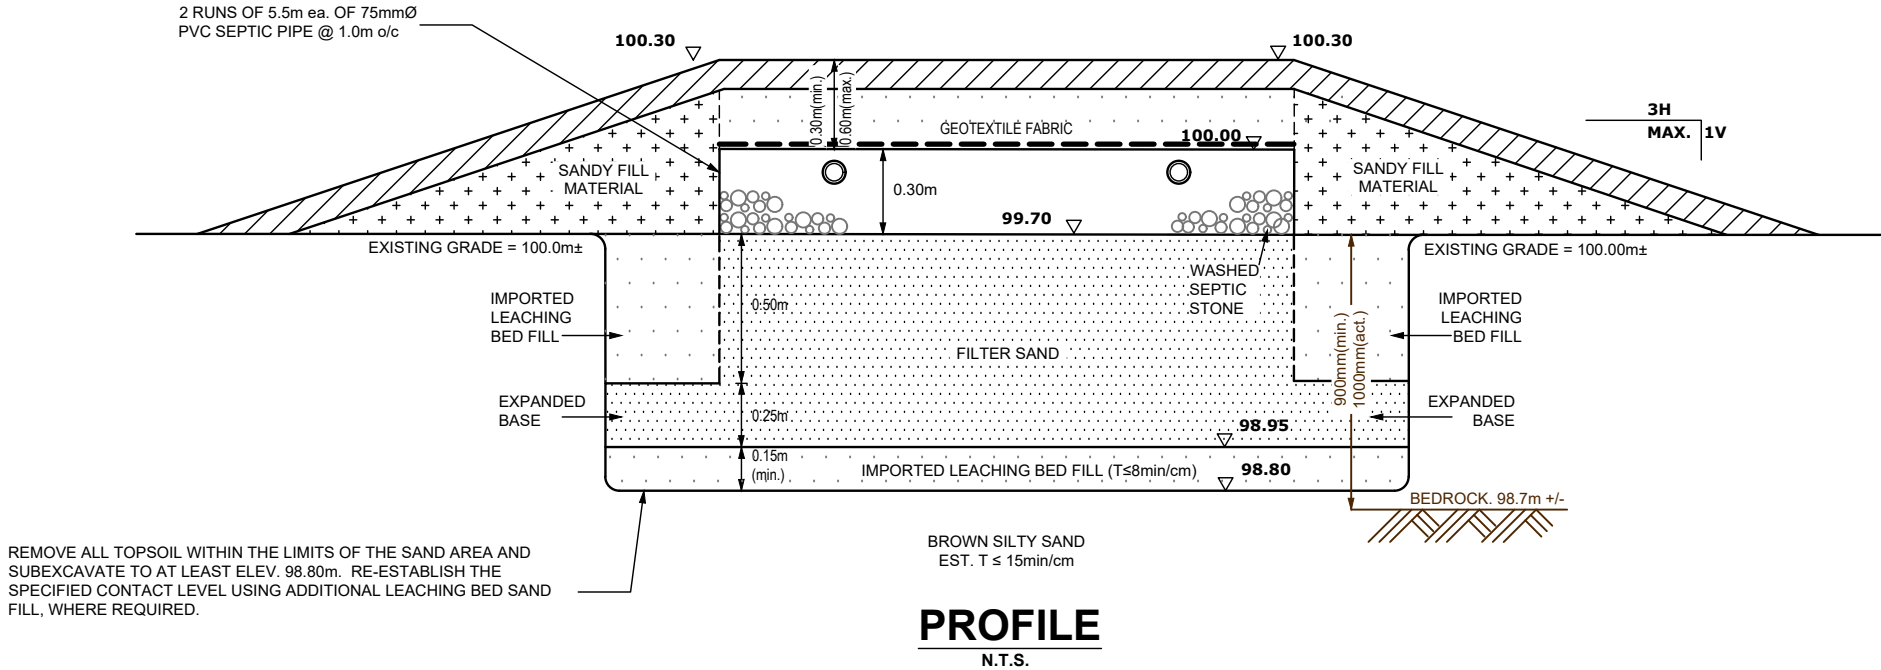
**PROPOSED SEWAGE  
SYSTEM REPLACEMENT  
FOR AN EXISTING OFFICE**

COVER MATERIAL TO CONSIST OF LEACHING BED FILL FOLLOWED BY APPROX. 0.10m OF SANDY TOPSOIL. LEACHING BED TO BE VEGETATED AS SOON AS POSSIBLE.

NOTE:  
THIS PLAN IS TO BE READ IN CONJUNCTION WITH DRAWING NO. PH4979-1(rev.1)

FINAL GRADING SHALL BE SUITABLY SHAPED TO DIRECT SURFACE WATER AWAY FROM THE PROPOSED SEWAGE SYSTEM.

The subject site is currently serviced by two onsite sewage systems and private drilled wells. The existing site usage requires limited water capacity and the proposed site usage is being maintained within the historical site use. Therefore, there is no change in the private service capacity for this application. The existing residence has a sewage system capacity of 1,725 L/day per the approved OSSO Certificate of Compliance. A new sewage system is proposed for the home-based business to comply with Part 8 – Ontario Building Code (OBC). A septic flow calculation was completed by Paterson and resulted in a total daily water demand calculation of 2,700 L/day from a combined 1,725 L/day from the residential building and 975 L/day from the business. Please refer to Paterson Sewage System design PH4979-1 and PH4979-2, attached, for full details.

Paterson completed a sewage system design for the existing home-based business. Paterson drawings PH4979-1 and PH4979-2 are attached and denote soils information in the southeast portion of the site with three hand auger holes.
