**Geotechnical Investigation
Proposed Residential Development
1174 Carp Road
Ottawa, Ontario**

GEMTEC Project: 101785.004

February 25, 2025
GEMTEC Project: 101785.004

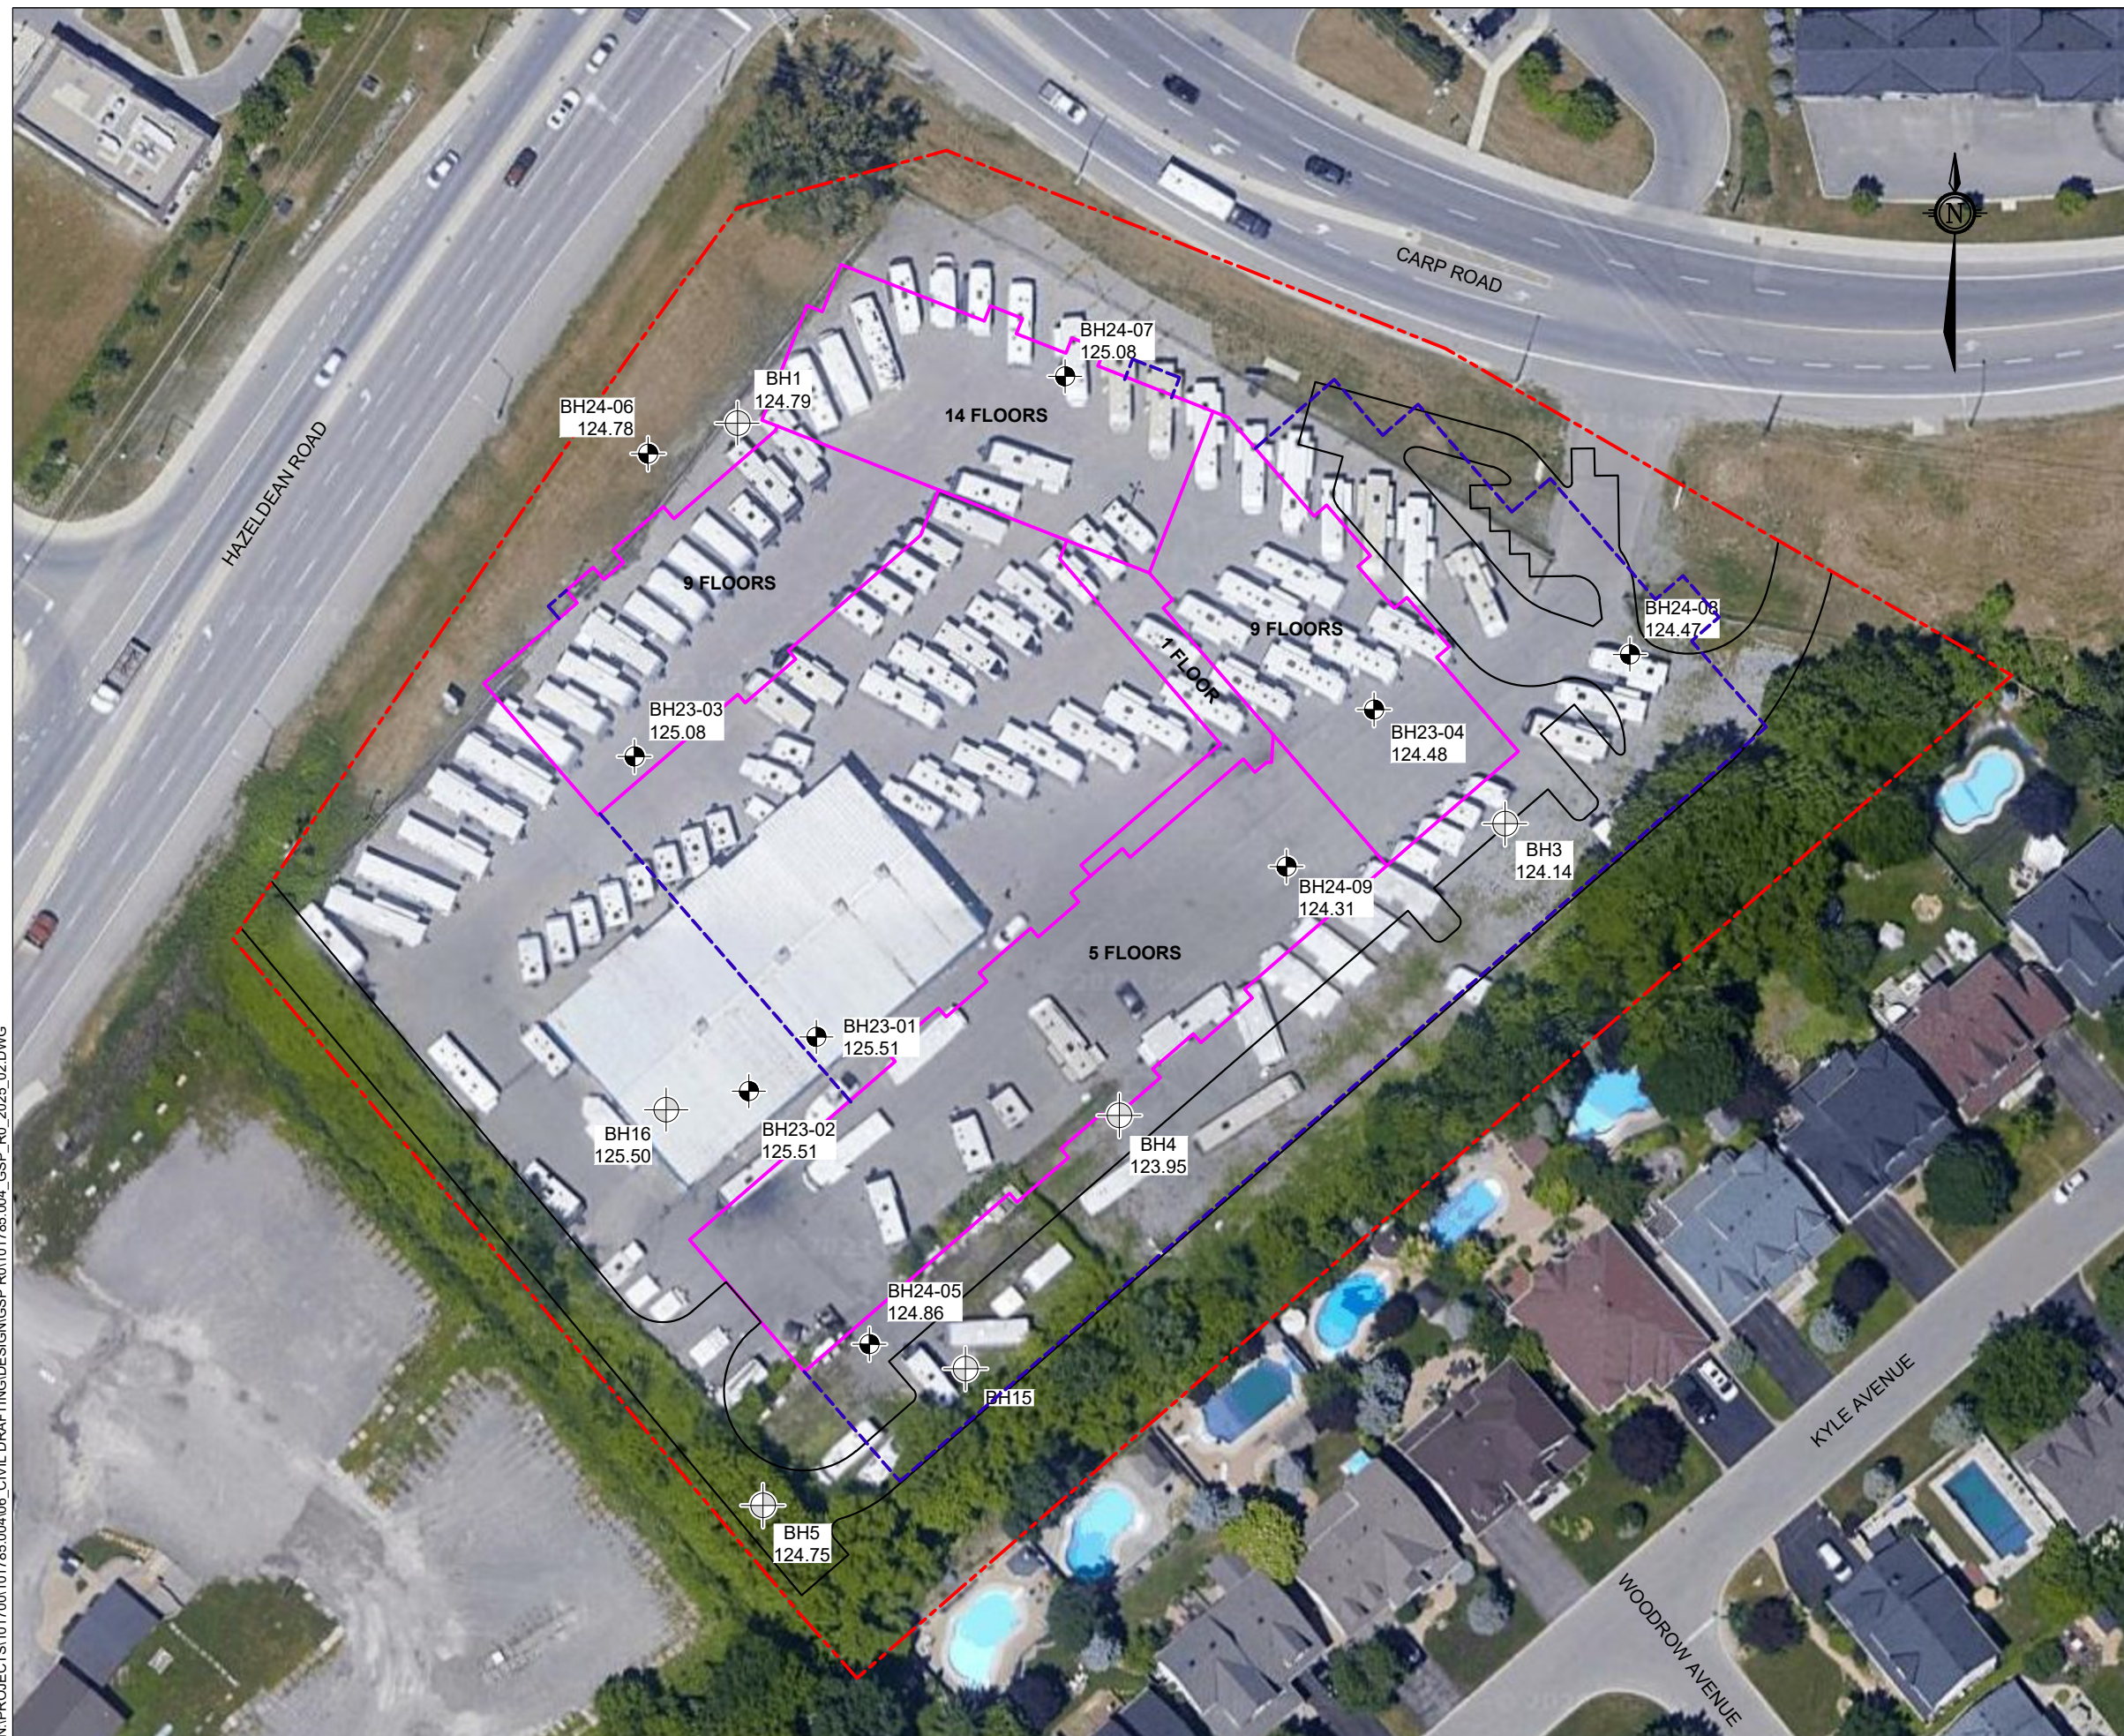
LEGEND

BH #	←	BOREHOLE ID
XX.XX	←	GROUND SURFACE ELEVATION, IN METRES GEODETIC DATUM

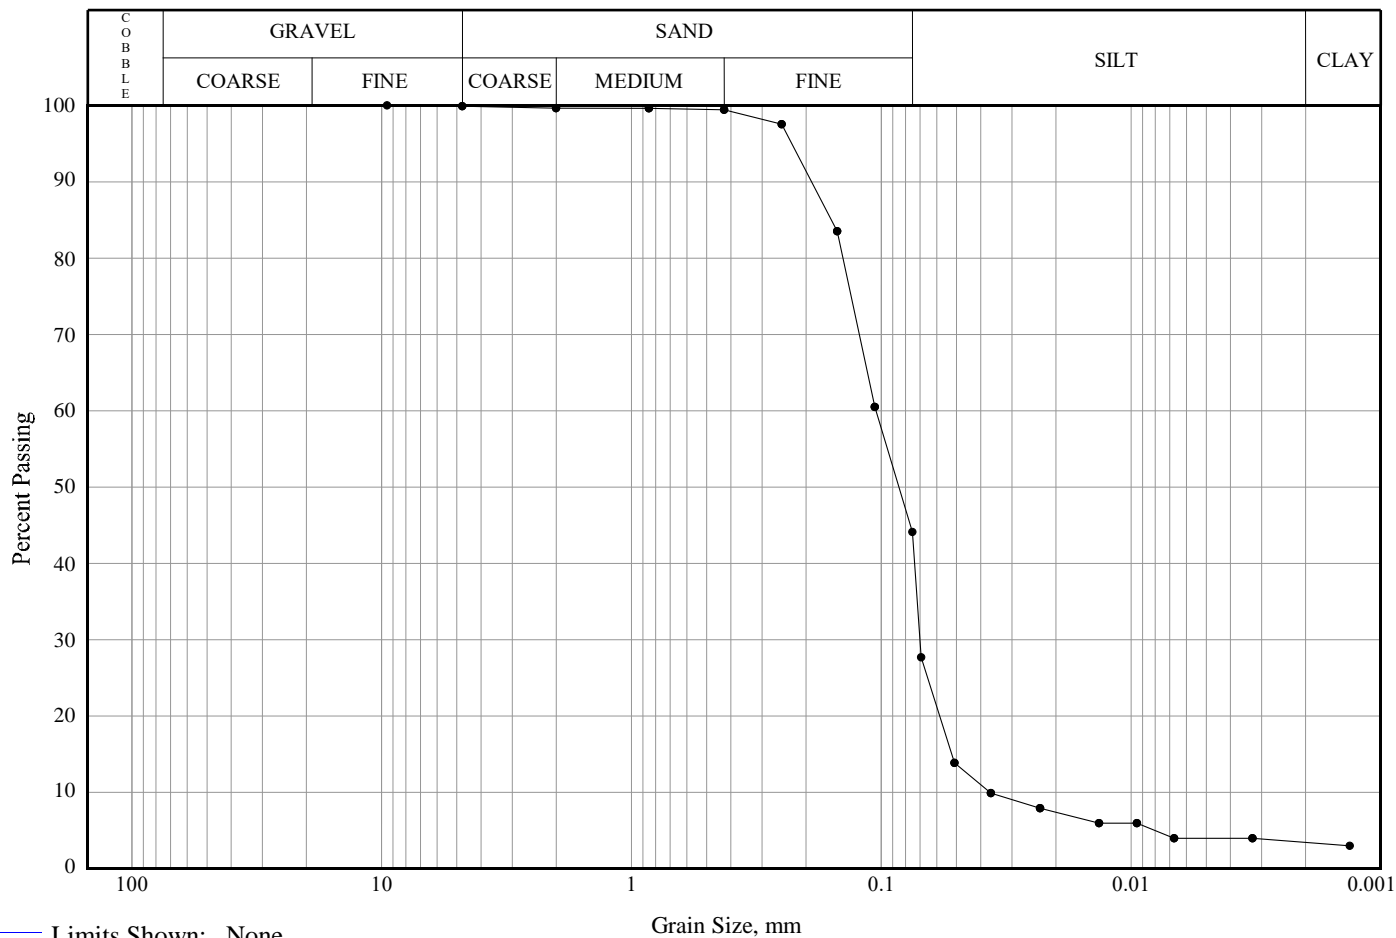
GEMTEC CONSULTING ENGINEERS AND SCIENTISTS	Client: Le Groupe Maurice Inc	Soils Grading Chart (LS-702/ ASTM D-422)
	Project: Detailed Geotechnical Investigation and Record of Site C	
	Project #: 101785004

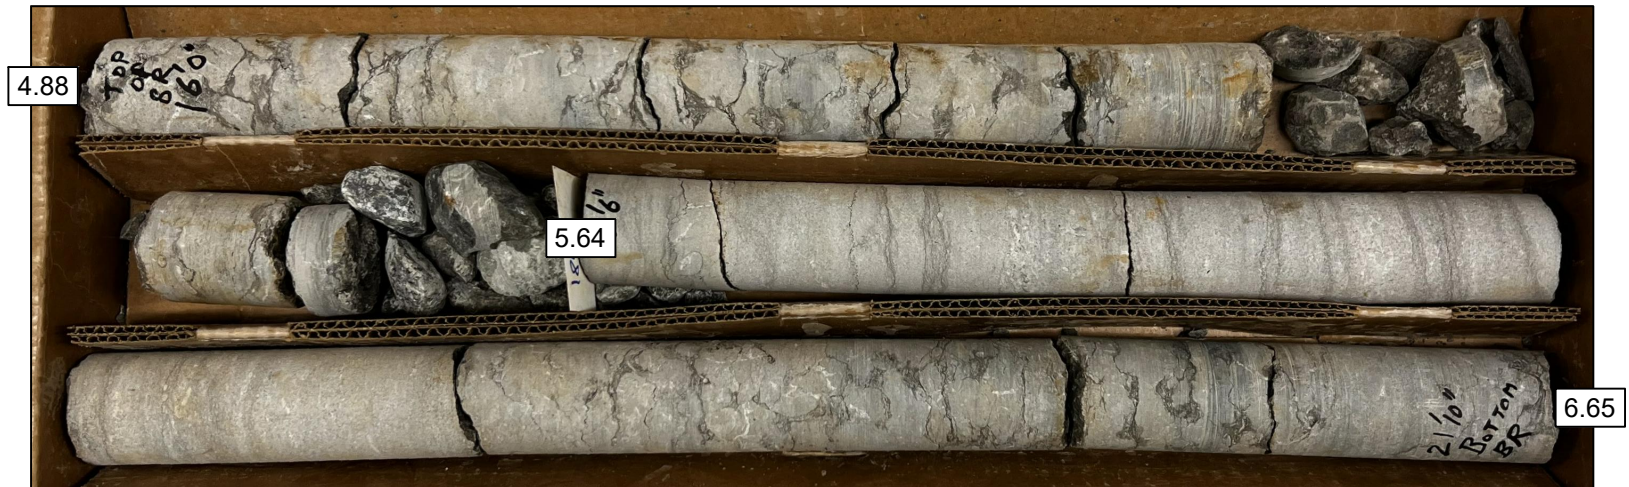
BOREHOLE: 23-03
BORING DATE: APRIL 10, 2023
DEPTH: 4.88 to 6.65 METRES

A layer of possible boulders or fractured bedrock with silty sand seams was encountered below the depth of auger refusal at the base of the sand and silt layer in borehole 23-03 at a depth of about 4.9 metres. The boulders or fractured bedrock extends to a depth of about 5.6 metres below the existing ground surface.

The recovered bedrock core samples have total core recovery (TCR) values ranging from about 93 to 100 percent, solid core recovery (SCR) values ranging from about 41 to 100 percent, and rock quality designation (RQD) values ranging from about 37 to 100 percent. Based on these values, in accordance with the classification system set out in the Canadian Foundation Engineering Manual (5th Edition) the bedrock can be classified as Poor to Excellent Quality.

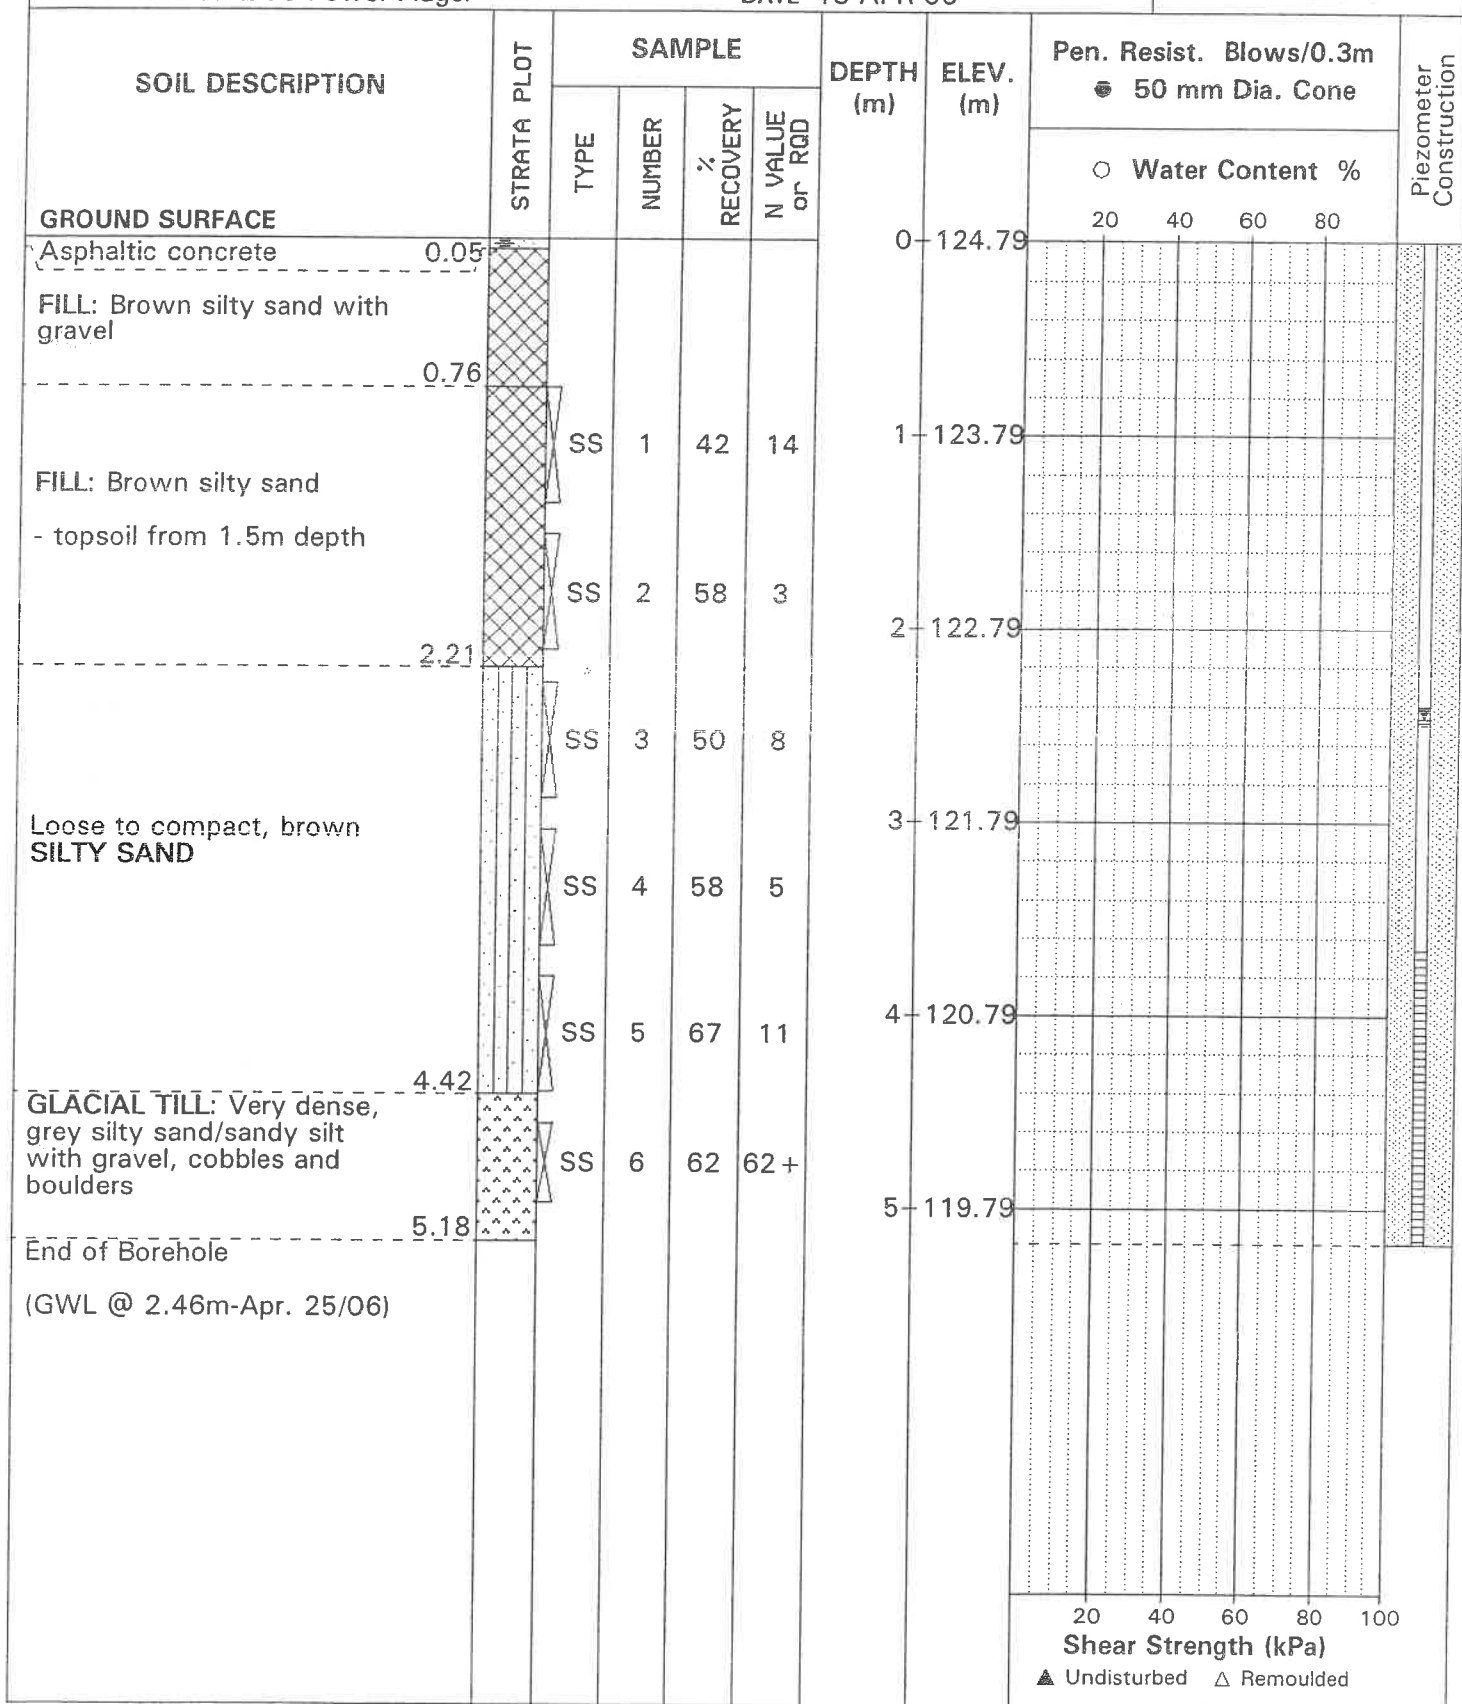
BORINGS BY CME 75 Power Auger

DATE 18 APR 06

DATUM Ground surface elevations provided by Fairhall, Moffatt and Woodland Ltd.

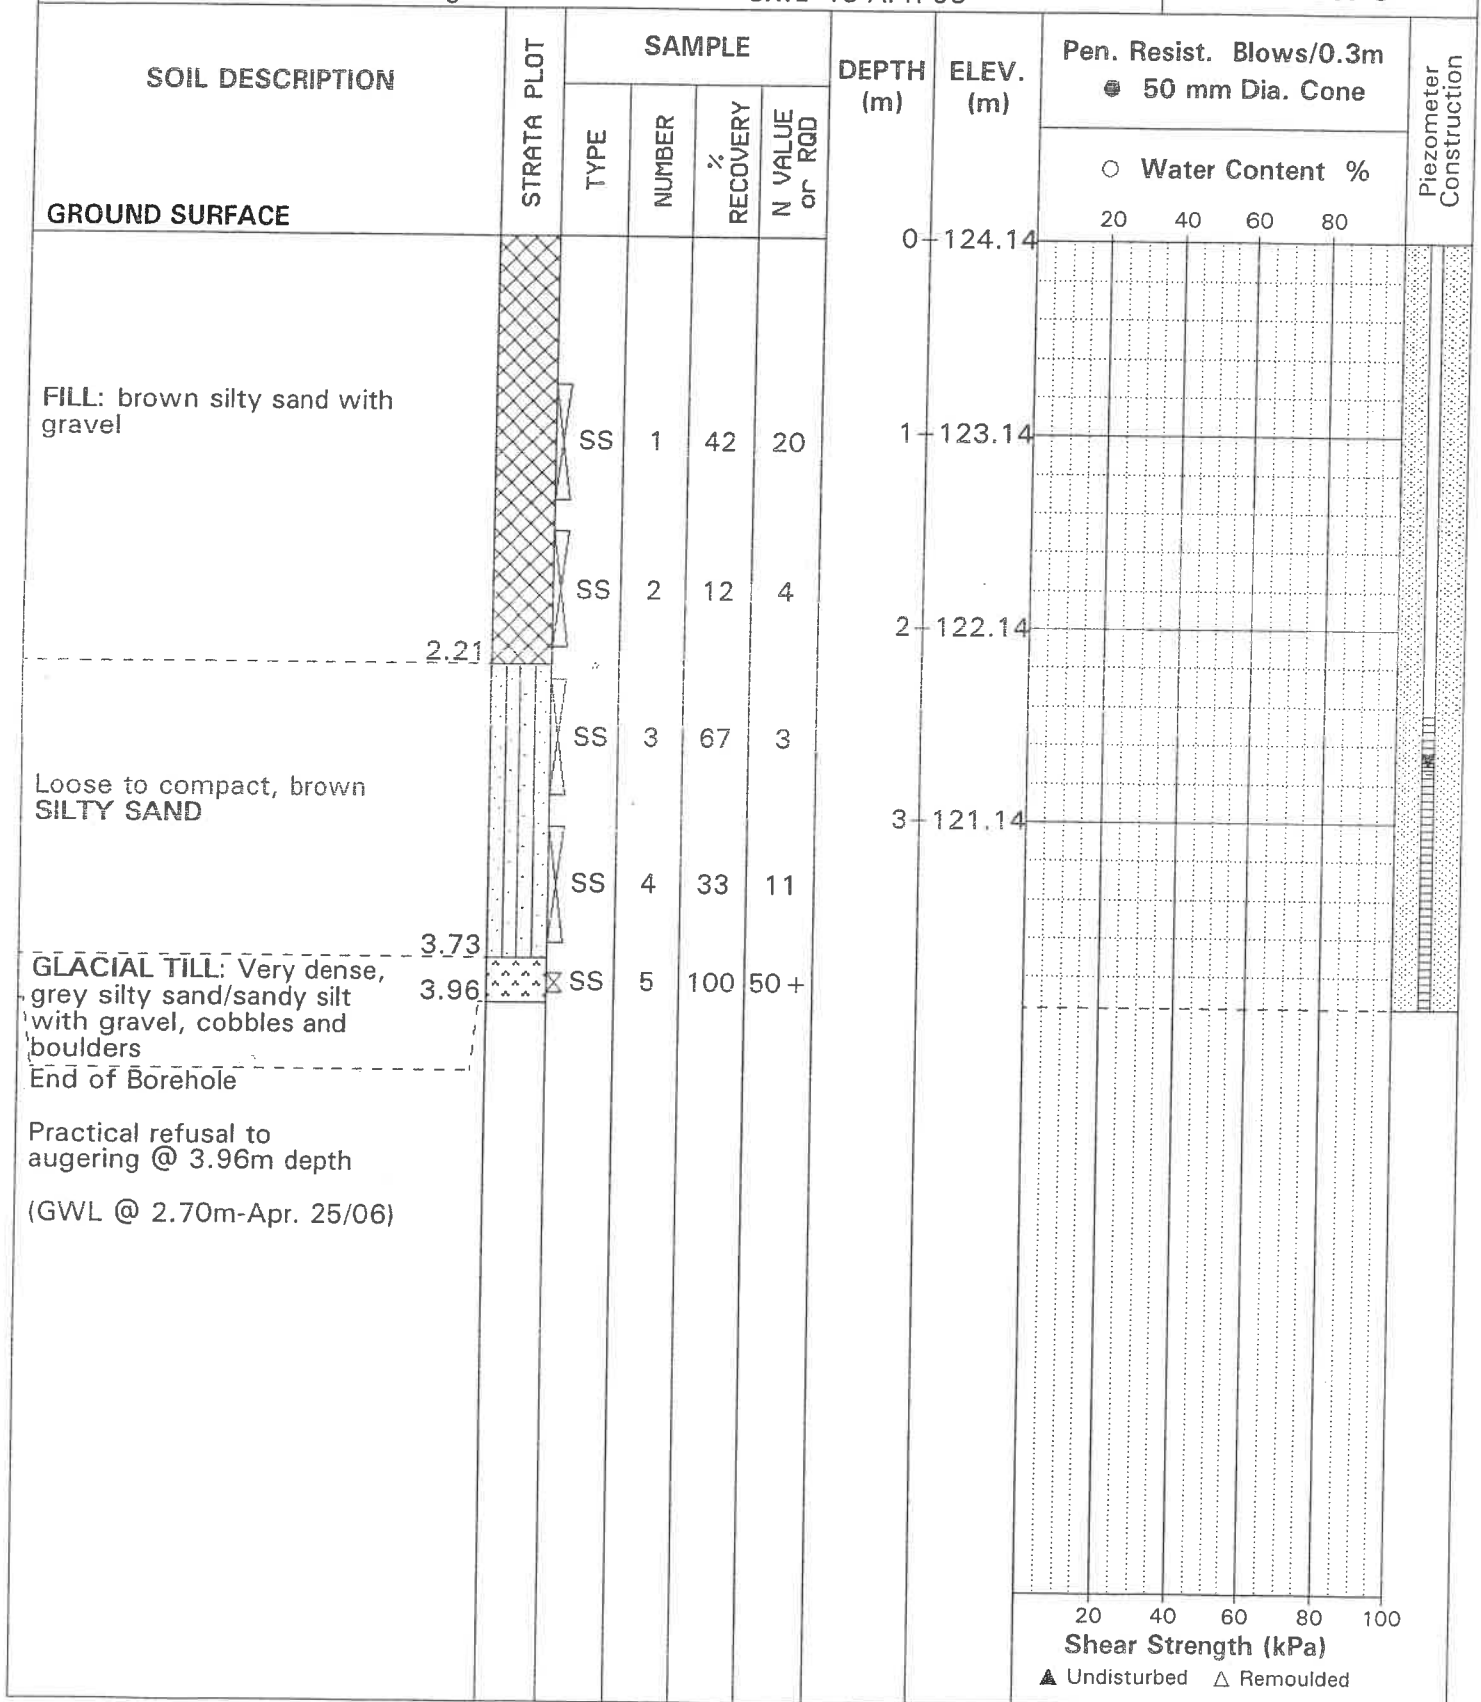
BORINGS BY CME 75 Power Auger

DATE 18 APR 06

DATUM Ground surface elevations provided by Fairhall, Moffatt and Woodland Ltd.

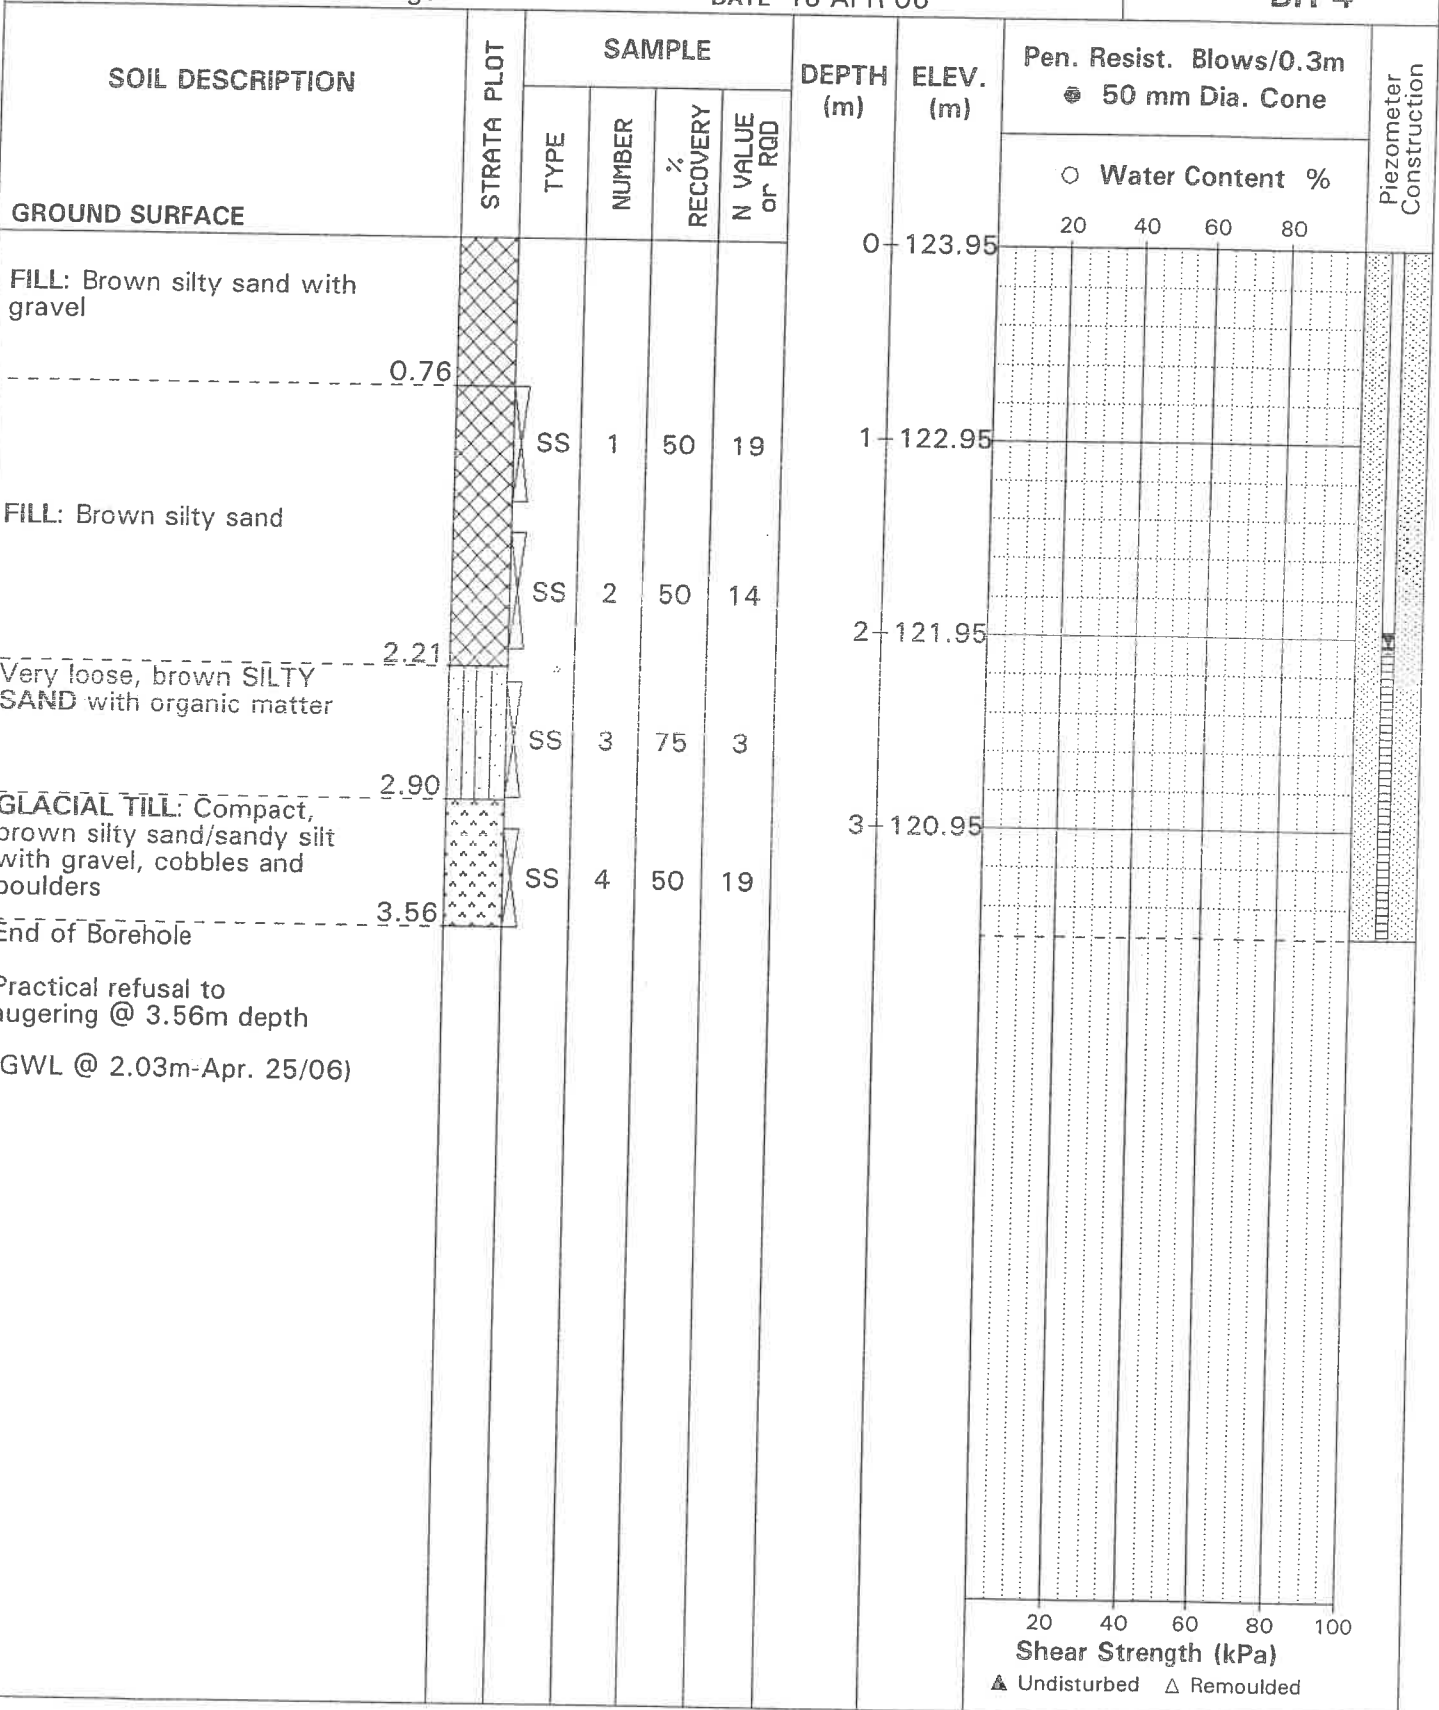
BH 4

DATUM Ground surface elevations provided by Fairhall, Moffatt and Woodland Ltd.

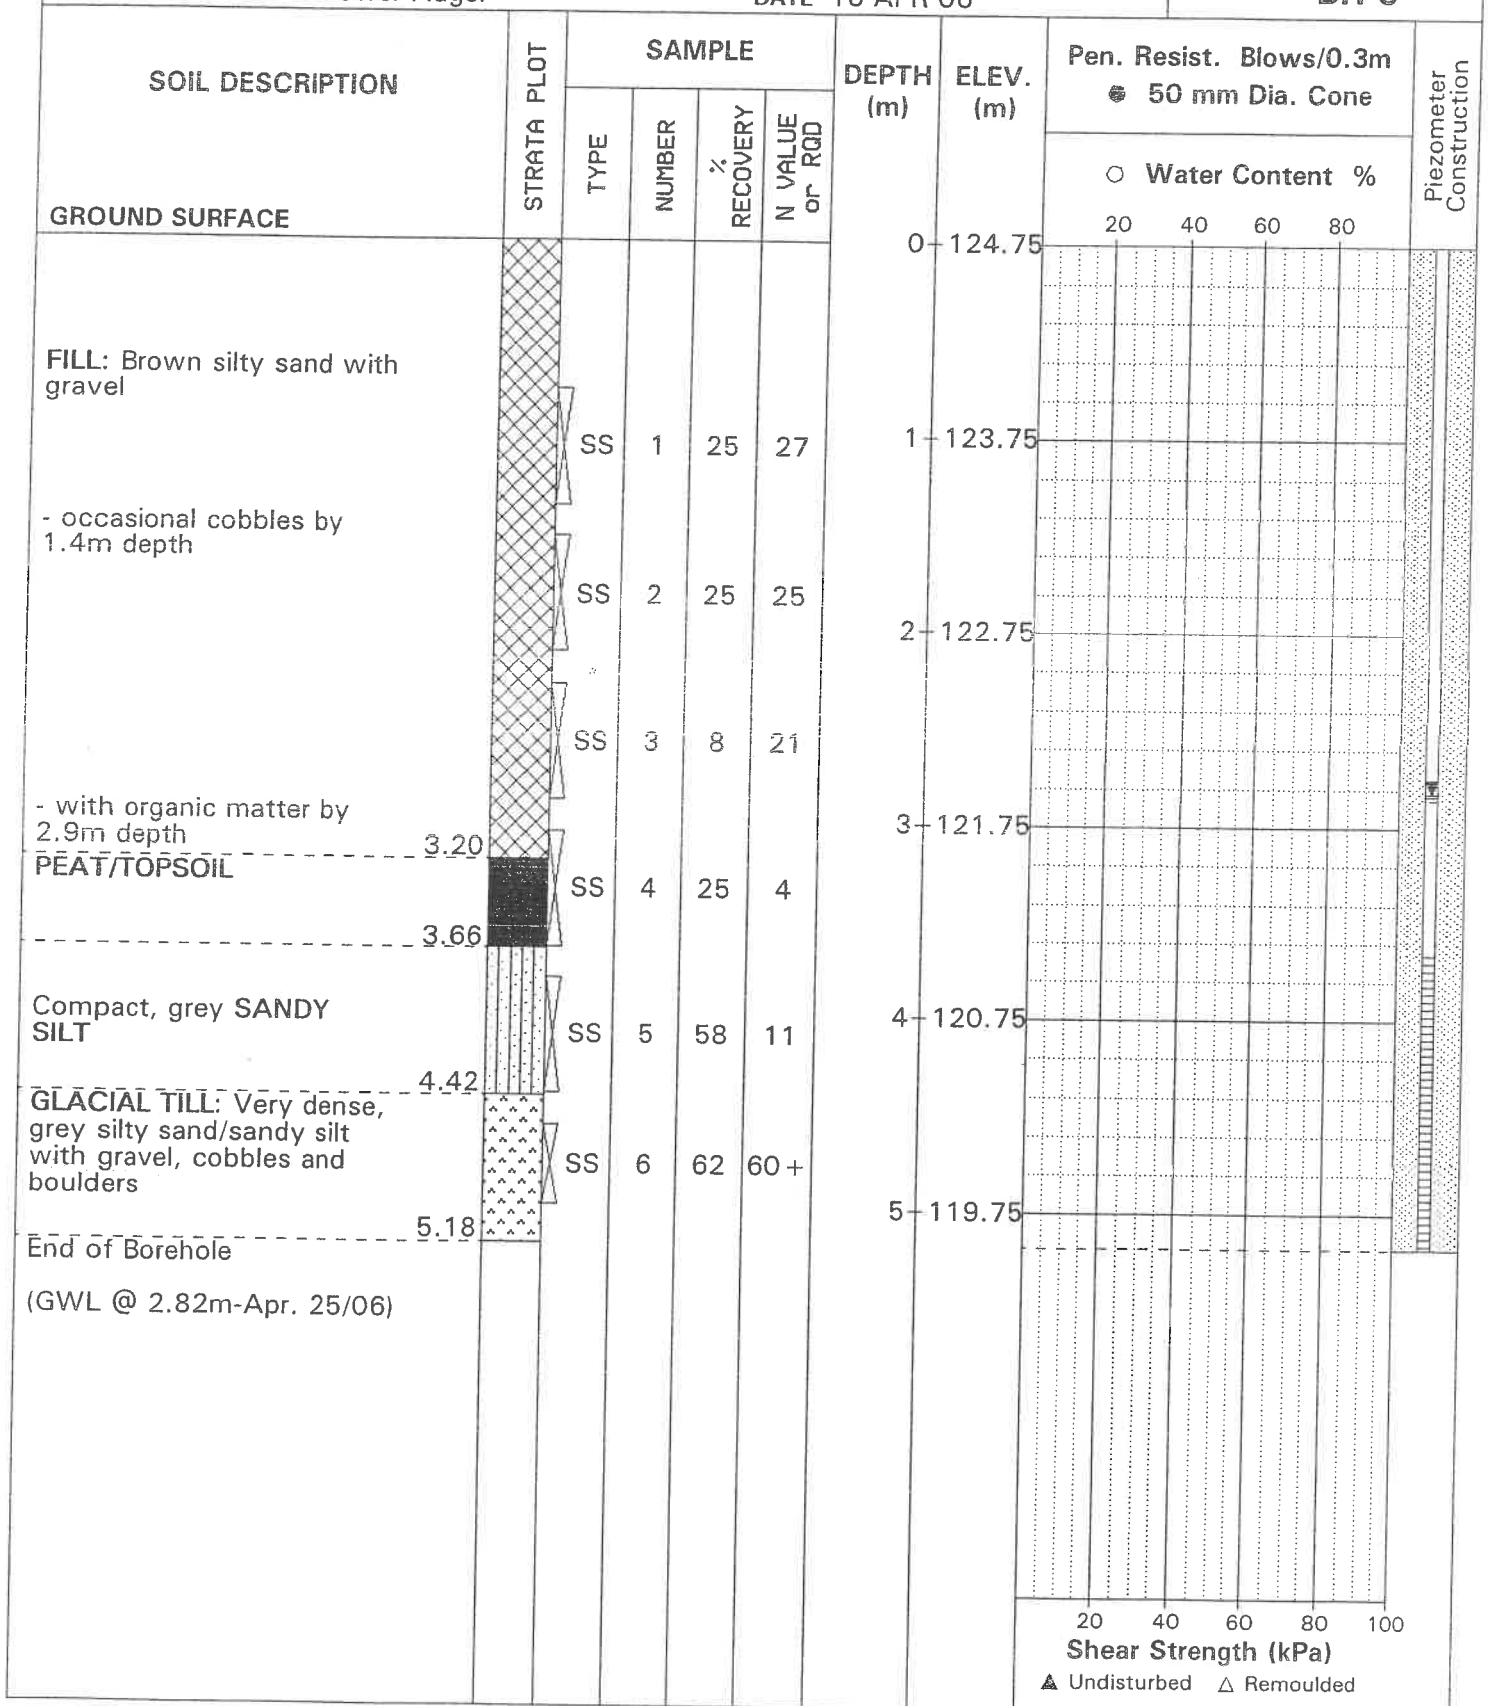
BORINGS BY CME 75 Power Auger

DATE 18 APR 06

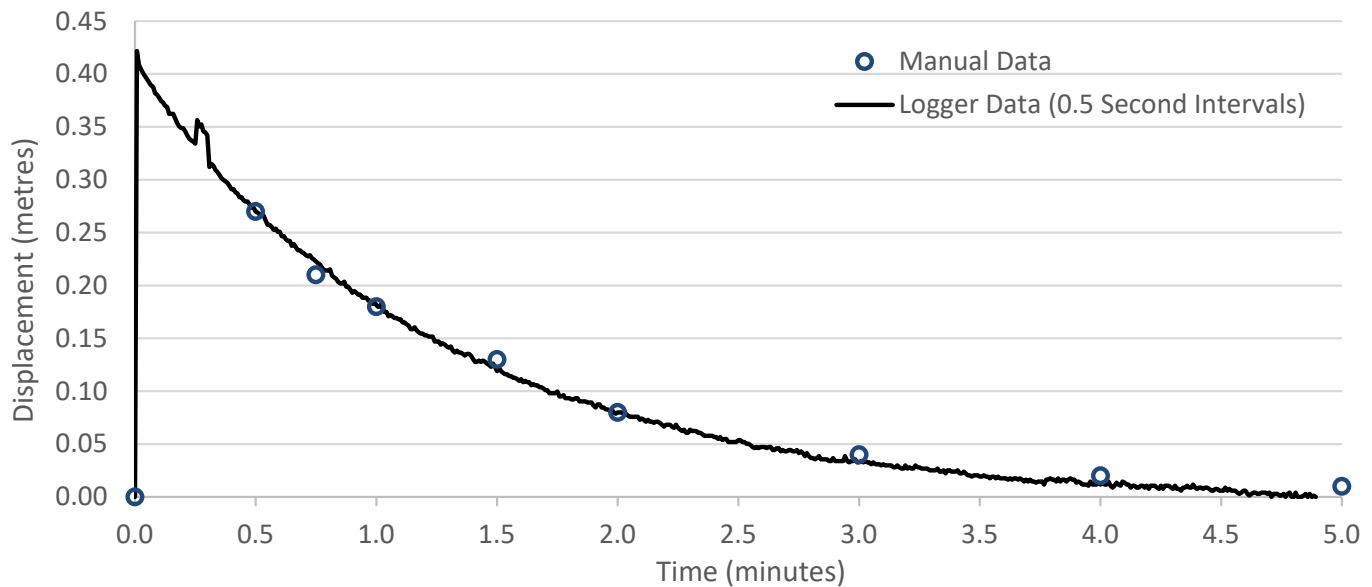
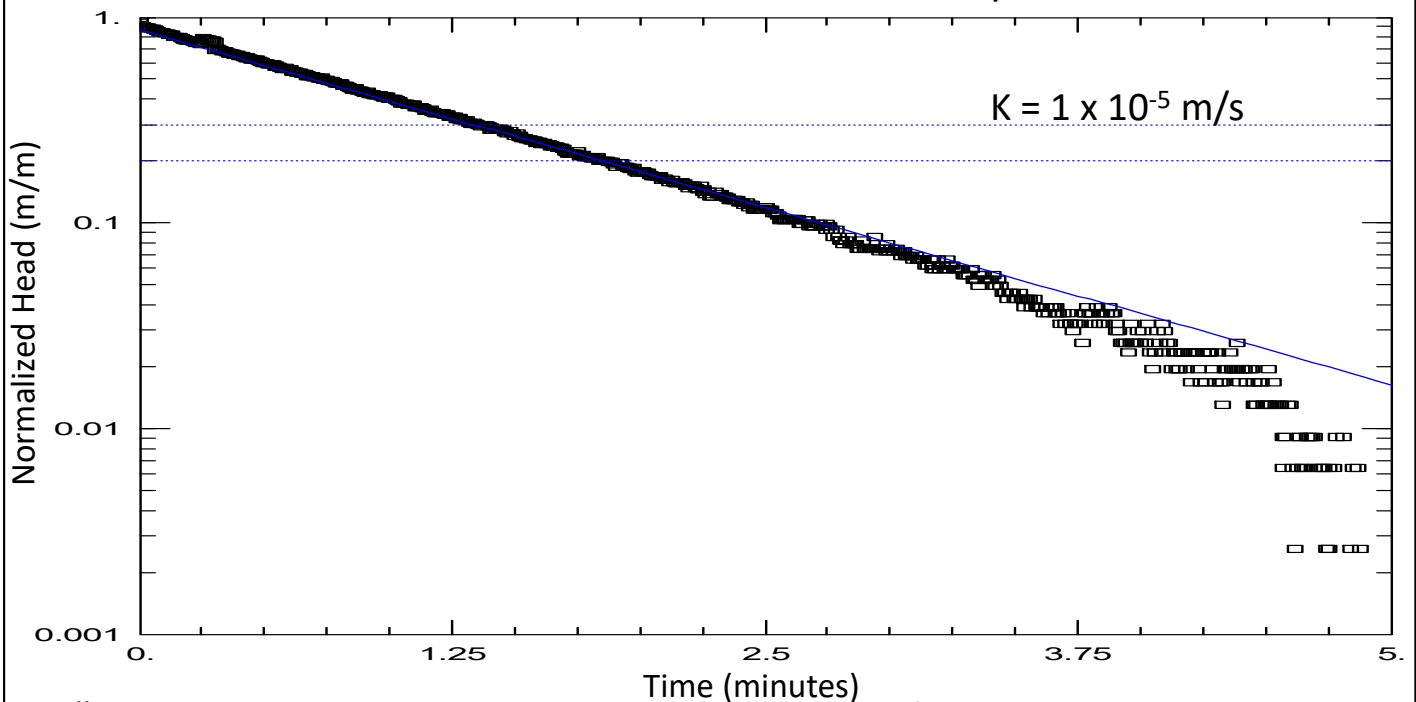
FIGURE E1

Borehole 24-07 Falling Head (FH) Test

Borehole 24-07 FH: Bouwer-Rice Analysis

Displacement observed (slug size): 0.42 metres (0.90 m)
Well Depth: 8.53 metres bgs
Screen Length: 1.52 metres
Well Radius: 0.0255 metres

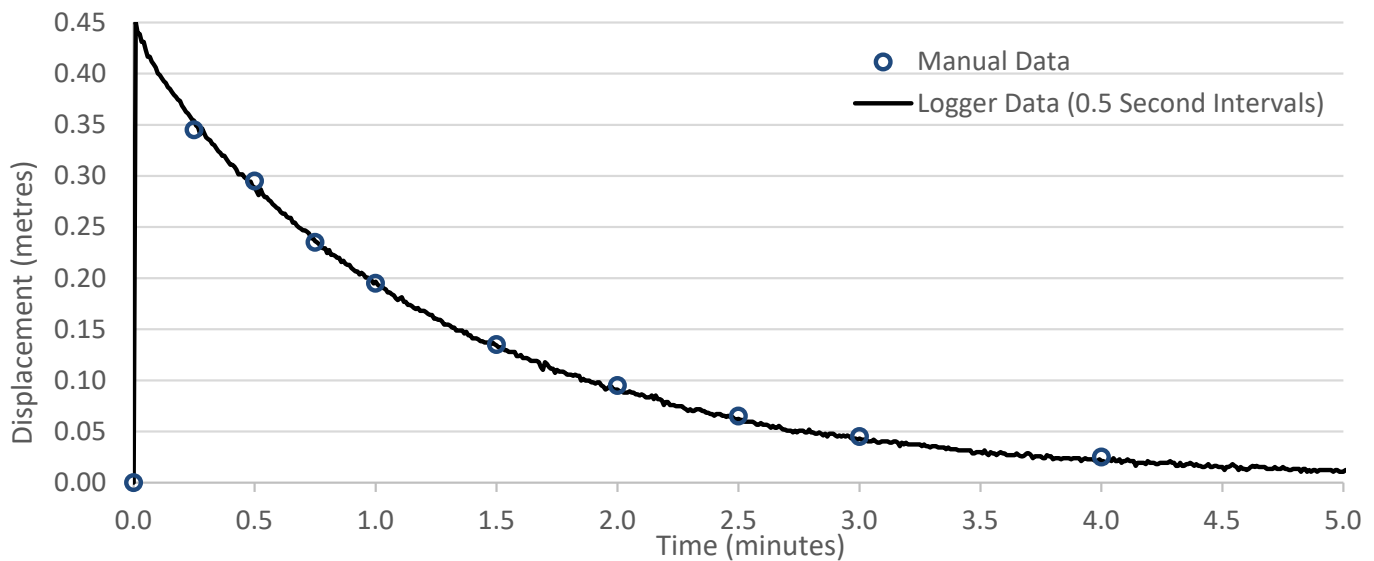
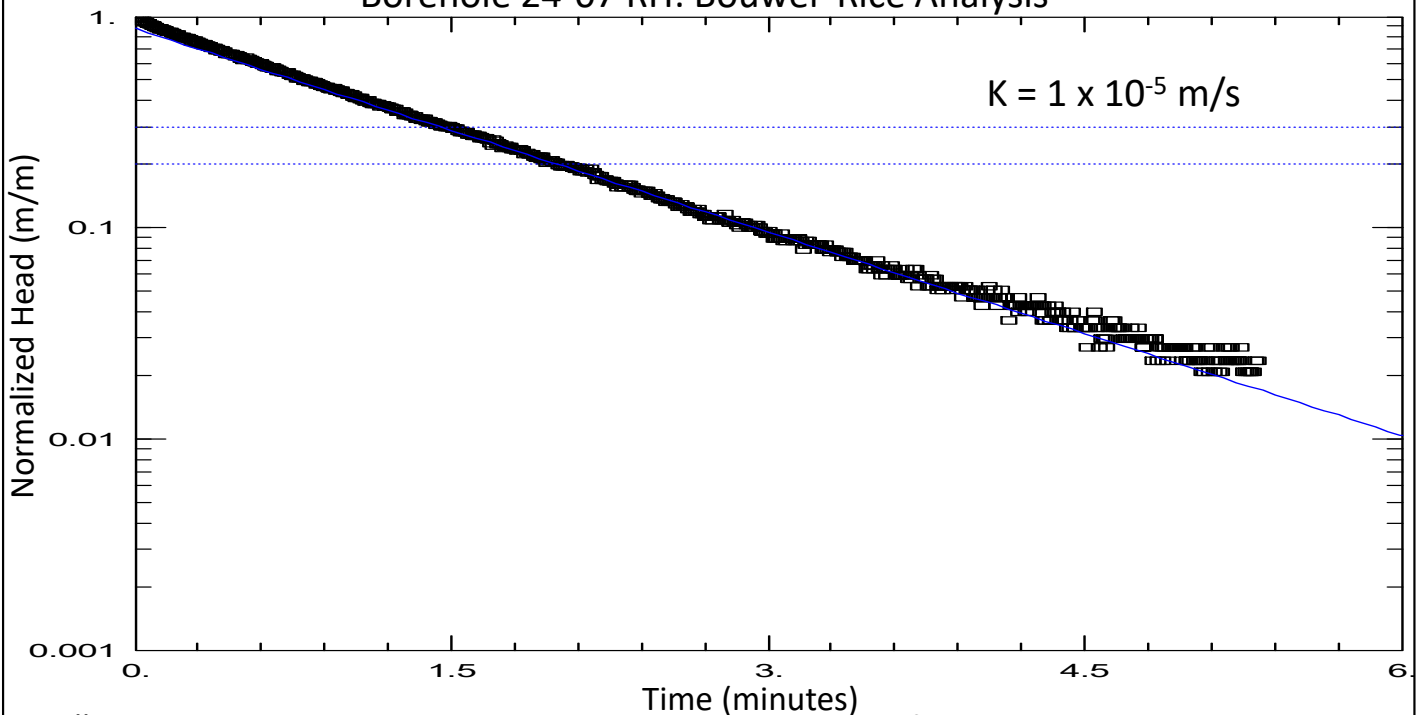
FIGURE E2

Borehole 24-07 Rising Head (RH) Test

Borehole 24-07 RH: Bouwer-Rice Analysis

Displacement observed (slug size): 0.45 metres (0.90 m)
Well Depth: 8.53 metres bgs
Screen Length: 1.52 metres
Well Radius: 0.0255 metres

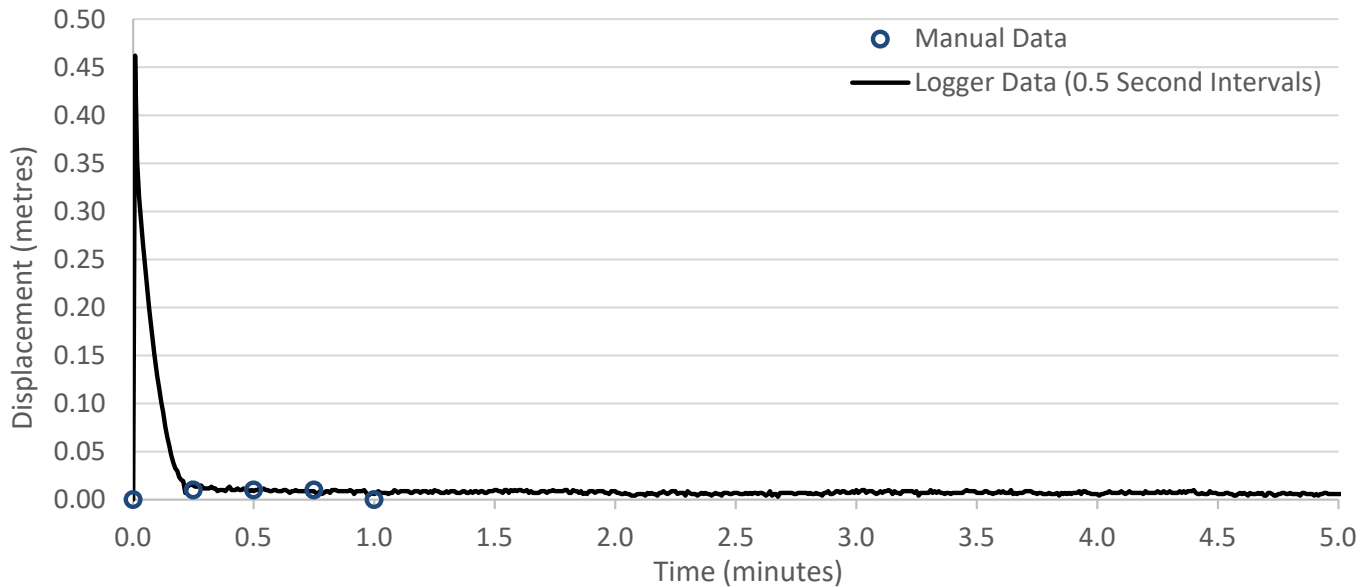
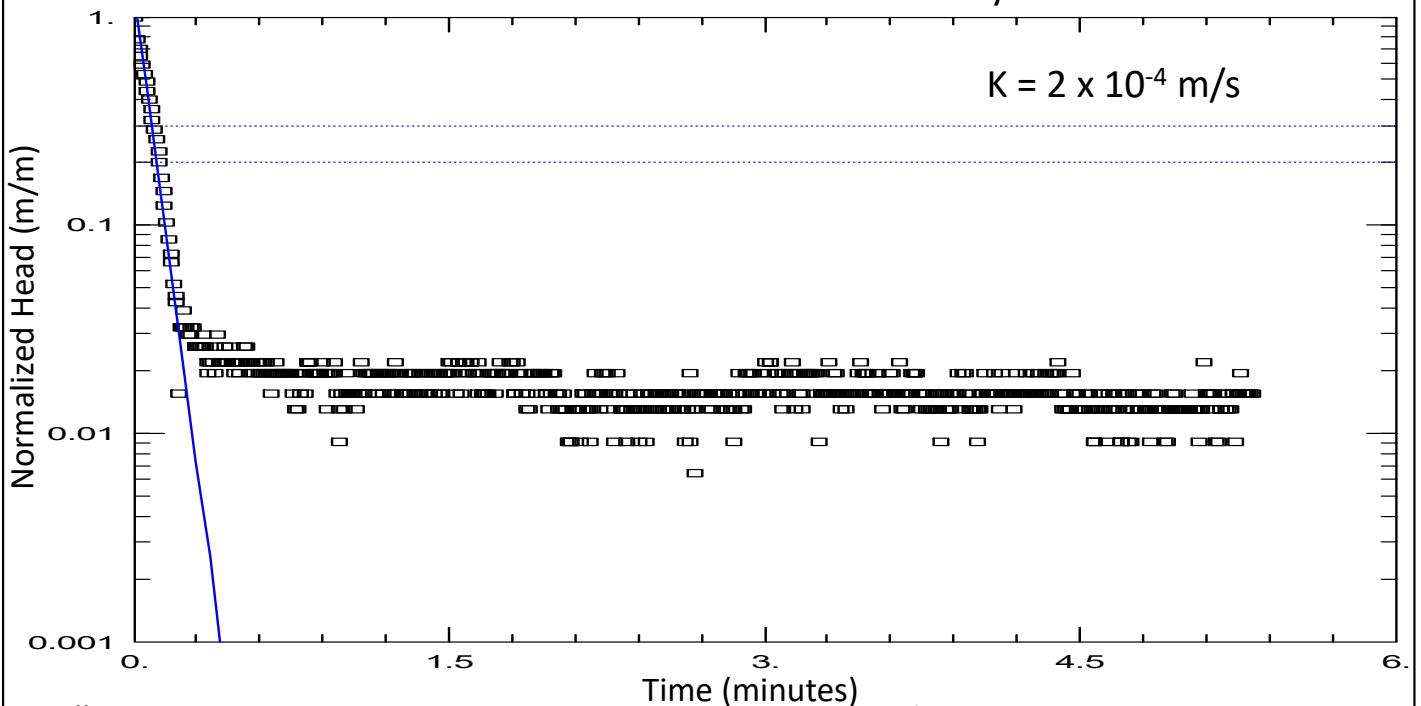
FIGURE E3

Borehole 24-08 Rising Head (RH) Test

Borehole 24-08 RH: Bouwer-Rice Analysis

Displacement observed (slug size): 0.46 metres (0.90 m)
Well Depth: 4.38 metres bgs
Screen Length: 1.52 metres
Well Radius: 0.0255 metres

It should be noted that the results from the falling head test completed at borehole 24-08 were not analyzed as the well is screened across the water table, and therefore drainage of displaced water into the unsaturated filter pack occurred almost instantaneously. As such, only the rising head test in borehole 24-08 was analyzed.
