**Geotechnical Investigation
Proposed Residential Development
1174 Carp Road
Ottawa, Ontario**

GEMTEC Project: 101785.004

February 25, 2025
GEMTEC Project: 101785.004

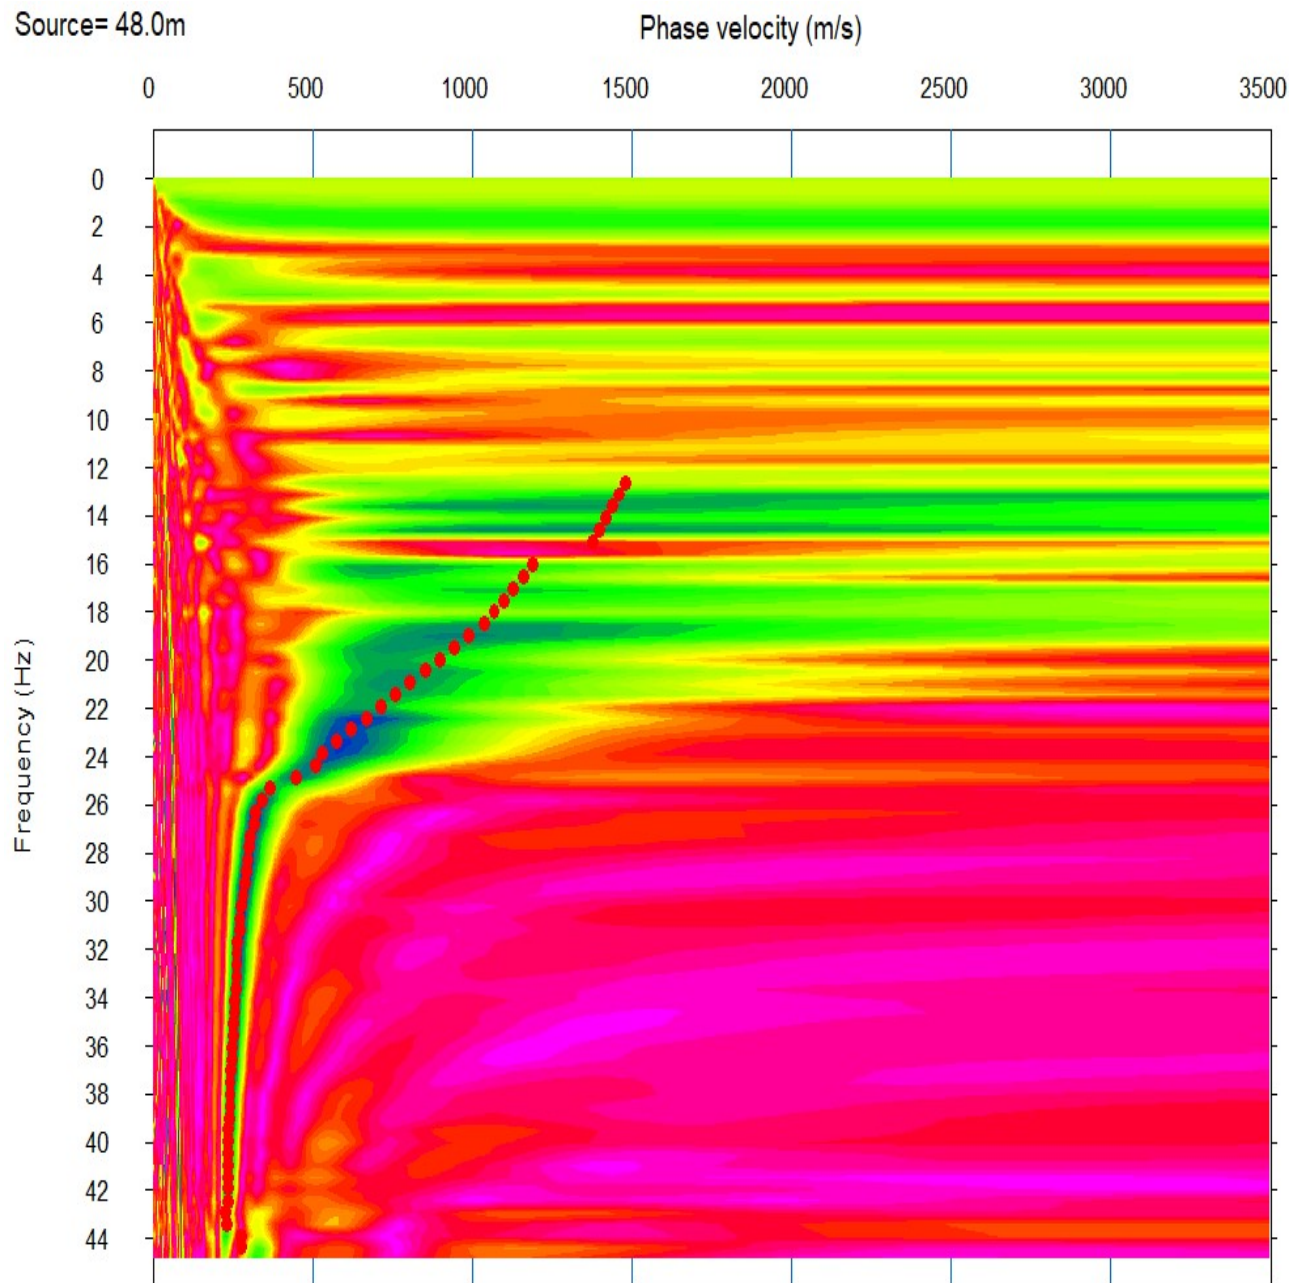
FIGURE 3

Phase Velocity vs Frequency Plot Displaying the Dispersion Curve and Picks for the an Active Shot Record
