Heritage Impact Assessment – 1010 Somerset Street West, Ottawa

Final Report

May 2025

Prepared by:
Stantec Consulting Ltd.
300-1331 Clyde Avenue
Ottawa, ON K2C 3G4

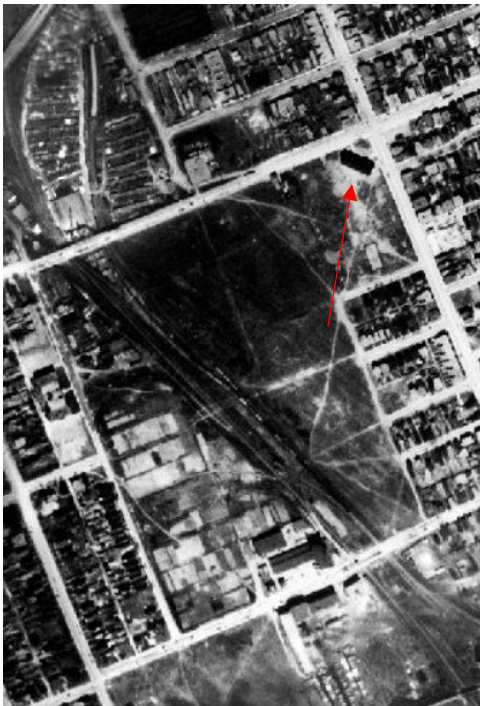
Plate 1: Aerial view of Study Area, 1928
(Plant Bath shown with red arrow)

The Plant Bath is located adjacent to 1010 Somerset Street West and was built in 1924. It was built as part of an initiative within the City of Ottawa to provide hygiene and improved health to predominantly working class families (Skyles 2017). The Plant Bath was built at the same time as the Champagne Bath (located approximately 5 km northeast of the Study Area). The Plant Bath was named after Frank H. Plant, who was the mayor of Ottawa at the time of construction (Skyles 2017). The bathhouse was in operation from 1924 to 1996, when the building was temporarily closed due to deterioration. In the early 2000s, the building was refurbished with a recreational centre built on the rear of the structure. Renovations cost approximately \$8 million and included removing the pool from the old building and the construction of two new pools, a hot tub, steam bath, and gyms in the new recreational centre. The Plant Bath was designated as a heritage building in 1994 (Skyles 2017).

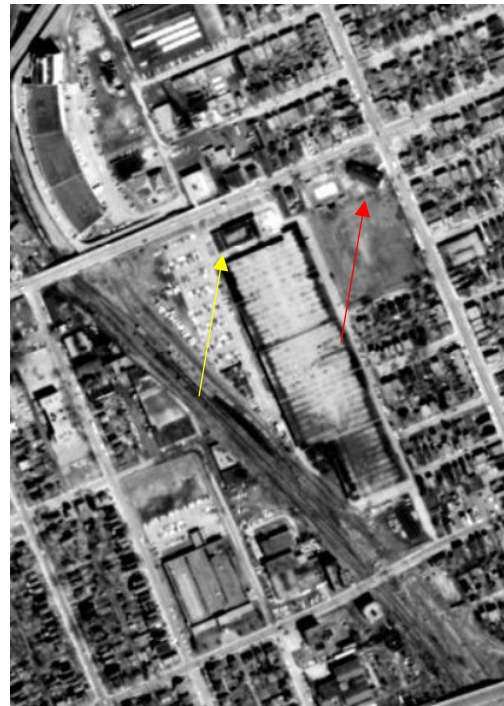
Plate 2: Aerial view of Study Area, 1965
(Plant Bath shown with red arrow,
1010 Somerset Street West shown
with yellow arrow)

Street West that was used for munitions and equipment during the Second World War (Plate 2) (Jay 2016). The warehouse was later demolished in 2015 (Jay 2016).

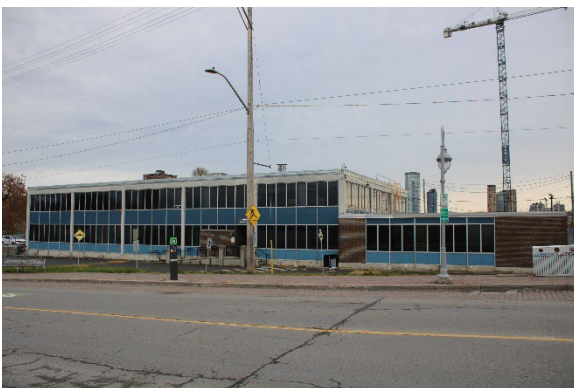
Photo 4 1010 Somerset Street West, looking south

Located on the south side of Somerset Street West, the extant structure at 1010 Somerset Street West is a two-storey International style building (Photo 4). The building has a flat roof and a concrete structure which is visible on the exterior of the building. The building uses a curtain wall system comprising aluminum ribs and mullions for the windows with blue spandrel panels (Photo 5). The windows and structural systems are regularly placed on the first and second storeys of the building. Brick veneer accent walls are located near entrances and corners of the building (Photo 6). A one-storey section is located on its west side (Photo 7). The building is surrounded by a paved parking lot (Photo 8).

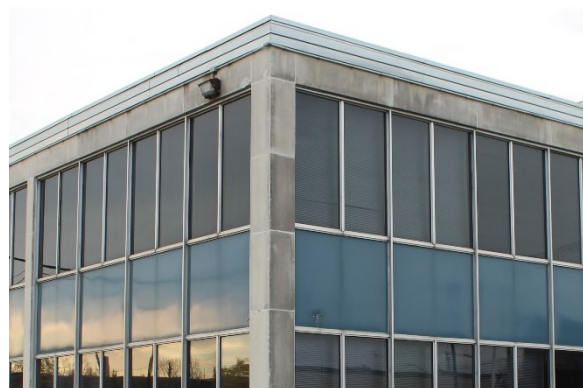
Photo 5 Detail of curtain wall and concrete structure

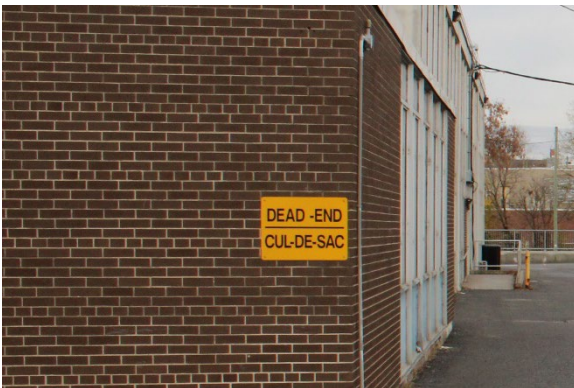
Photo 6 Typical brick veneer, looking west

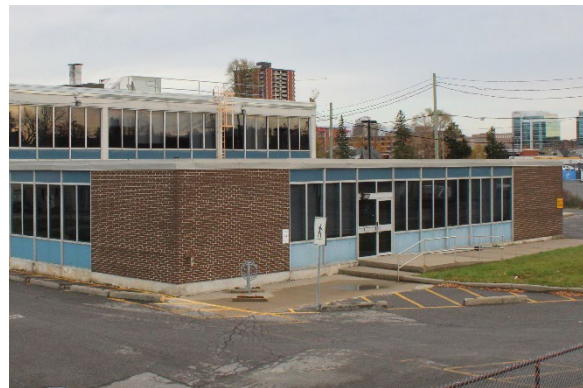
Photo 7 One storey section on west side, looking southwest

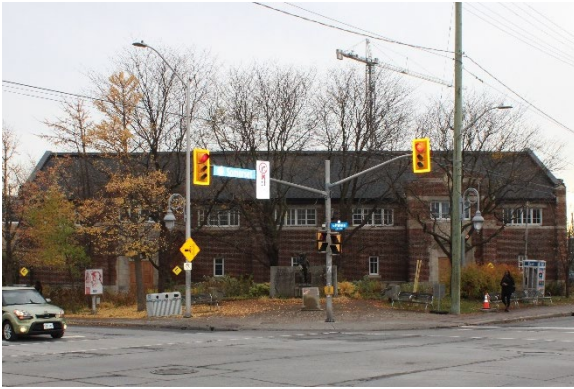
Photo 9 Plant Bath looking southwest

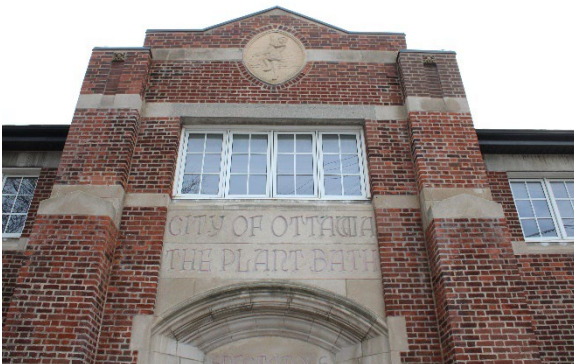
Photo 11 Plant Bath northeast former entrance

As identified in Section 6, there is the potential for indirect impacts to the Plant Bath from construction-related ground vibration. As identified during the field investigations, the northeast corner of the wall has begun to deteriorate and changes in its context may elevate the risk of further damage. To mitigate this risk, a strategy to carry out a pre-condition survey, vibration monitoring, and post-condition survey is typically employed. These plans are most often developed by a licensed Geotechnical Engineer with heritage experience and can be further defined as detailed design progresses.

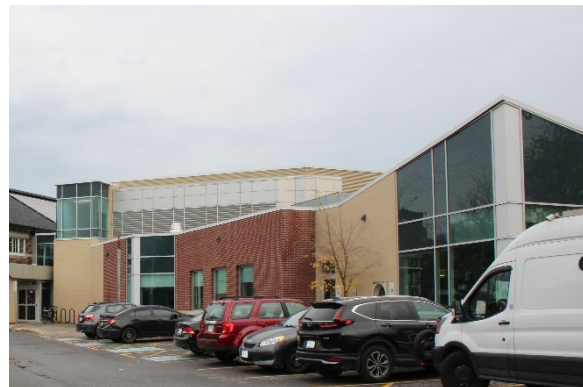
Photo 12 View of contemporary addition to the Plant Bath, looking northeast

atrium between the historic Plant Bath and the addition (Photo 13). The addition of the Plant Recreation Centre is visible from the Study Area (Photo 14).

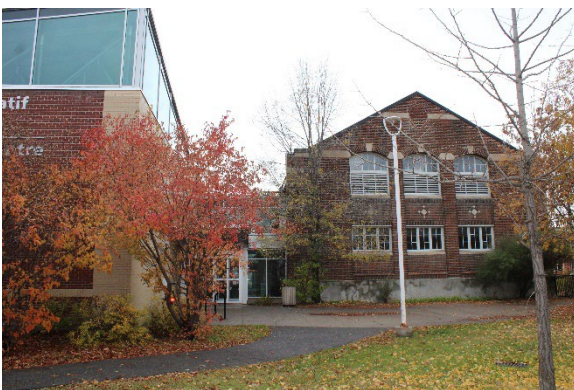
Photo 13 Plant Recreation Centre south entrance, looking northwest

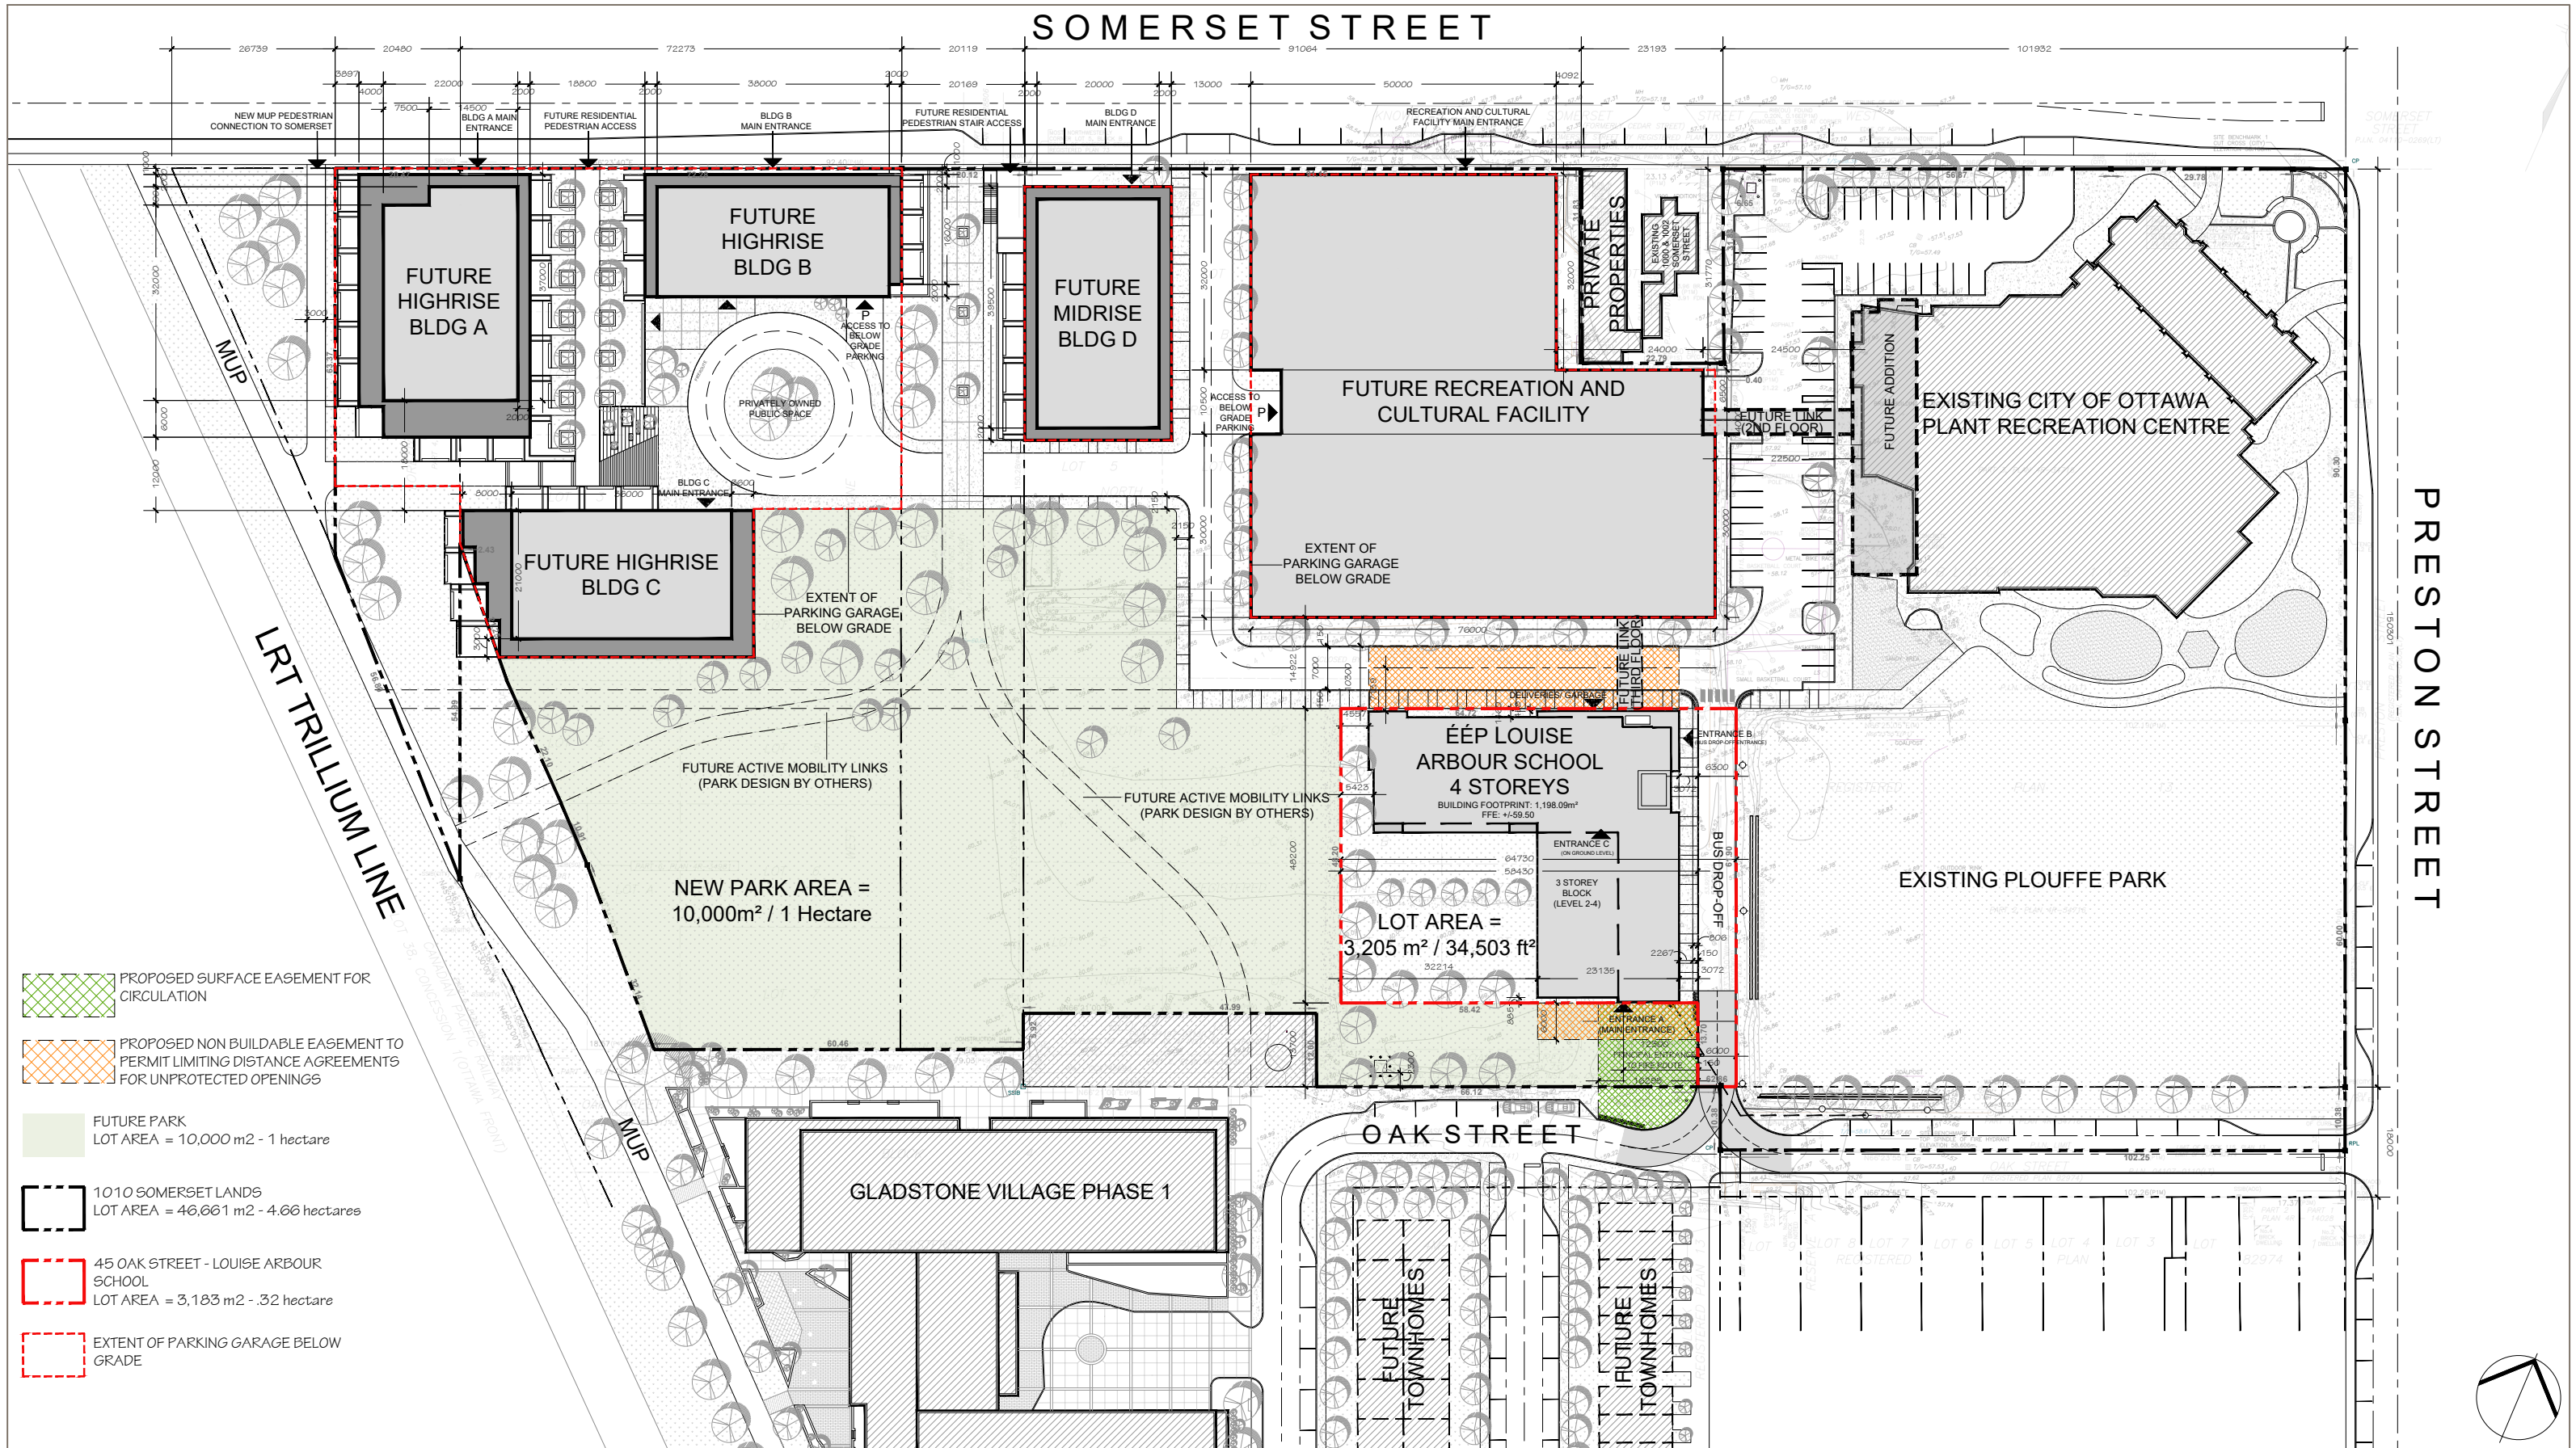
Appendix A Development Concept Plan

1010 SOMERSET ST.
