**Hydrogeological Investigation,
Terrain Analysis, and Groundwater
Impact Assessment
Zoning Amendment
6158 Rideau Valley Drive
Ottawa, Ontario**

June 13, 2025

File: 100011.082

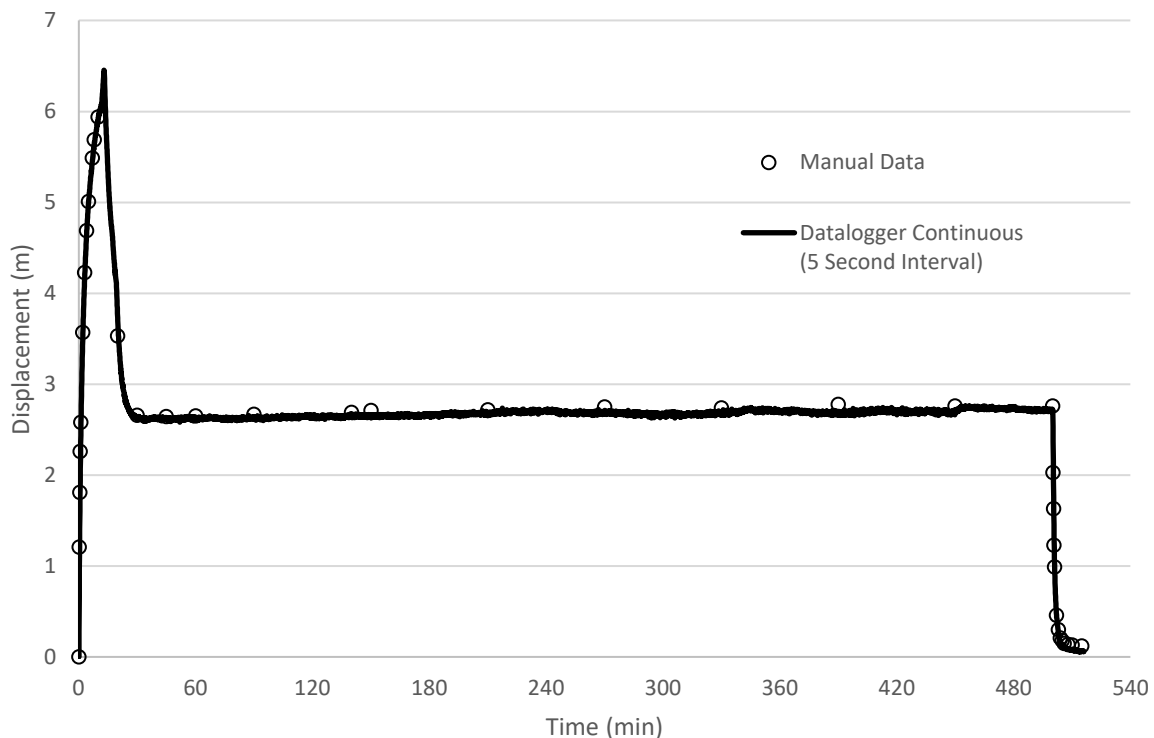
Pumping Test Data (TW1): Drawdown and Recovery

Water Levels TW23-1

Static : 9.38 m below top of casing

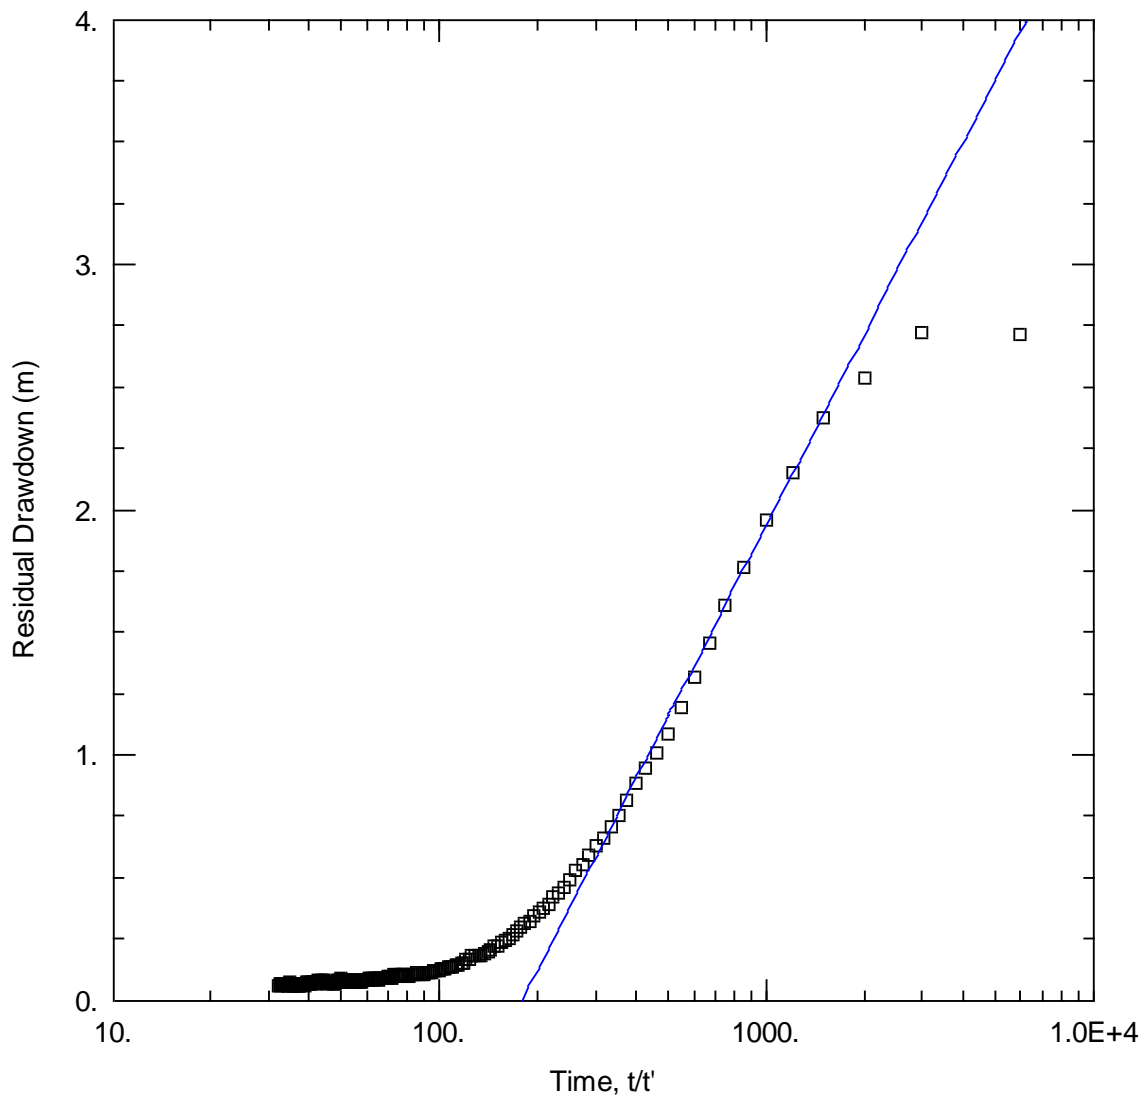
Pumping Test Analysis (TW1): Theis-Recovery (Confined Aquifer)

Estimated Transmissivity: 3.8 m²/day or 4 x 10⁻⁵ m²/s

The transmissivity of the water supply aquifer was estimated from the pumping test drawdown data using Aqtesolv (Version 4.5), a commercially available software program from HydroSOLVE Inc. The Theis recovery method was employed to analyze the pumping test data. Insufficient drawdown was observed during the pumping test for analysis of aquifer properties. Analyses
