**Geotechnical Investigation Report  
Proposed Development  
5872, 5880, and 5884 Hazeldean  
Road and 7 Savage Drive  
Ottawa, Ontario**

GEMTEC Project: 104054.001

October 2, 2025  
GEMTEC Project: 104054.001

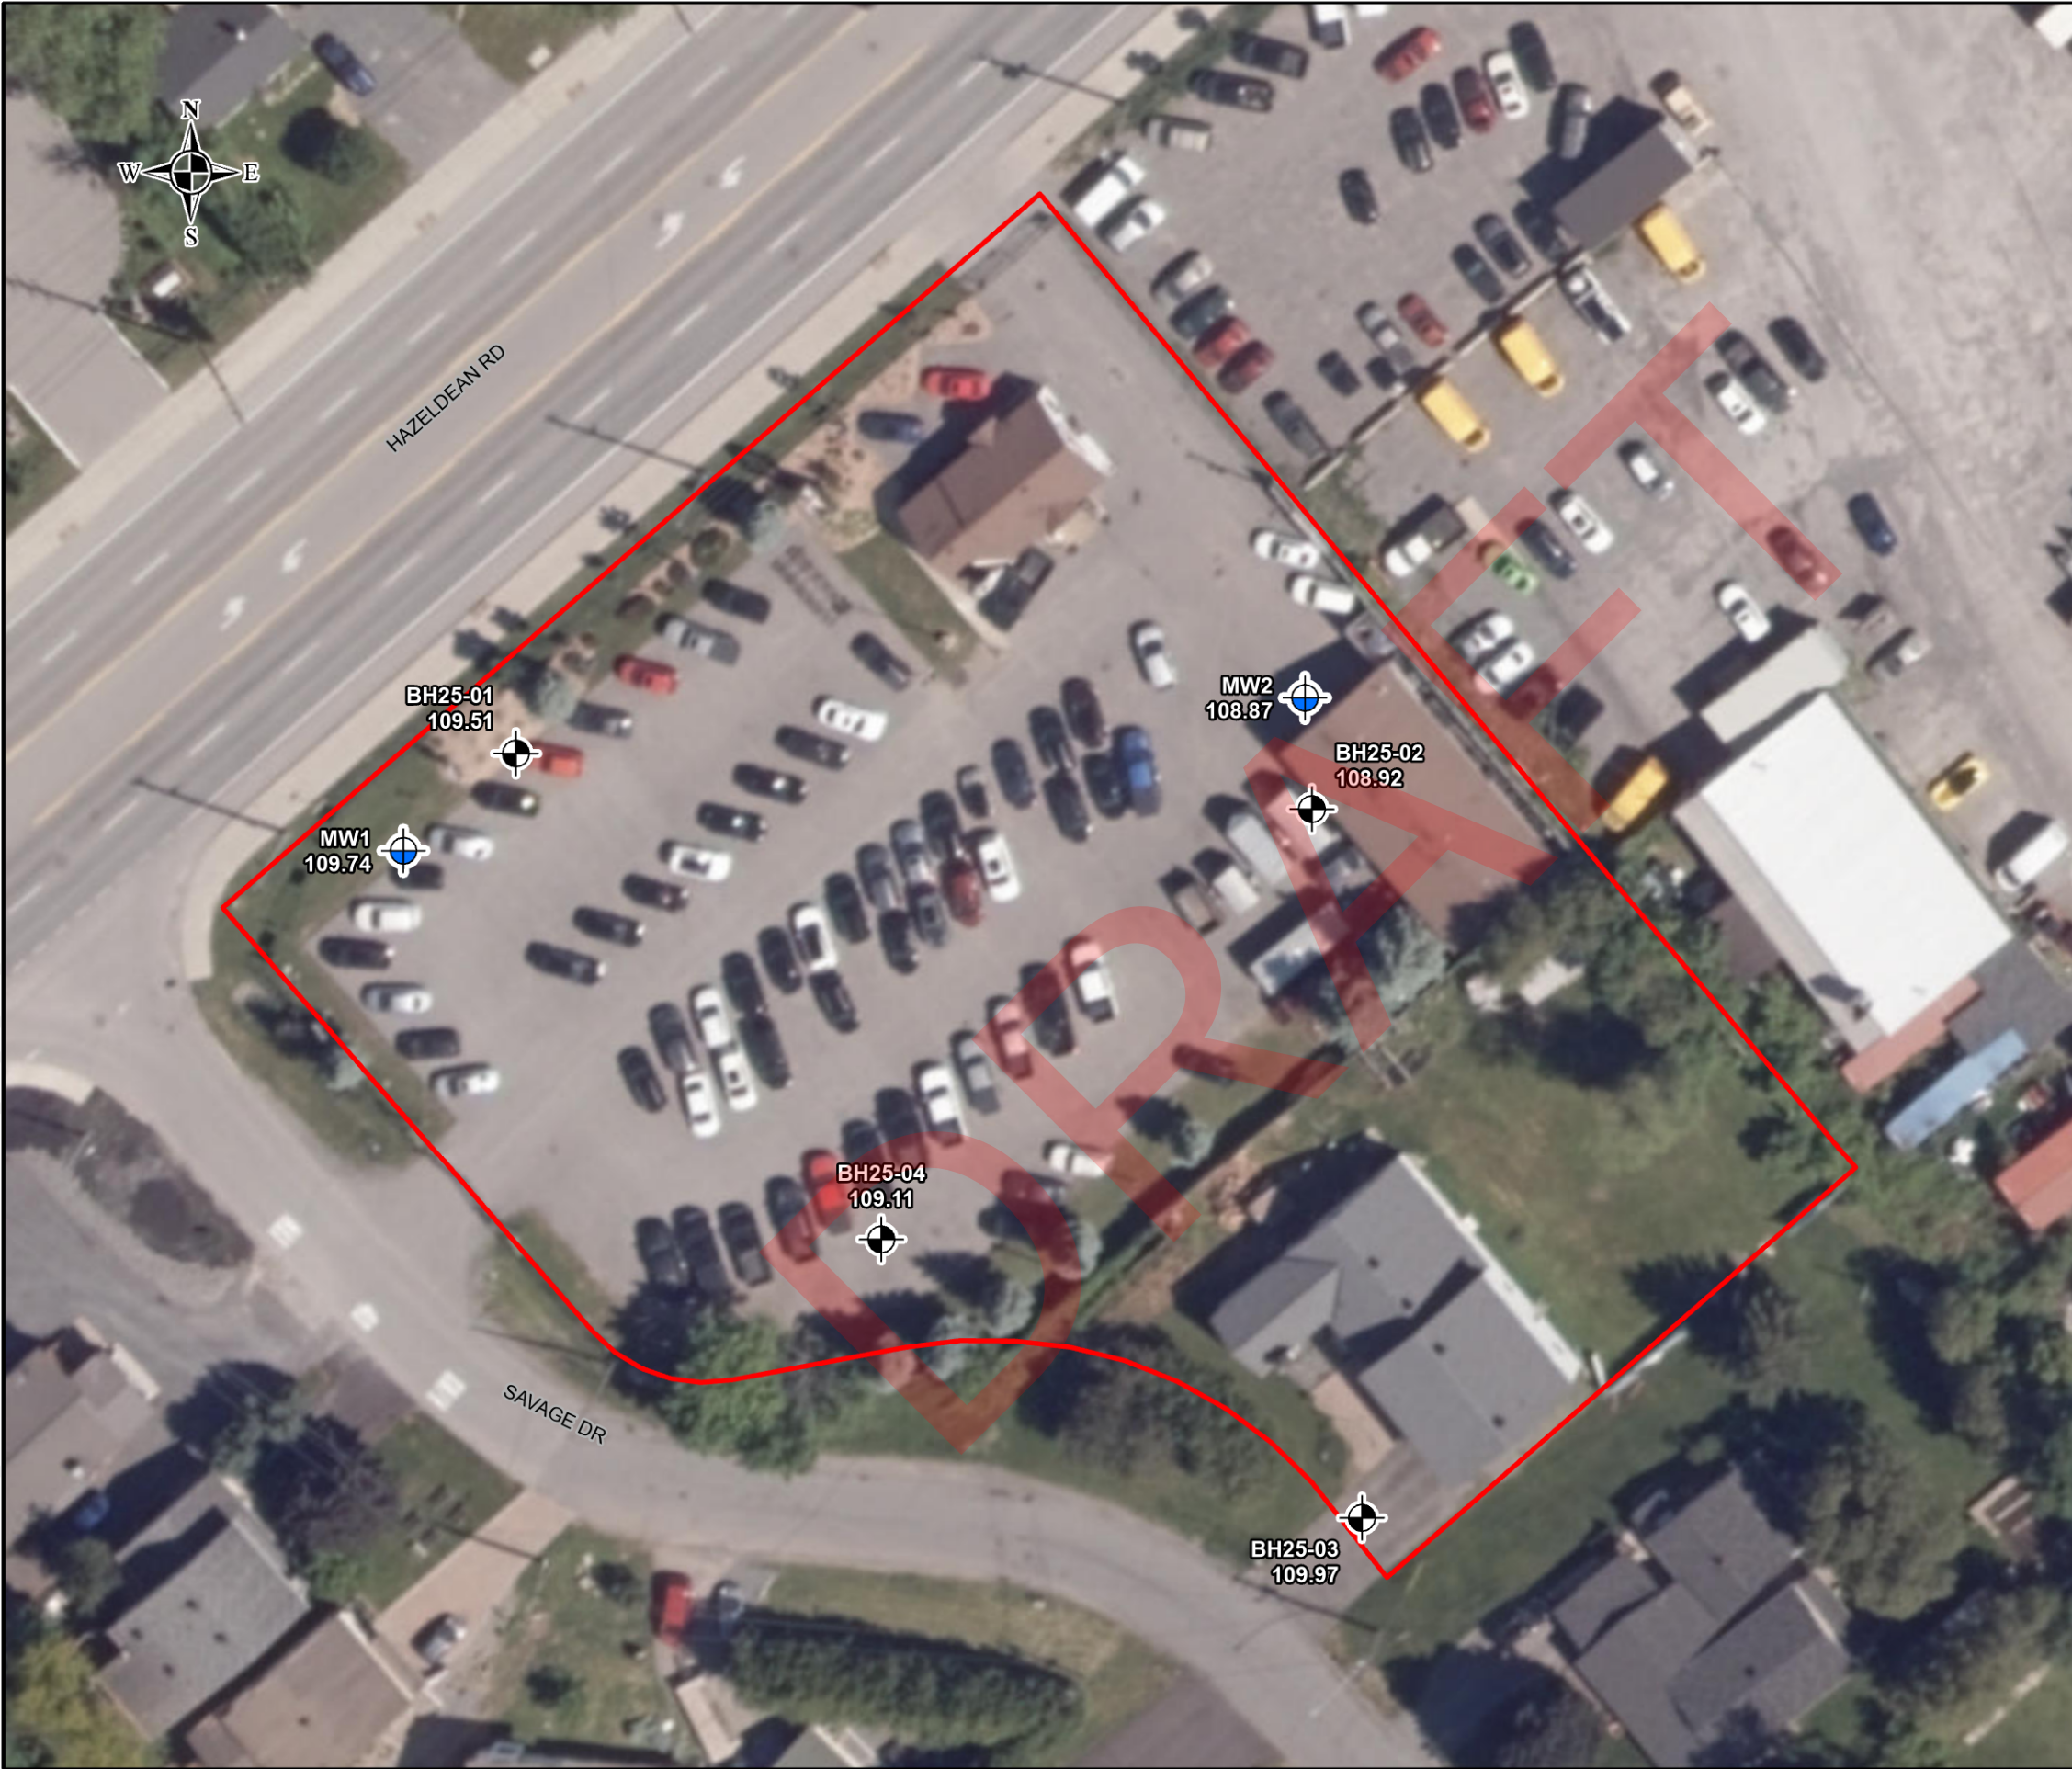
| <b>Date</b><br>JUNE 2025 | <b>FIGURE 1</b> |

- BH# — BOREHOLE ID
- XXXX — GROUND SURFACE ELEVATIONS, IN METRES GEODETIC DATUM
- BOREHOLE LOCATION (GEMTEC 2025)
- MONITORING WELL LOCATION (ELEVATIONS RECORDED BY GEMTEC, PINCHIN 2024)
- APPROXIMATE SITE BOUNDARY

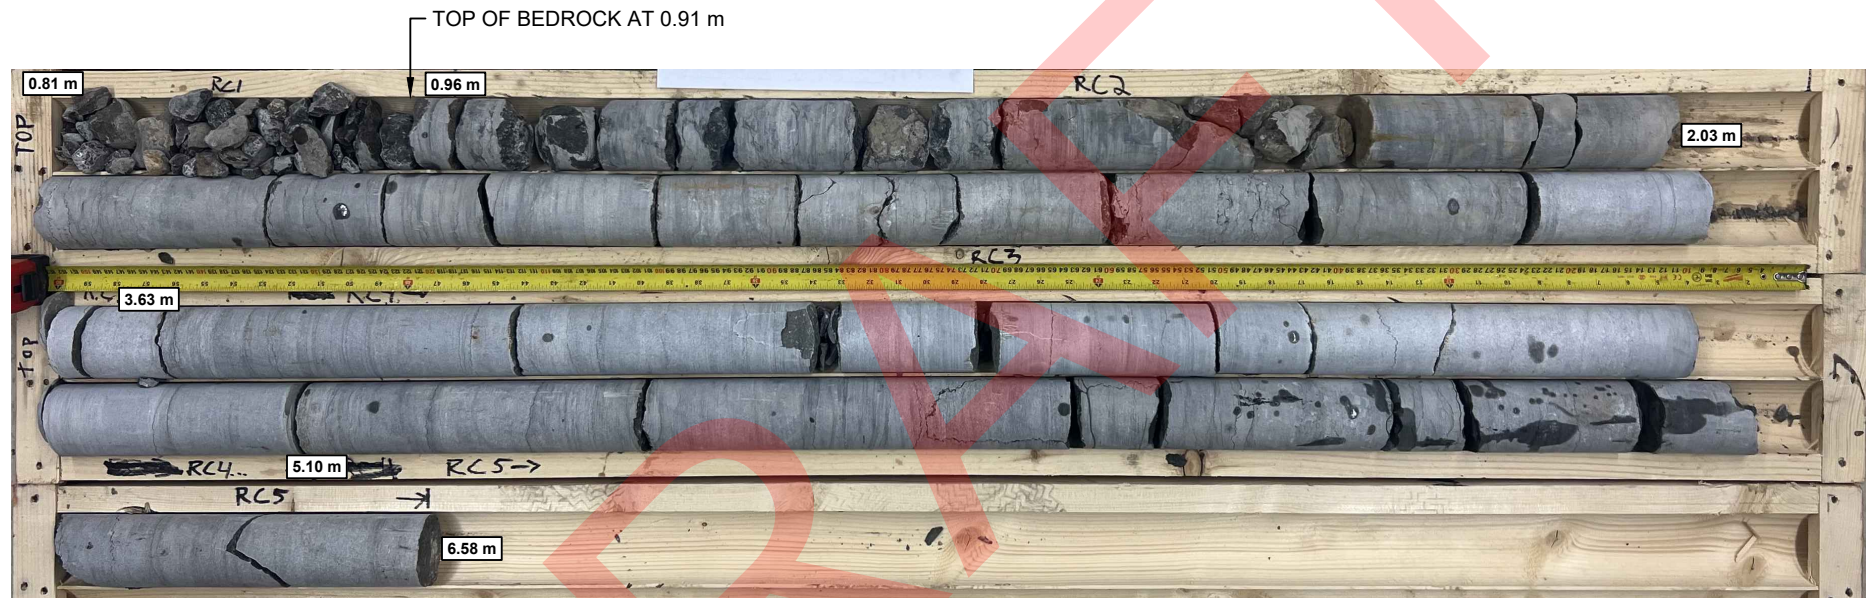
**BOREHOLE: 25-01**  
**BORING DATE: APRIL 30, 2025**  
**DEPTH: 0.81 TO 6.58 METRES BELOW GROUND SURFACE**

NOTE: MATERIAL IN CORE BOX FROM 0.81 TO 0.91 METRES BELOW GROUND SURFACE IS GRAVEL WITHIN FILL MATERIAL

The upper about 0.3 and 0.2 metres of the bedrock in the boreholes 25-02 and 25-03, respectively, is moderately to highly fractured, with solid core recovery values of about 0 to 50 percent and rock quality designation values of 0 percent.

Below the fractured zone, total core recover (TCR) values ranging from about 83 to 100 percent, solid core recovery (SCR) values ranging from about 25 to 100 percent, and rock quality designation (RQD) values ranging from about 18 to 100 percent were obtained. Based on these values, in accordance with the classification system set out in the Canadian Foundation Engineering Manual (5<sup>th</sup> Edition) the bedrock can be classified as Very Poor to Excellent Quality, possibly increasing with depth.

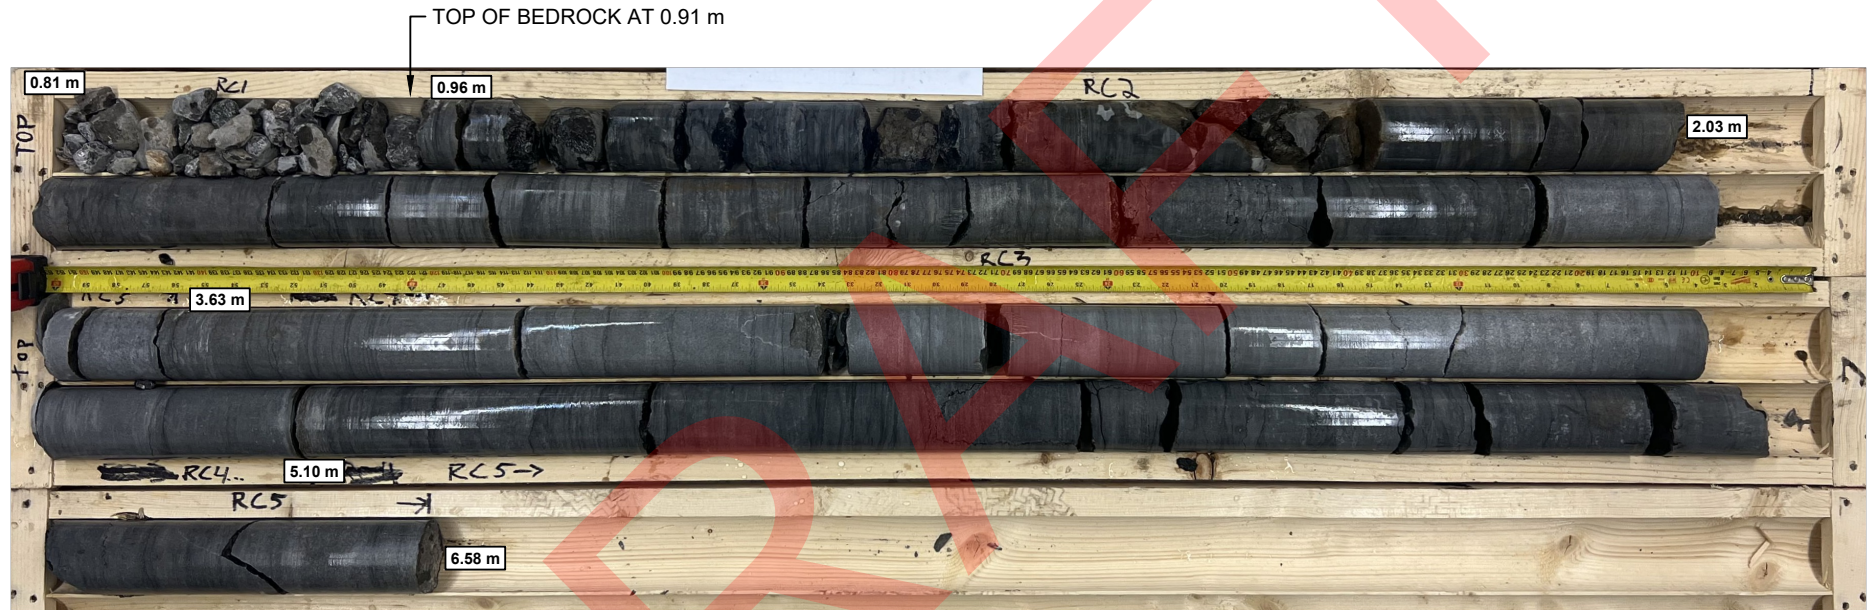
FIGURE C2

BOREHOLE: 25-01  
BORING DATE: APRIL 30, 2025  
DEPTH: 0.81 TO 6.58 METRES BELOW GROUND SURFACE

NOTE: MATERIAL IN CORE BOX FROM 0.81 TO 0.91 METRES BELOW GROUND SURFACE IS GRAVEL WITHIN FILL MATERIAL

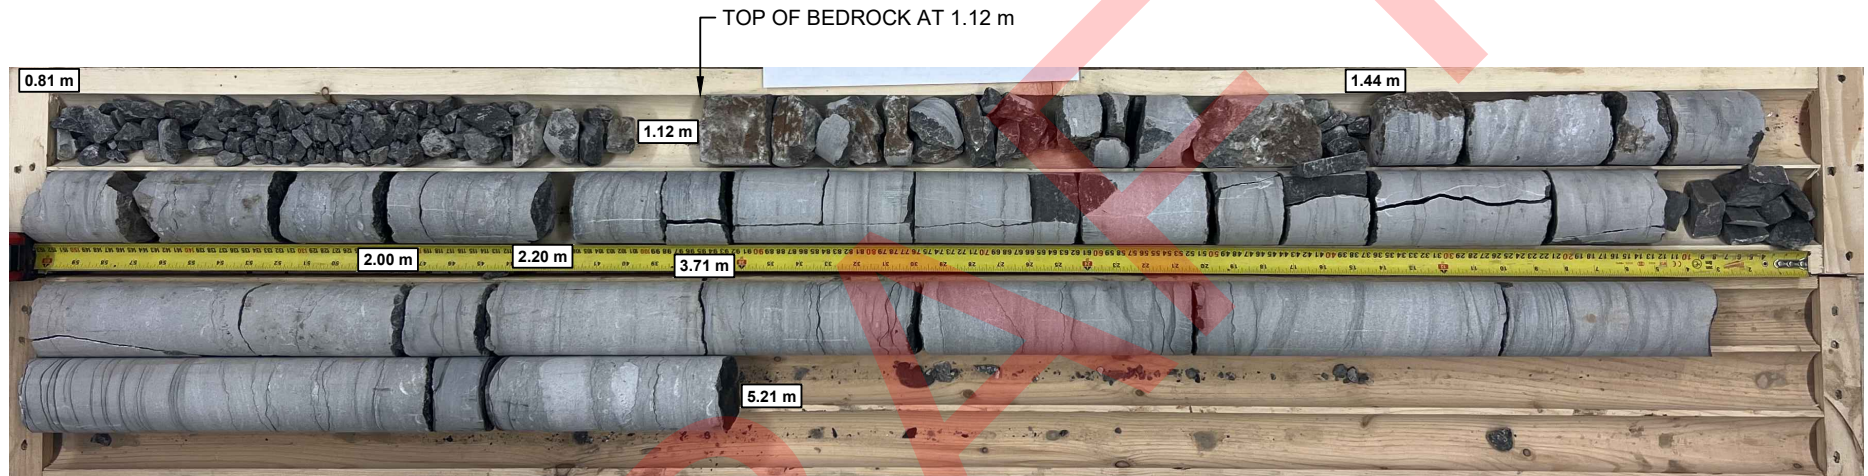
**FIGURE C3**

**BOREHOLE: 25-02**  
**BORING DATE: APRIL 30, 2025**  
**DEPTH: 0.81 TO 5.21 METRES BELOW GROUND SURFACE**

NOTE: MATERIAL IN CORE BOX FROM 0.81 TO 1.12 METRES BELOW GROUND SURFACE IS GRAVEL WITHIN FILL MATERIAL

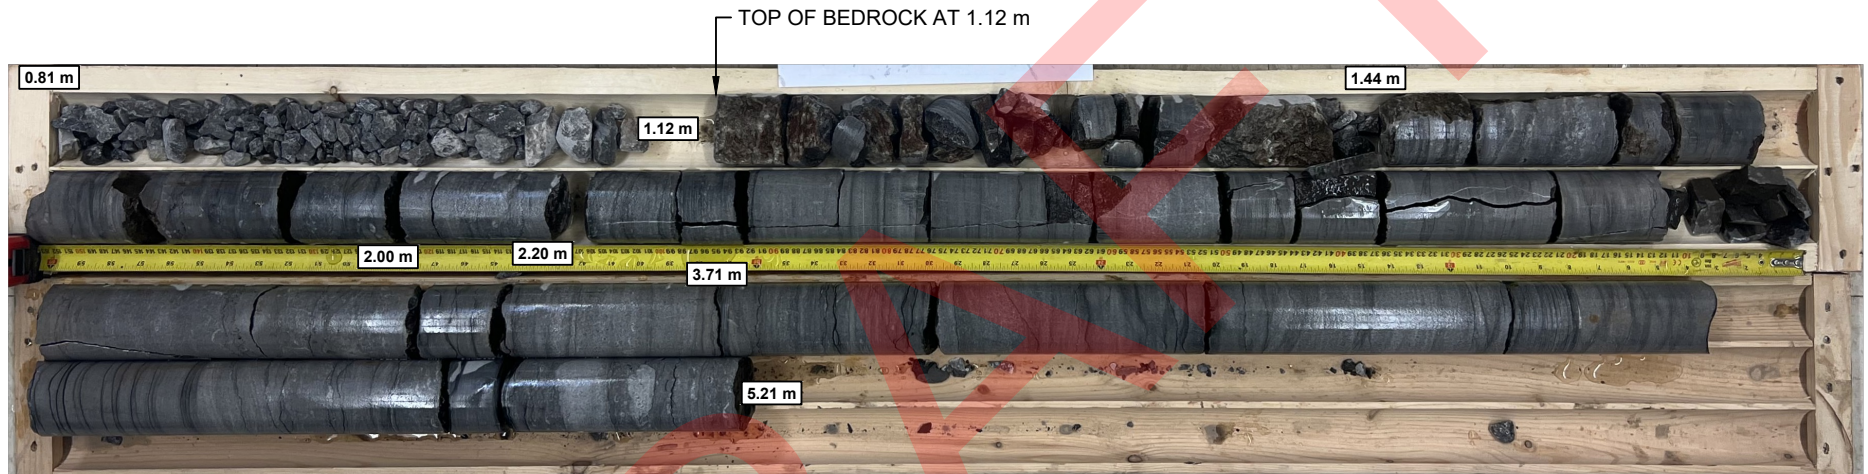
**FIGURE C4**

**BOREHOLE: 25-02**  
**BORING DATE: APRIL 30, 2025**  
**DEPTH: 0.81 TO 5.21 METRES BELOW GROUND SURFACE**

NOTE: MATERIAL IN CORE BOX FROM 0.81 TO 1.12 METRES BELOW GROUND SURFACE IS GRAVEL WITHIN FILL MATERIAL

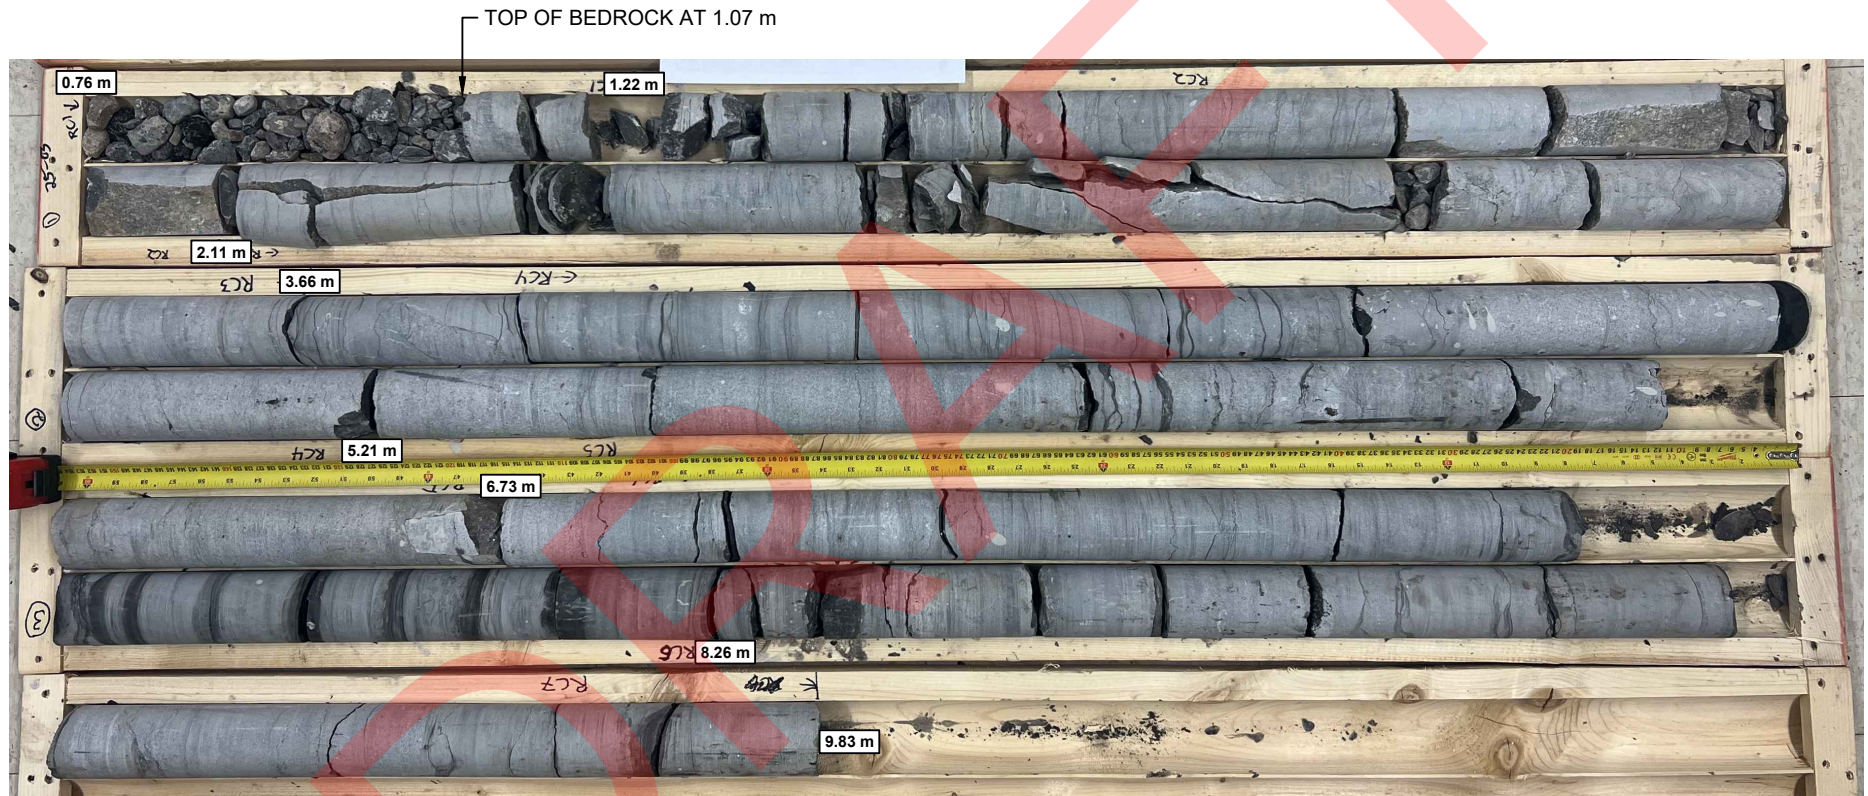
**FIGURE C5**

**BOREHOLE: 25-03**  
**BORING DATE: MAY 1, 2025**  
**DEPTH: 0.76 TO 9.83 METRES BELOW GROUND SURFACE**

NOTE: MATERIAL IN CORE BOX FROM 0.76 TO 1.07 METRES BELOW GROUND SURFACE IS GRAVEL WITHIN FILL MATERIAL

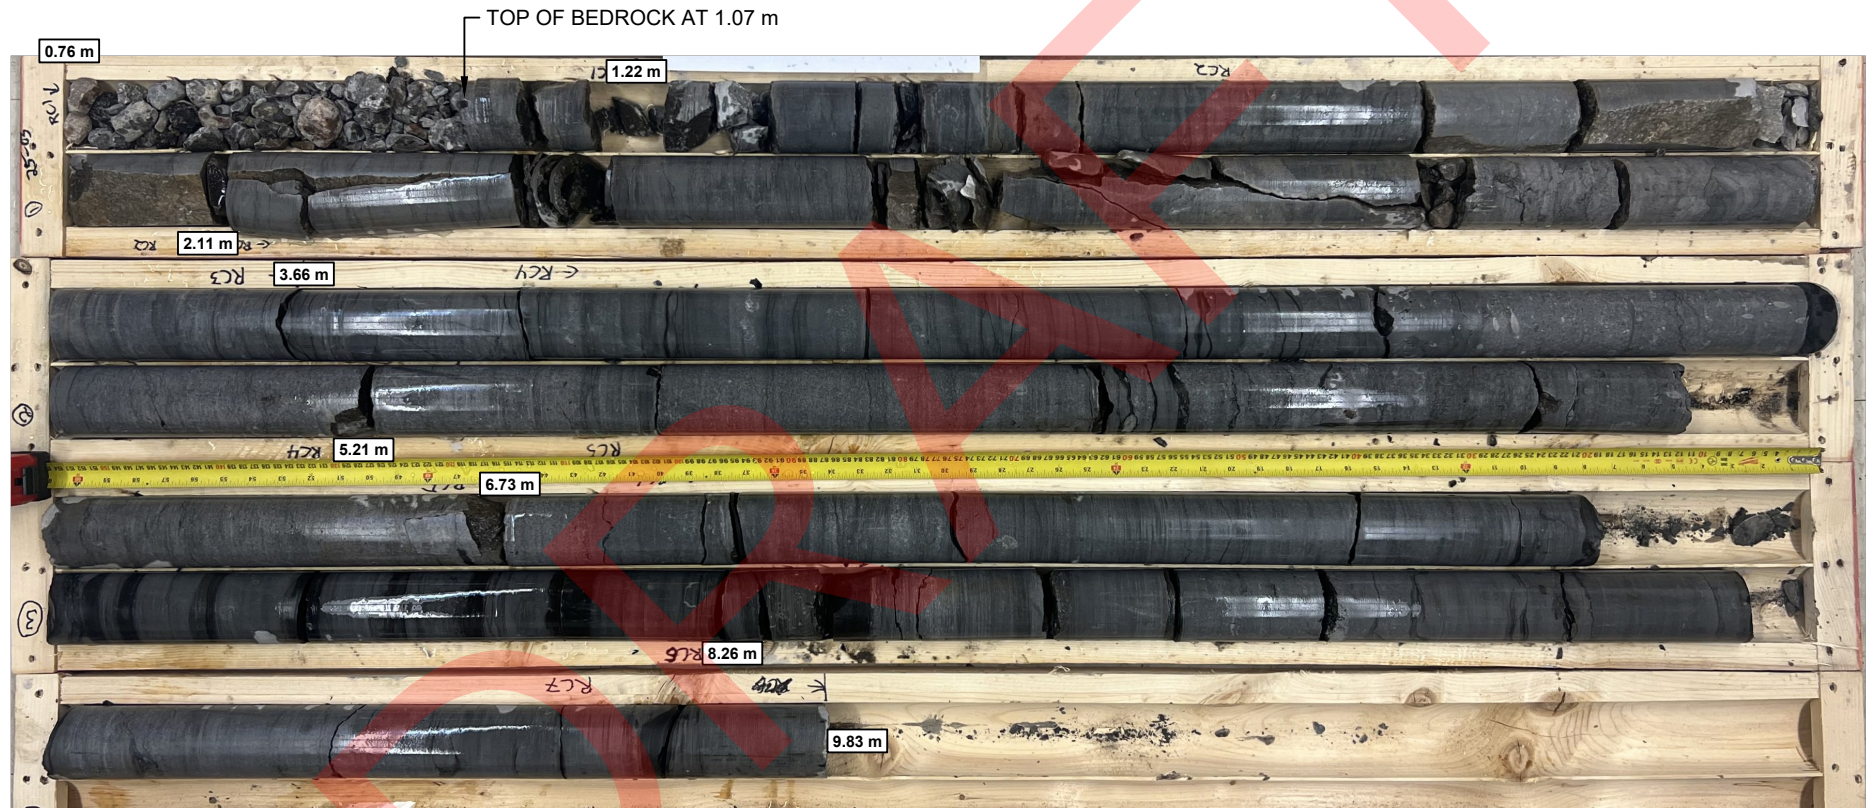
**BOREHOLE: 25-03**  
**BORING DATE: MAY 1, 2025**  
**DEPTH: 0.76 TO 9.83 METRES BELOW GROUND SURFACE**

NOTE: MATERIAL IN CORE BOX FROM 0.76 TO 1.07 METRES BELOW GROUND SURFACE IS GRAVEL WITHIN FILL MATERIAL
