Geotechnical Investigation

Proposed Residential Development

Arcadia – Stage 6
Campeau Drive - Ottawa

Report: PG5648-1 Revision 4 dated June 30, 2022

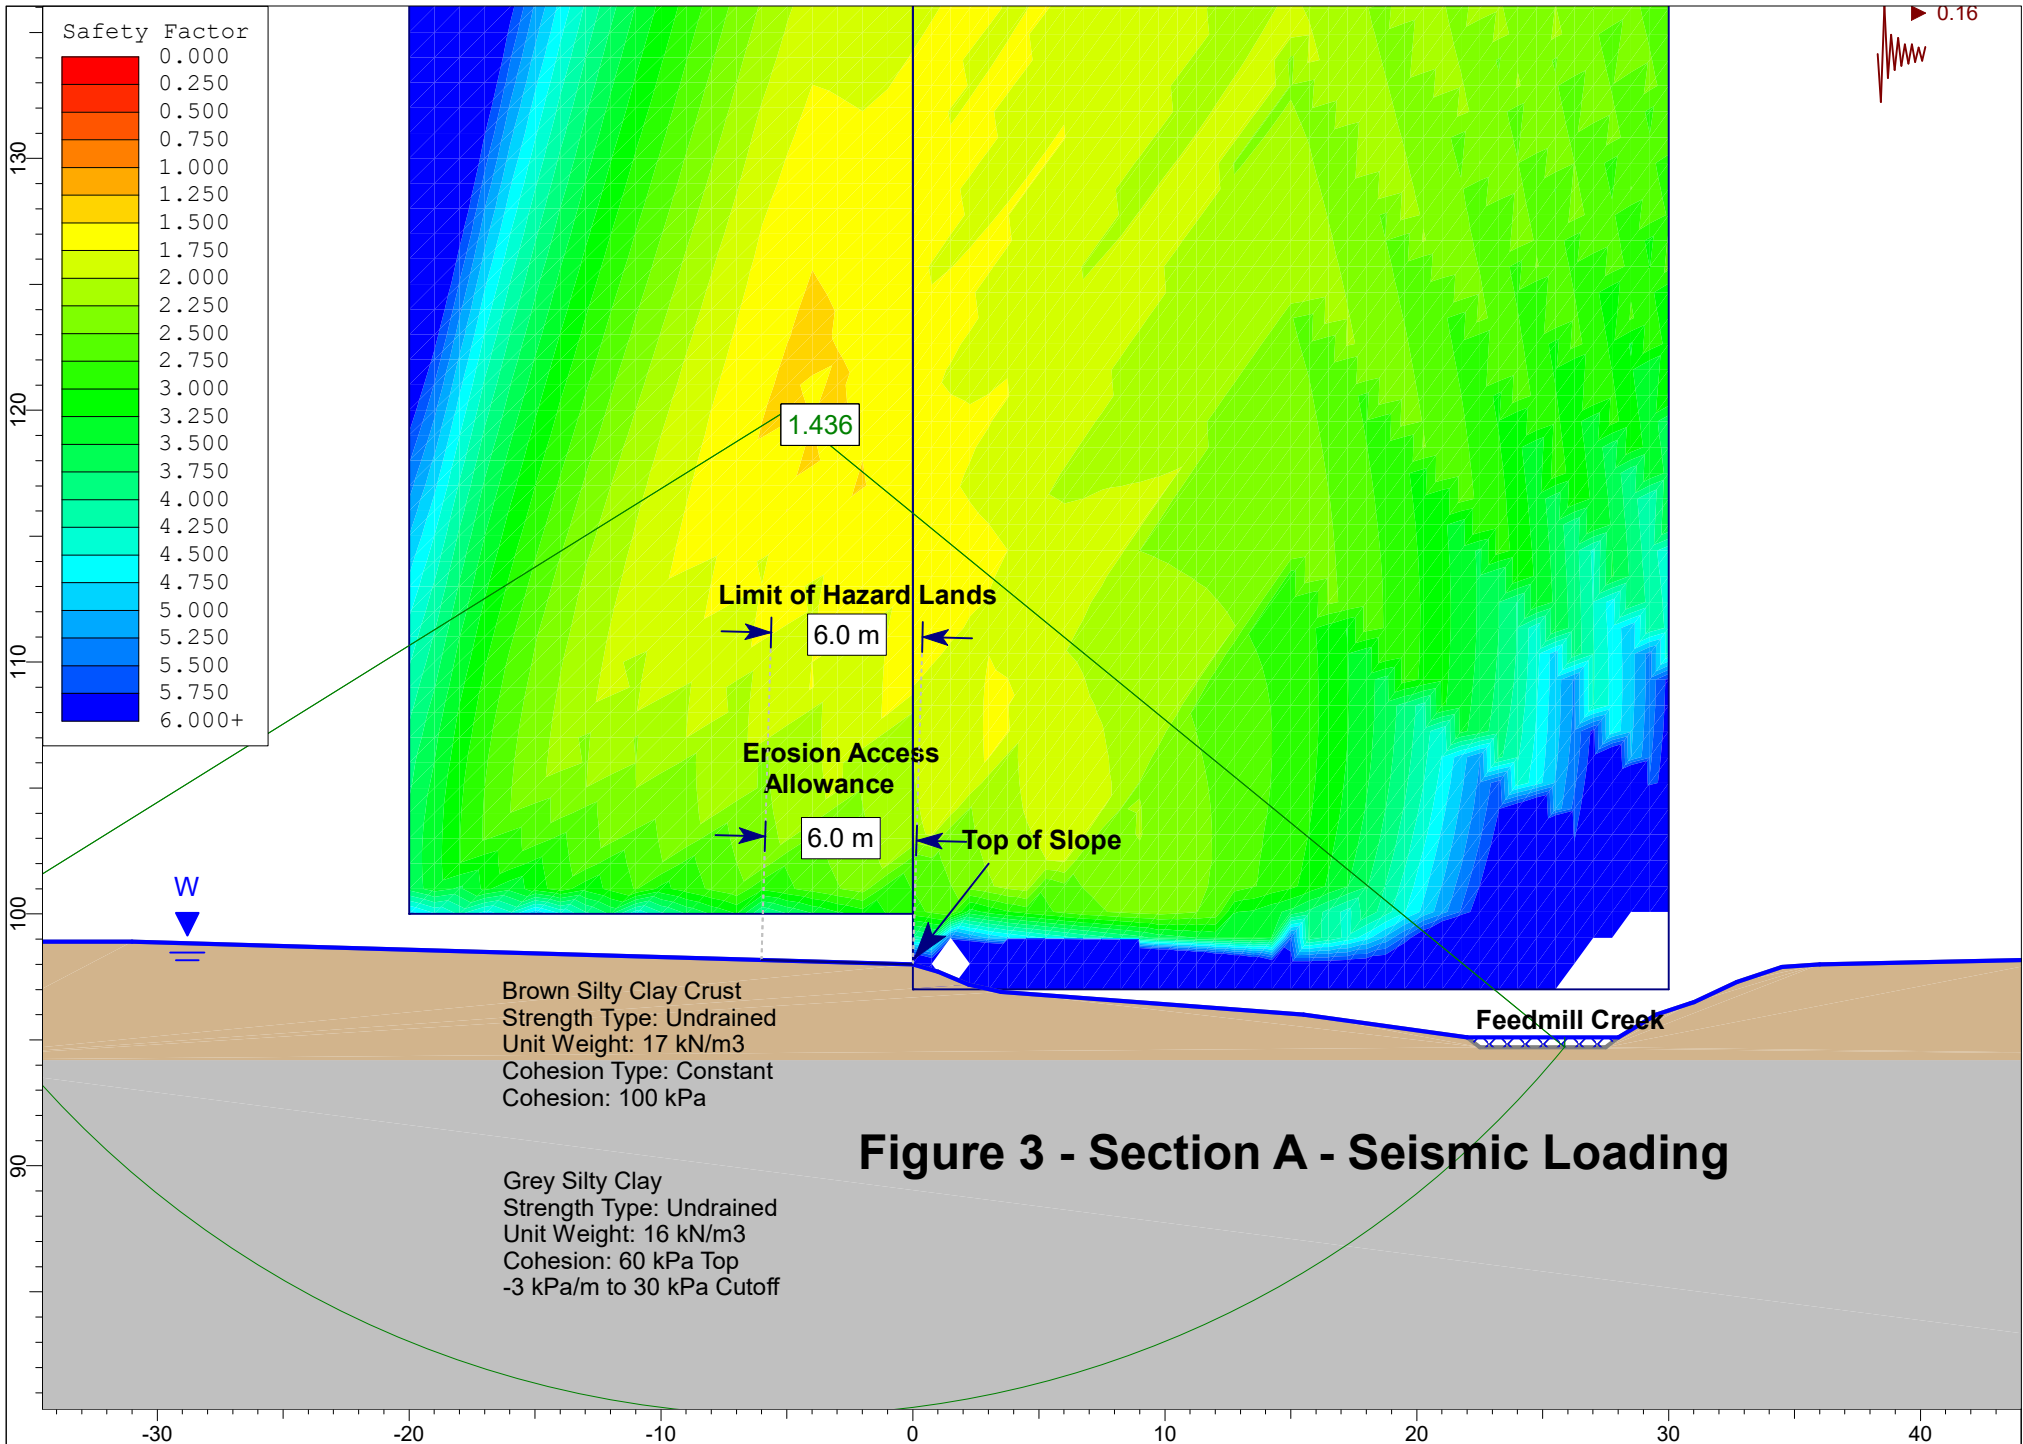
Figure 3 - Section A - Seismic Loading

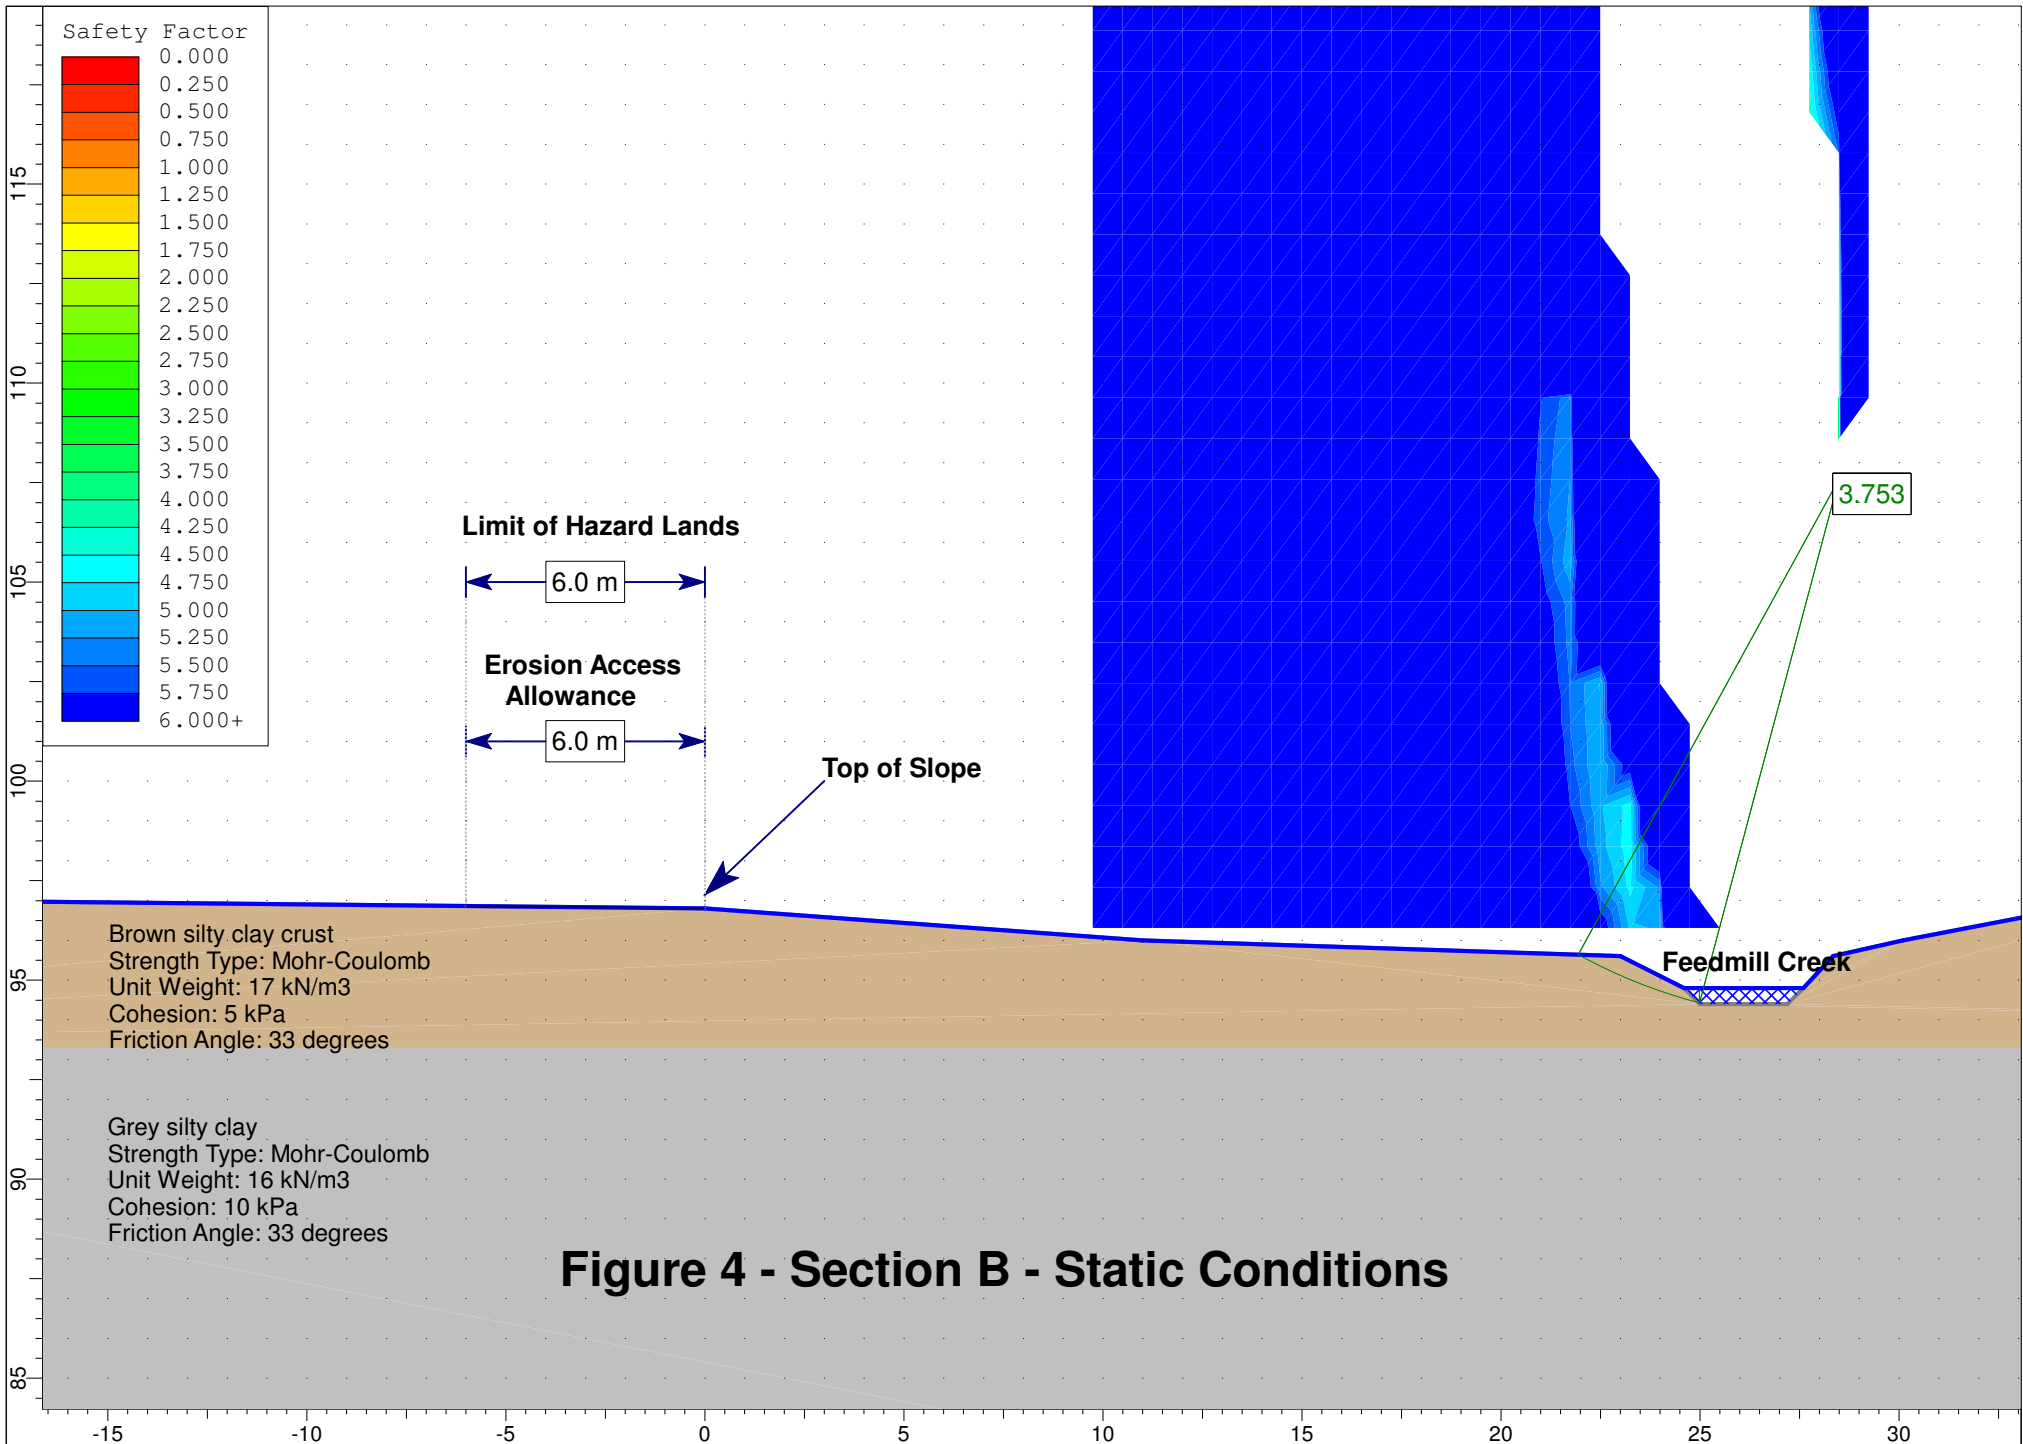
Figure 4 - Section B - Static Conditions
