HYDROGEOLOGICAL INVESTIGATION REPORT

Proposed Development,
261 Buena Vista Road,
Ottawa, Ontario

CO680.02

April 17, 2026

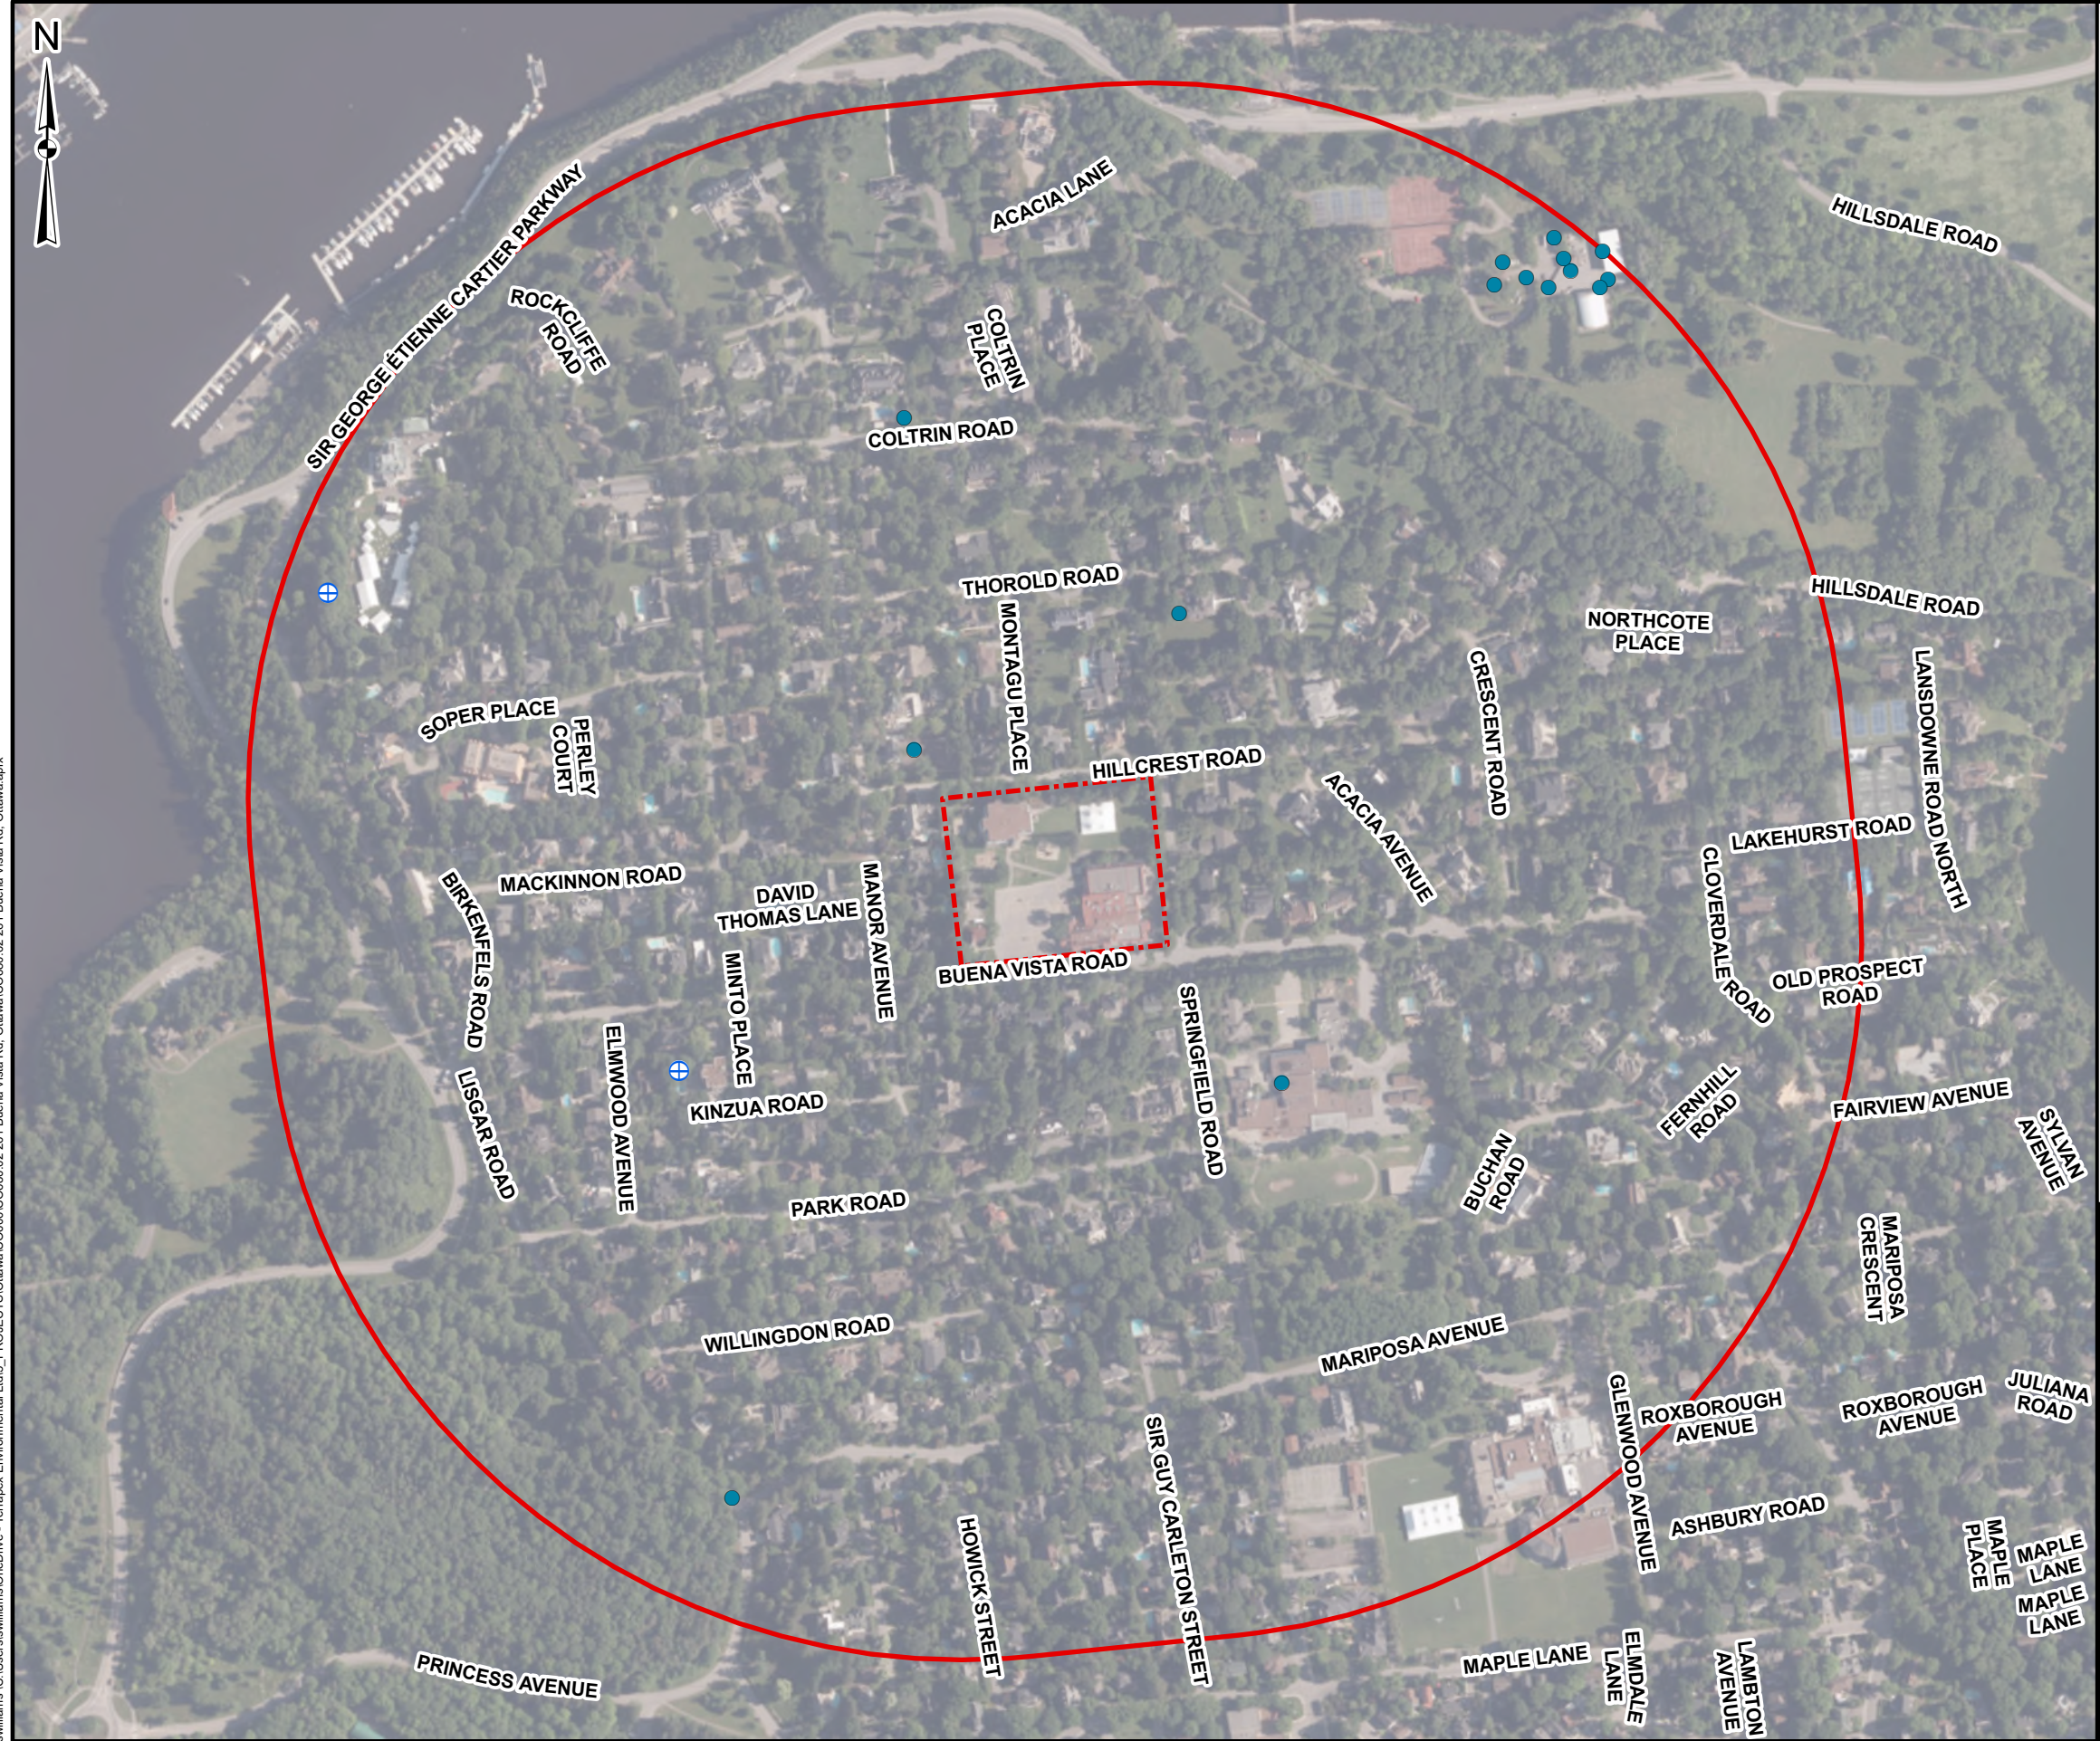
TITLE:
WATER WELL RECORDS - 500 m

- SITE BOUNDARY
- MECP WATER WELL RECORDS LOCATIONS**
- ⊕ WATER SUPPLY (DOMESTIC)
- OBSERVATION/MONITORING WELL AND/OR TEST HOLE (INCLUDING ABANDONED, OTHER OR UNKNOWN)

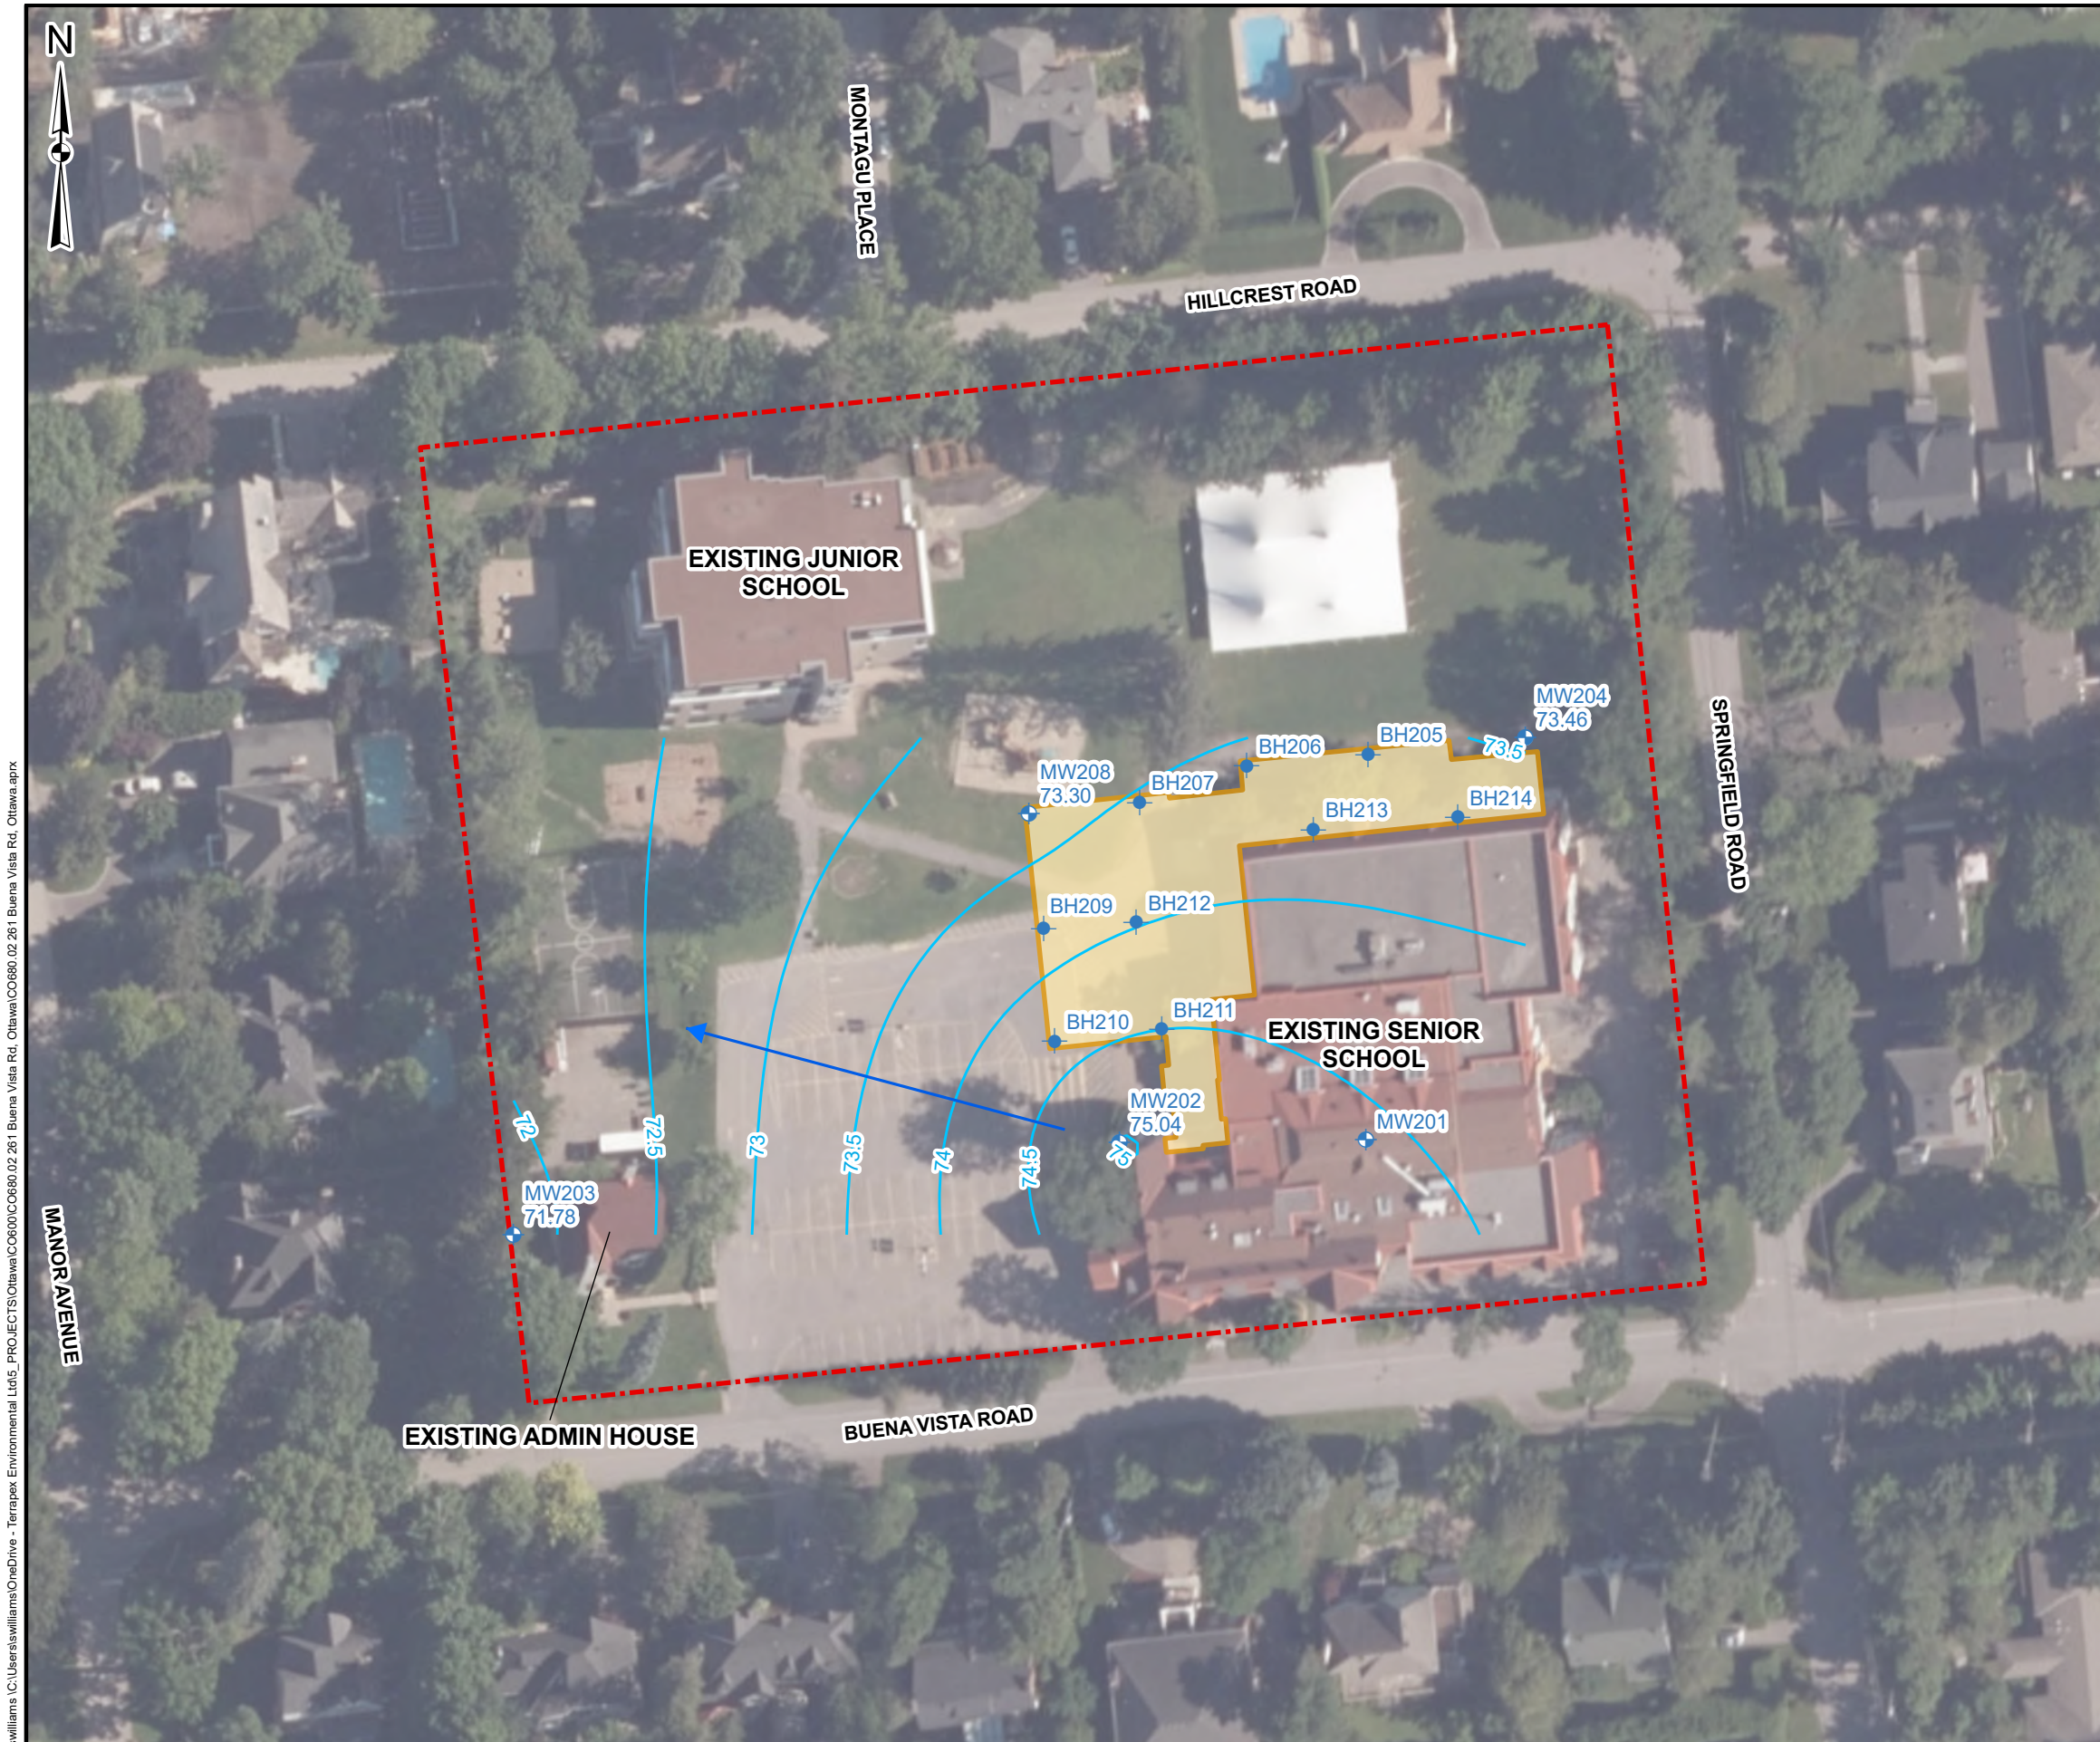
- ⋯ SITE BOUNDARY
- PROPOSED ADDITION
- + BOREHOLE
- + MONITORING WELL
- GROUNDWATER FLOW DIRECTION
- GROUNDWATER CONTOUR
- 74.51 STATIC WATER LEVEL (27 Mar. 2026) (m ASL)
