Geotechnical Investigation

251 Penfield Drive
Ottawa Ontario

Ottawa Community Housing
Corporation

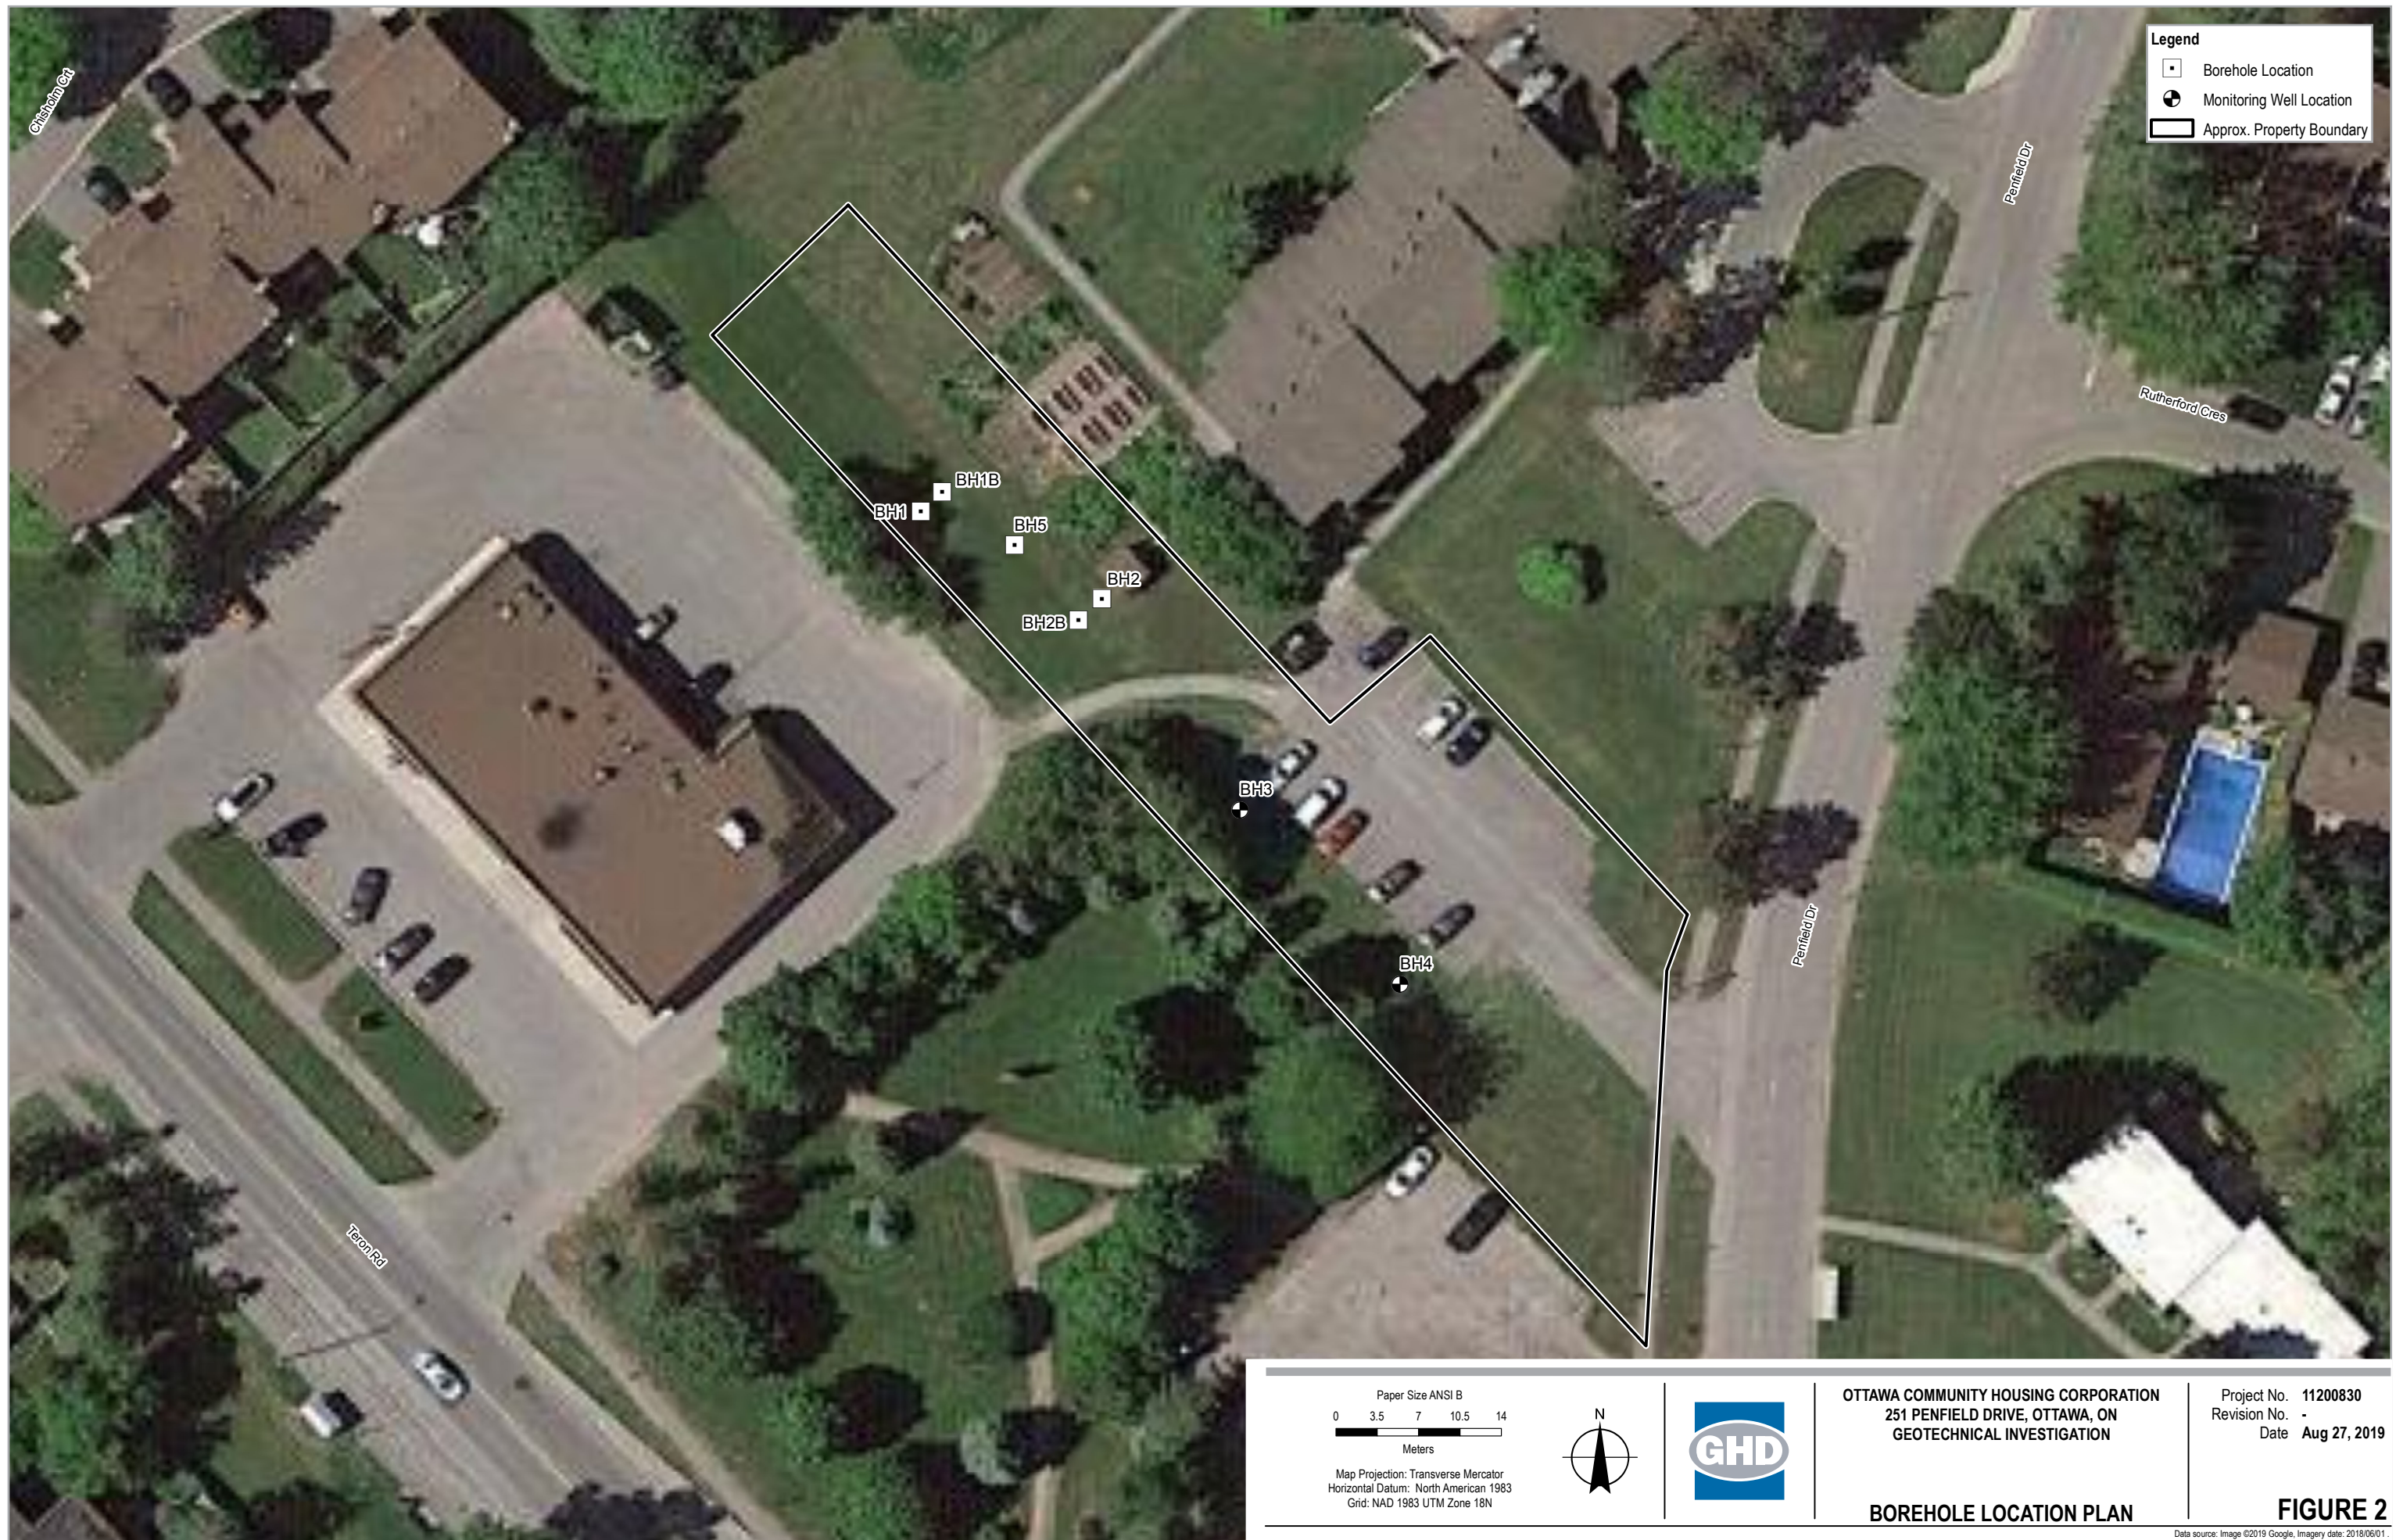
Legend

- Borehole Location
- Monitoring Well Location
- Approx. Property Boundary

- Underground Service Clearances.
- Fieldwork | The proposed scope included the advancement of a total of seven boreholes within the proposed building and parking lot footprints and installation of two monitoring wells to measure ground water level.
- Lab Testing | Two hydrometer grain size analysis, three Atterberg limit tests, and moisture contents on all collected samples. Chemical testing for corrosion assessment and protection measures for ductile iron and concrete on one collected soil sample.
- Reporting | Preparation of this Geotechnical Report which summarizes the findings of the fieldwork programs and presents recommendations for the design and construction of the structure.
