SOMERSET HOUSE
HERITAGE IMPACT ASSESSMENT
352 SOMERSET STREET WEST, OTTAWA

COMMONWEALTH HISTORIC RESOURCE MANAGEMENT
Version 4. JULY 2023

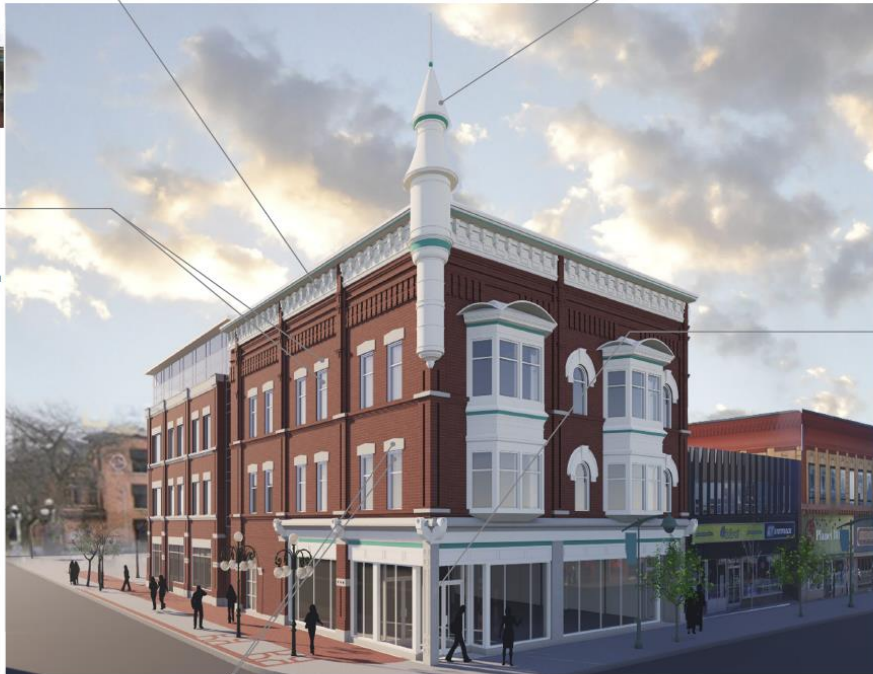
Existing metal corner turret and decorative details to be restored and repainted as per historical record. Top portion to be reconstructed as per historical record. Refer to HIA by John Stewart.

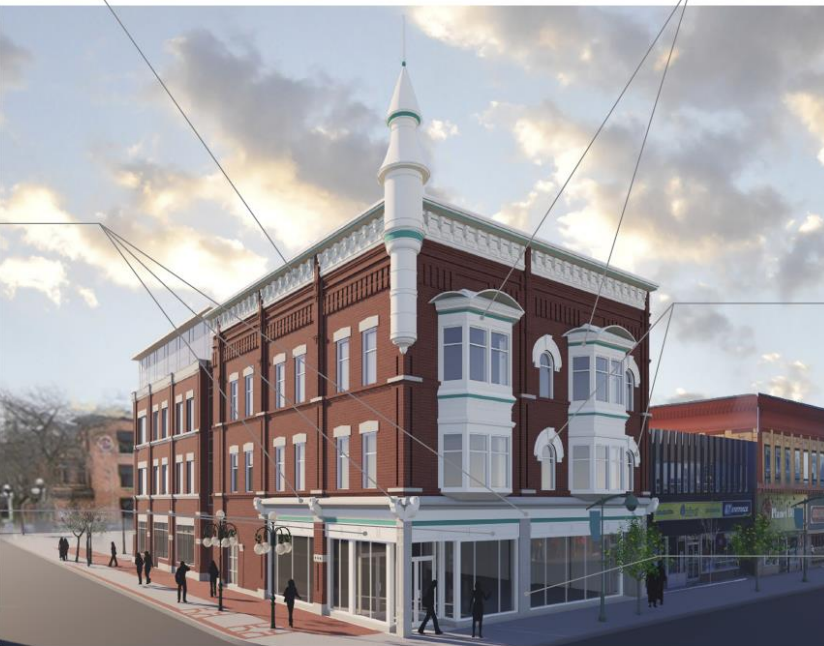
New large bay windows and decorative details to be completely reconstructed and painted as per historical record intent or as shown below in picture and 3d view. Refer to HIA by John Stewart.

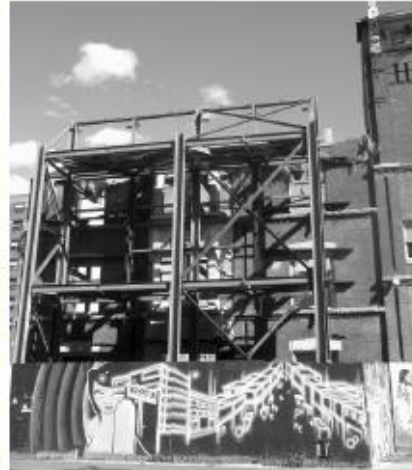
Figure 4: 2007 Steel Bracing

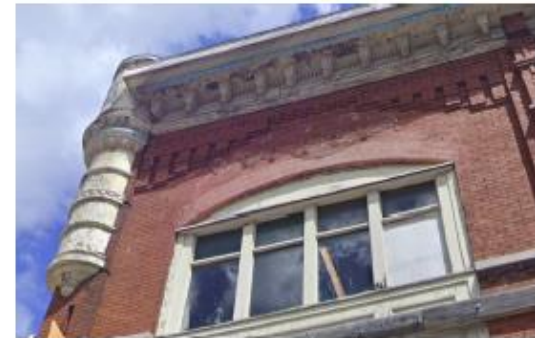
Figure 13: Open skyward facing joints on the stone stringcourse with stained and eroded brick dentils below.

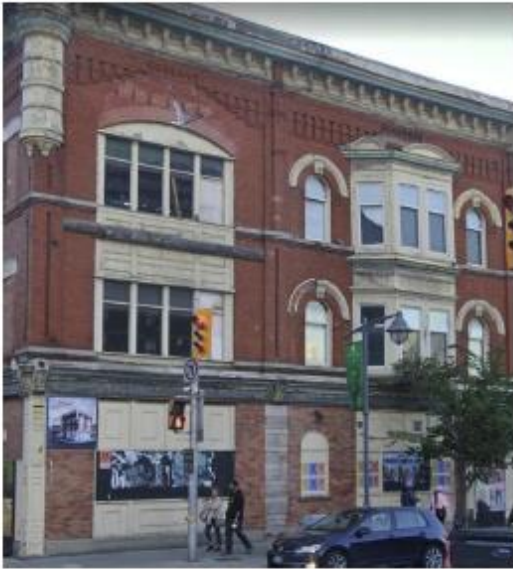
- The bay window on the west façade is being supported on the interior by steel cables. The base framing of these windows appears to be detached from the second-floor level. It is understood that strengthening of the bay window joist connections has been previously completed.

- A significant portion of insulation is missing from between the wooden studs, leaving the bay window exposed. The studs appear in deteriorated condition but could not be reviewed in detail due to access limitations. The windows are sagging to one side with cracks and separations in the wood frame and sill, and peeling paint on the interior side.

Figure 21: Openings on the west façade.

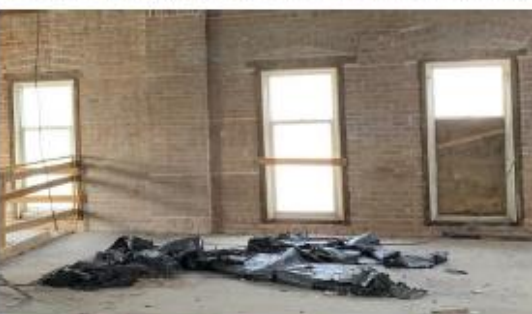
Figure 34: Interior of third floor windows on the north façade.

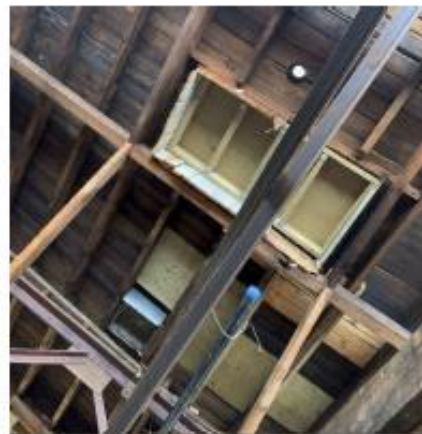
Figure 36: Roof drains

- It is recommended to review the roof framing and its structural stability as it is only supported by three of the four original walls.
- As well, a detailed review of roofing, parapets, flashings, and roof penetrations is recommended, as mentioned also in the Ojdrovic engineering report. This review would likely need to be performed from a lift to ensure proper, safe access to all areas of concern.
- Following the roof review, design and implement repairs to the roofing system, parapets, flashings, roof drains and penetrations to prevent further water ingress into the building.
- The east side of the roof and any roof openings should be covered to enclose the space and to prevent water infiltration.
