Jock River, Barrhaven Conservancy

Erosion Hazard Assessment and Erosion Threshold Analysis

Prepared for:
David Schaeffer Engineering Ltd.
120 Iber Road, Unit 103
Stittsville, ON
K2S 1E9

January 11, 2018
PN17071

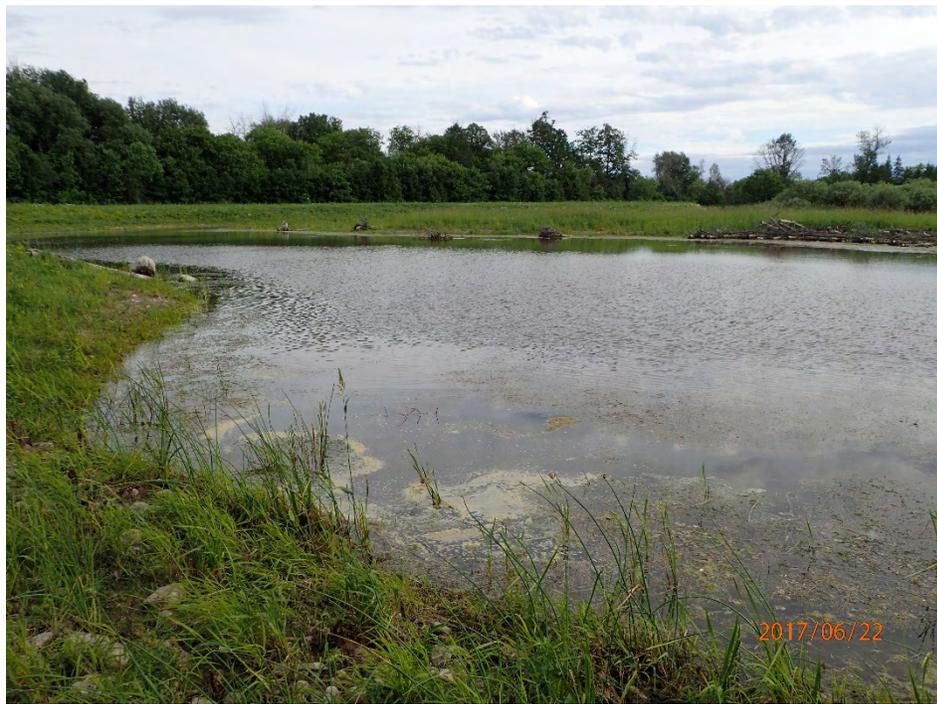
Photo
14
Storm
-water
Pond
at FD1

Photograph taken facing south from Reach FD1.

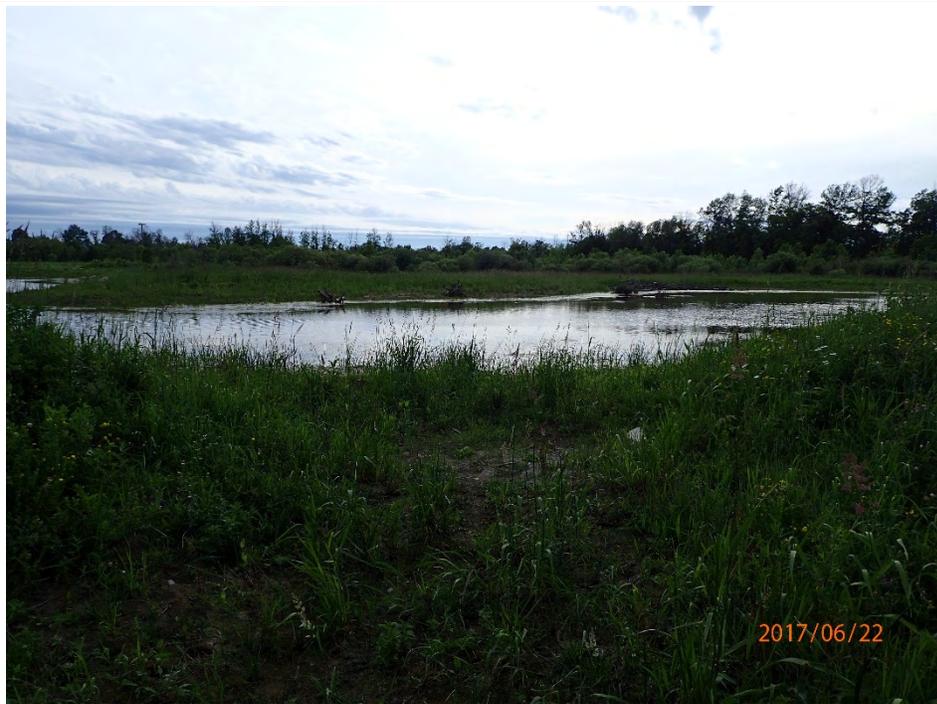
Photo
15
Reach
FD1-1

Photograph taken facing west from overflow channel FD1-1.

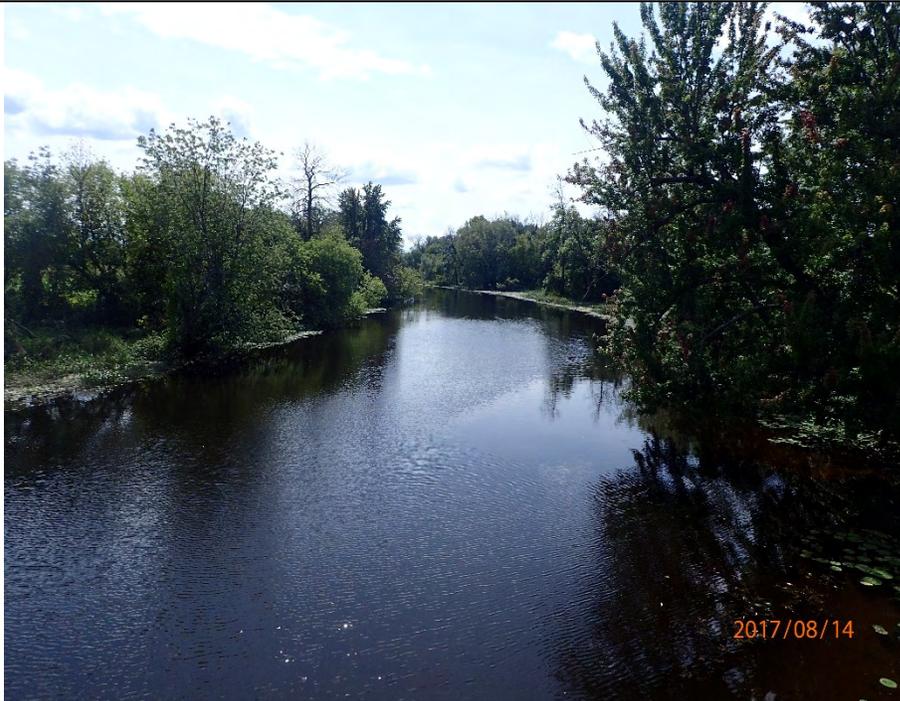
Photo
24

Photograph taken facing upstream, west, from Borrisokane Road.

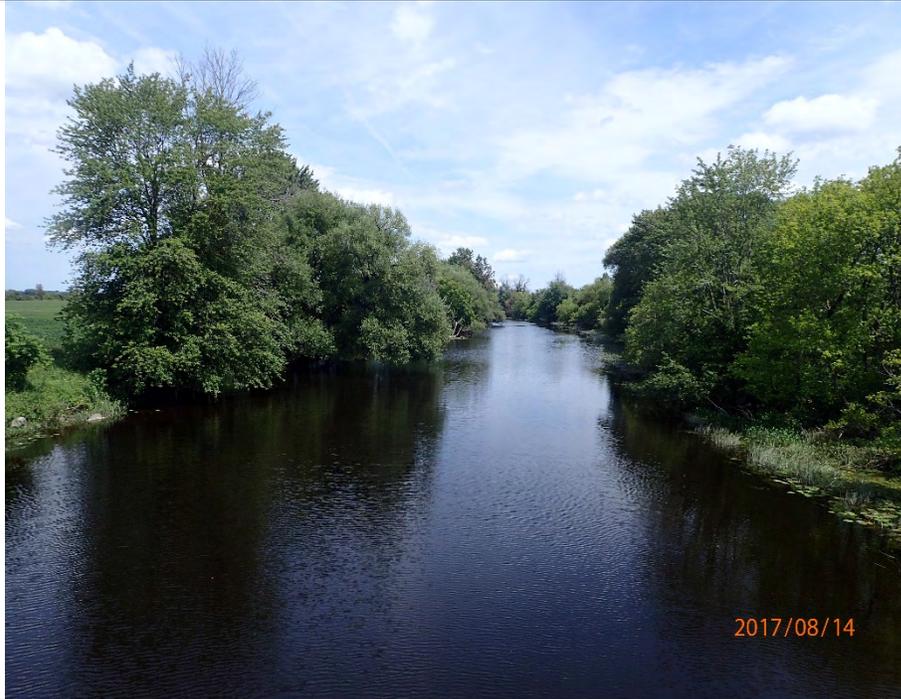
Photo
26
Reach
JR-3

Photograph taken facing downstream, east, from Borriskane Road.

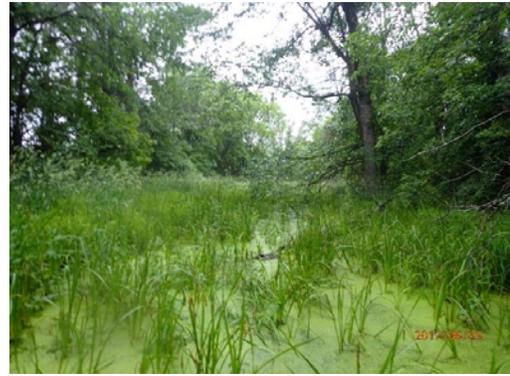
Photograph at cross section 2 (facing upstream)

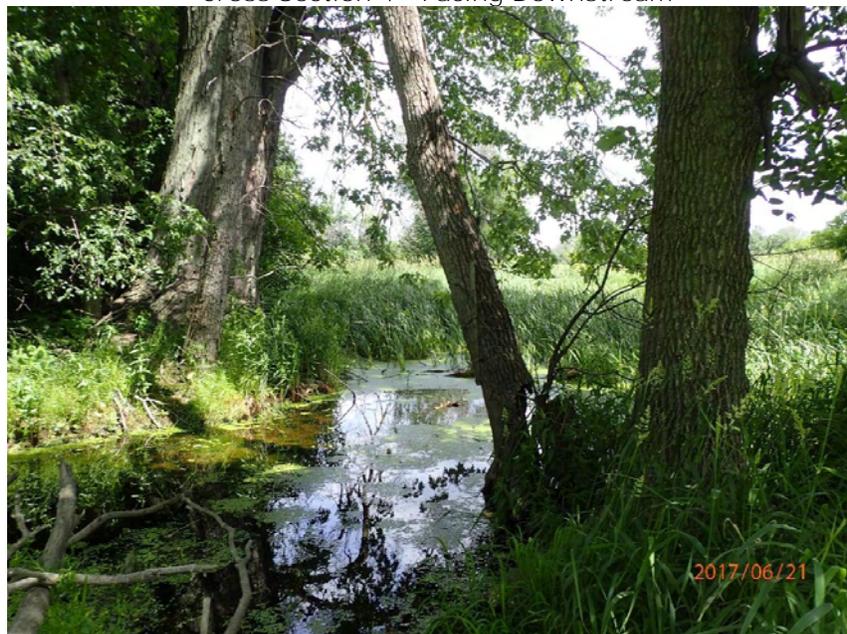
Cross Section 4 - Facing Downstream

This channel runs between agricultural fields before flowing into Jock River. The channel is straight, slightly entrenched, and has a low gradient. Riffle-pool sequences are absent within this reach, only run features are present. Bank erosion was not present. Woody debris is present in the channel at a low density. Average bankfull width and depth are 9.23 m and 0.23 m, respectively. Bank material consists of sandy loam, bed material consists of fine sediment and organics. Depth of fine sediment on the bed at the time of assessment was approximately 0.30 - 0.40 m.

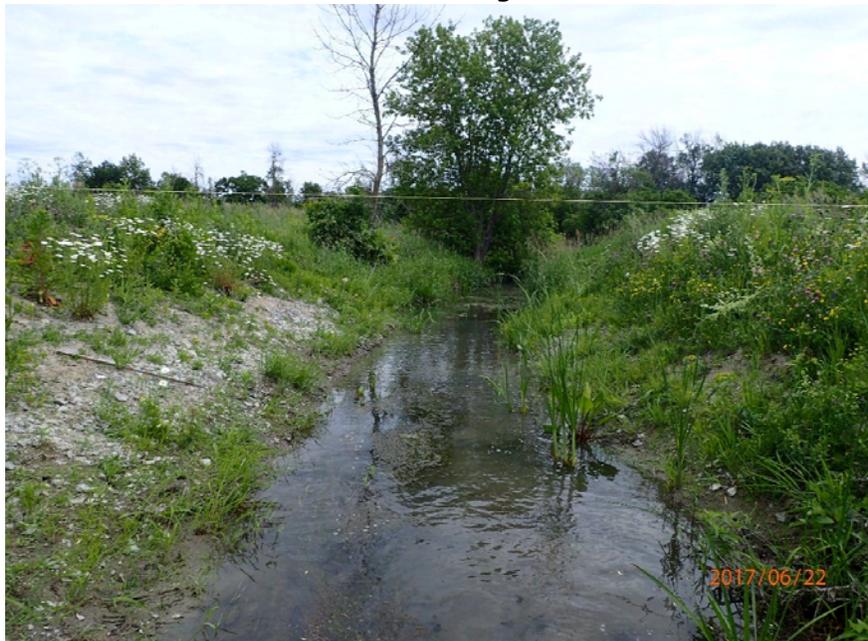
Cross Section 4 - Facing Downstream

This channel runs between agricultural fields before flowing into Jock River. The channel is sinuous with a low gradient, and highly entrenched. Riffle-pool sequences are absent within this reach, only run features are present. Undercutting is present in the downstream portion of the reach. A low density of woody debris is present in the channel. Average bankfull width and depth are 4.69 m and 0.50 m, respectively. Bank material consists of clay, silt and sand, with rip-rap between cross sections 2 and 5. Bed material consists of clay, and sporadic rip-rap. Depth of fine sediment on the bed at time of assessment was approximately 0.05 - 0.20 m.

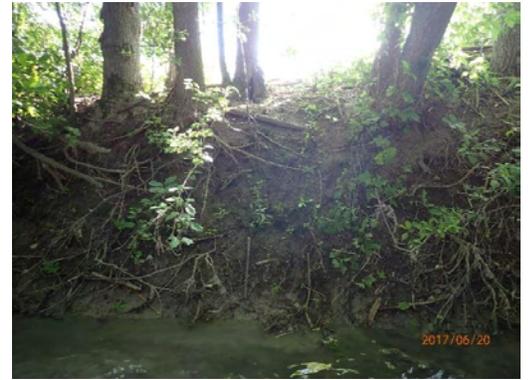
Photograph at cross section 6 (looking at the right bank)

Bank Characteristics							
	Minimum	Maximum	Average		Minimum	Maximum	Average
Bank Height (m):	1.4	1.70	1.59				
Bank Angle (deg):	50	80	67	Torvane Value (kg/cm ²):		Not measured	
Root Depth (m):	0.20	1.00	0.53	Penetrometer Value (kg/cm ³):		Not measured	
Root Density (%):	5	25	13	Bank Material (range):		Clay, Silt	
Bank Undercut (m):		N/A: no undercuts

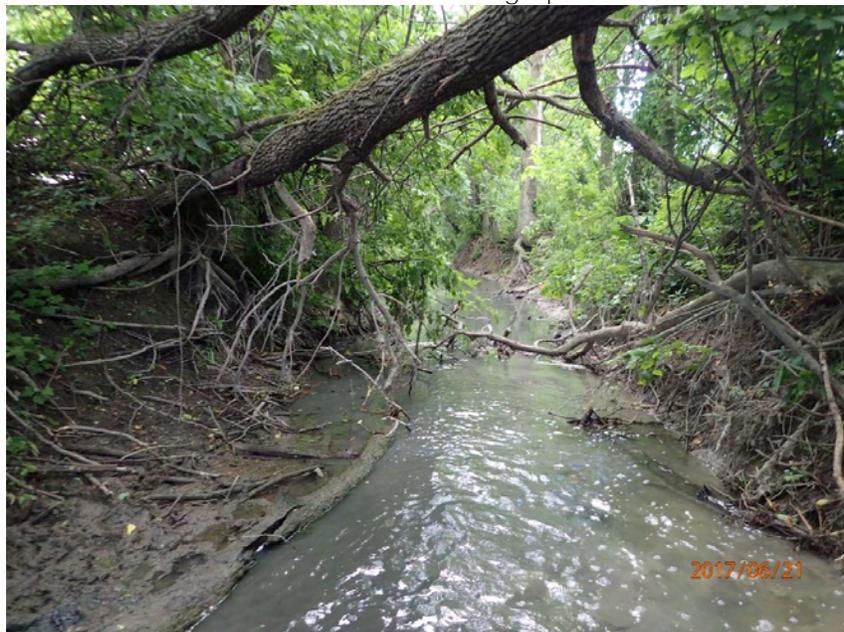
Cross Section 5 - Facing Upstream

This channel runs between agricultural fields before flowing into Jock River. The channel is straight and highly entrenched, with a low gradient. This reach did not contain riffle-pool sequences, only run features were present. Average bankfull width and depth are 4.6 m and 0.7 m, respectively. Bank erosion was evident. Woody debris was commonly observed in the channel. Both bed and bank material consisted of a sandy loam. Depth of fines on the bed were approximately 0.2 - 0.3 m at time of assessment.
