## Geotechnical Investigation

Proposed Residential Development  
Cardinal Creek Village South  
Old Montreal Road  
Ottawa, Ontario

November 29, 2021

Report: PG5201-1  
Revision 5

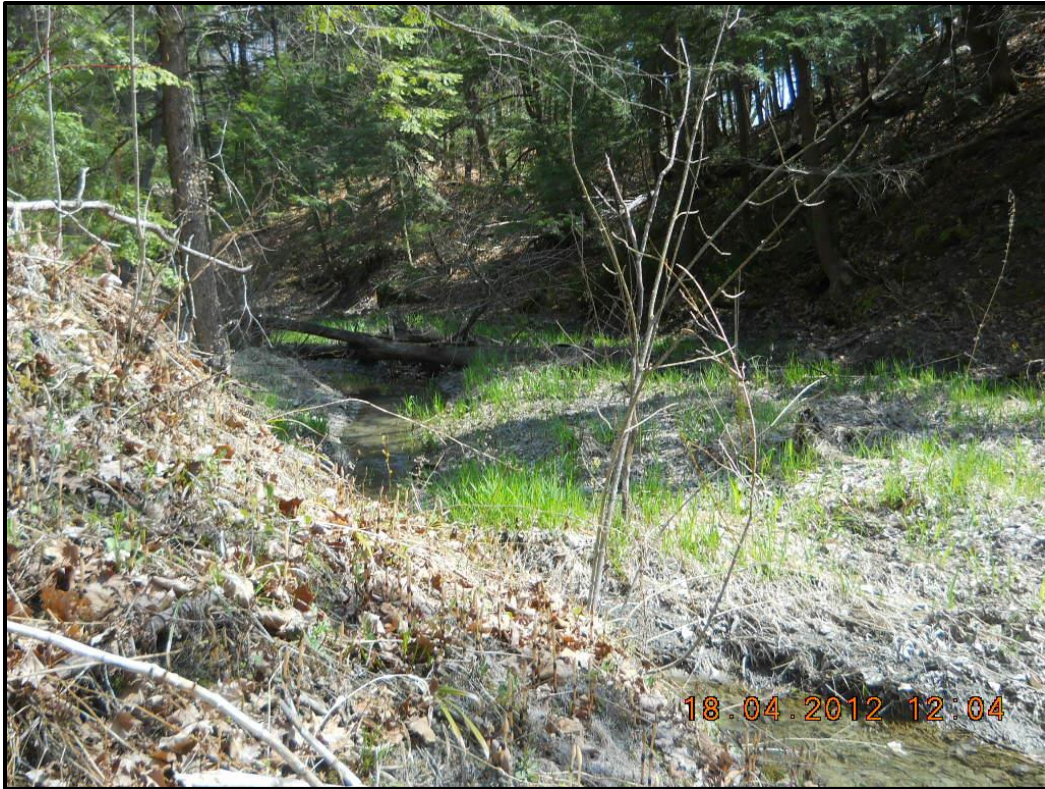
The subject tributaries to Cardinal Creek were observed to be stable based on the slope condition review conducted on April 18, 2012 and current review on September 10, 2020 with some toe erosion noted throughout where the watercourse is located in close proximity to the valley corridor wall. Photographs from our site visits are presented in Appendix 2.

Photo 1: Photo taken on April 18, 2012 from the north bank of the valley corridor wall along the South Tributary looking east (upstream) near Section I.

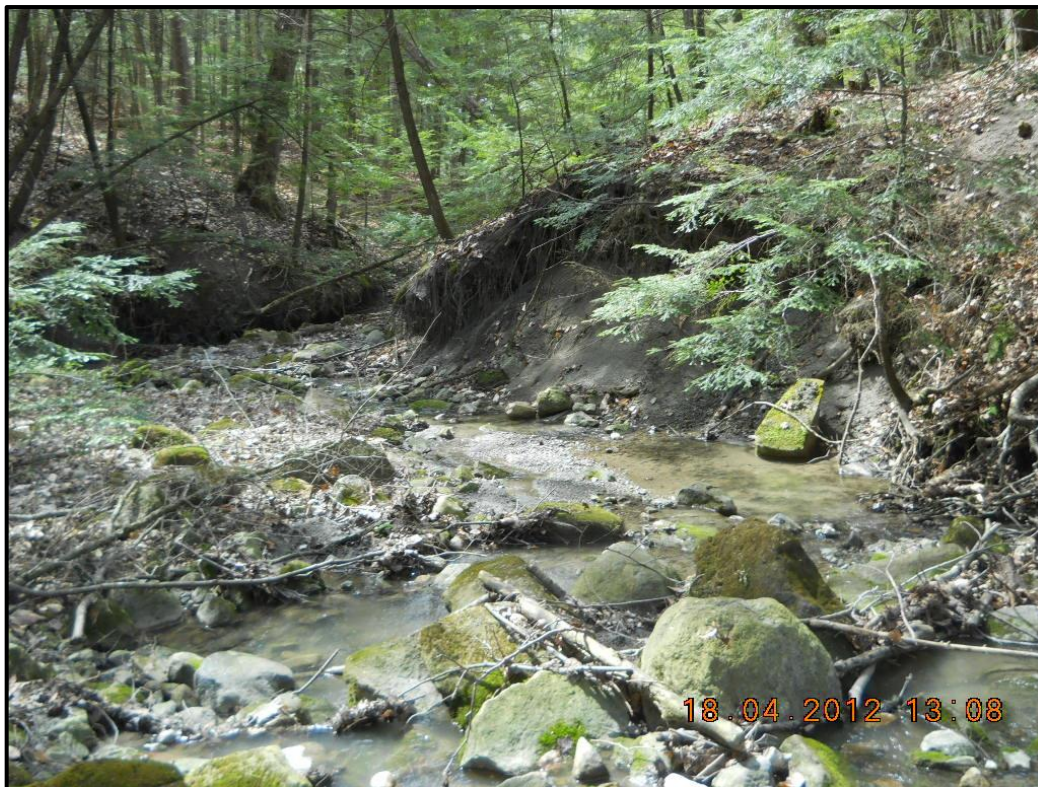
Photo 3: Photo taken on April 18, 2012 from the north bank of the valley corridor wall along the South Tributary looking west (downstream) at Section G.

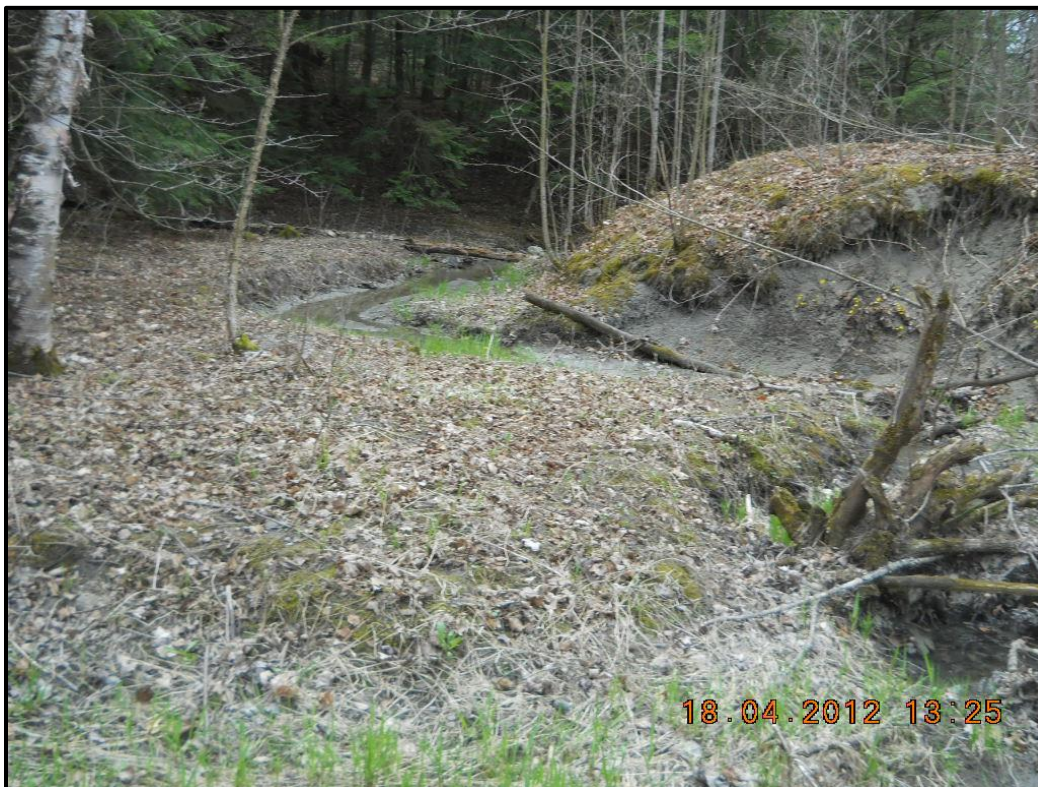
The results for the existing static slope conditions at the slope stability sections are presented in Appendix 2. The slope stability factors of safety were found to be greater than 1.5 at all sections analyzed, except for Sections F and JJ, which are located along the south valley corridor wall of the stable slope allowance from top of slope, respectively.

Photo 4: Photo taken on April 18, 2012 from the south bank of the South Tributary looking west (downstream) near Section F.

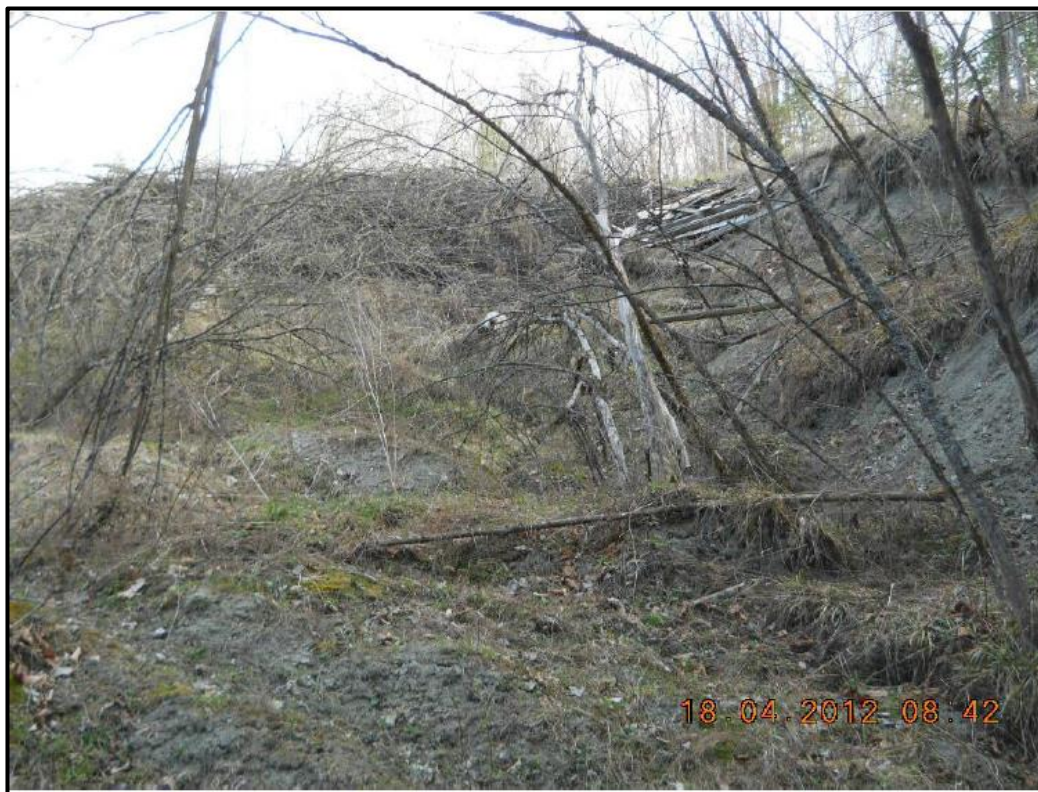
Photo 5: Photo taken on April 18, 2012 of the east bank of the valley corridor along Mid-Branch 1, north of Section J.

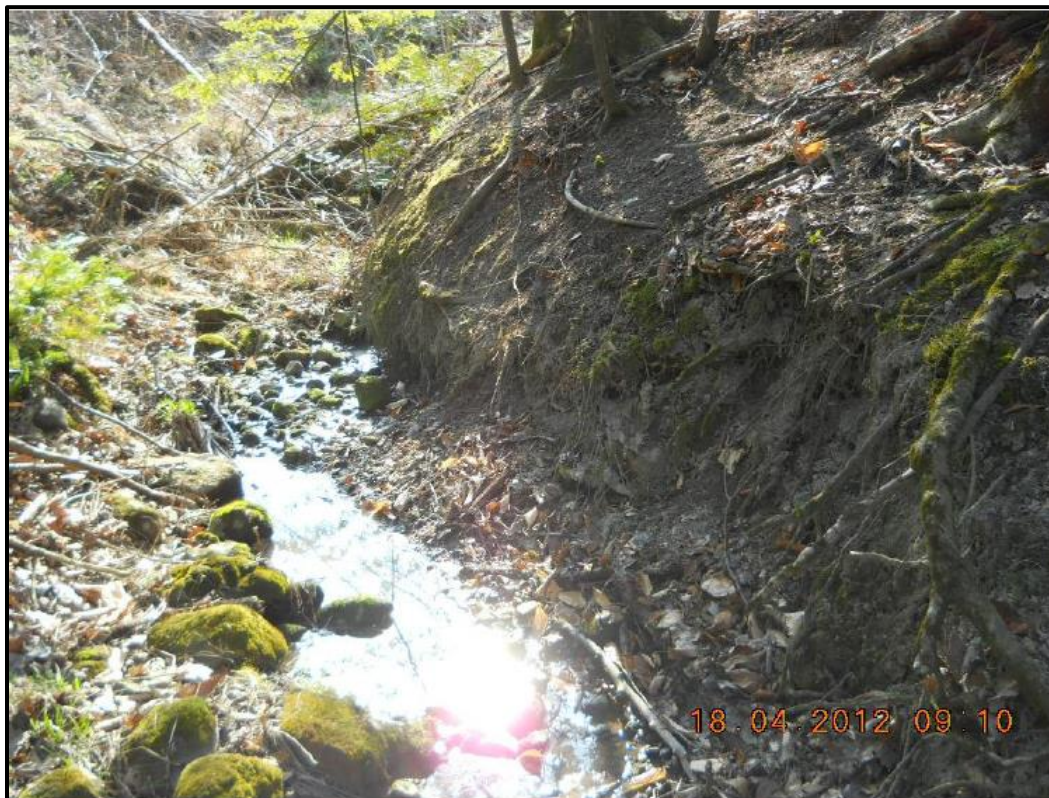
Photo 6: Photo taken on April 18, 2012 along the watercourse along Mid-Branch 1 looking east (upstream) near Section N.

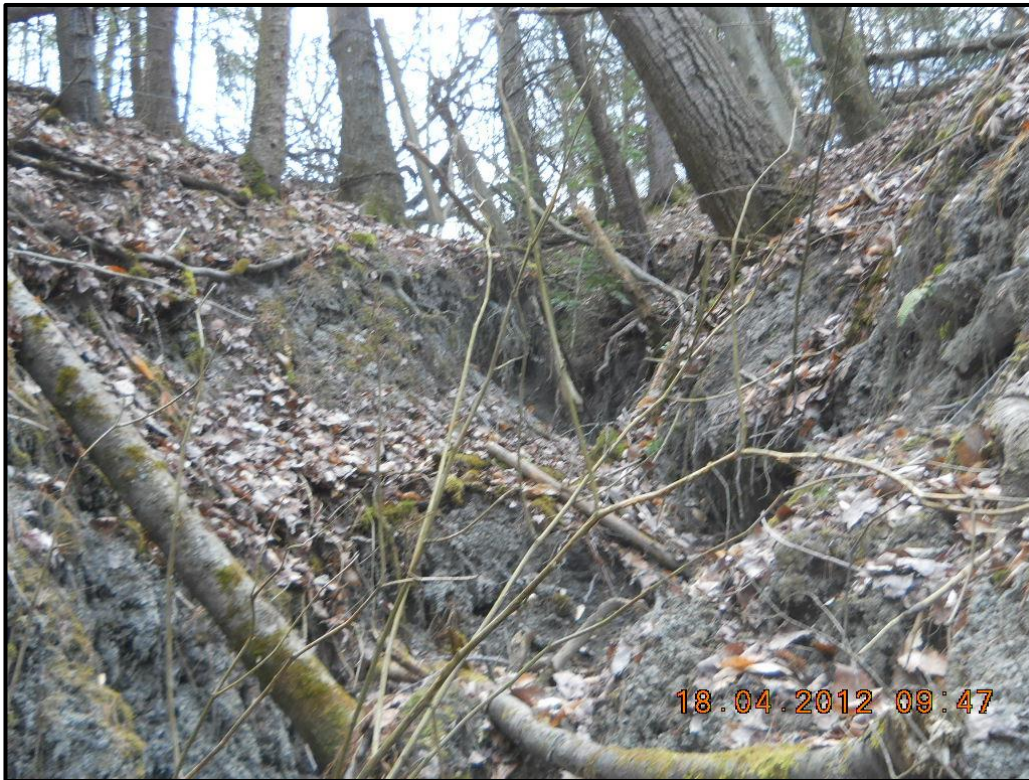
Photo 7: Photo taken on April 18, 2012 of the drainage ravine near Section K.

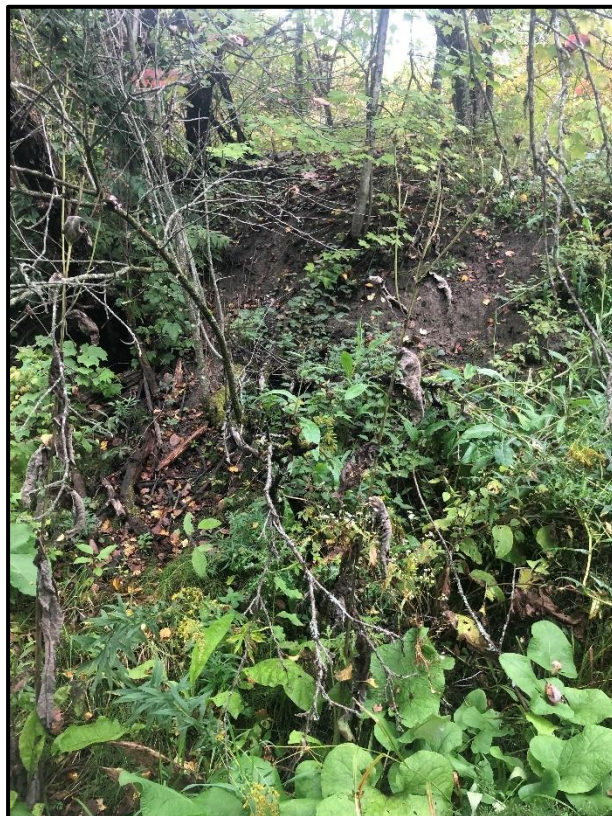
Photo 8: Photo taken on September 10, 2020 of the north slope face, looking northwest.

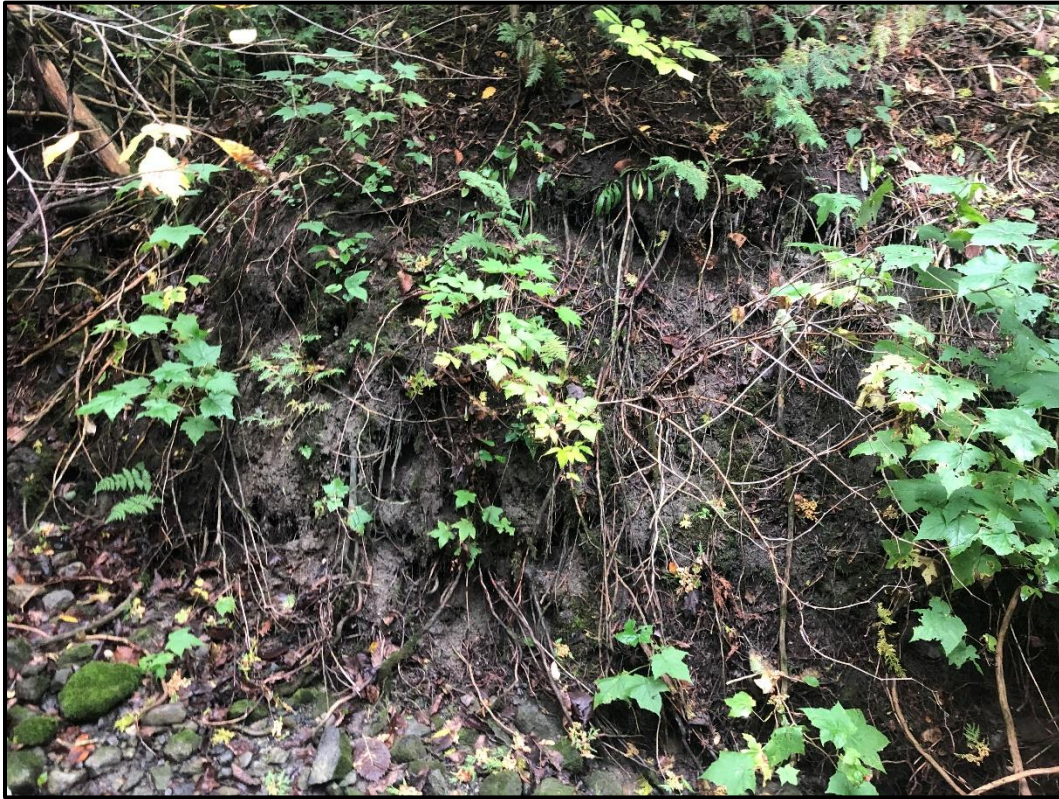
Photo 9: Photo taken on September 10, 2020 of the north slope face, looking northwest.

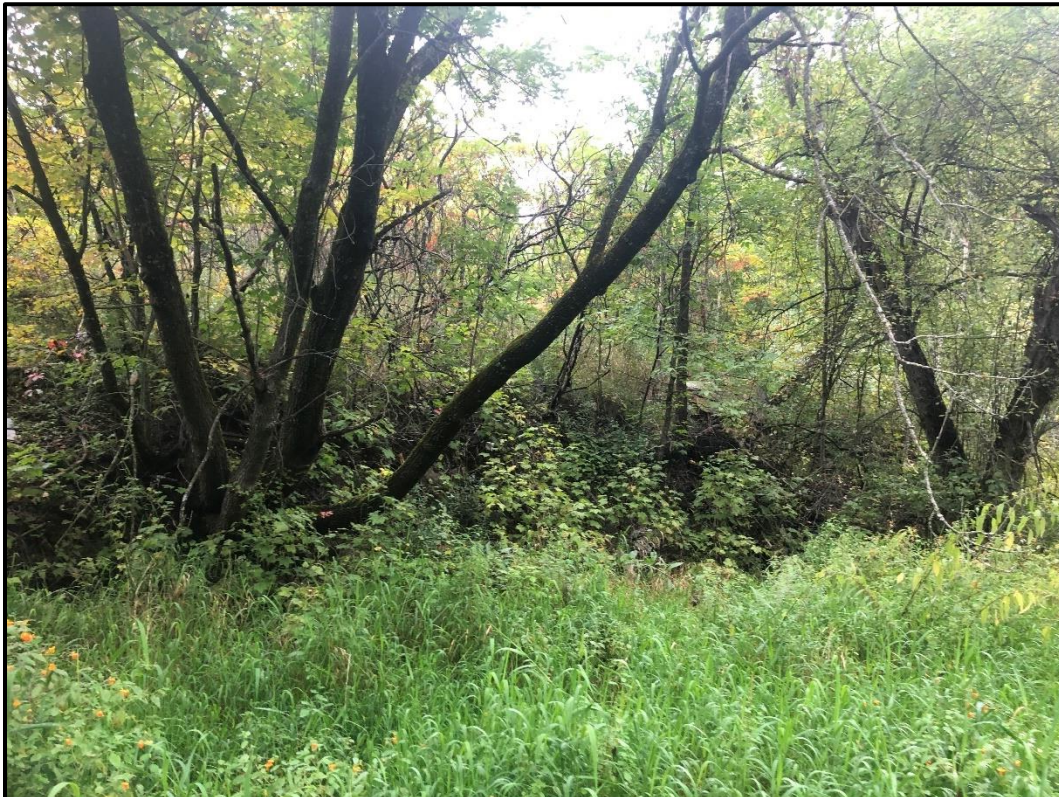
Photo 10: Photo taken on September 10, 2020 of the north slope face, looking north.

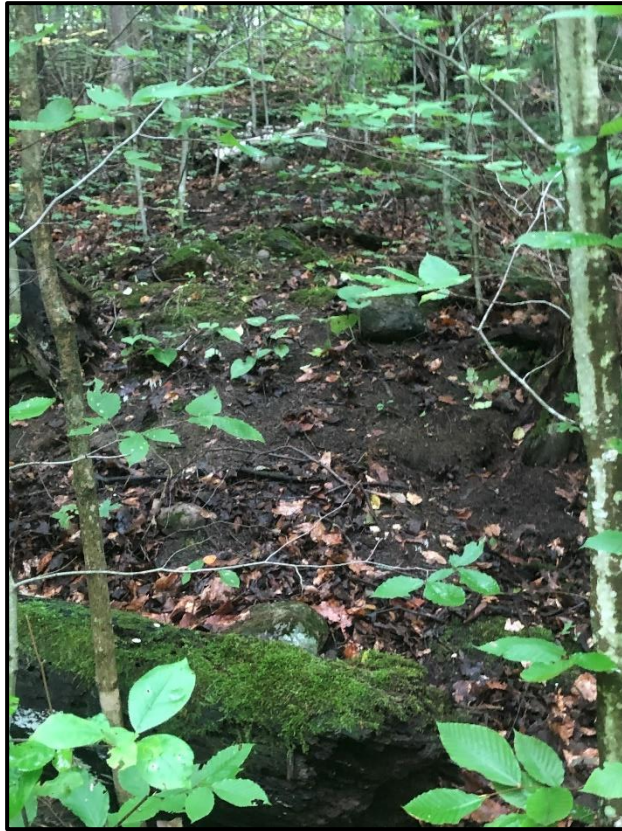
Photo 11: Photo taken on September 10, 2020 of the south slope face, looking southeast near Section O

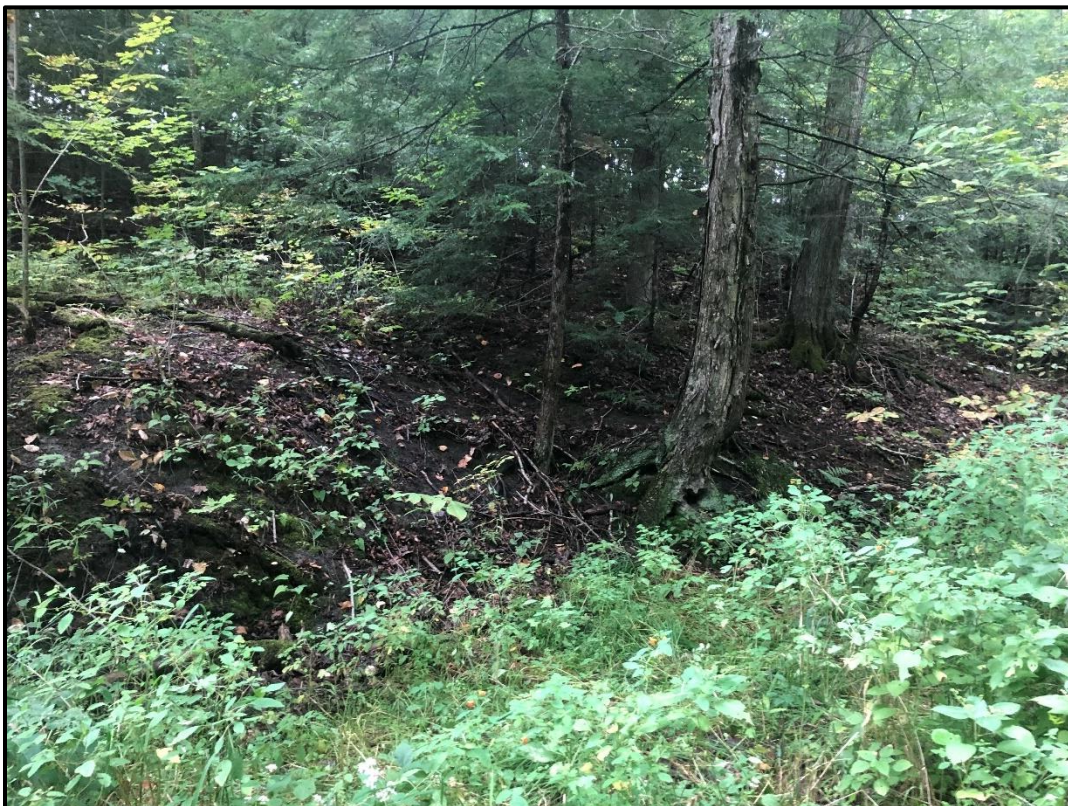
Photo 12: Photo taken on September 10, 2020 of the north slope face, looking northwest.

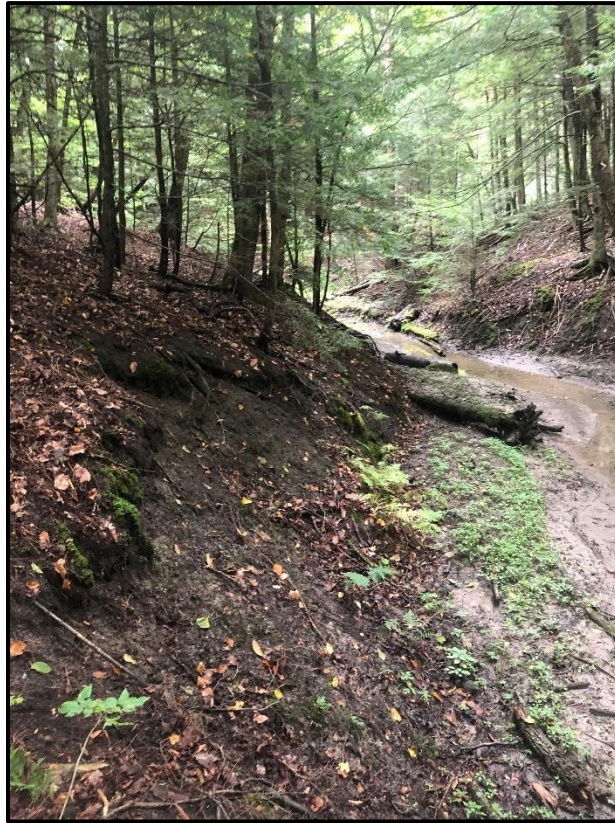
Photo 13: Photo taken on September 10, 2020 of the north slope face, looking east (upstream) near Section H.

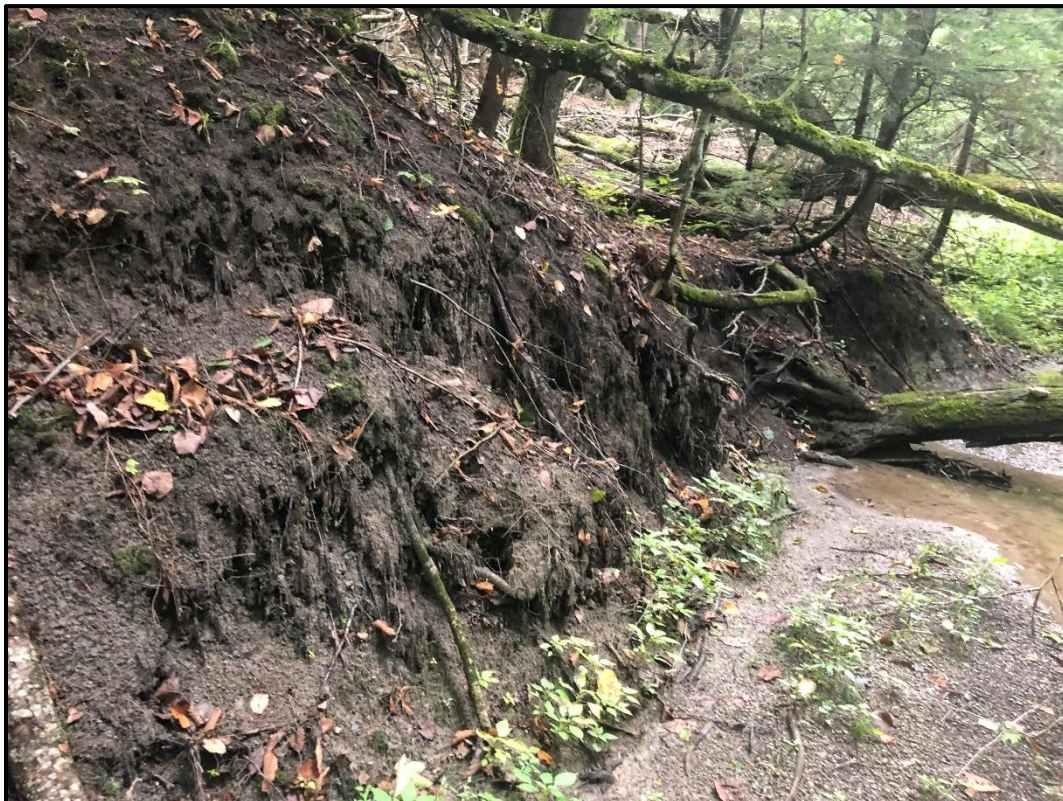
Photo 14: Photo taken on September 10, 2020 of the north slope face, looking northwest near Section CC.

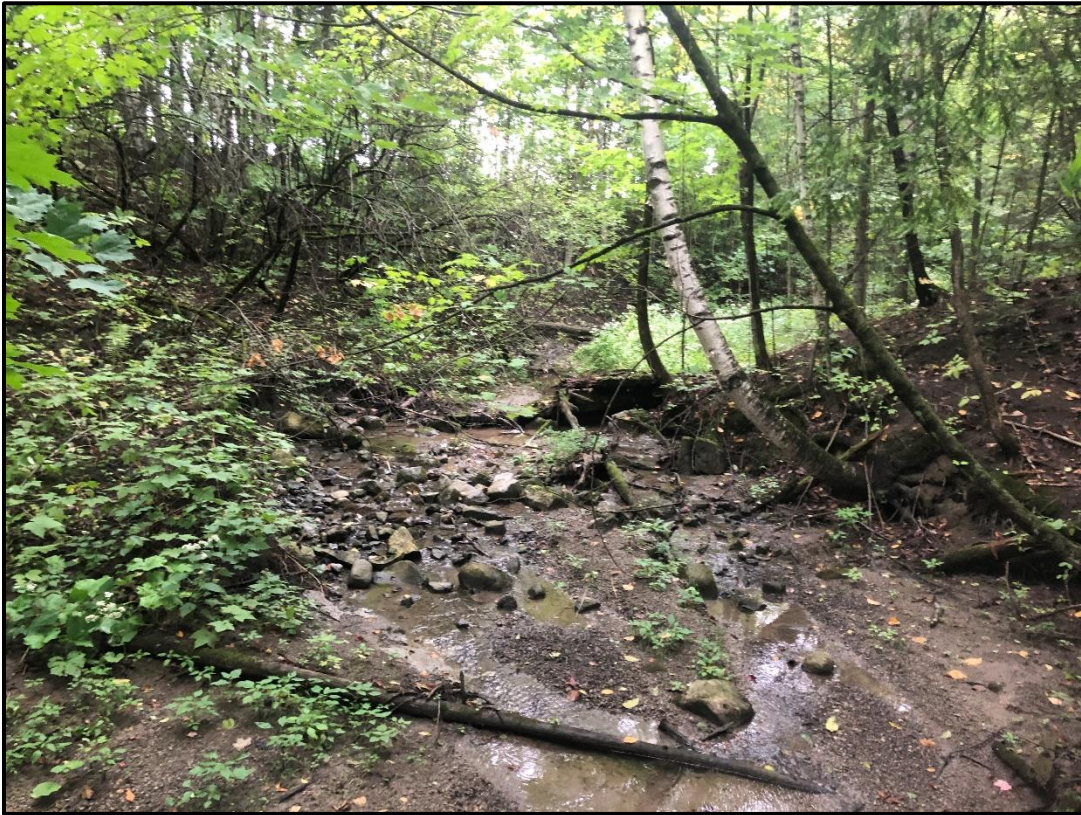
Photo 17: Photo taken on September 10, 2020 along the watercourse, looking east (upstream).
