Landslide Risk Assessment
Proposed Residential Development
Old Montreal Road
Ottawa, Ontario

Taggart Investments

March 2, 2022

Report: PG5201-1

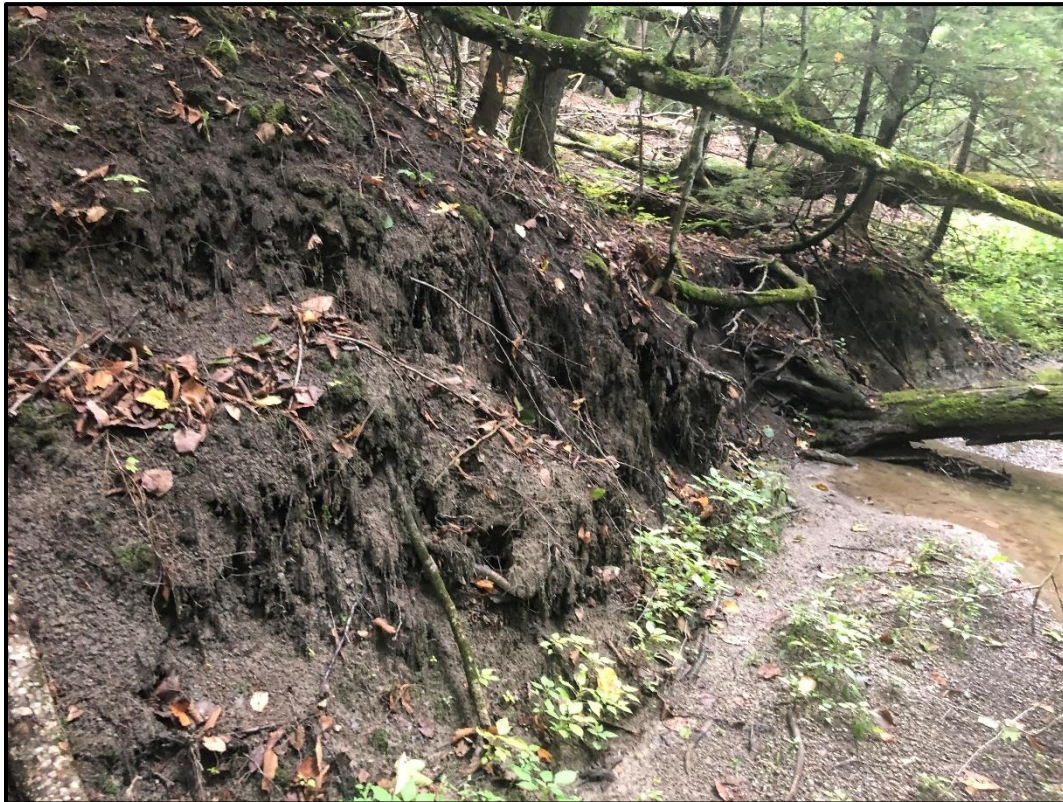
Photo 15: Photo taken on September 10, 2020 of the north slope face, looking northwest near sections G and II

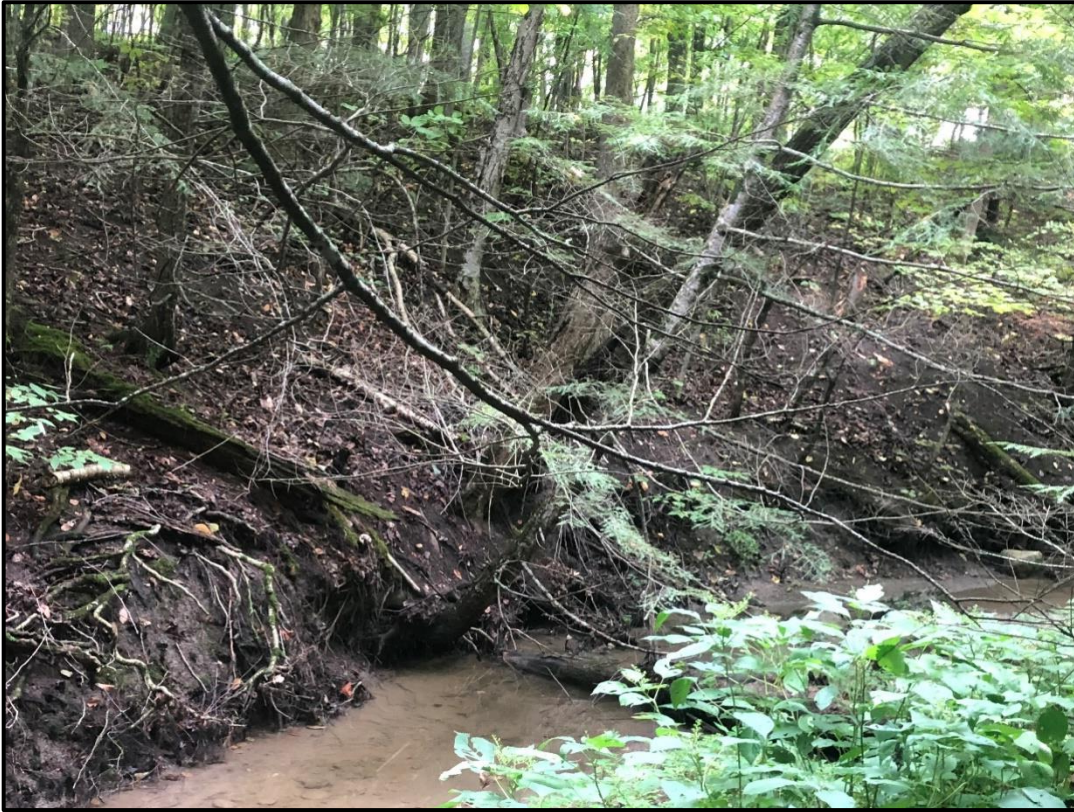
Photo 16: Photo taken on September 10, 2020 of the south slope face near section HH.

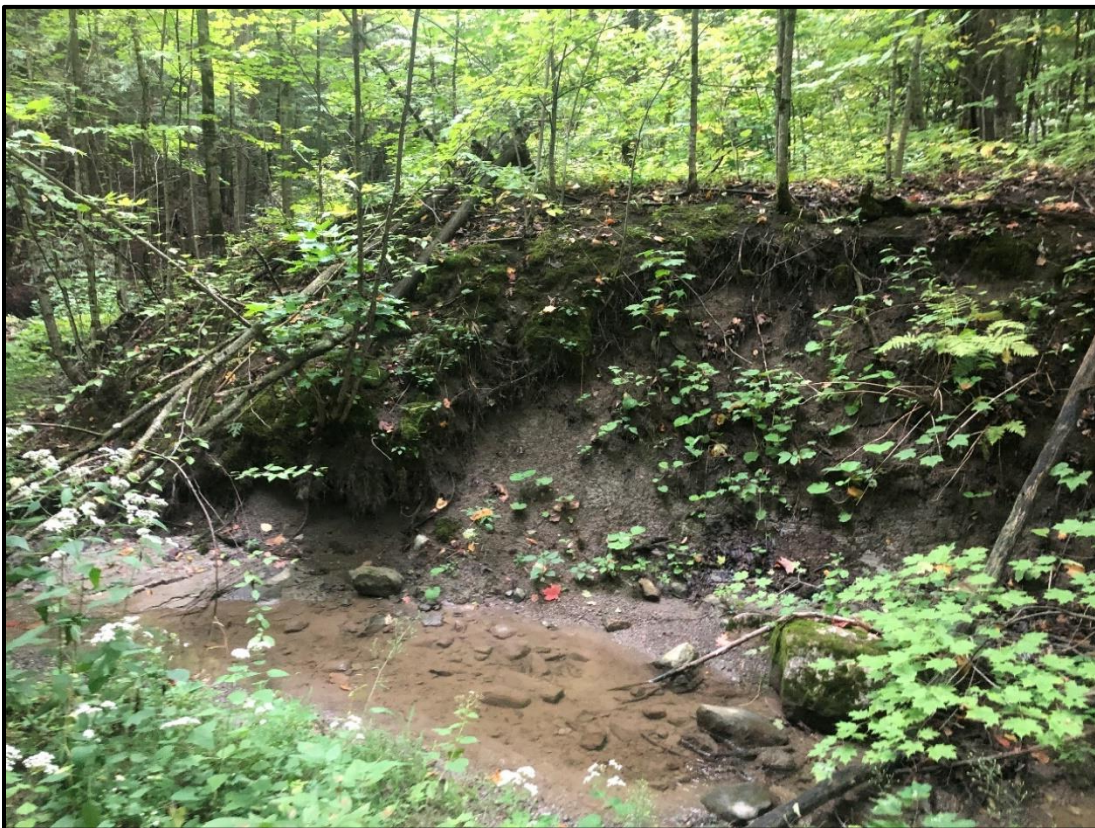
Photo 17: Photo taken on September 10, 2020 along the watercourse, looking east (upstream).

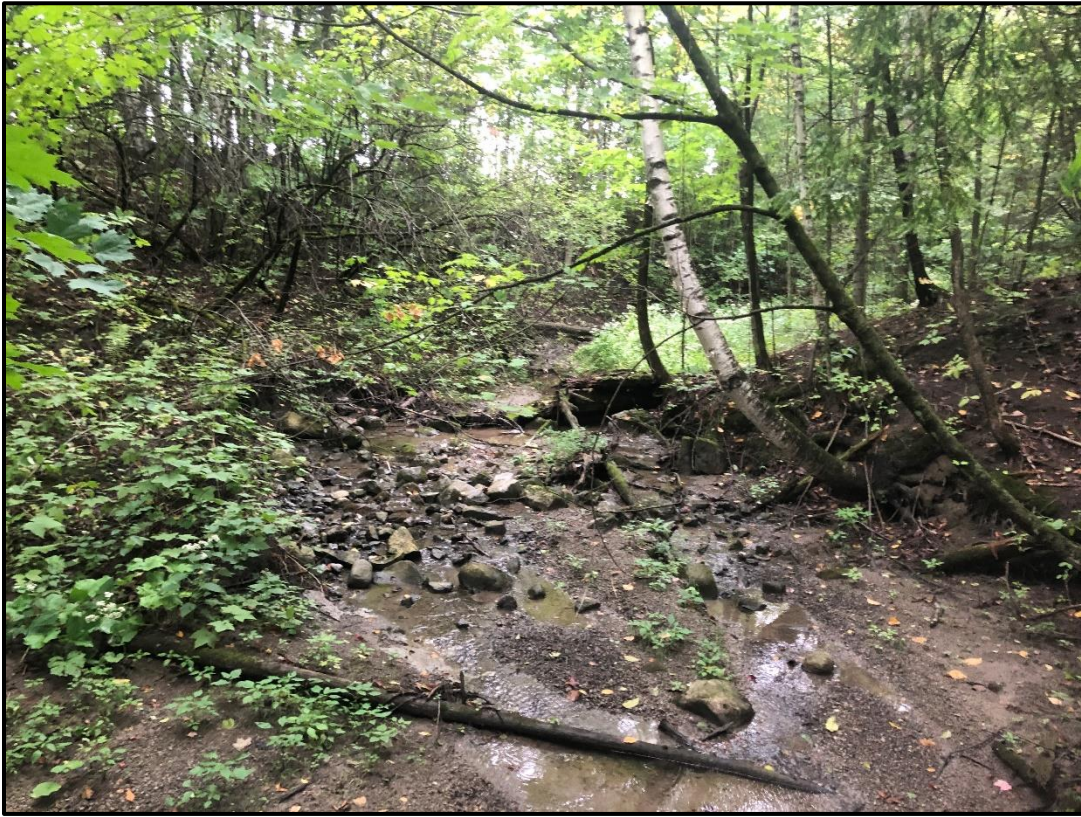
Photo 18: Photo taken on September 10, 2020 of the north slope face, looking north at section GG.

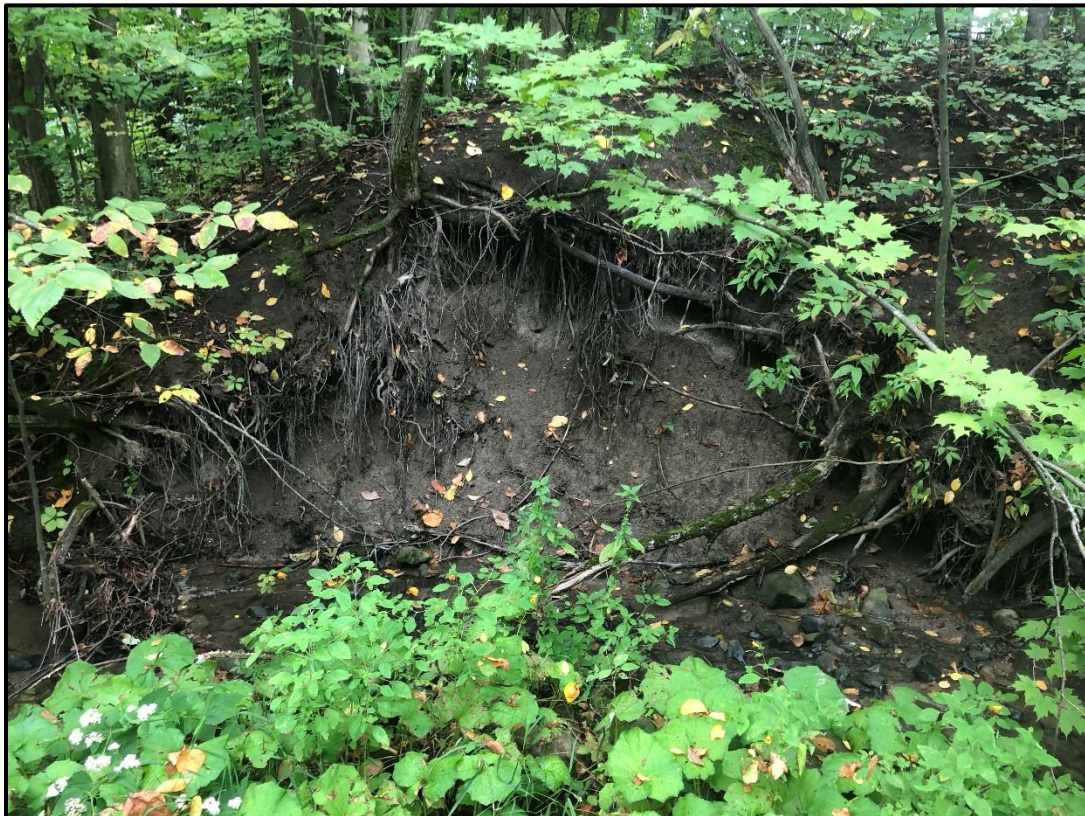
Photo 19: Photo taken on September 10, 2020 along the watercourse, looking east (upstream).

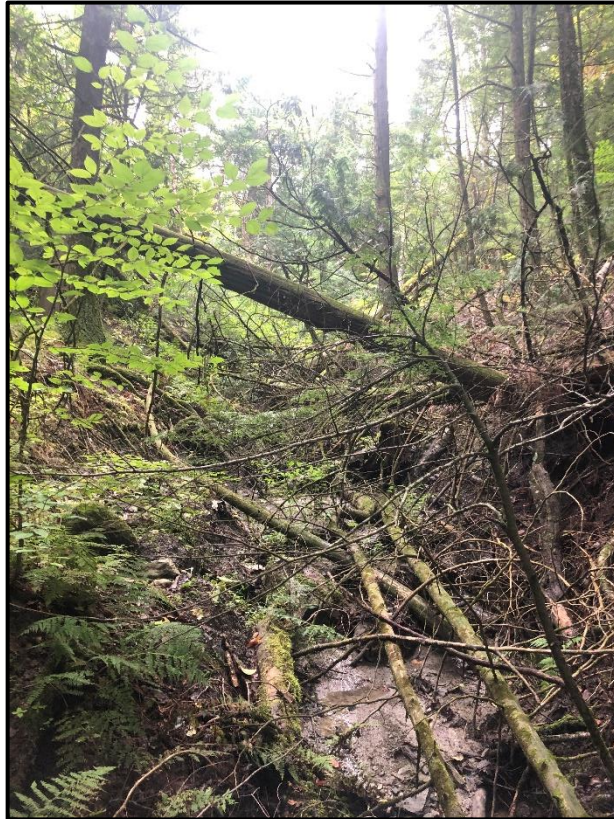
Photo 22: Photo taken on September 10, 2020 along the watercourse along Mid-Branch 1 looking north.
