McKINLEY
ENVIRONMENTAL
SOLUTIONS

April 23rd, 2020

RE: Woodlot S-23 Large Tree Inventory – Minto Communities and Valecraft Homes Kanata North
Developments (Revised)

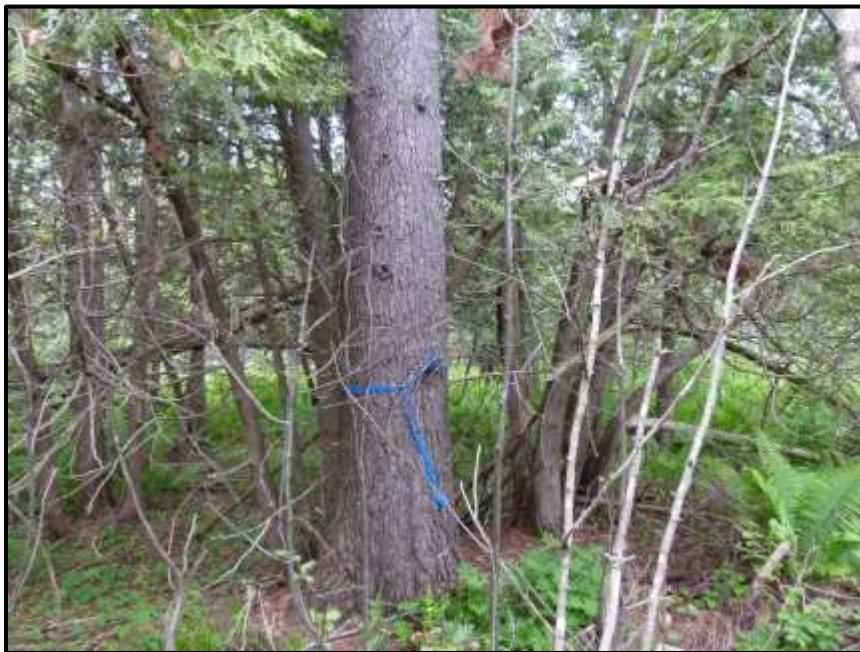
Photograph 7: Tree #8 – dead White Ash (May 27th, 2019).

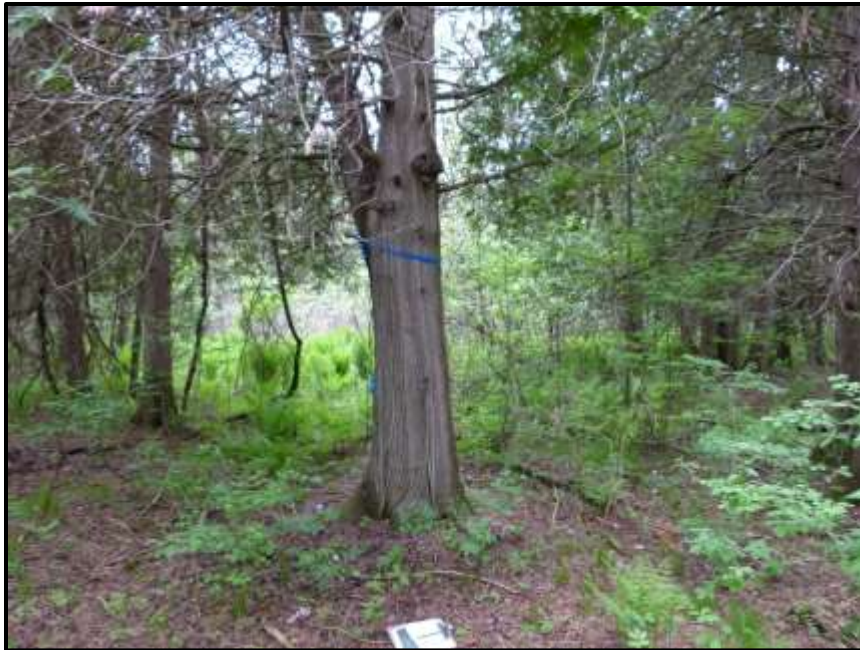
Photograph 8: Tree #9 – White Pine in good condition (May 27th, 2019).

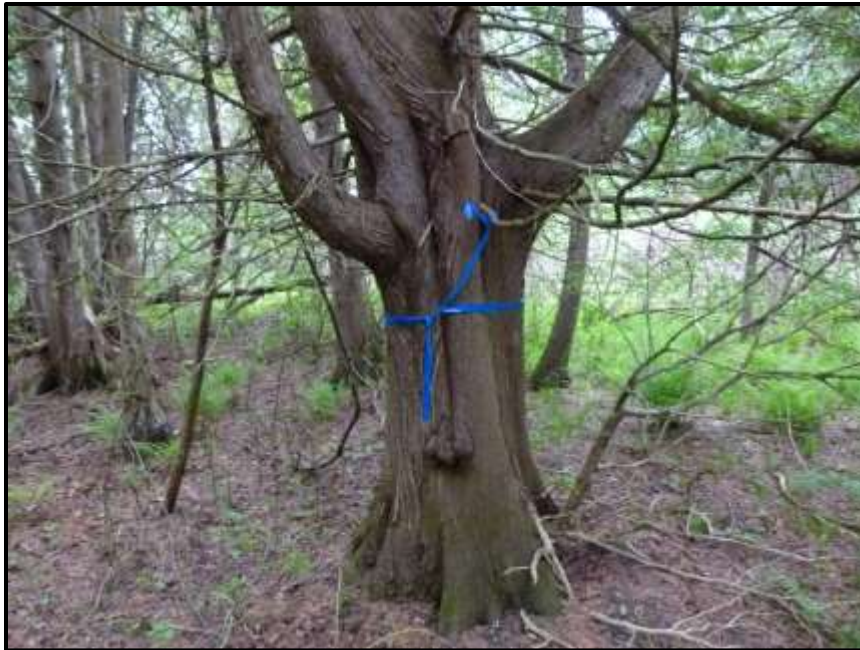
Photograph 10: Tree #11 – dead White Cedar (May 27th, 2019).

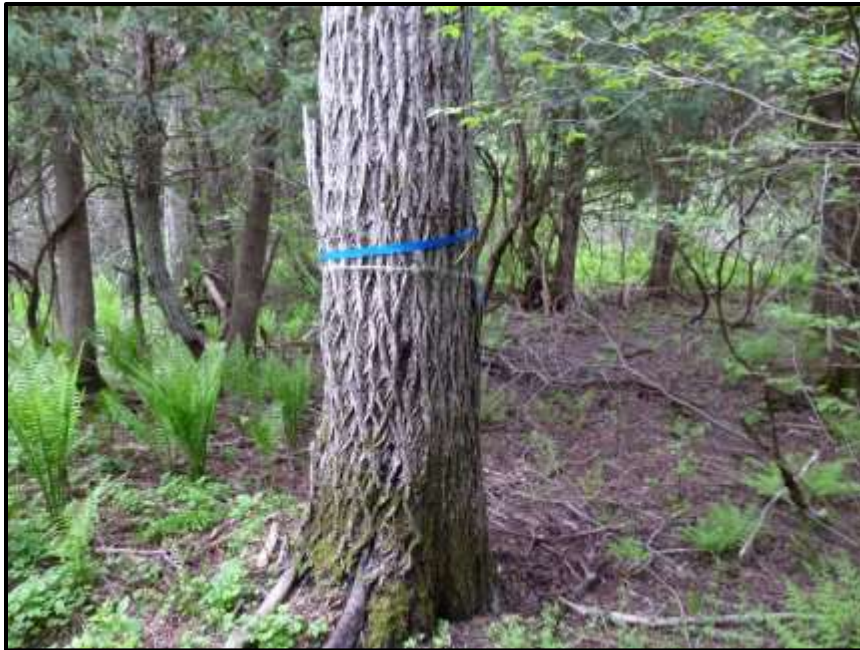
Photograph 12: Tree #13 – Category 3 Butternut (May 27th, 2019).

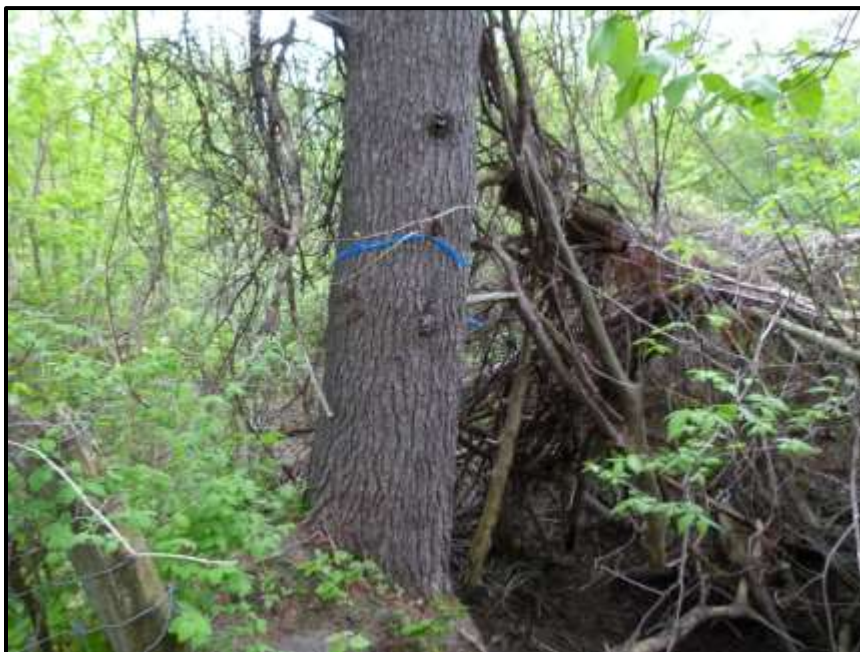
Photograph 15: Tree #16 - Category 1 Butternut (May 27th, 2019).

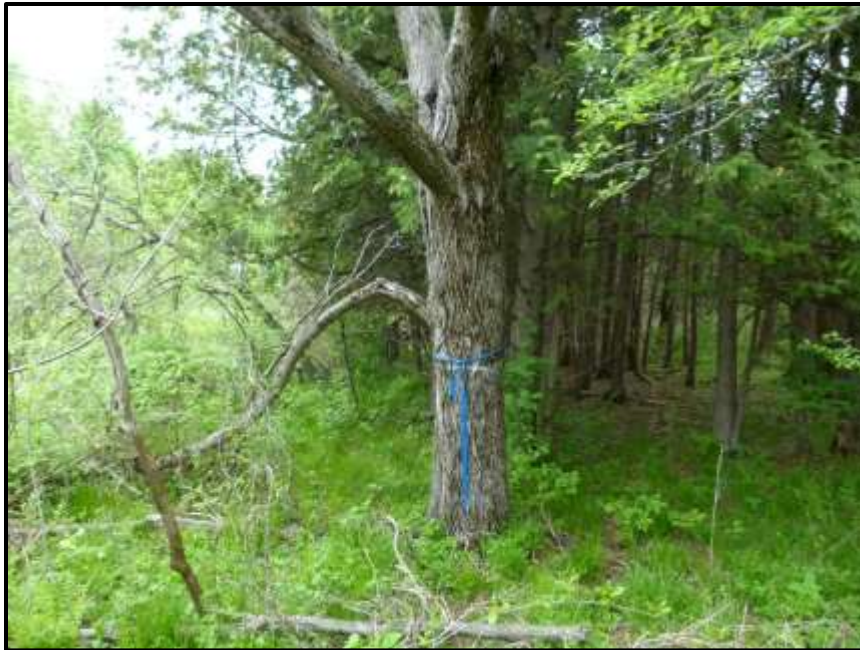
Photograph 16: Tree #17 - White Pine in good condition (May 27th, 2019).

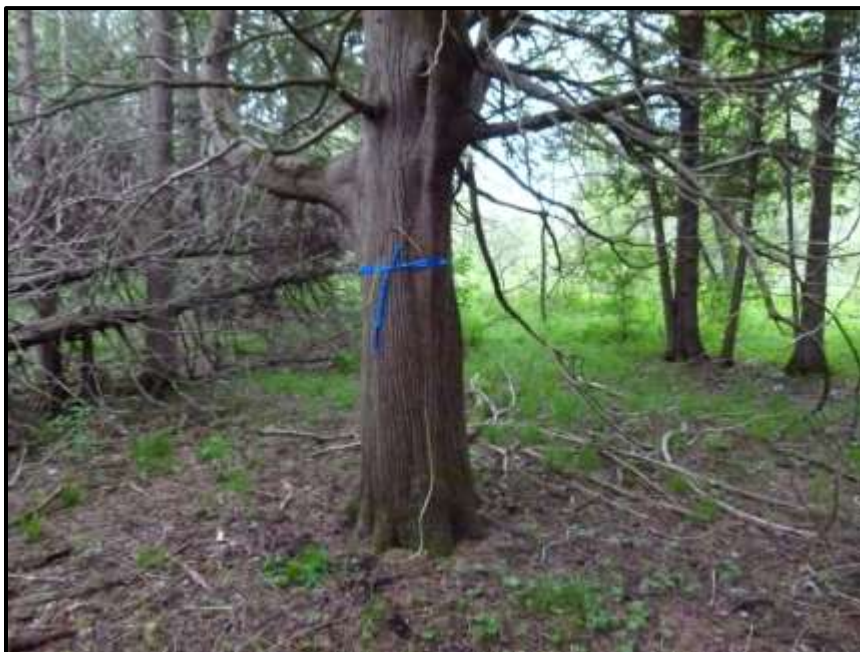
Photograph 17: Tree #18 – Category 2 Butternut (May 27th, 2019).

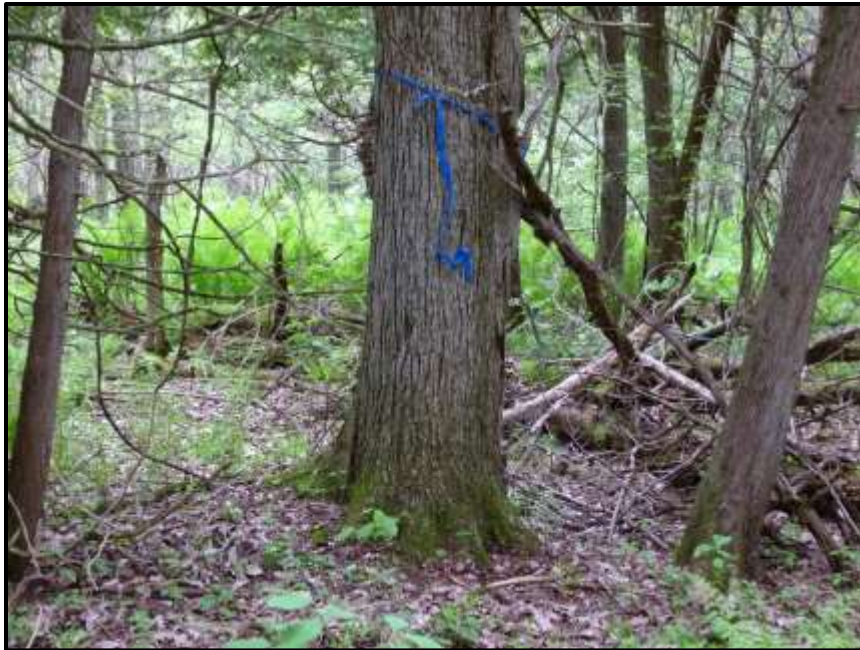
Photograph 20: Tree #21 – Bur Oak in good condition (May 27th, 2019).

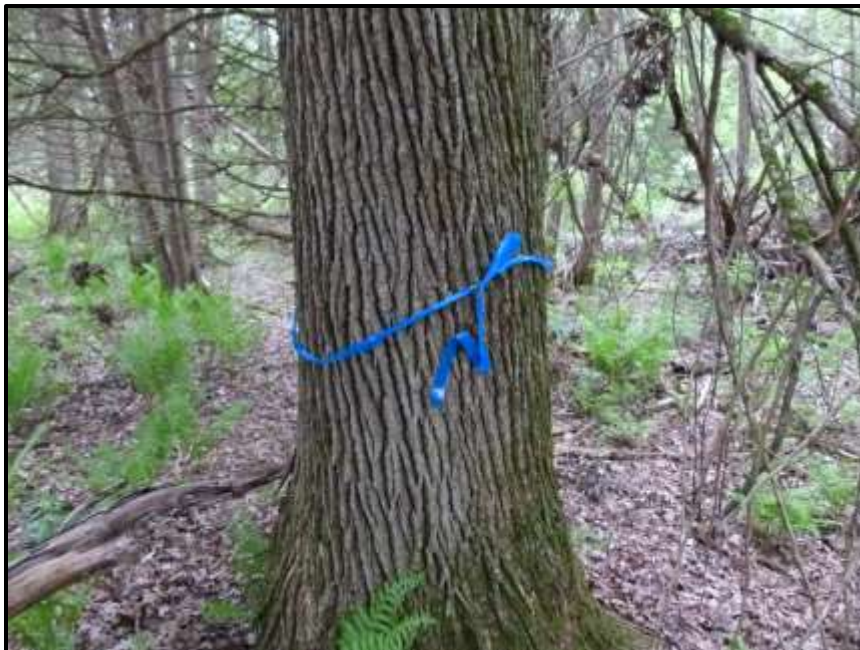
Photograph 21: Tree #22 – Bur Oak in good condition (May 27th, 2019).

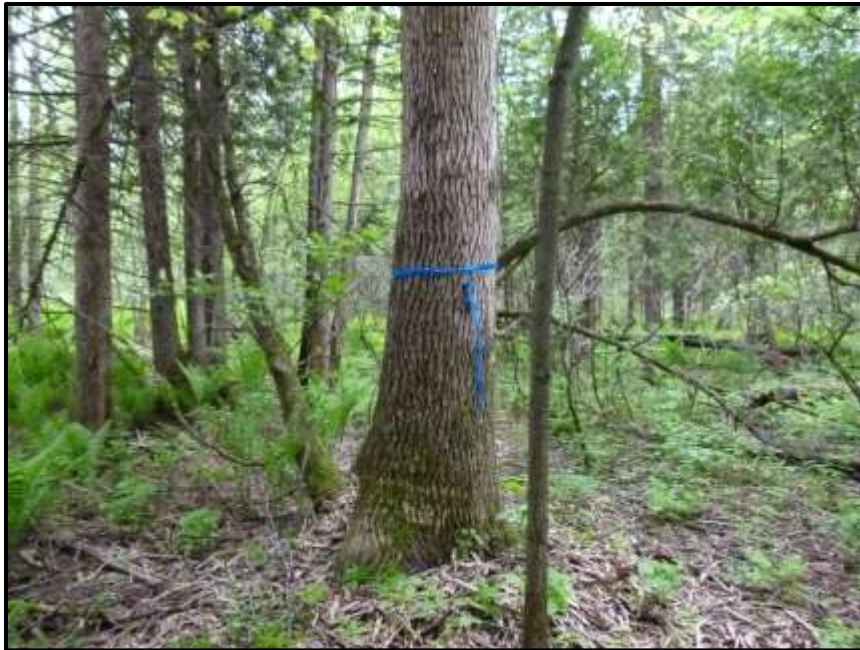
Photograph 24: Tree #25 – Category 3 Butternut Tree (May 27th, 2019).

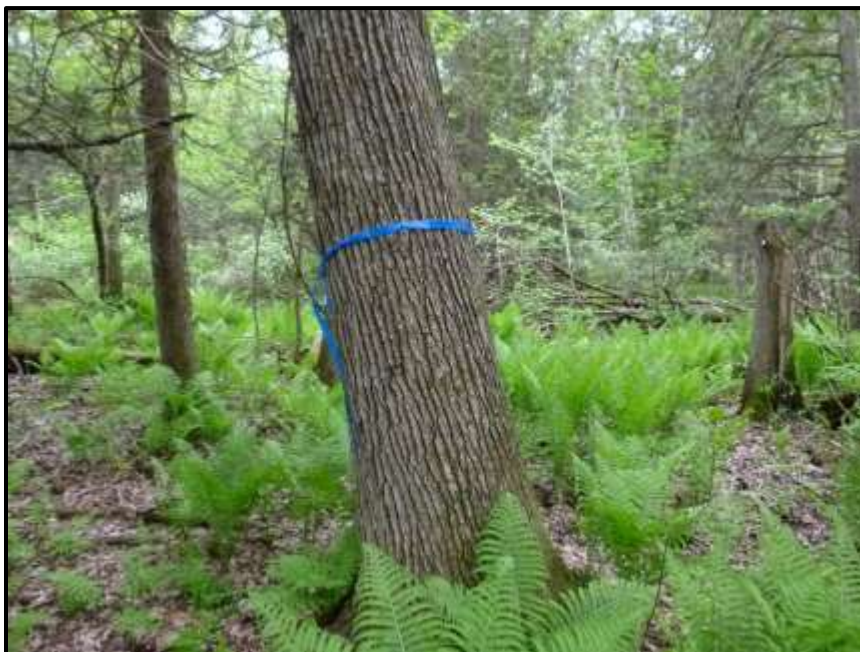
Photograph 25: Tree #26 – dead White Ash (May 27th, 2019).

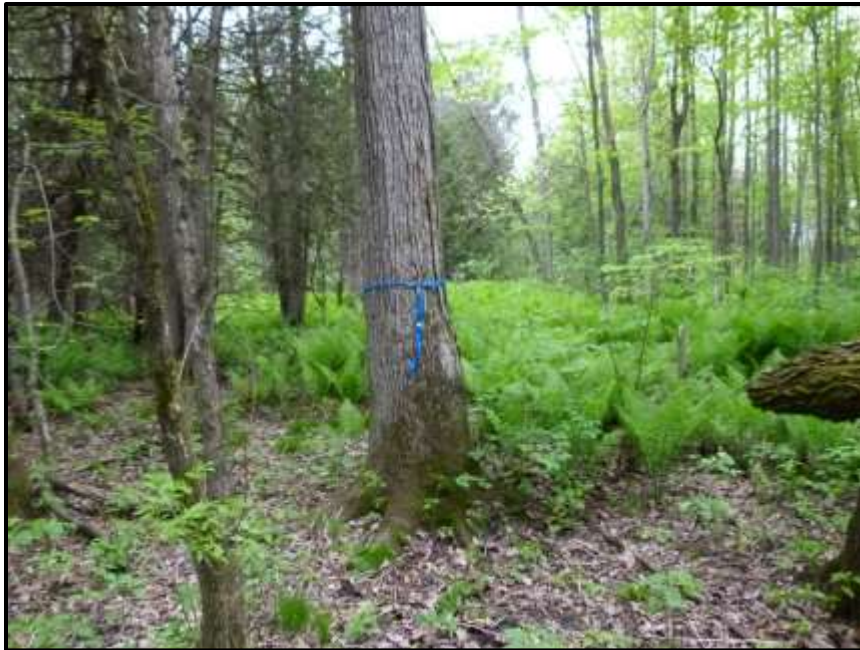
Photograph 26: Tree #27 – Bur Oak in good condition (May 27th, 2019).

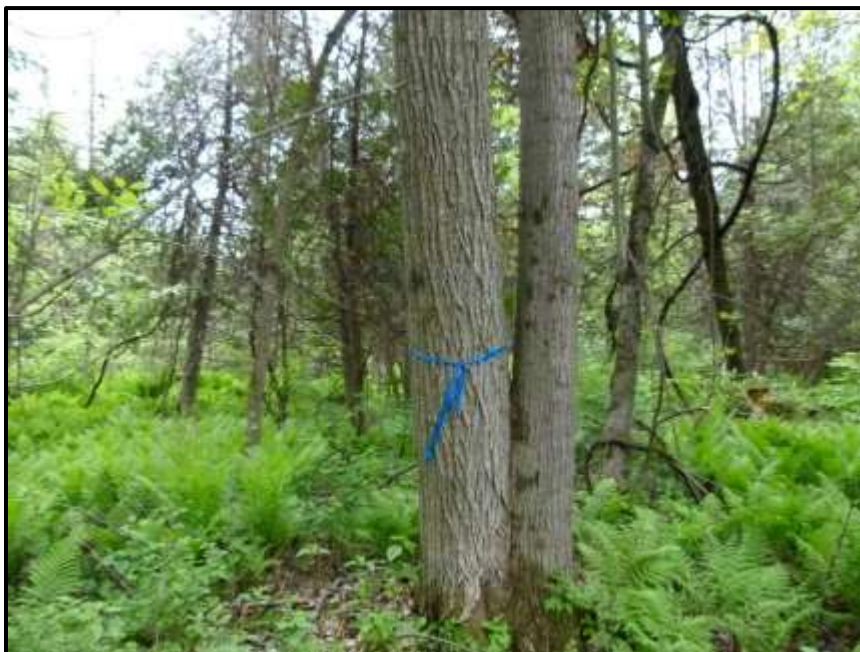
Photograph 27: Tree #28 – Bur Oak in good condition (May 27th, 2019).

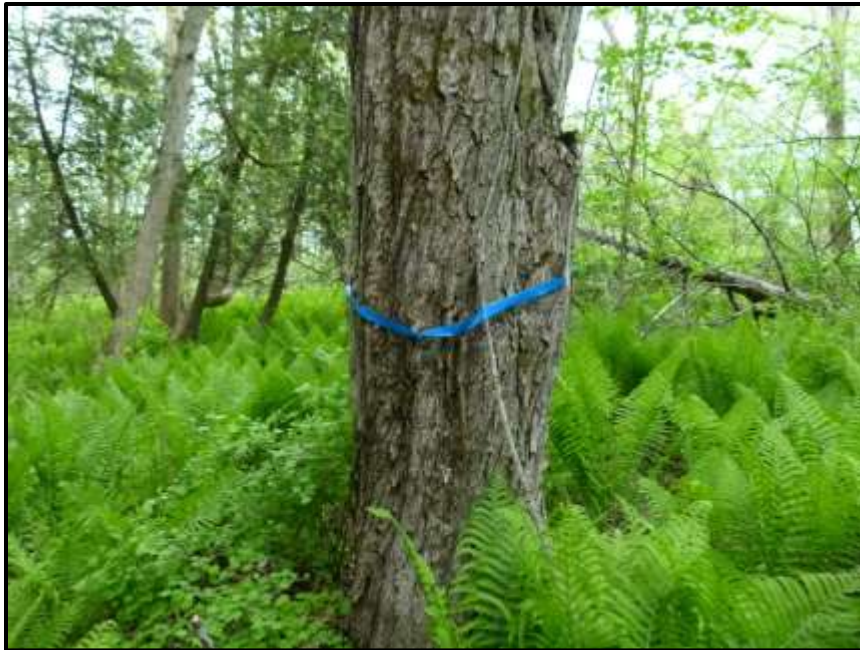
Photograph 28: Tree #29 – Bur Oak in good condition (May 27th, 2019).

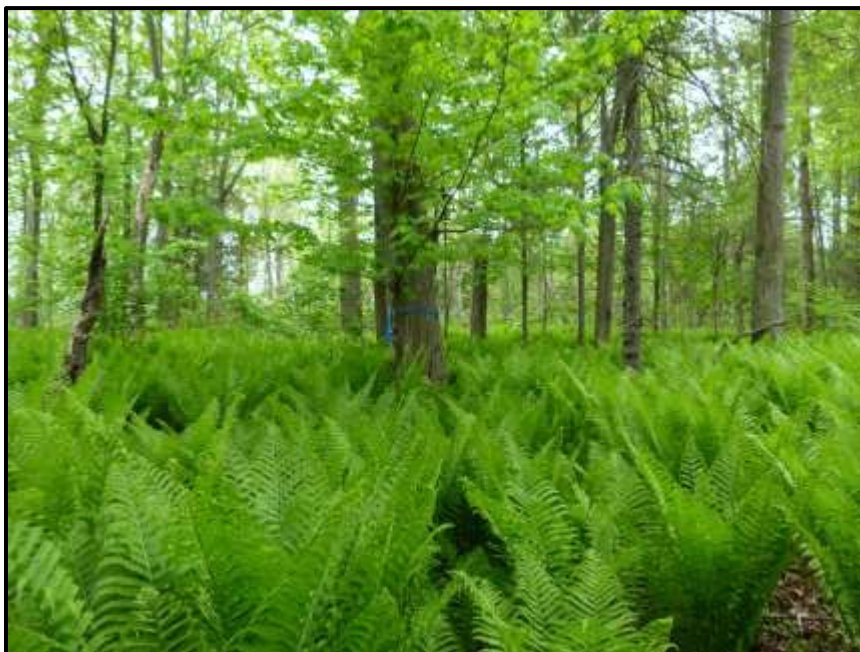
Photograph 29: Tree #30 – Sugar Maple in good condition (May 27th, 2019).

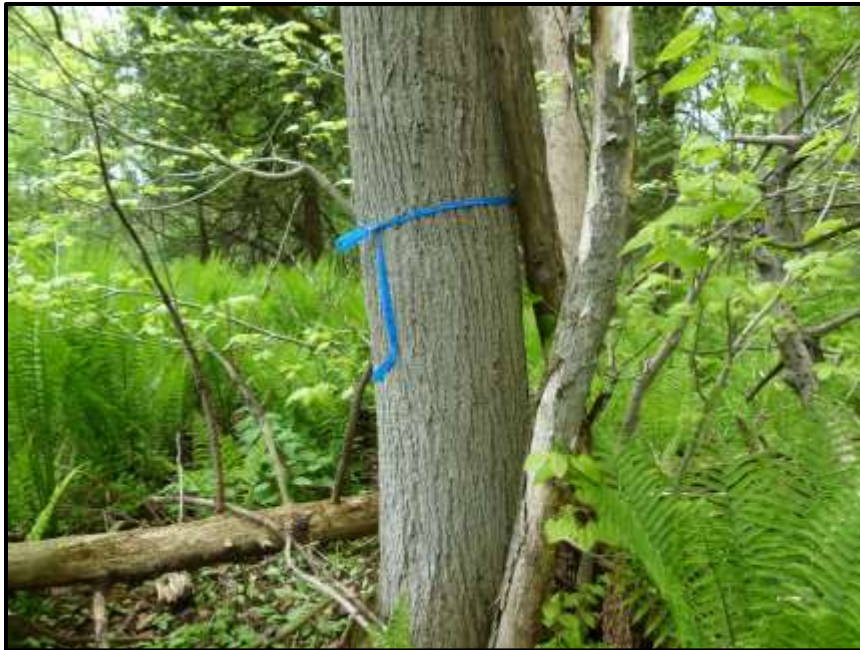
Photograph 32: Tree #33 – dead White Ash (May 27th, 2019).

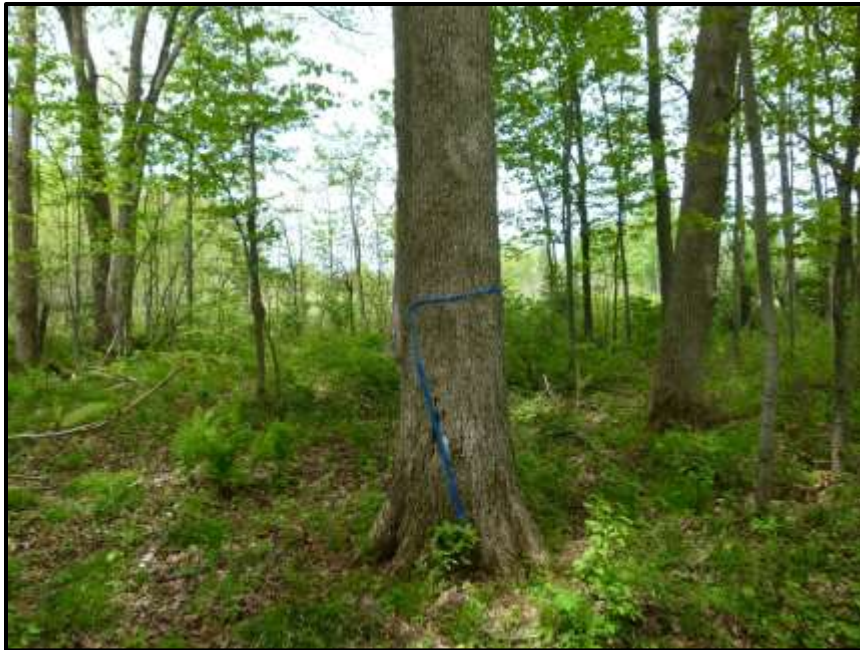
Photograph 34: Tree #35 – White Pine in good condition (May 27th, 2019).

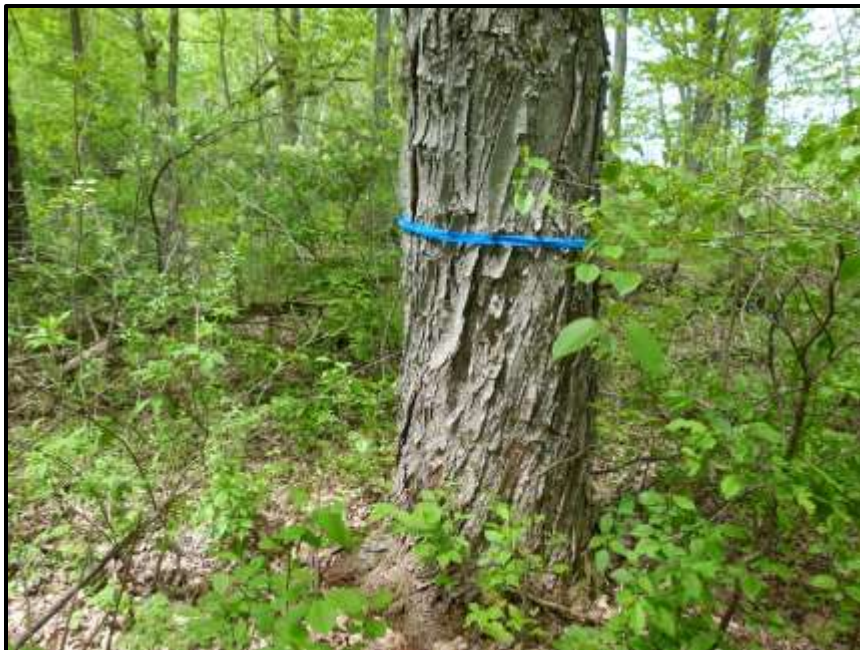
Photograph 37: Tree #38 – Sugar Maple in poor condition (May 27th, 2019).

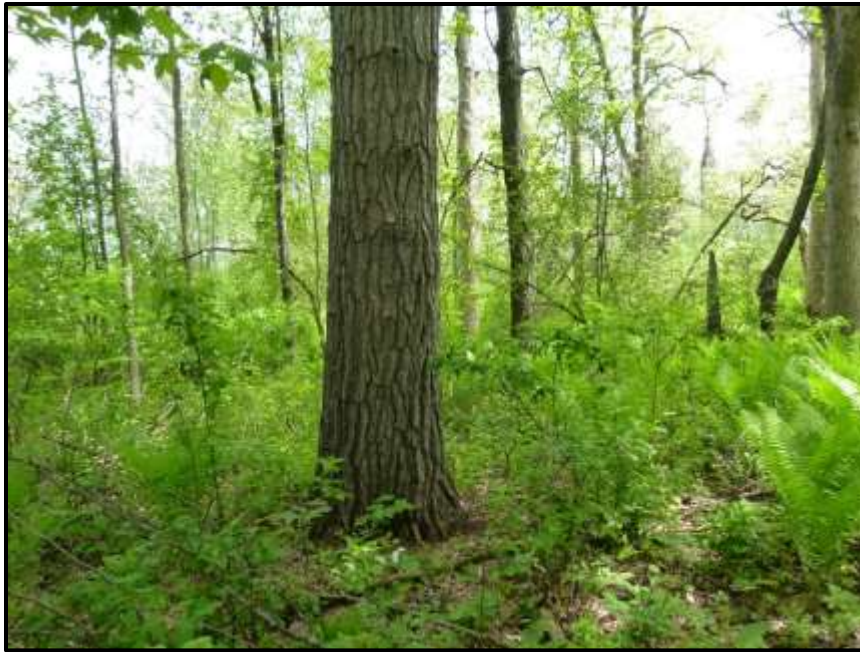
Photograph 38: Tree #39 – Sugar Maple in good condition (May 27th, 2019).

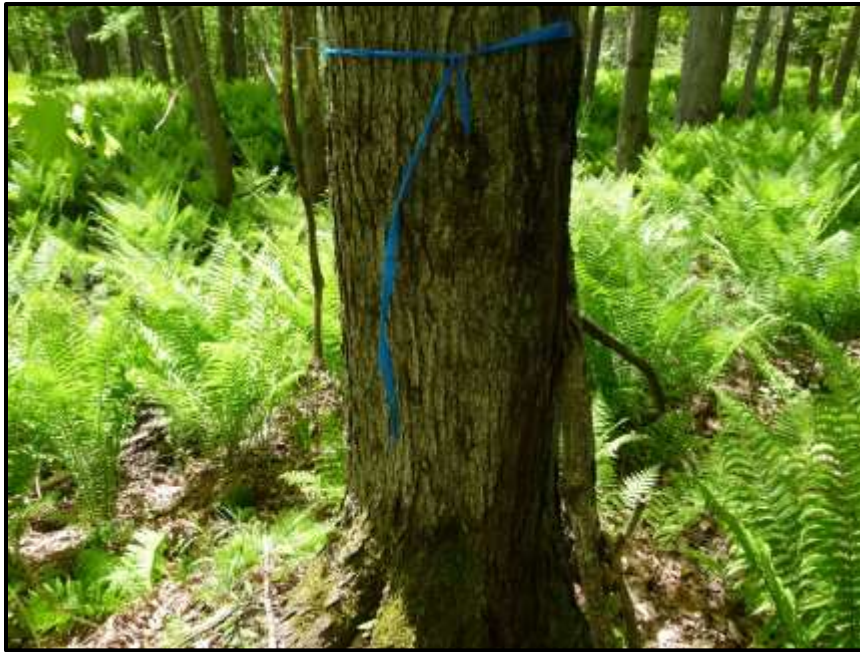
Photograph 40: Tree #41 – Sugar Maple in good condition (May 27th, 2019).

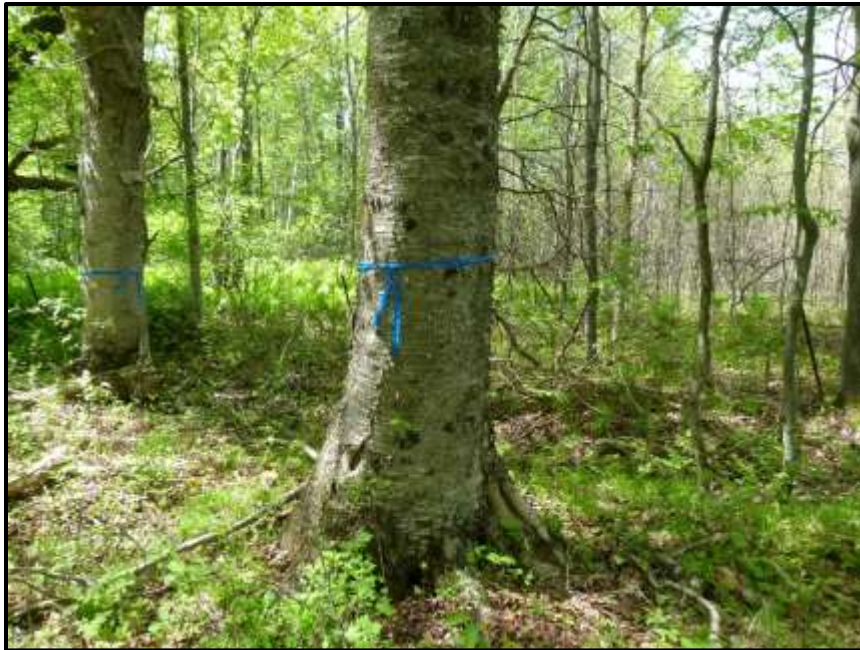
Photograph 42: Tree #43 – Yellow Birch in good condition (May 27th, 2019).

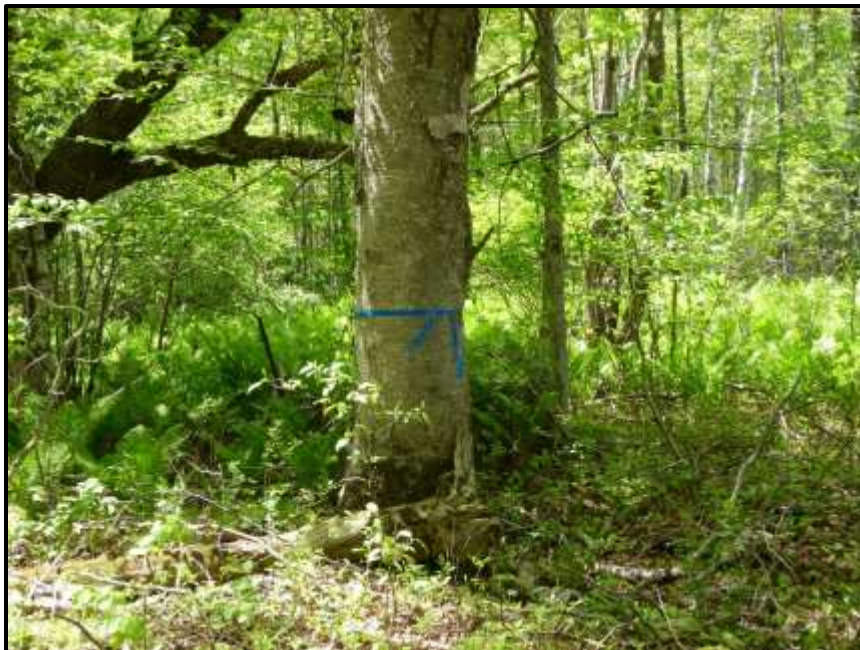
Photograph 43: Tree #44 – Yellow Birch in good condition (May 27th, 2019).

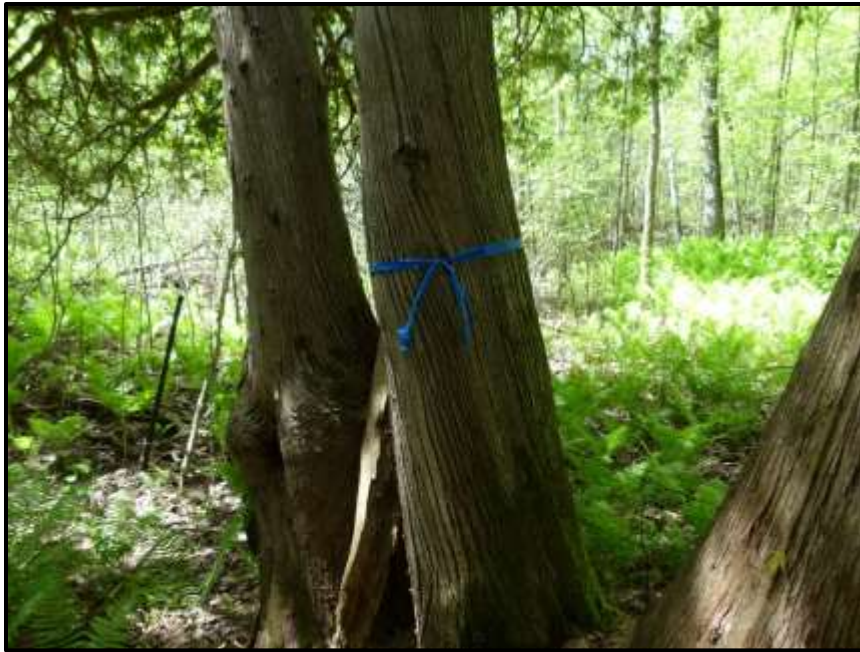
Photograph 44: Tree #45 – Yellow Birch in good condition (May 27th, 2019).

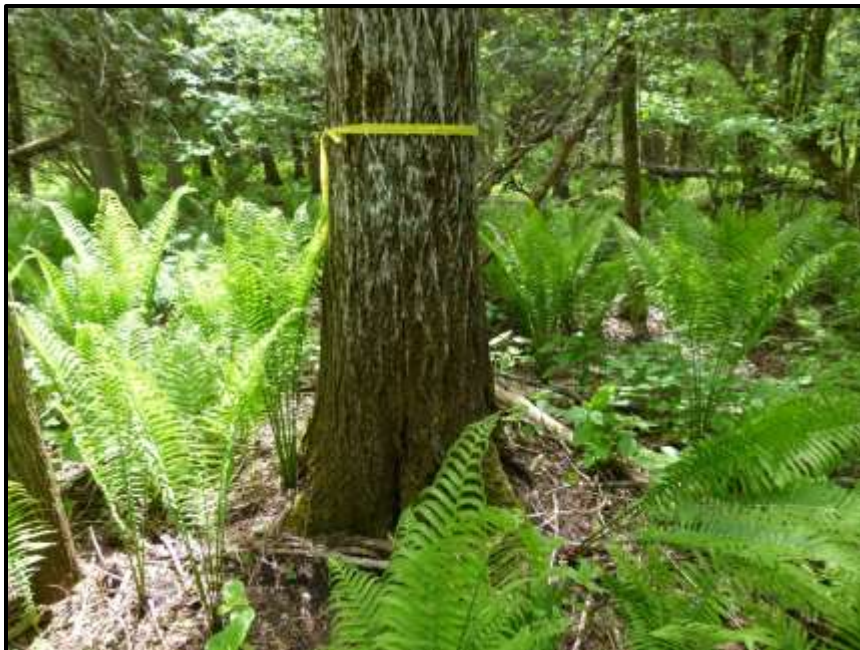
Photograph 51: Tree #52 – dead White Ash (May 27th, 2019).

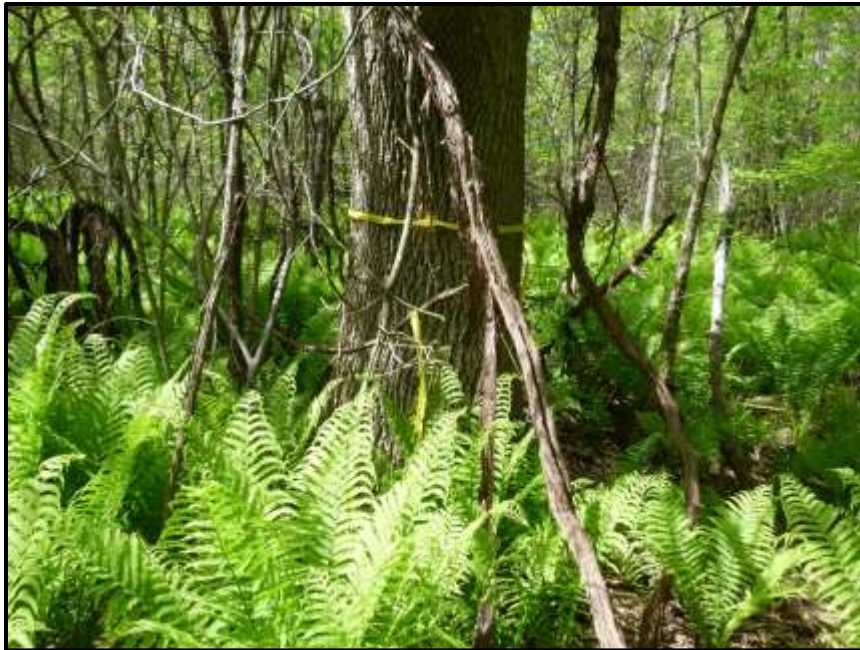
Photograph 52: Tree #53 – Category 3 Butternut (May 27th, 2019).

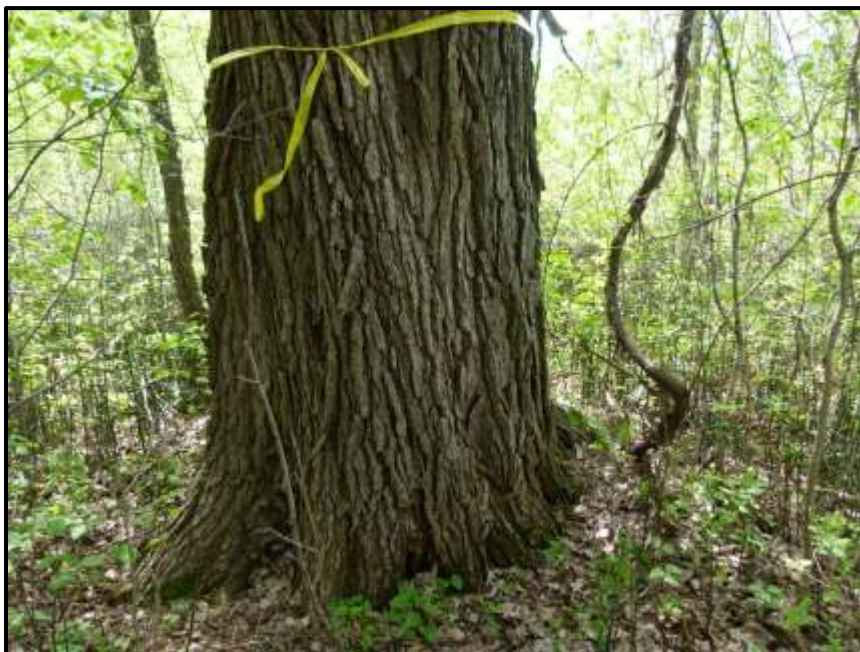
Photograph 53: Tree #54 – dead White Ash (May 30th, 2019).

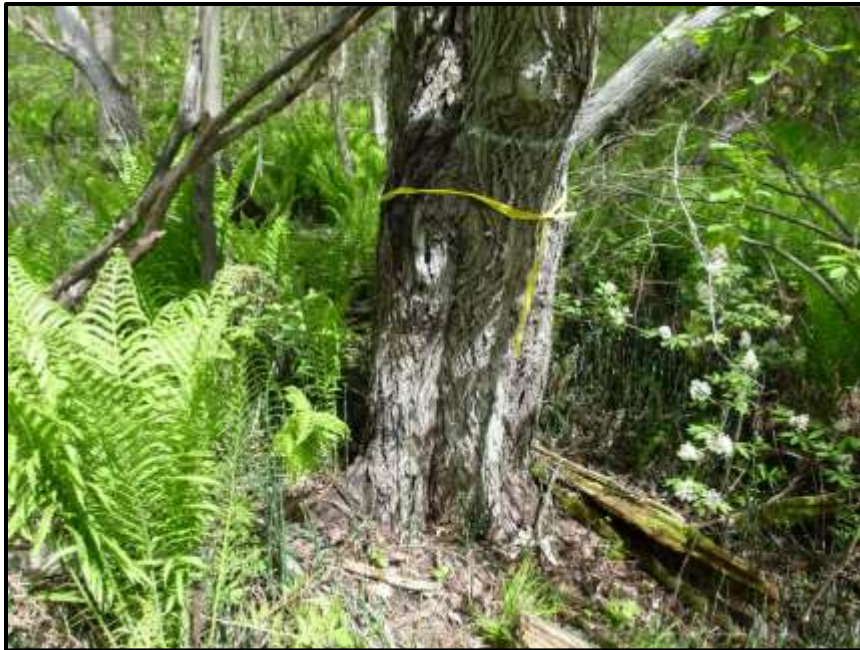
Photograph 54: Tree #55 – Bur Oak in good condition (May 30th, 2019).

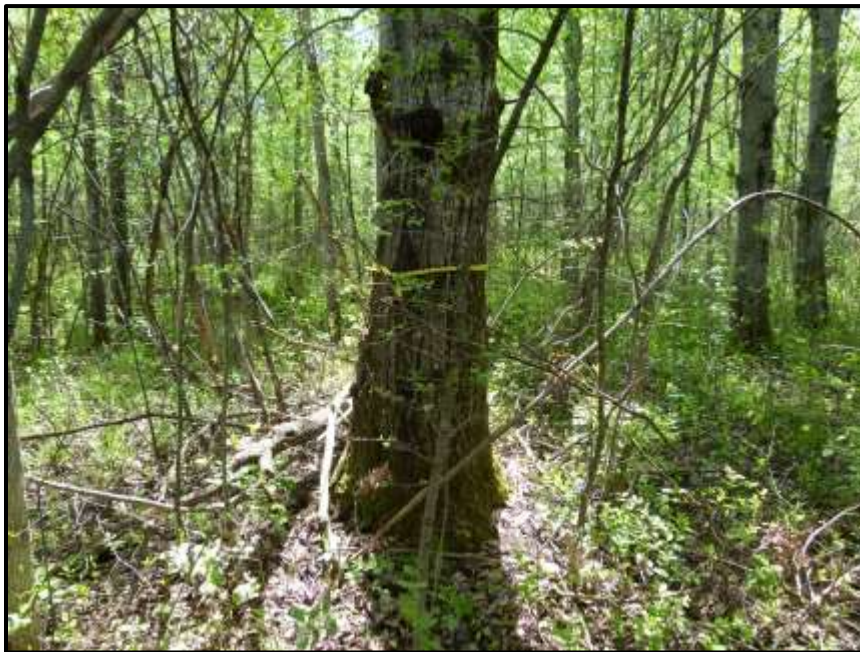
Photograph 58: Tree #59 – Trembling Aspen in good condition (May 30th, 2019).

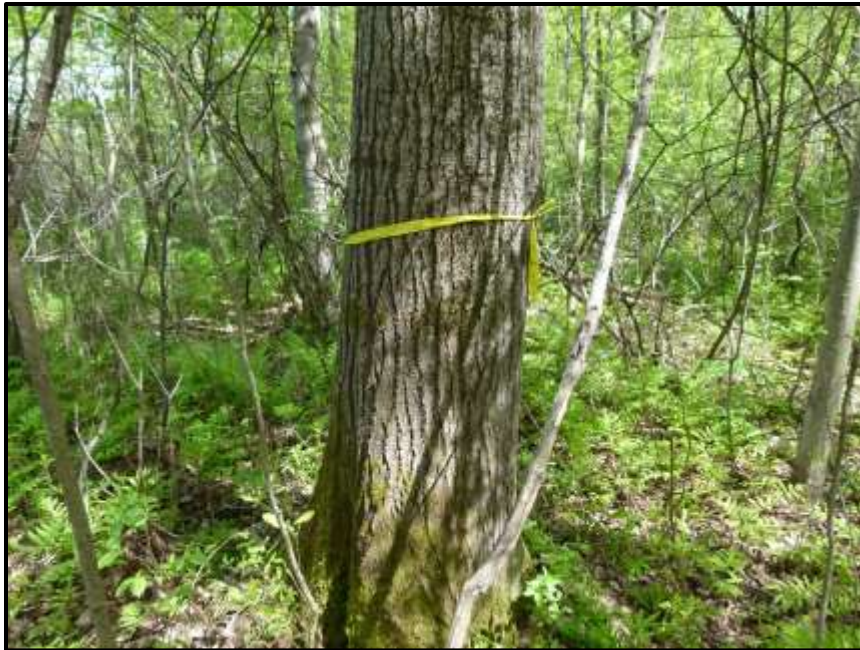
Photograph 59: Tree #60 – Trembling Aspen in good condition (May 30th, 2019).

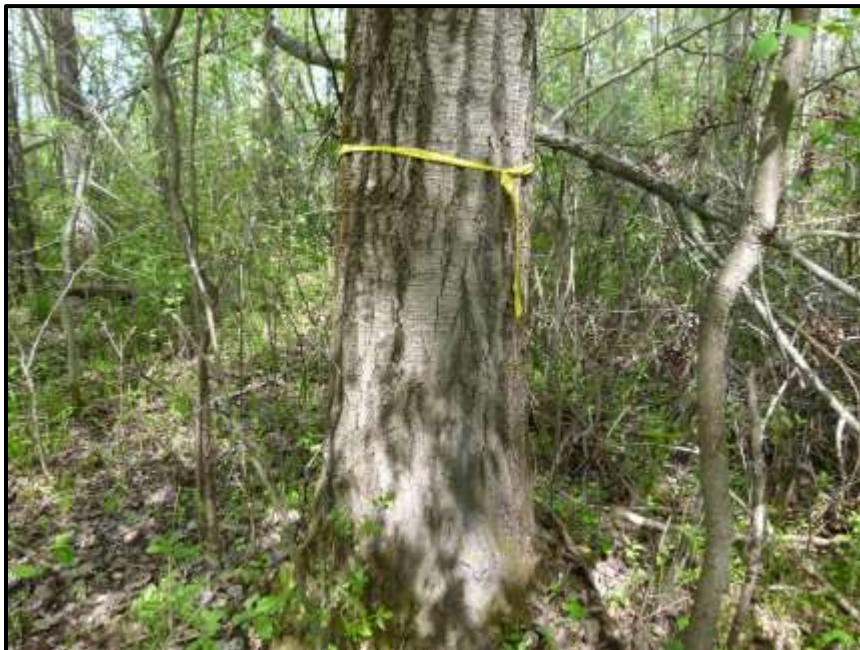
Photograph 60: Tree #61 – Trembling Aspen in good condition (May 30th, 2019).

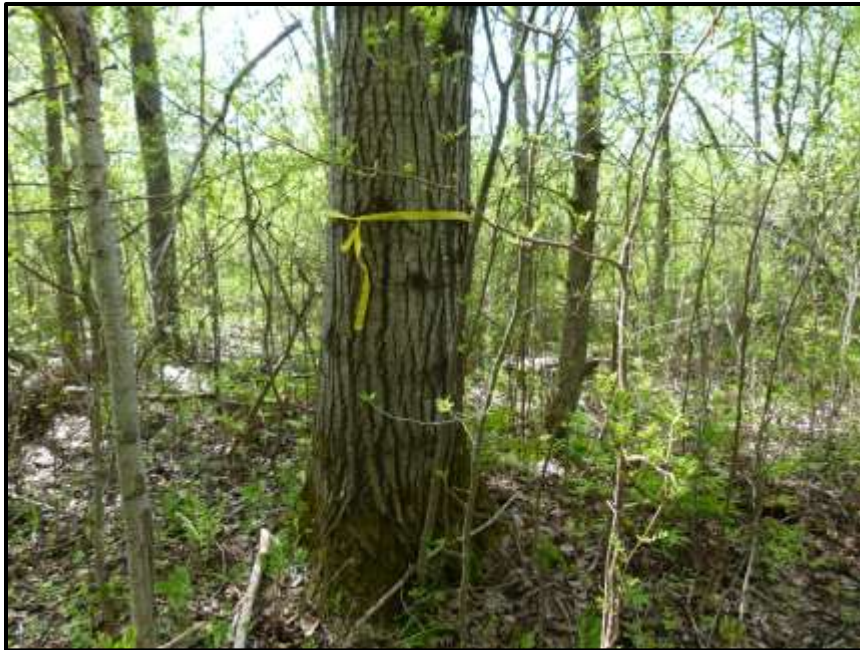
Photograph 61: Tree #62 – Trembling Aspen in good condition (May 30th, 2019).

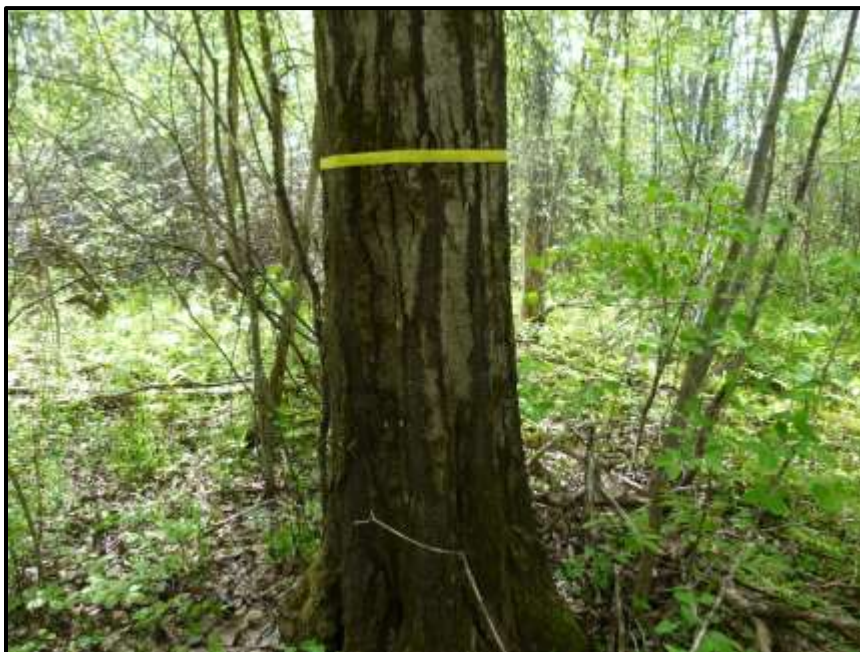
Photograph 62: Tree #63 – Trembling Aspen in good condition (May 30th, 2019).

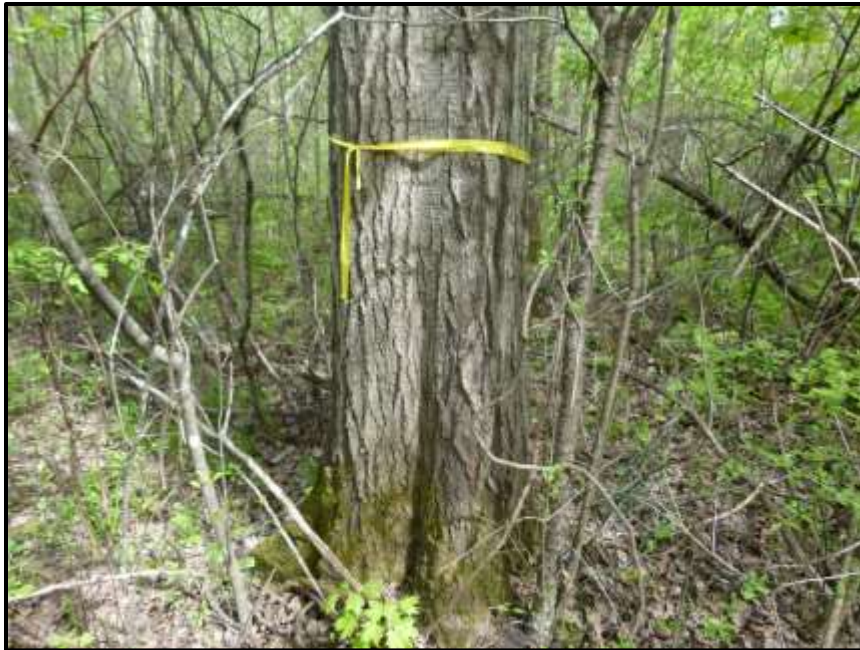
Photograph 63: Tree #64 – Trembling Aspen in good condition (May 30th, 2019).

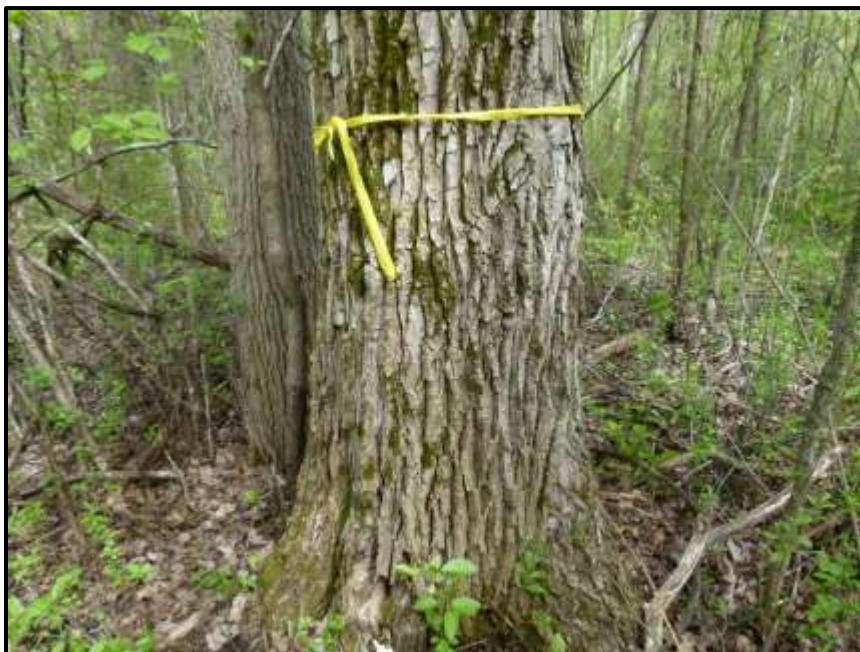
Photograph 64: Tree #65 – Trembling Aspen in good condition (May 30th, 2019).

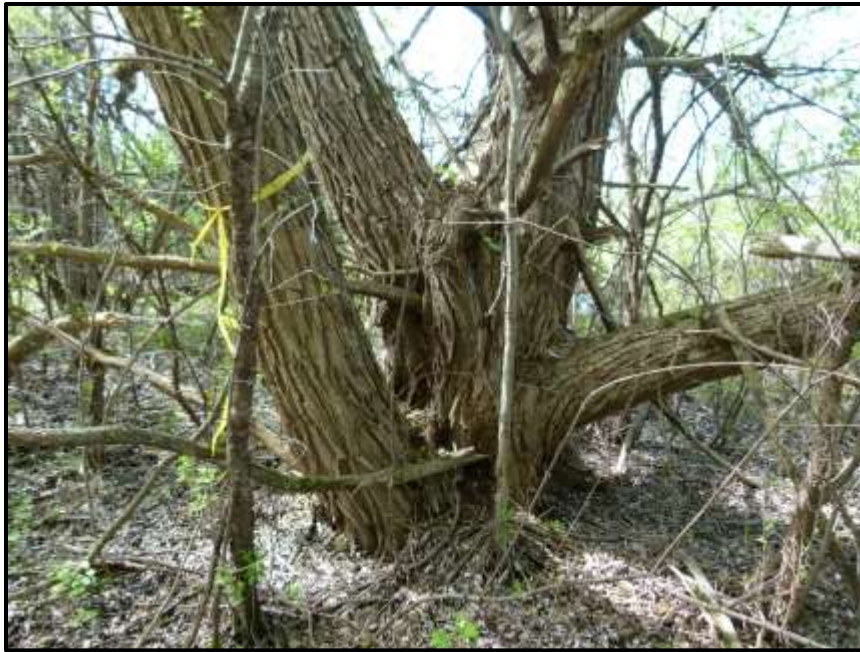
Photograph 65: Tree #66 – Crack Willow in good condition (May 30th, 2019).

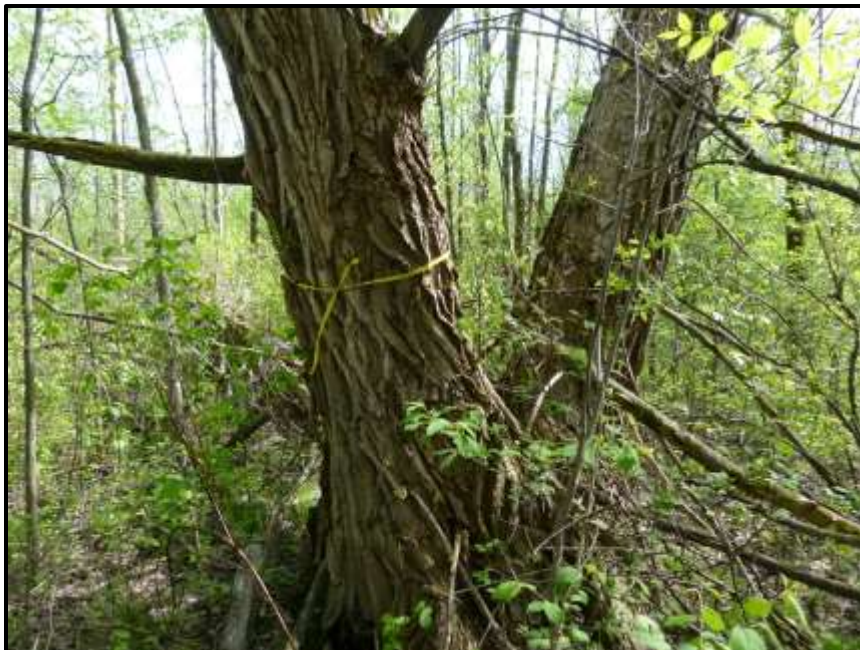
Photograph 66: Tree #67 – Crack Willow in good condition (May 30th, 2019).

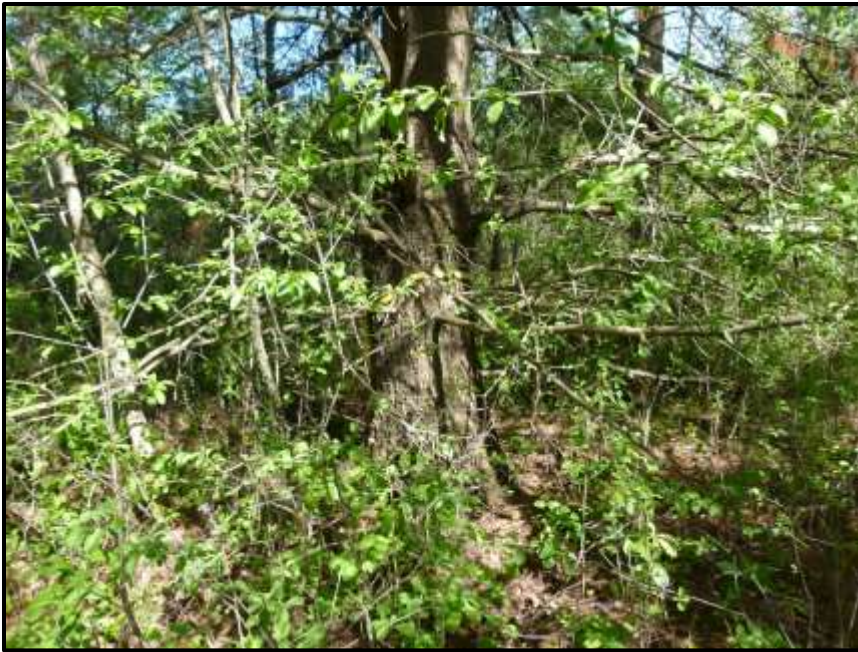
Photograph 67: Tree #68 – White Pine in good condition (May 30th, 2019).

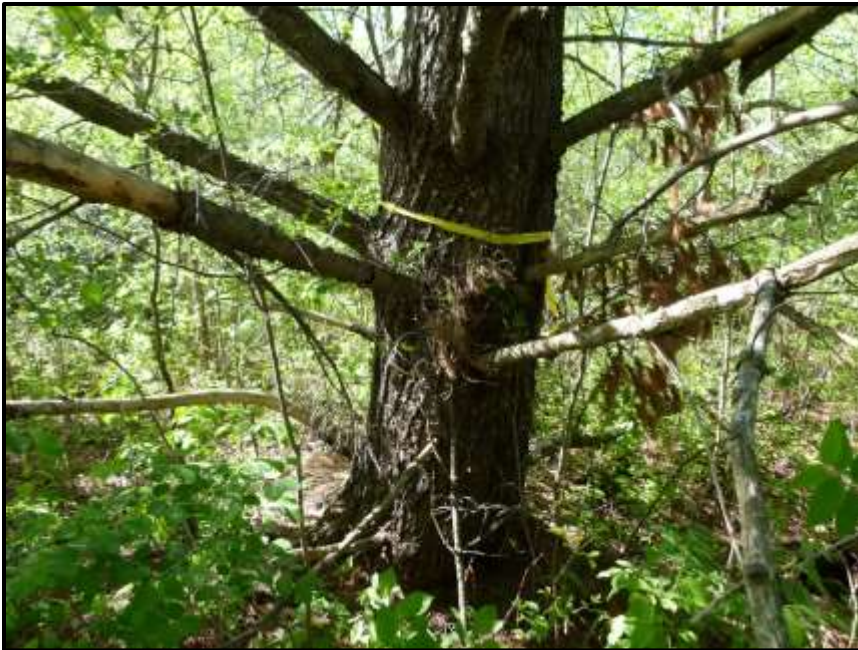
Photograph 68: Tree #69 – White Pine in good condition (May 30th, 2019).

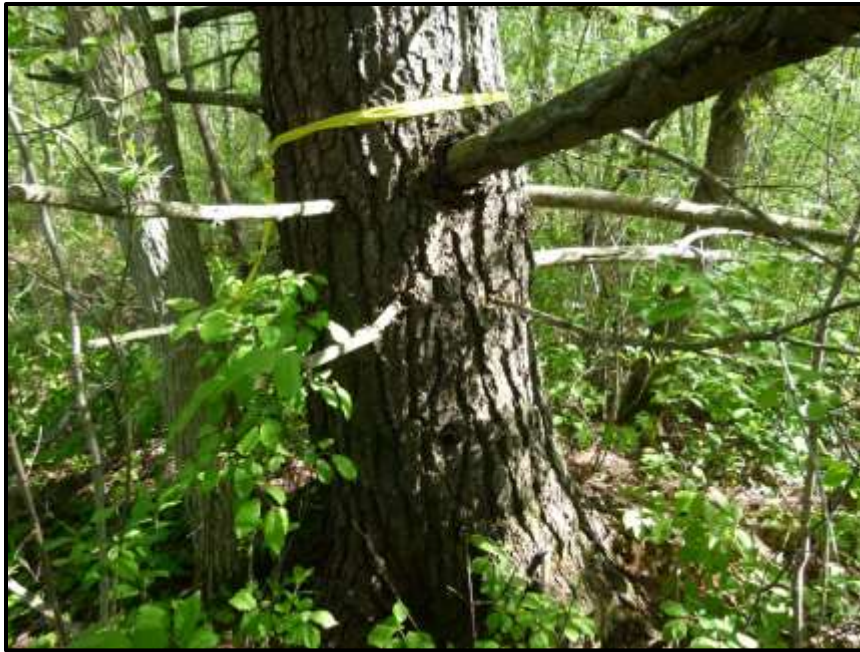
Photograph 69: Tree #70 – White Pine in good condition (May 30th, 2019).

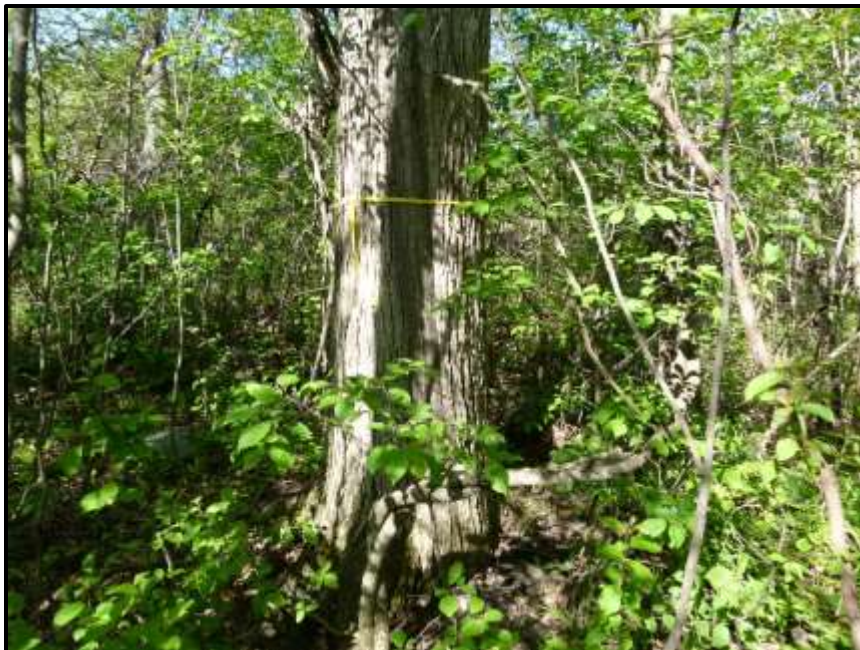
Photograph 70: Tree #71 – White Pine in good condition (May 30th, 2019).
