June 3<sup>rd</sup>, 2019

RE: Woodlot S-23 Large Tree Inventory – Minto Communities and Valecraft Homes Kanata North  
Developments

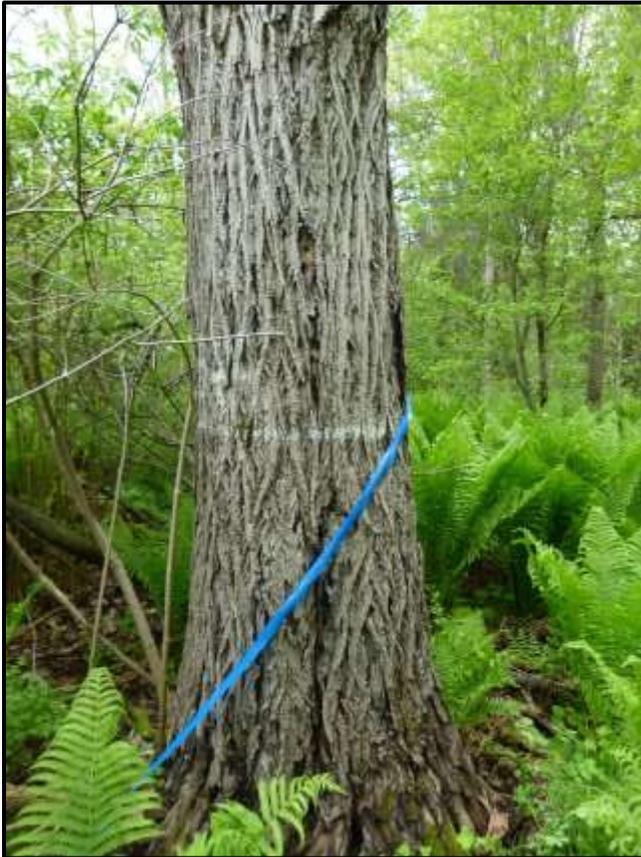
Photograph 6: Tree #7 – Category 1 Butternut (May 27<sup>th</sup>, 2019).

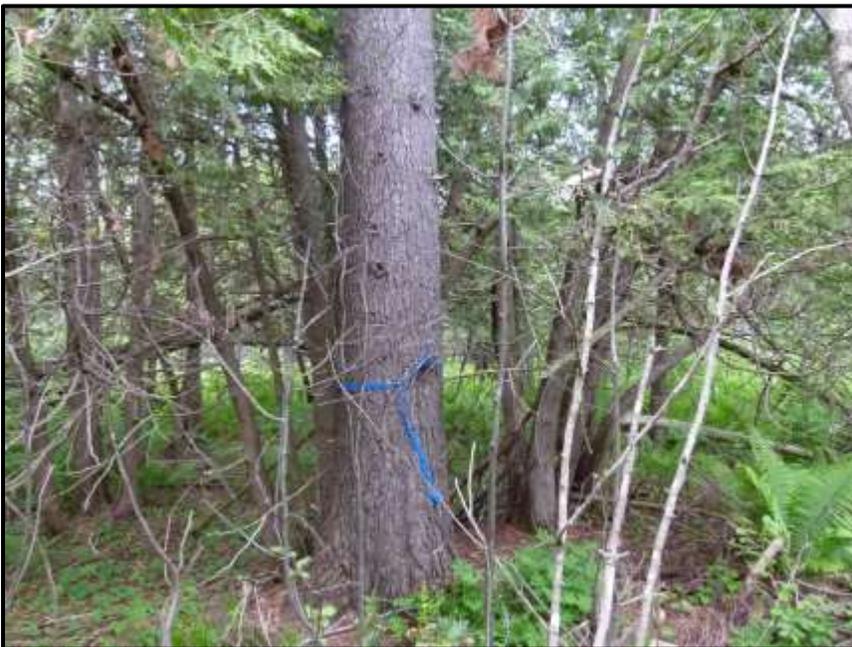
Photograph 8: Tree #9 – White Pine in good condition (May 27<sup>th</sup>, 2019).

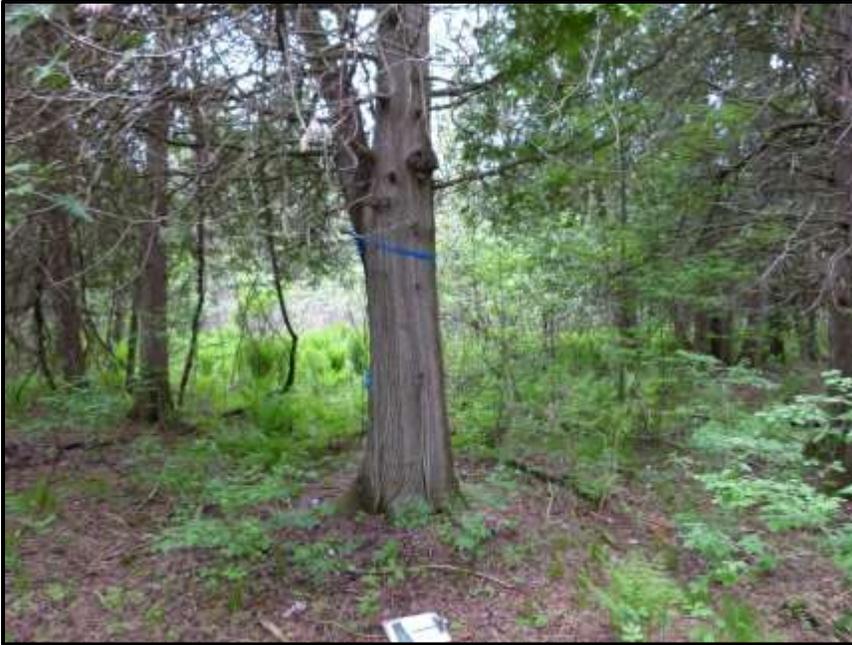
Photograph 9: Tree #10 – White Cedar in good condition (May 27<sup>th</sup>, 2019).

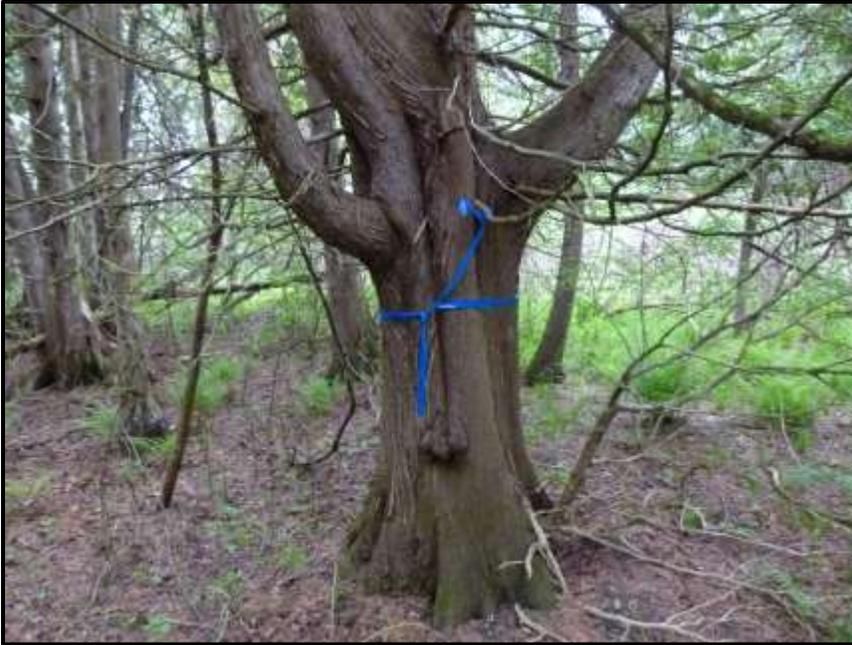
Photograph 11: Tree #12 – White Cedar in good condition (May 27<sup>th</sup>, 2019).

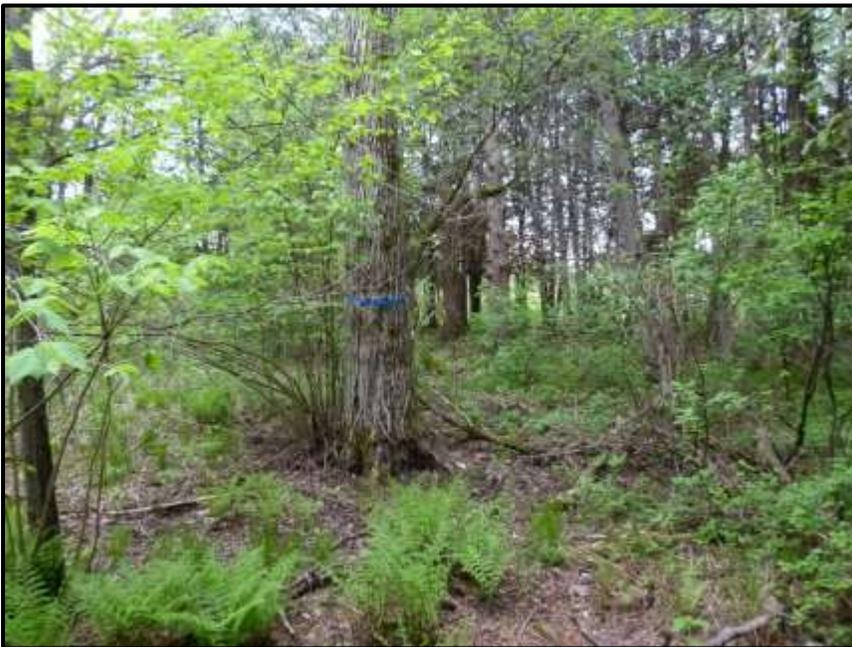
Photograph 12: Tree #13 – Category 3 Butternut (May 27<sup>th</sup>, 2019).

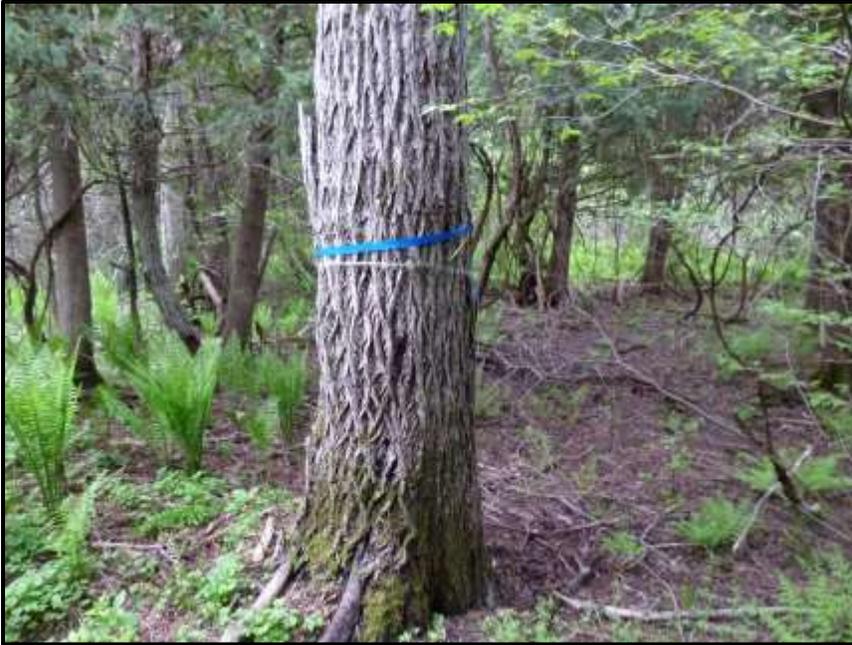
Photograph 13: Tree #14 - Category 3 Butternut (May 27<sup>th</sup>, 2019).

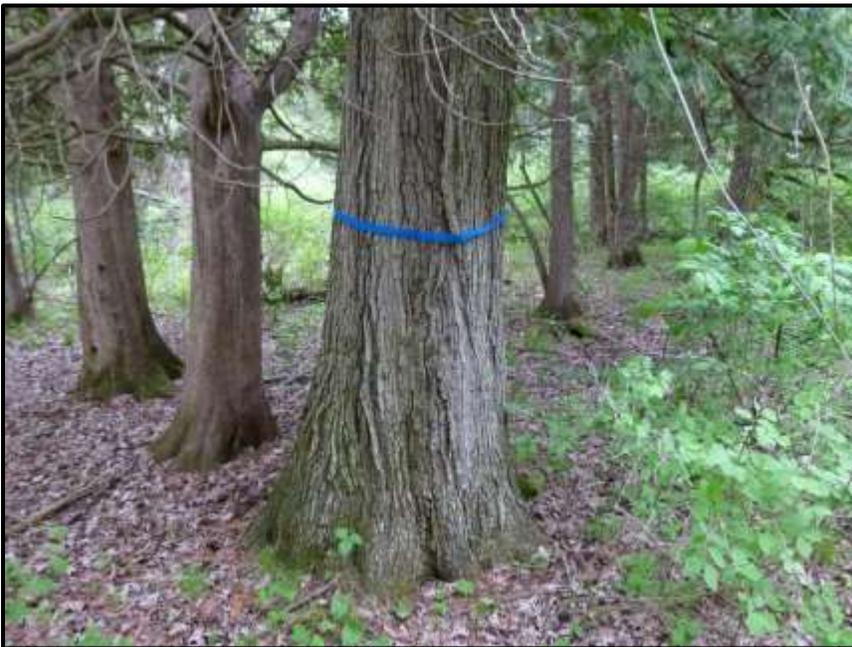
Photograph 14: Tree #15 - Bur Oak in good condition (May 27<sup>th</sup>, 2019).

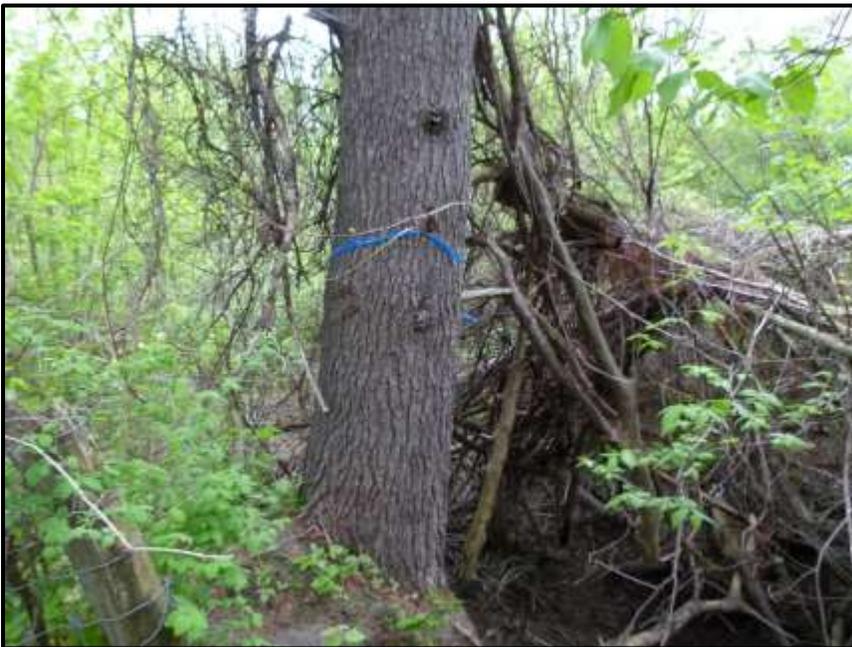
Photograph 16: Tree #17 - White Pine in good condition (May 27<sup>th</sup>, 2019).

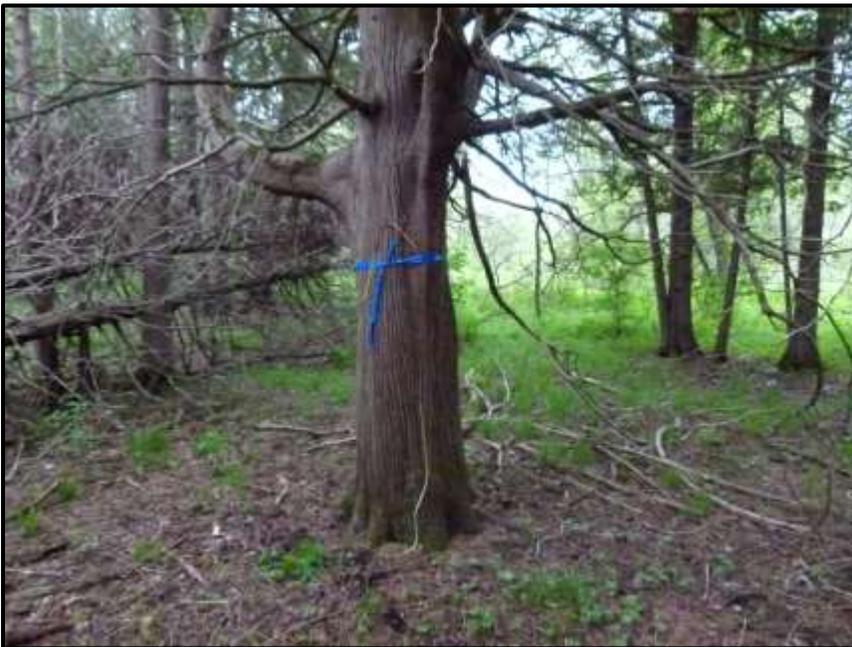
Photograph 18: Tree #19 – White Cedar in good condition (May 27<sup>th</sup>, 2019).

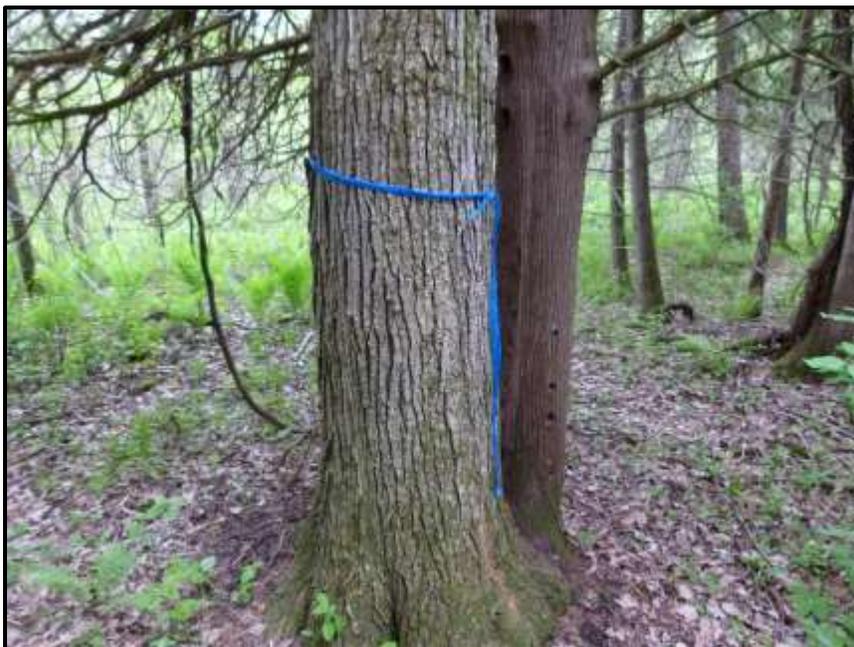
Photograph 20: Tree #21 – Bur Oak in good condition (May 27<sup>th</sup>, 2019).

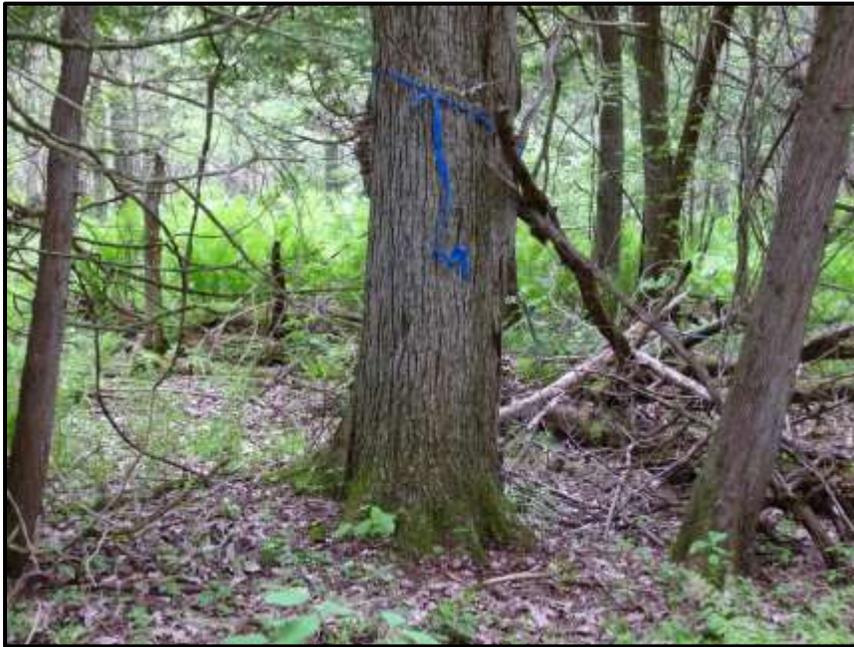
Photograph 21: Tree #22 – Bur Oak in good condition (May 27<sup>th</sup>, 2019).

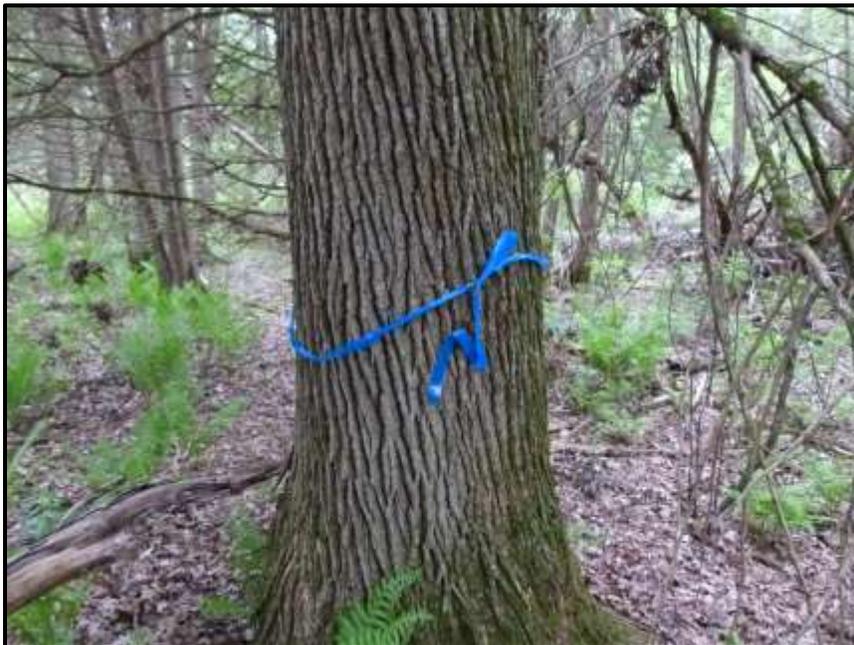
Photograph 22: Tree #23 – Bur Oak in good condition (May 27<sup>th</sup>, 2019).

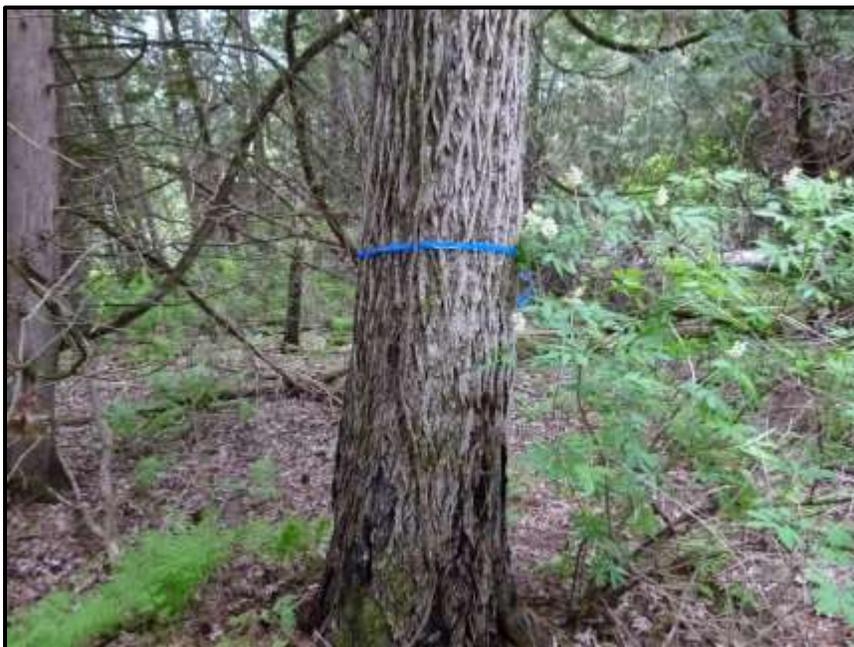
Photograph 24: Tree #25 – Category 3 Butternut Tree (May 27<sup>th</sup>, 2019).

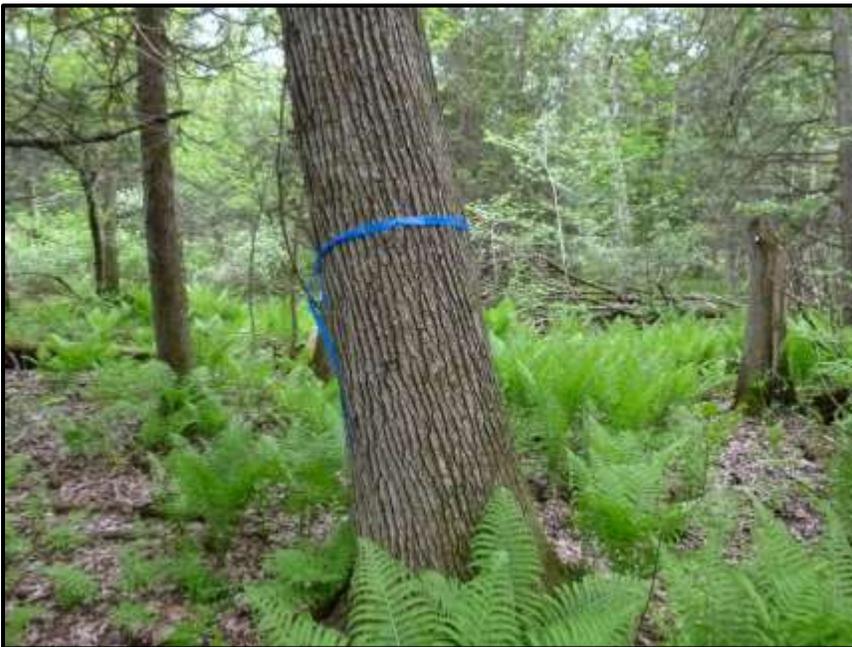
Photograph 26: Tree #27 – Bur Oak in good condition (May 27<sup>th</sup>, 2019).

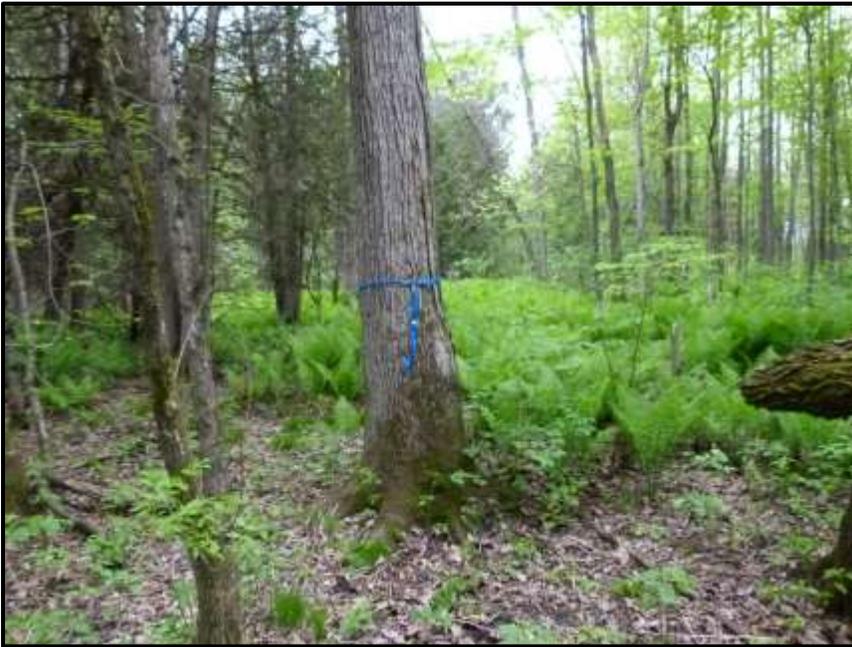
Photograph 27: Tree #28 – Bur Oak in good condition (May 27<sup>th</sup>, 2019).

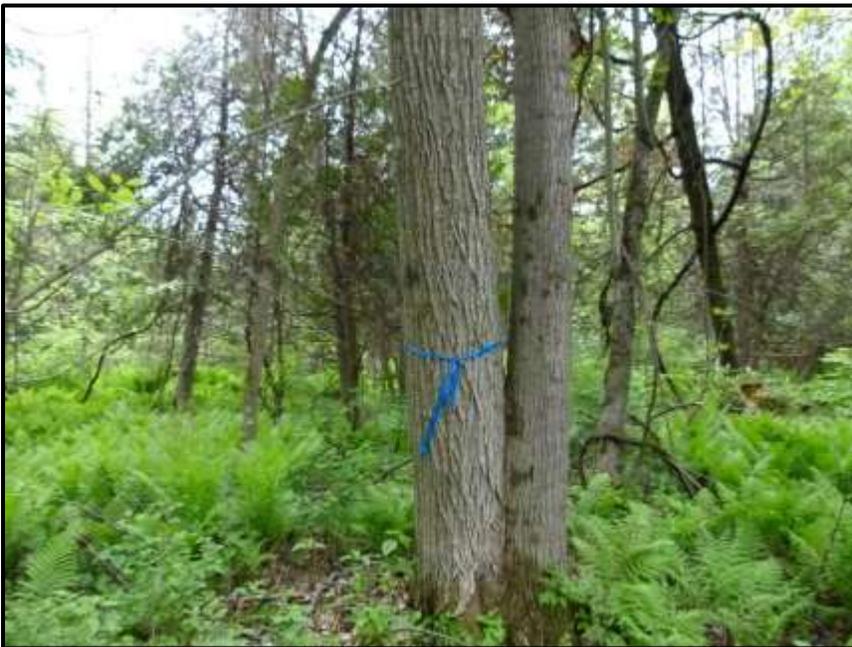
Photograph 28: Tree #29 – Bur Oak in good condition (May 27<sup>th</sup>, 2019).

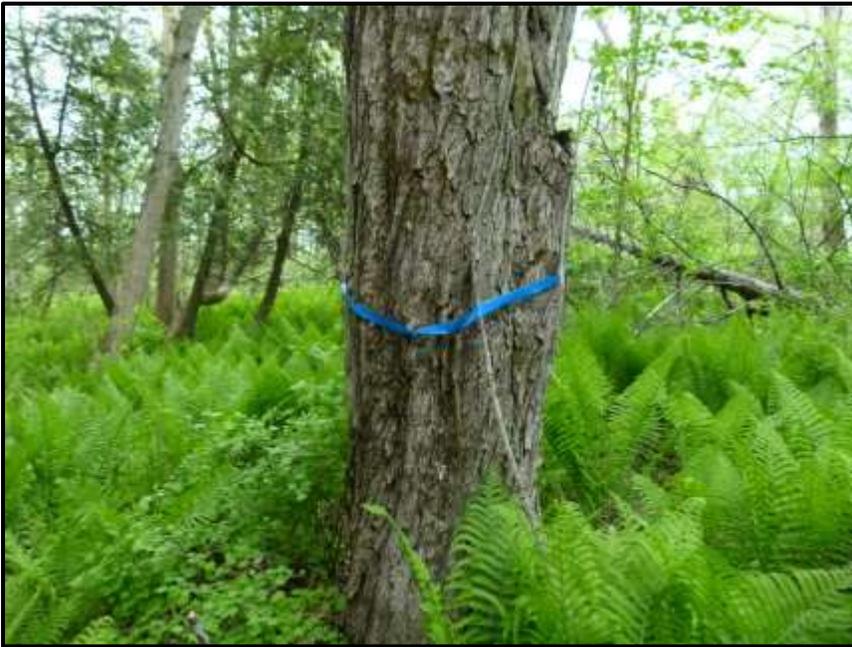
Photograph 29: Tree #30 – Sugar Maple in good condition (May 27<sup>th</sup>, 2019).

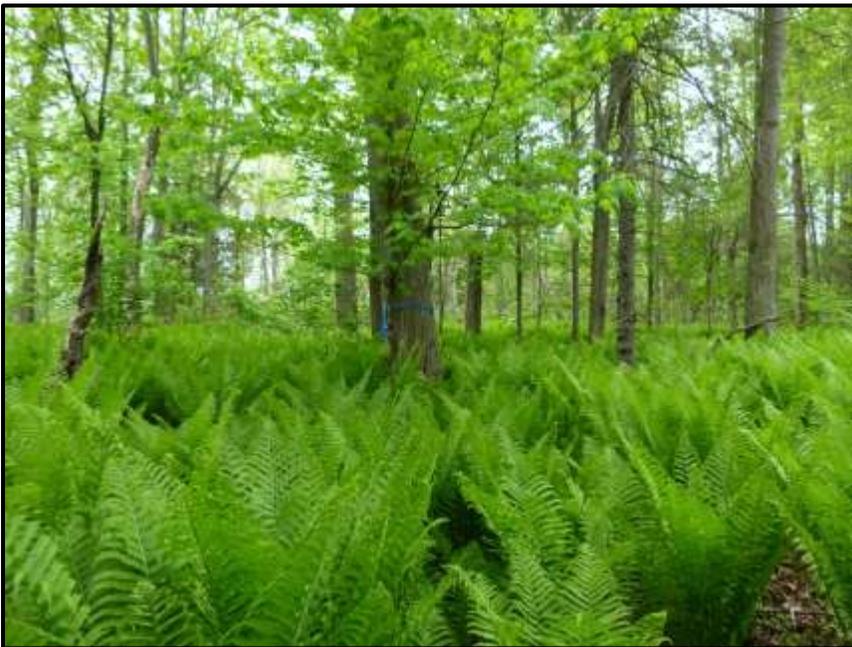
Photograph 30: Tree #31 – Sugar Maple in good condition (May 27<sup>th</sup>, 2019).

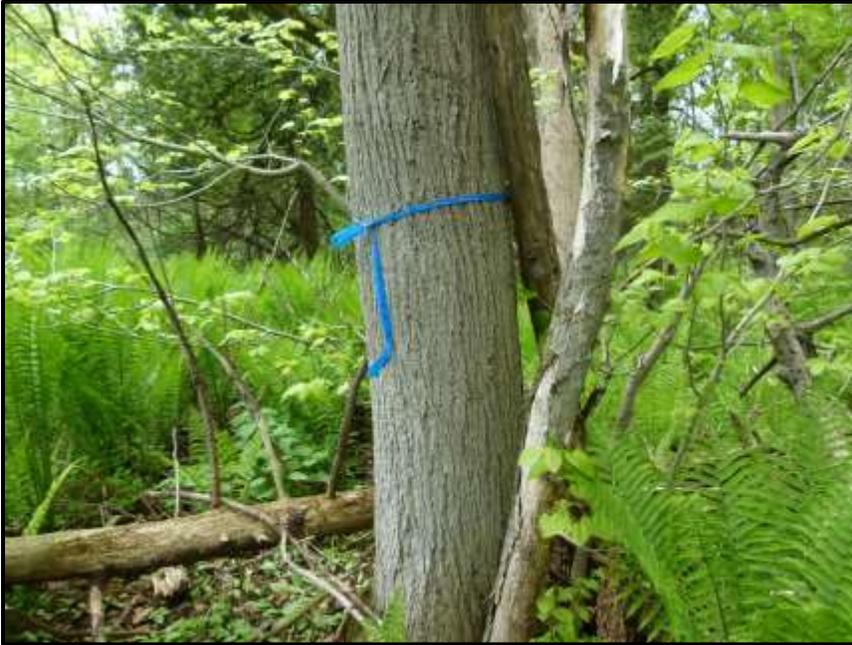
Photograph 33: Tree #34 – Basswood in good condition (May 27<sup>th</sup>, 2019).

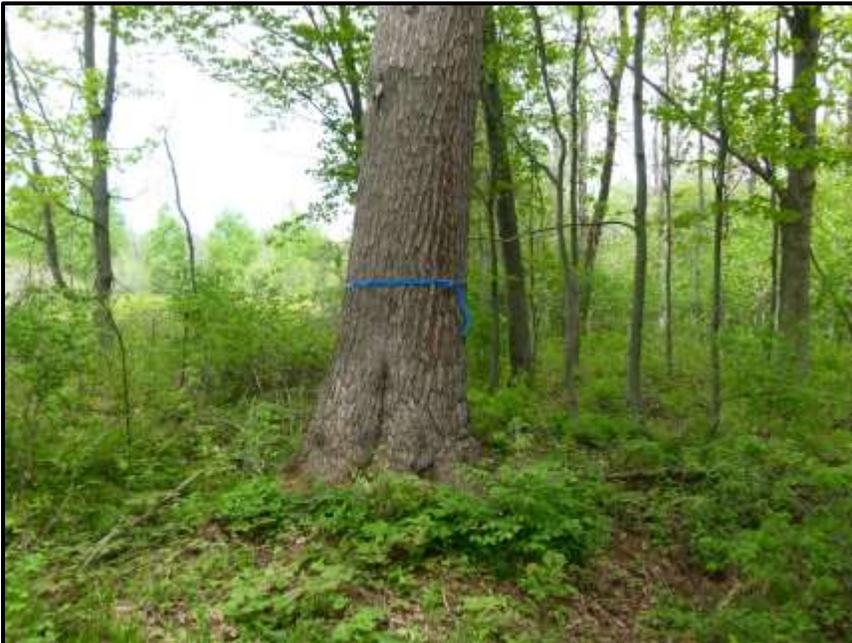
Photograph 34: Tree #35 – White Pine in good condition (May 27<sup>th</sup>, 2019).

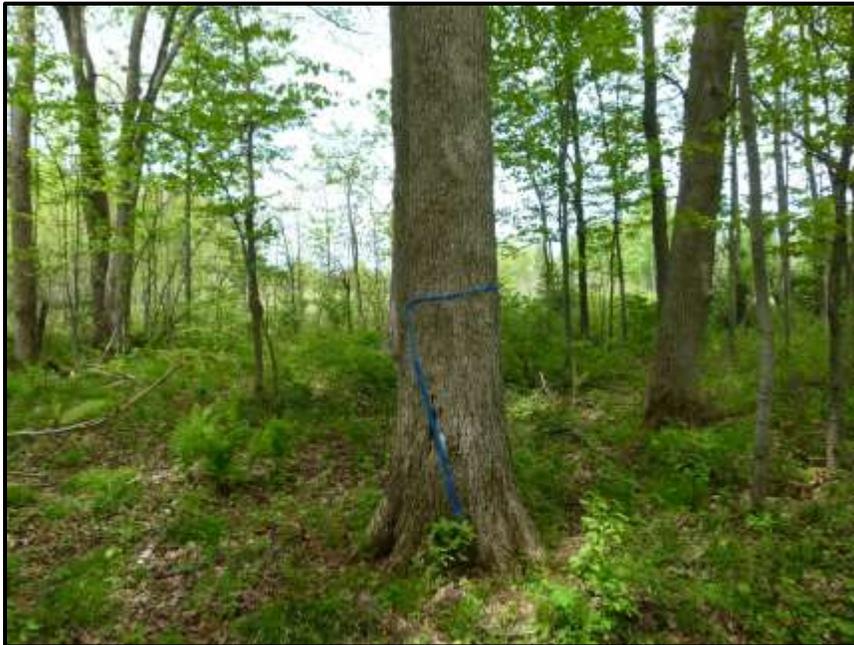
Photograph 35: Tree #36 – Bur Oak in good condition (May 27<sup>th</sup>, 2019).

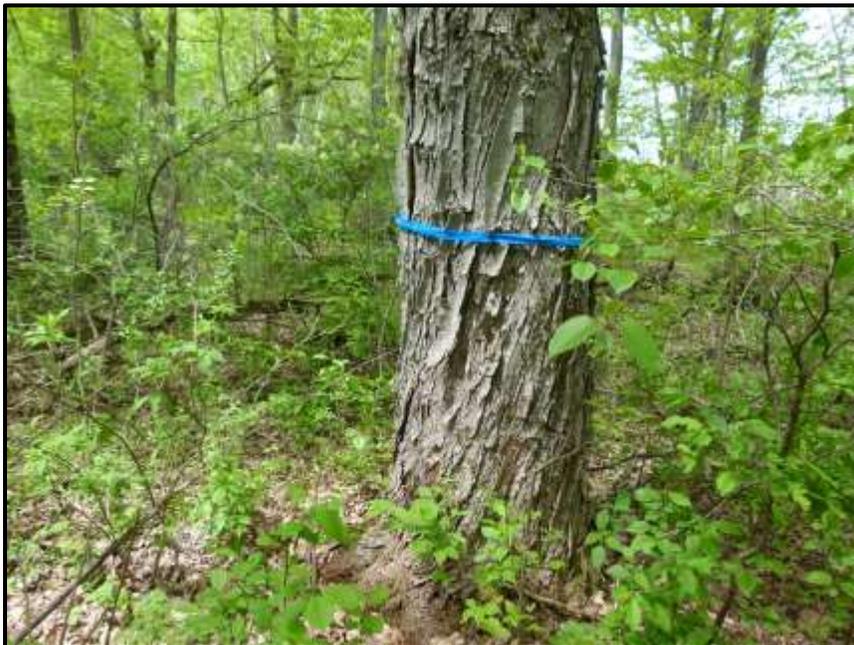
Photograph 38: Tree #39 – Sugar Maple in good condition (May 27<sup>th</sup>, 2019).

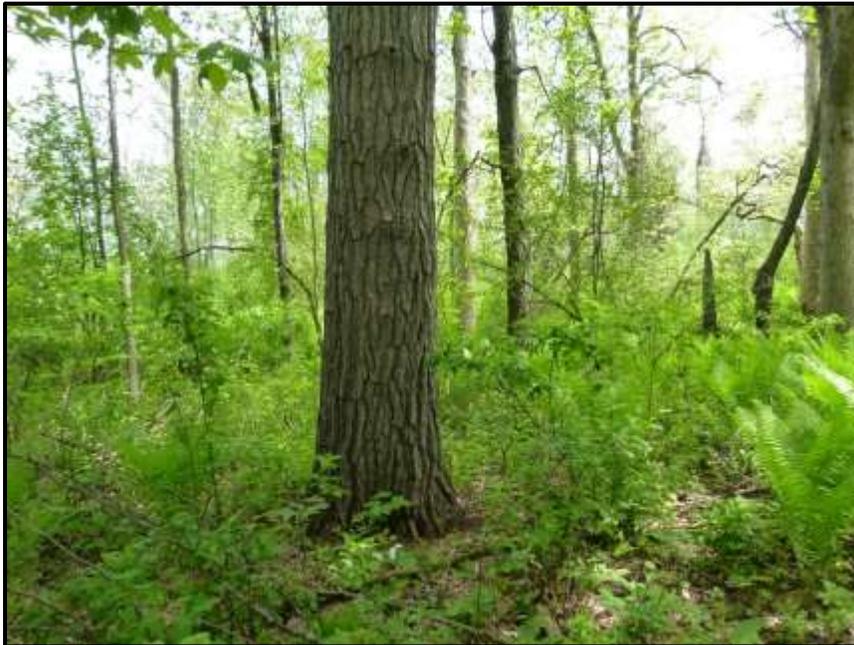
Photograph 39: Tree #40 – White Pine in good condition (May 27<sup>th</sup>, 2019).

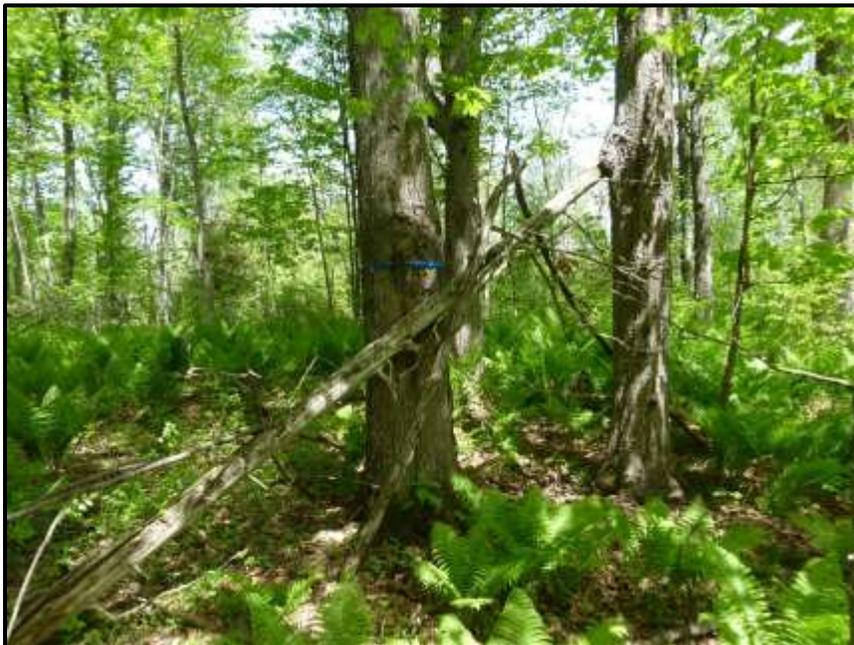
Photograph 40: Tree #41 – Sugar Maple in good condition (May 27<sup>th</sup>, 2019).

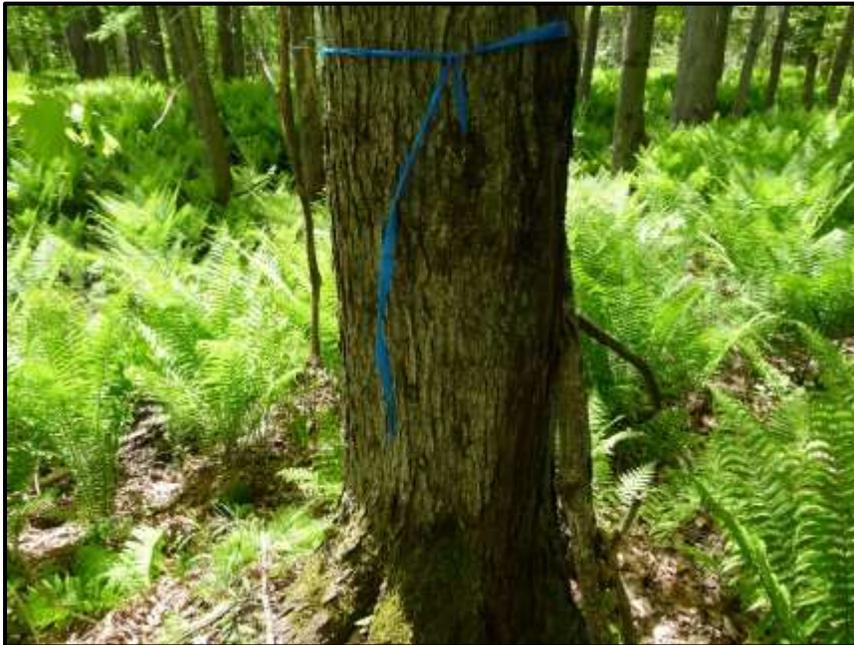
Photograph 41: Tree #42 – Sugar Maple in good condition (May 27<sup>th</sup>, 2019).

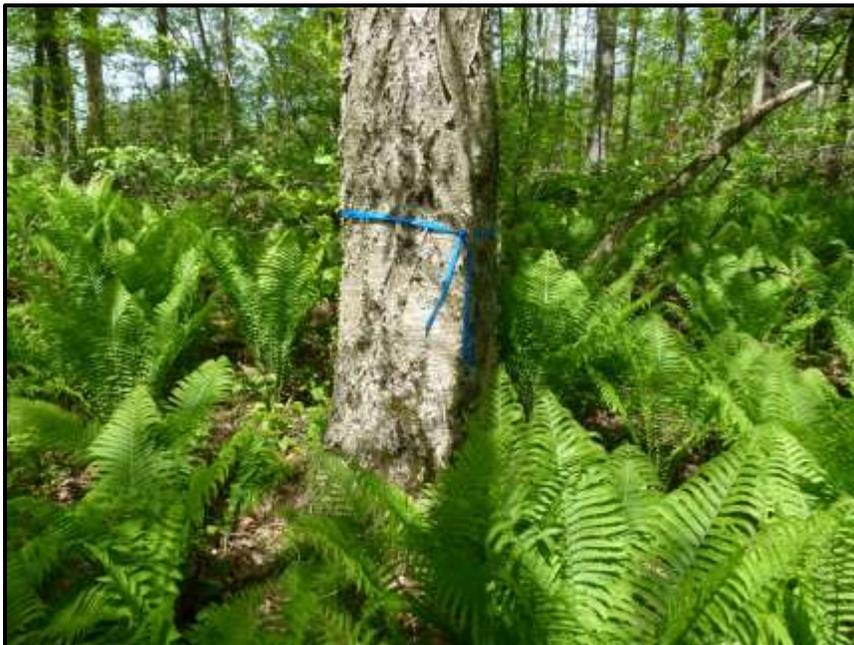
Photograph 42: Tree #43 – Yellow Birch in good condition (May 27<sup>th</sup>, 2019).

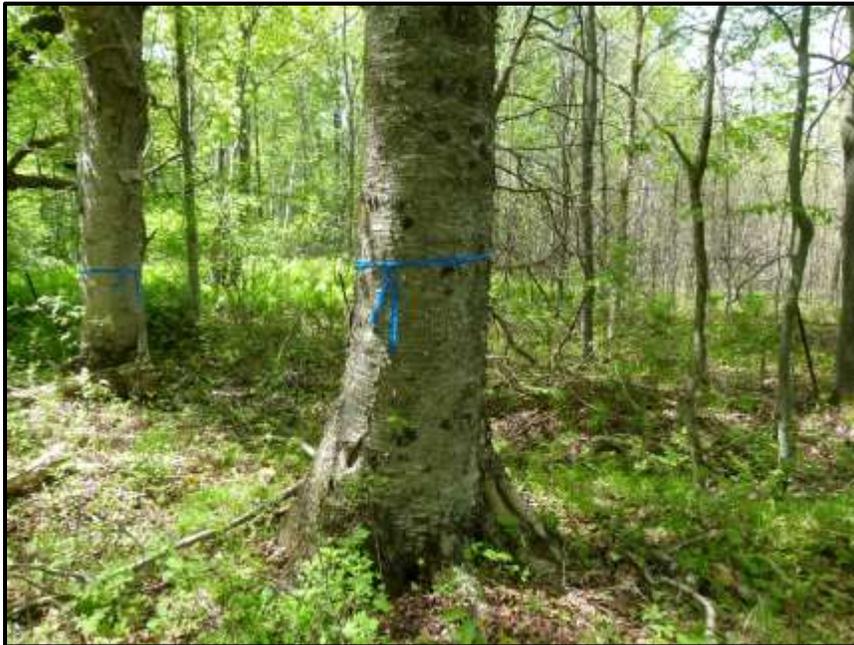
Photograph 43: Tree #44 – Yellow Birch in good condition (May 27<sup>th</sup>, 2019).

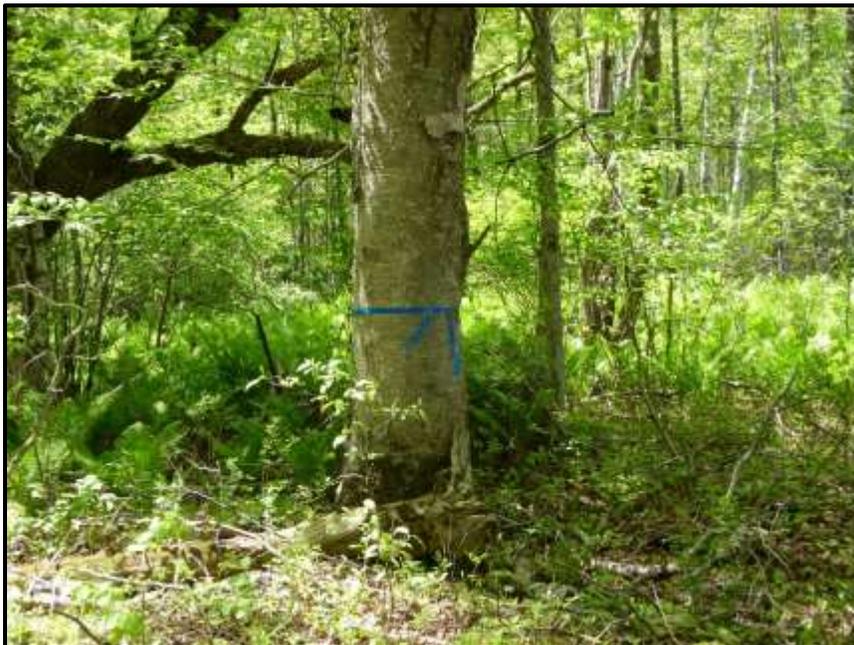
Photograph 44: Tree #45 – Yellow Birch in good condition (May 27<sup>th</sup>, 2019).

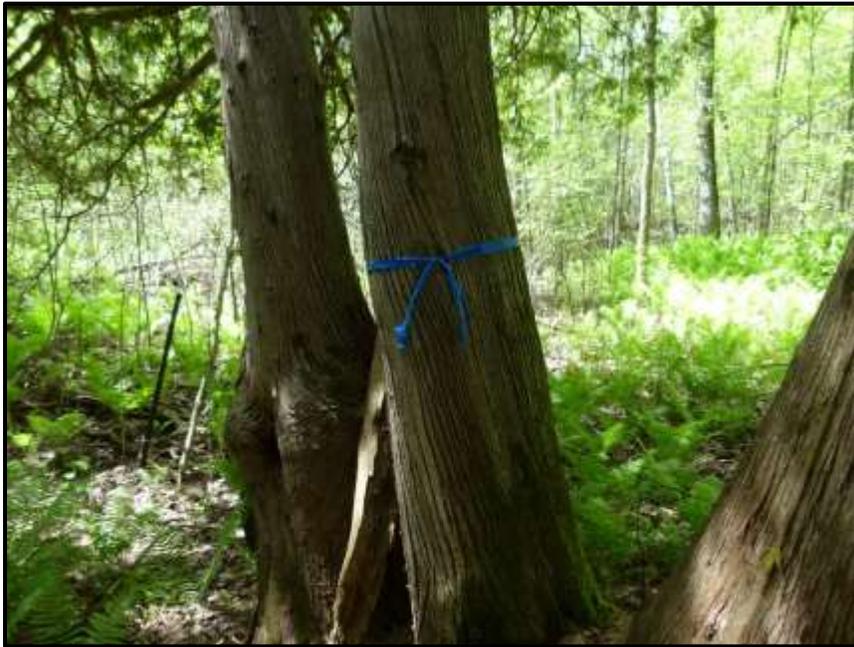
Photograph 45: Tree #46 – White Cedar in good condition (May 27<sup>th</sup>, 2019).

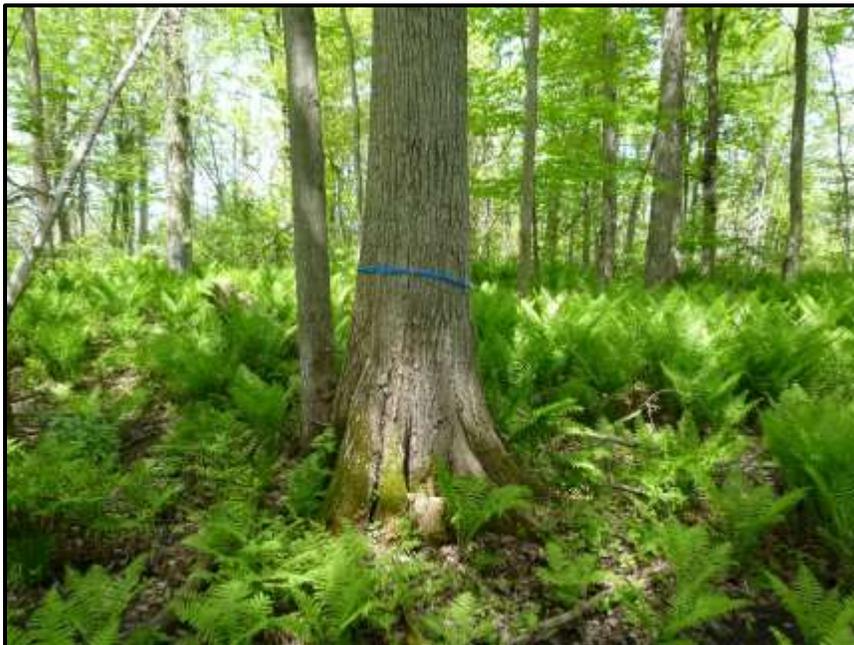
Photograph 46: Tree #47 – American Elm in good condition (May 27<sup>th</sup>, 2019).

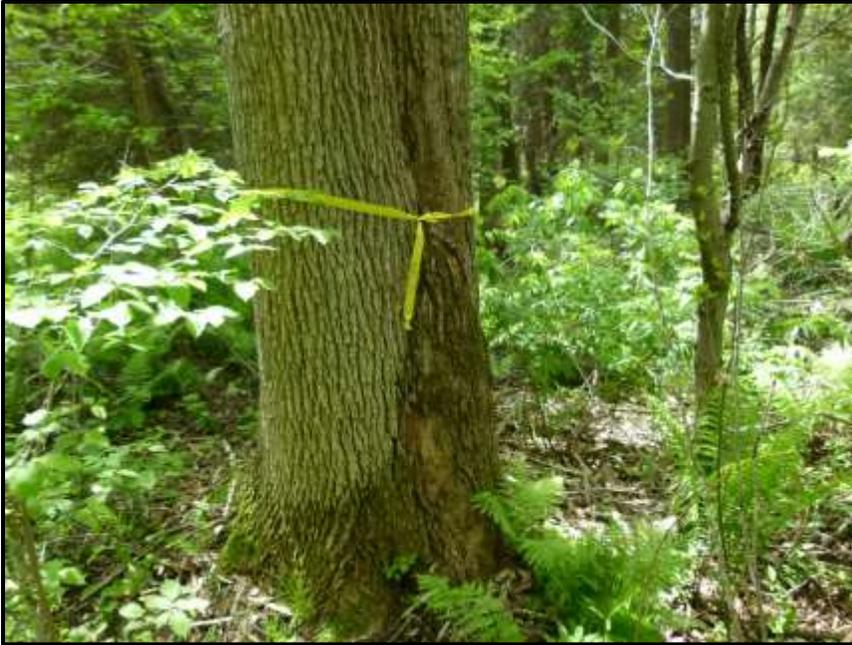
Photograph 51: Tree #52 – dead White Ash (May 27<sup>th</sup>, 2019).

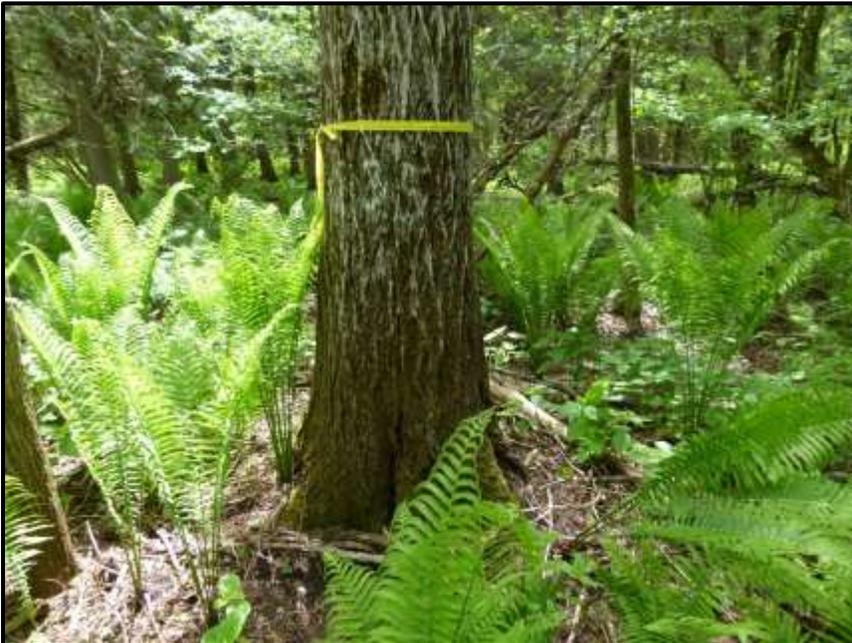
Photograph 52: Tree #53 – Category 3 Butternut (May 27<sup>th</sup>, 2019).

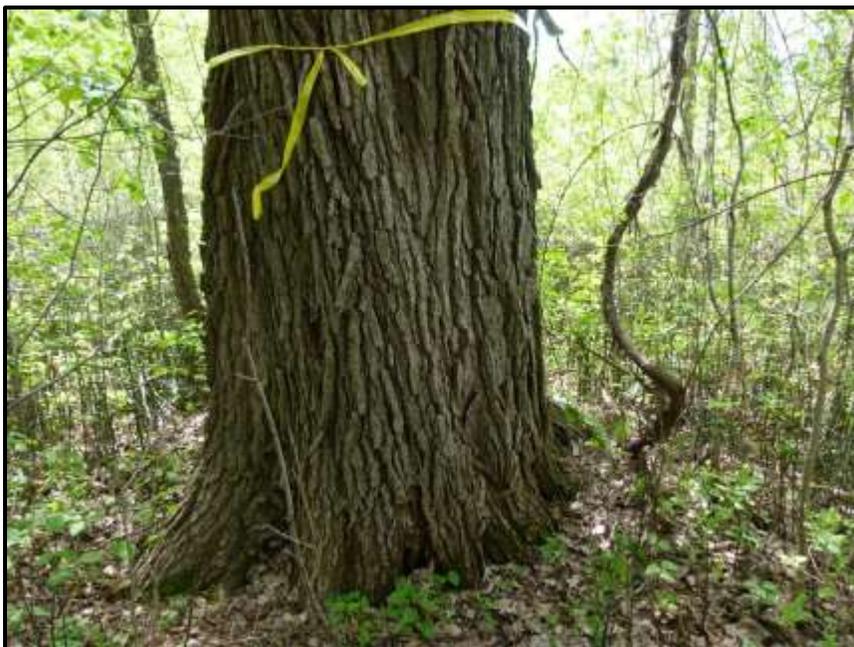
Photograph 54: Tree #55 – Bur Oak in good condition (May 30<sup>th</sup>, 2019).

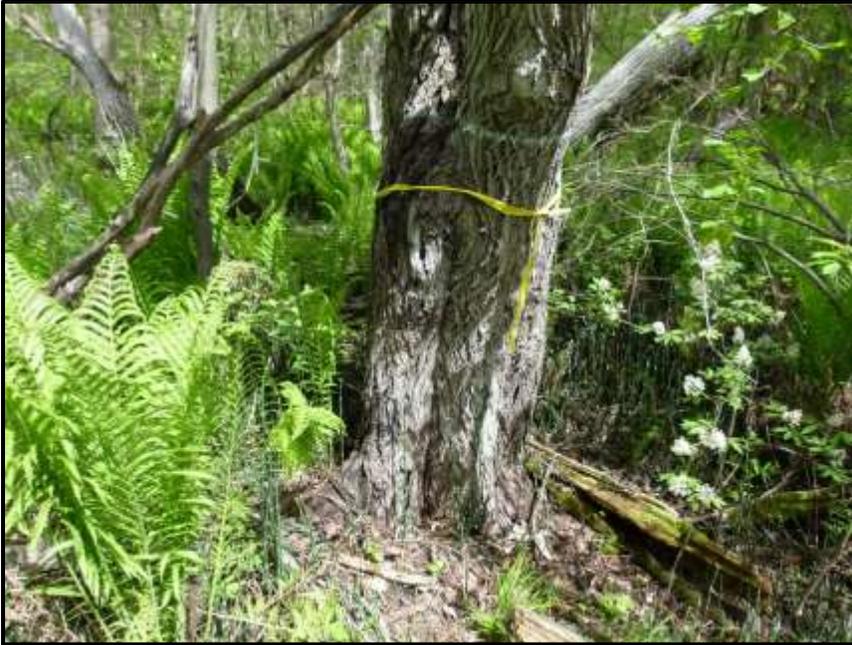
Photograph 55: Tree #56 – Category 3 Butternut (May 30<sup>th</sup>, 2019).

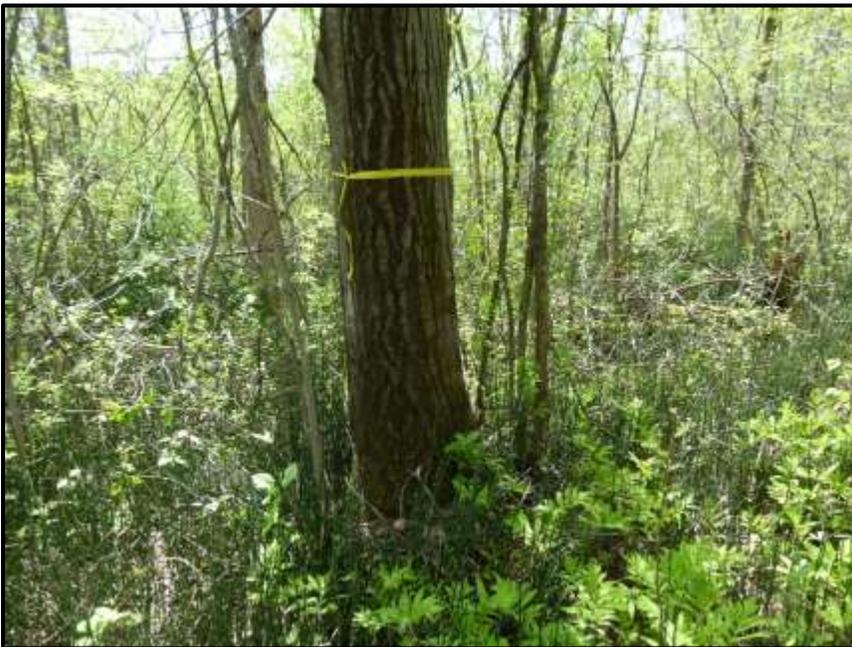
Photograph 56: Tree #57 – Trembling Aspen in good condition (May 30<sup>th</sup>, 2019).

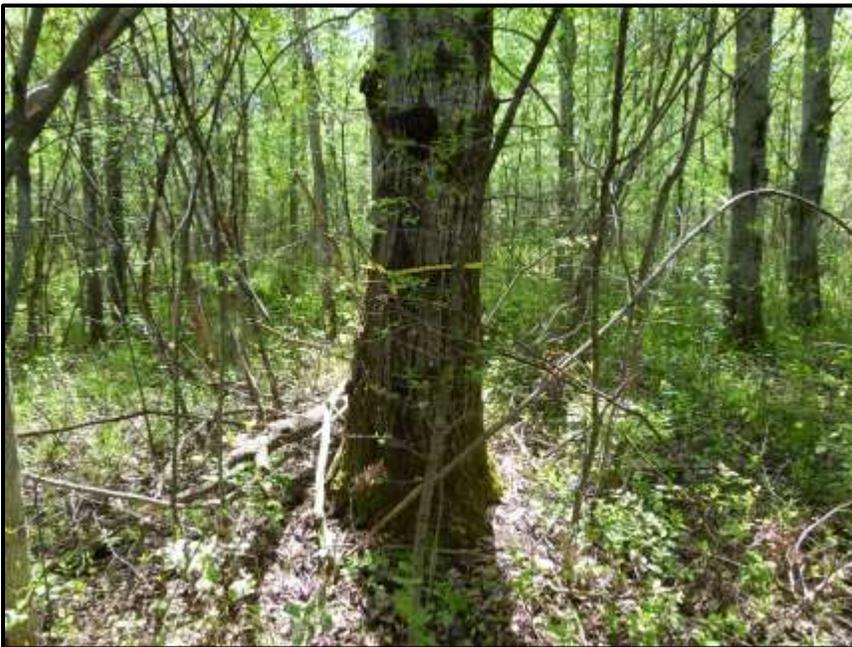
Photograph 58: Tree #59 – Trembling Aspen in good condition (May 30<sup>th</sup>, 2019).

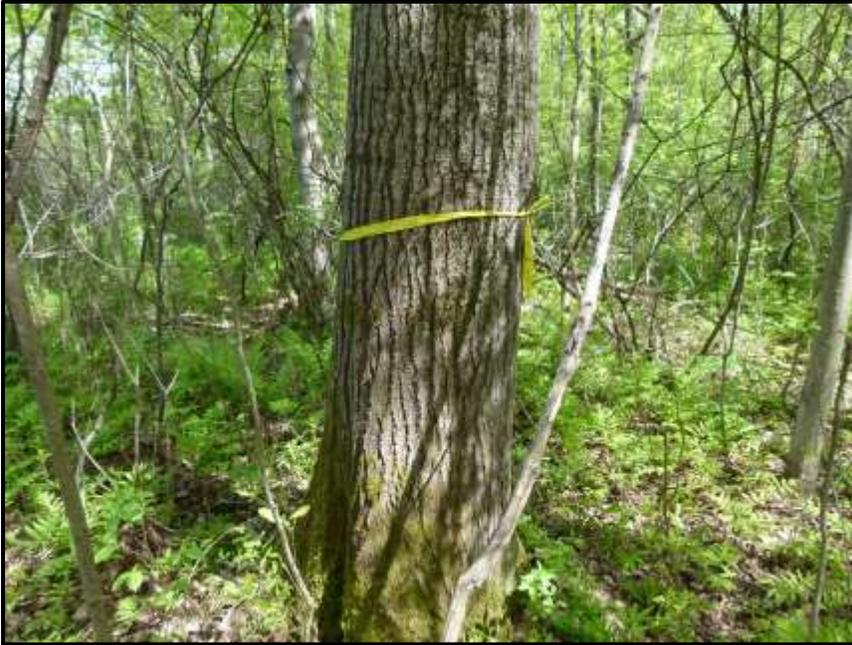
Photograph 59: Tree #60 – Trembling Aspen in good condition (May 30<sup>th</sup>, 2019).

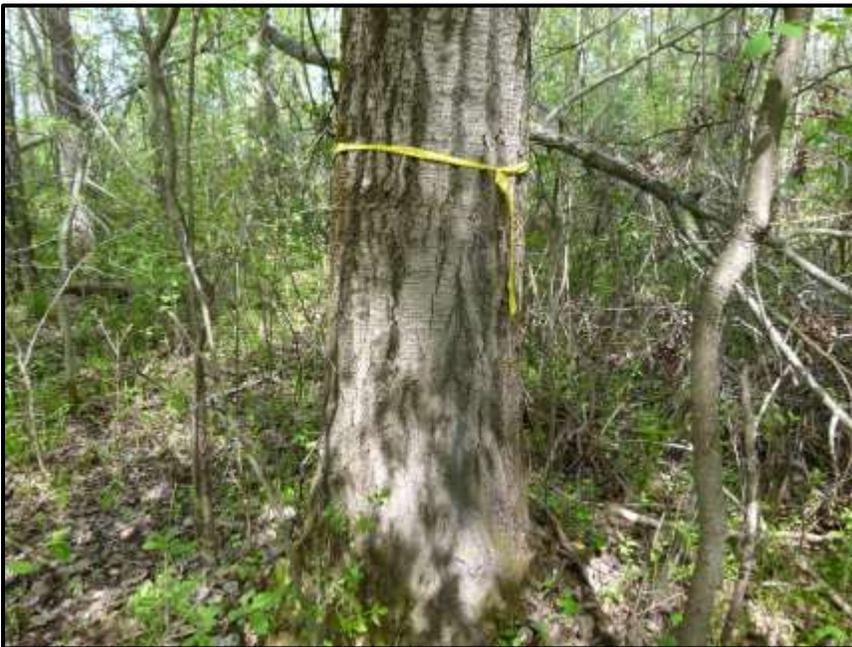
Photograph 60: Tree #61 – Trembling Aspen in good condition (May 30<sup>th</sup>, 2019).

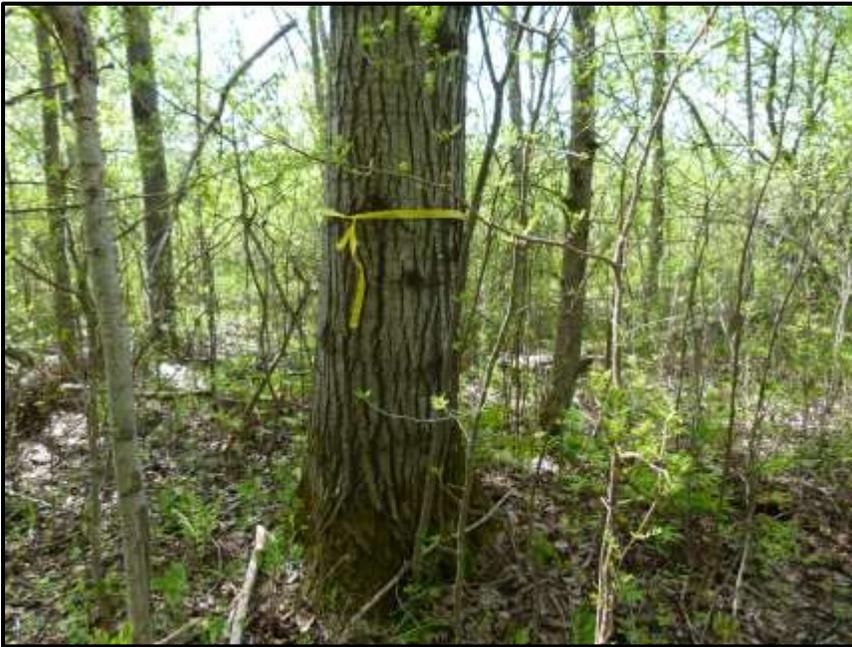
Photograph 61: Tree #62 – Trembling Aspen in good condition (May 30<sup>th</sup>, 2019).

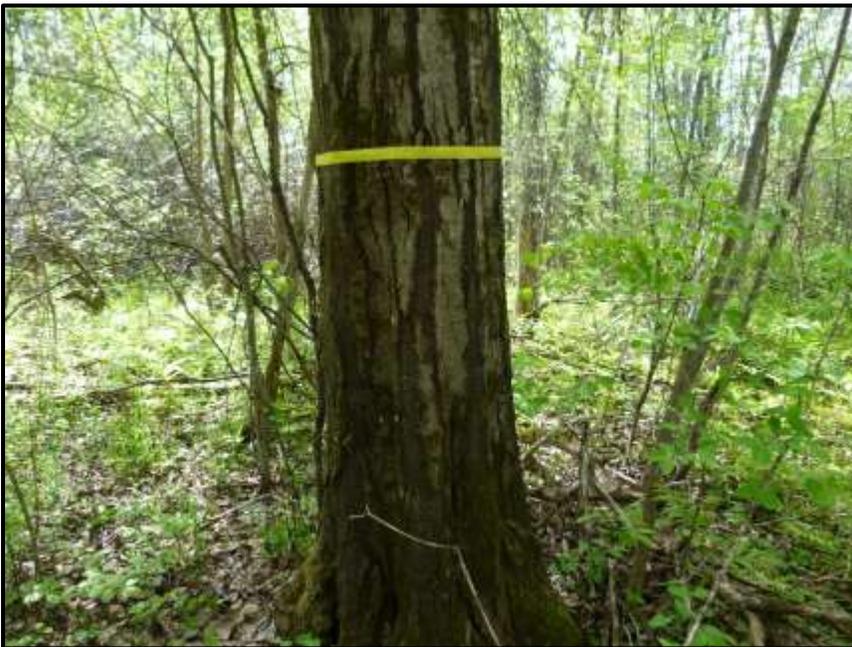
Photograph 62: Tree #63 – Trembling Aspen in good condition (May 30<sup>th</sup>, 2019).
