June 3<sup>rd</sup>, 2019

RE: Woodlot S-23 Large Tree Inventory – Minto Communities and Valecraft Homes Kanata North  
Developments

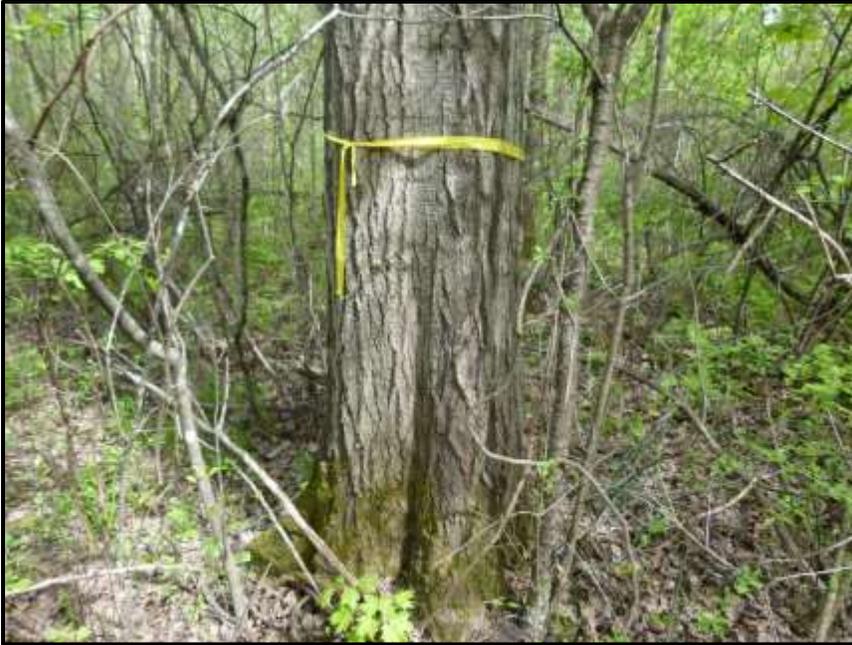
Photograph 63: Tree #64 – Trembling Aspen in good condition (May 30<sup>th</sup>, 2019).

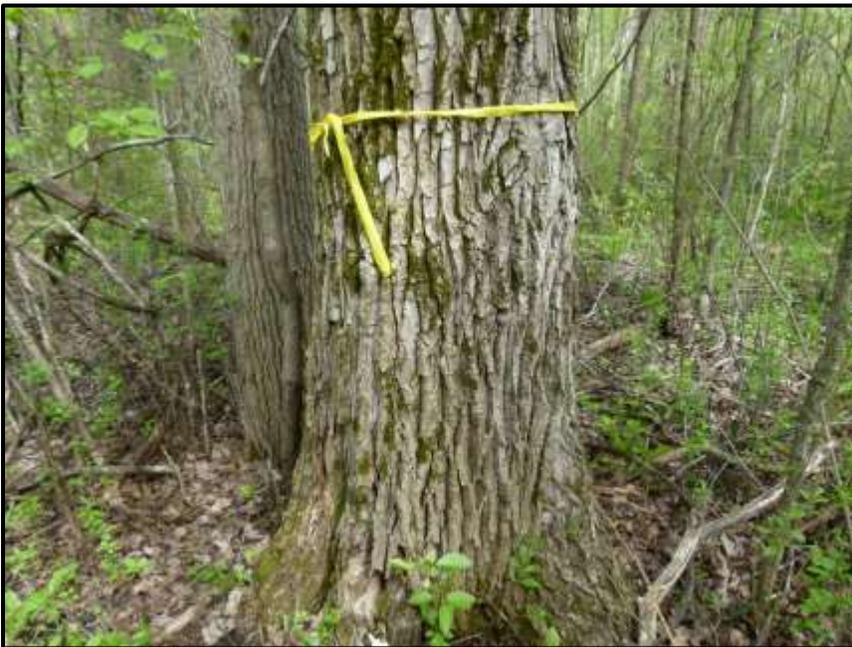
Photograph 64: Tree #65 – Trembling Aspen in good condition (May 30<sup>th</sup>, 2019).

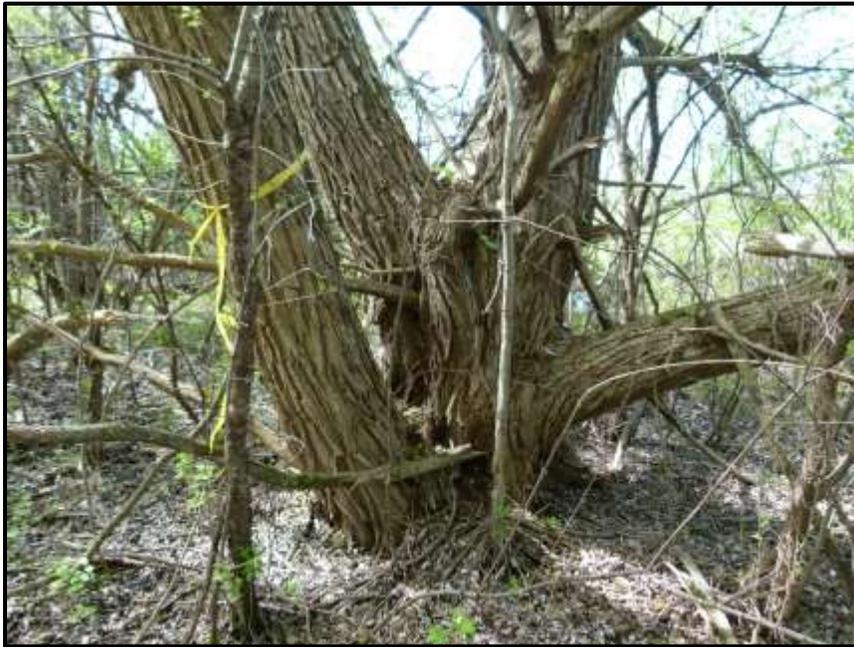
Photograph 65: Tree #66 – Crack Willow in good condition (May 30<sup>th</sup>, 2019).

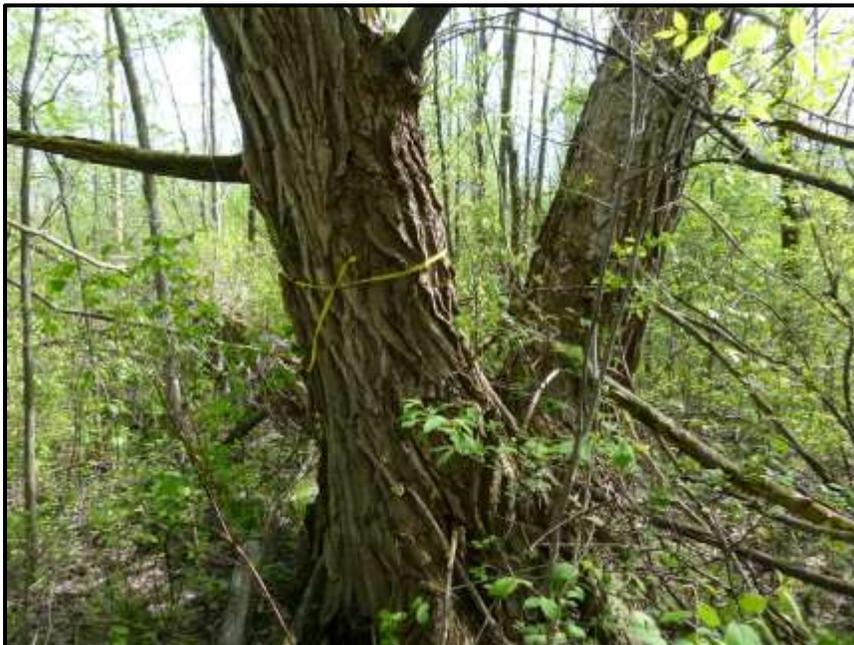
Photograph 66: Tree #67 – Crack Willow in good condition (May 30<sup>th</sup>, 2019).

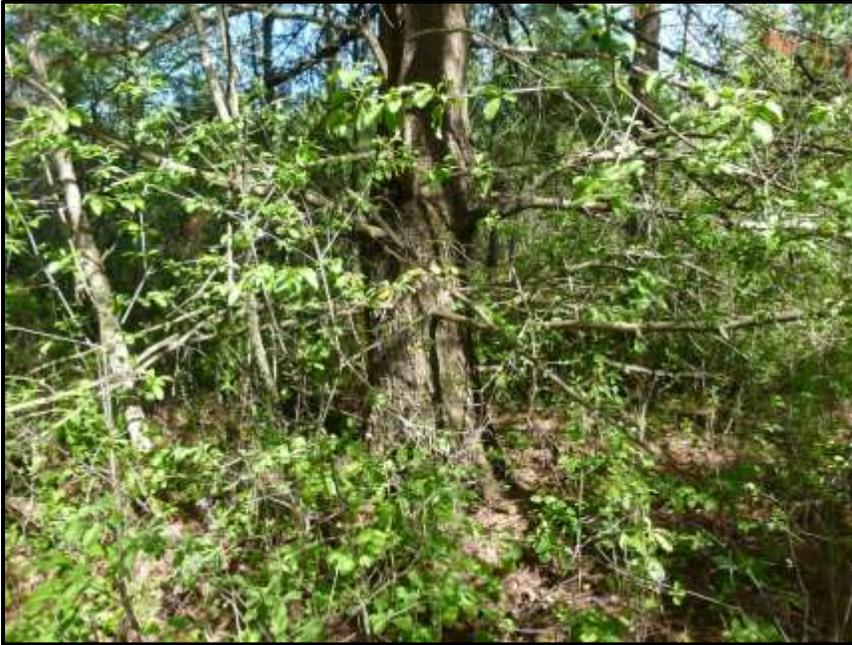
Photograph 67: Tree #68 – White Pine in good condition (May 30<sup>th</sup>, 2019).

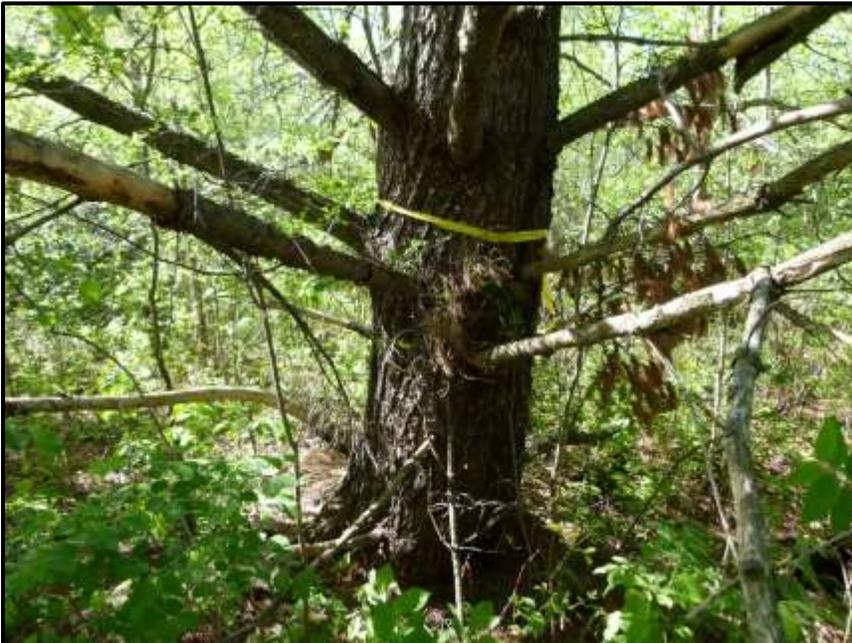
Photograph 68: Tree #69 – White Pine in good condition (May 30<sup>th</sup>, 2019).

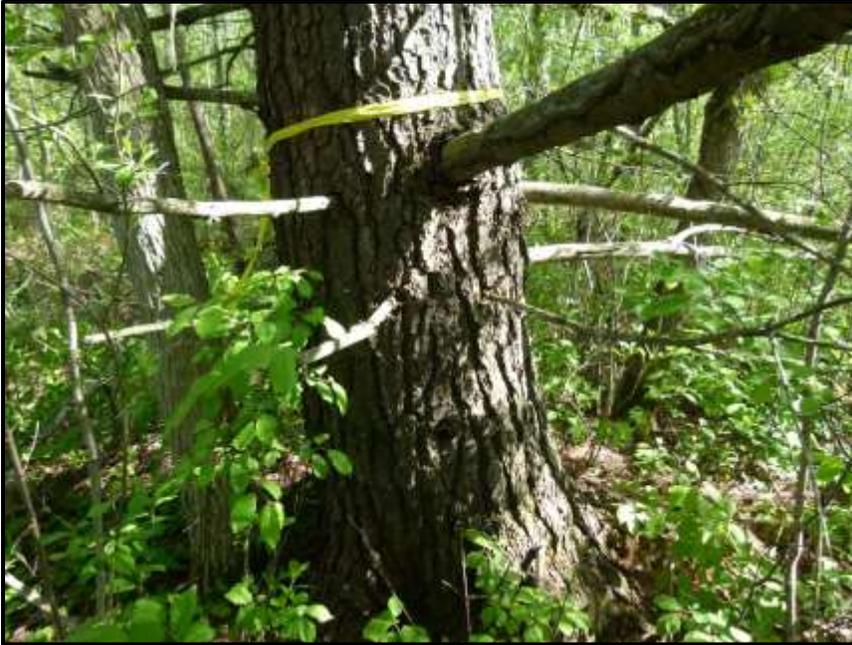
Photograph 69: Tree #70 – White Pine in good condition (May 30<sup>th</sup>, 2019).

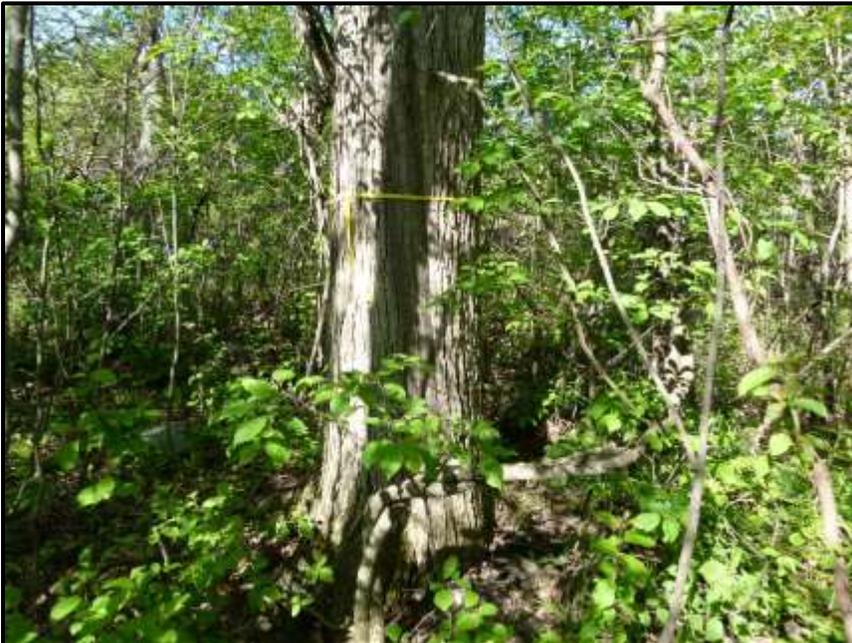
Photograph 70: Tree #71 – White Pine in good condition (May 30<sup>th</sup>, 2019).
